CHAPTER 16 – REFERENCES

LIQUID PHASE DIFFUSION BOND REPAIR OF WESTINGHOUSE 501F, ROW 3 VANES

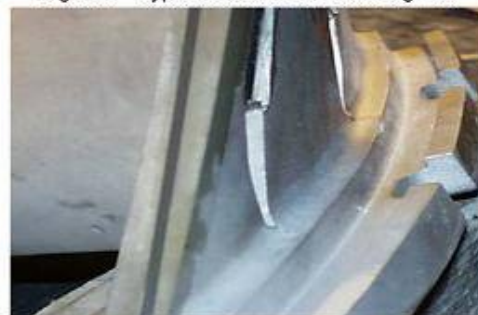
pits/dents and build up the hook fit areas as a result of downstream deflection of the inner buttress/seal areas, as a result of axial creep. Figure 1 shows a typical example of a W501F, Row 3 vane with 3 airfoils. The vane is cast from a Cobalt superalloy referred to as X-45. Its chemical composition is Co-25.5Cr-10.5Ni-7W-0.25C-2(max)Fe-0.010B. The high Cr content contributes to corrosion, low temperature oxidation and sulphidation resistance.

Figure 6 – Hook fit area, which needs to be restored

Figures 42(a) and (b) show the build up of the hook fit areas, which was required because of downstream deflection of the inner buttress/seal areas, as a result of axial creep.

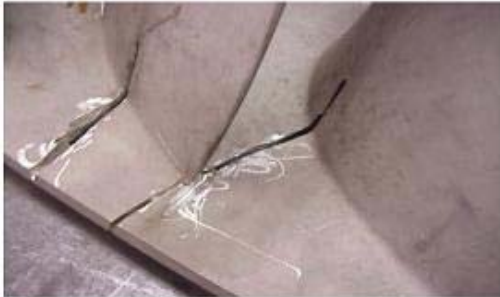
Figure 35(a) – Routed crack

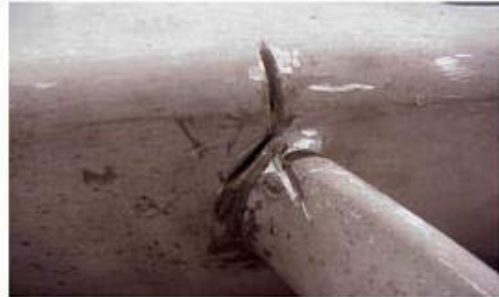
Figure 37(a) – Routed crack

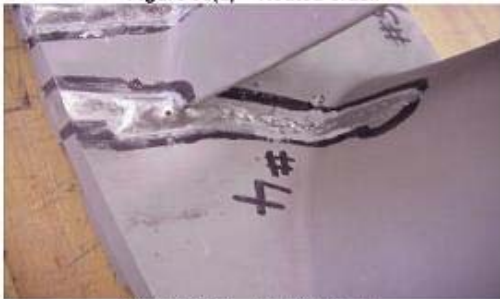
Figure 35(b) – Repaired area

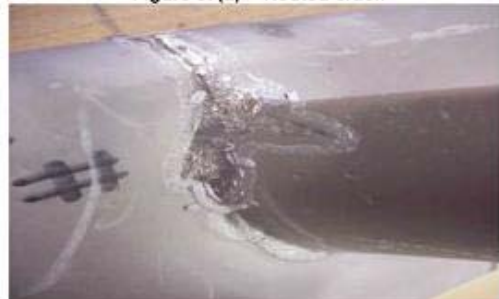
Figure 37(b) – repaired area

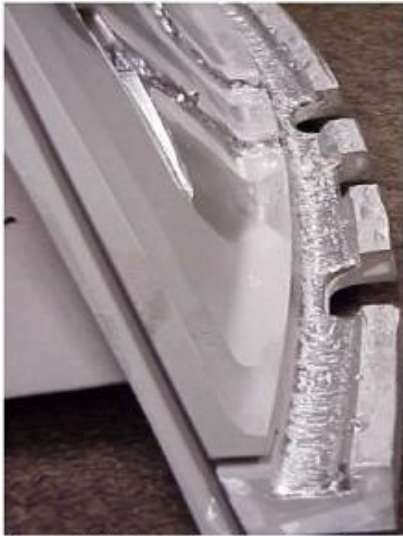
Figure 42(a) – Hook fit restoration, using paste.

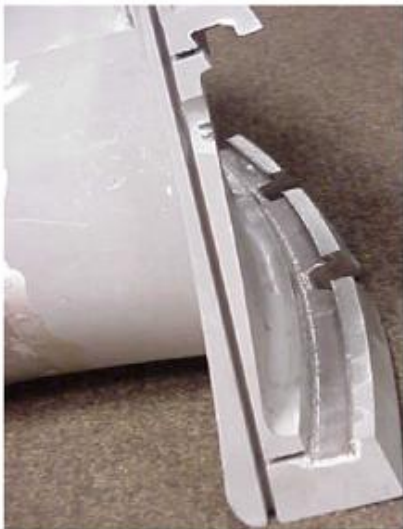
Figure 42(b) – Hook fit restoration, using pre-sintered plate.

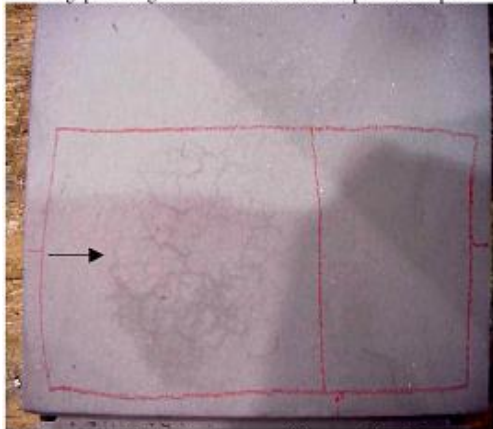
stage stator segments as well as to repair cracks and pits/dents. The process was also used to repair craze cracking on the Row 2 vanes. Figures 1-4 show typical examples of the cracking on both components. The Row 2 vanes and 2nd stage stator segments are cast from IN738 and IN939, respectively. The nominal composition of IN738 and IN939 is Ni-16Cr-8.5Co-1.75Mo-2.6W-1.75Ta-0.9Nb-3.4Al-3.4Ti-0.1Zr-0.17C and Ni-22.4Cr-19Co-2W-1.4Ta-1Nb-1.9Al-3.7Ti-0.1Zr-0.15C, respectively. These cracks are wide; therefore conventional narrow gap brazing cannot be utilised as a repair technique.

Figure 1 – Typical craze cracking on the Siemens V84.2, Row 2 vane.

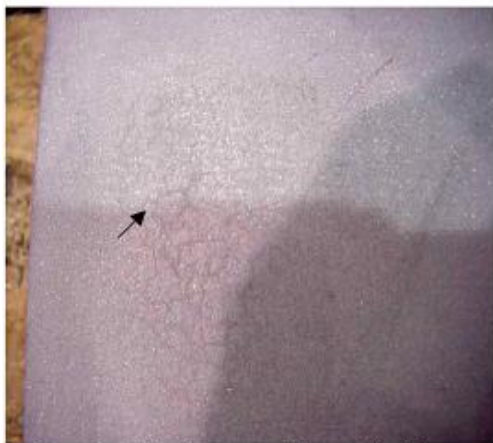
Figure 2 – Typical craze cracking on the Siemens V84.2, Row 2 vane.

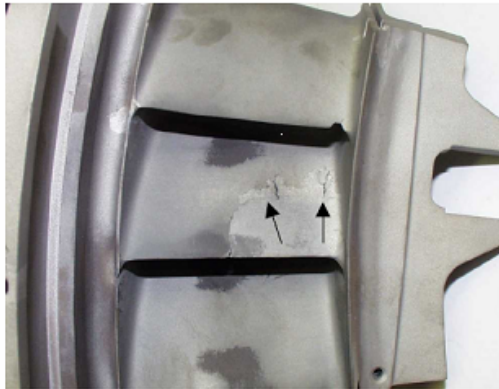
IN939 as a result of its high Al + Ti content is not readily weldable and suffers from strain age cracking, as seen in Figs. 11 and 12.

Figure 11 – Strain age cracking, on the airfoil, after initial attempts at a weld repair.

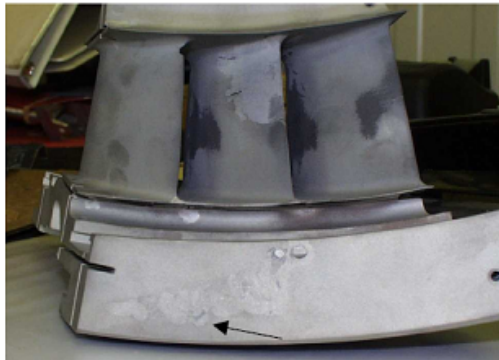
Figure 12 – Strain age cracking, on the shroud/butress, after initial attempts at a weld repair.

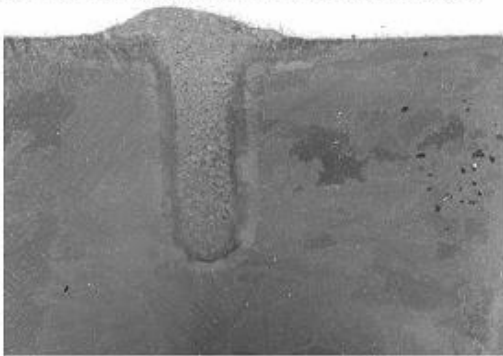
Figure 22 shows the macrograph of a cross section taken through the LPDB repair of the Tornado 2nd stage stator segment. As can be seen the filler metal has flowed completely down to the bottom of the crack and has bonded excellently to

Figure 22 – Macrograph of the joint taken through the LPDB repair of the Tornado, 2nd stage stator segment. Mag. 5X

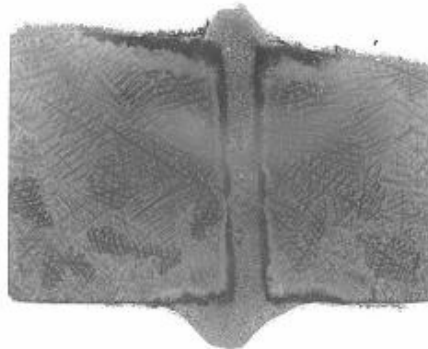
the sidewalls of the routed out crack. Figure 23 shows a cross section taken through a “through” crack at the trailing edge of the airfoil. Once again there is good bonding to the sidewalls of the routed out crack.

Figure 23 - Macrograph of the joint taken through the LPDB repair of the Tornado, 2nd stage stator segment. Mag. 5X

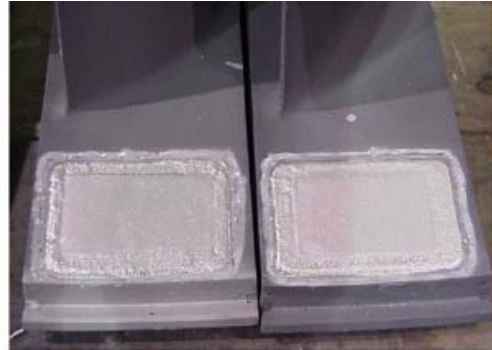
Figure 35 – V84.2, row 2 vanes repaired with the LPDB process.

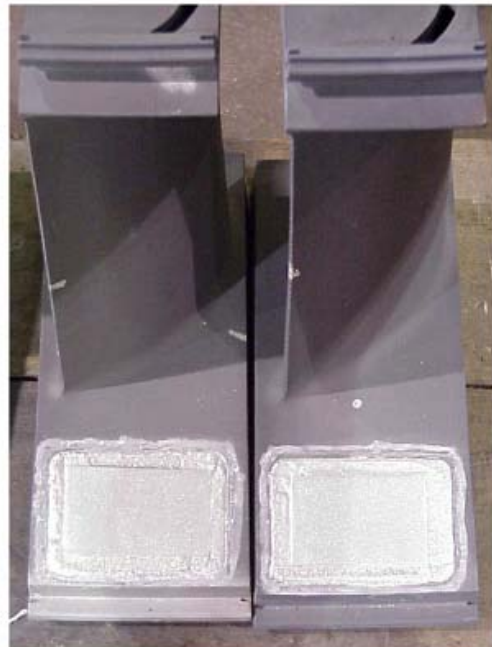
Figure 36 – V84.2, row 2 vanes repaired with the LPDB process.

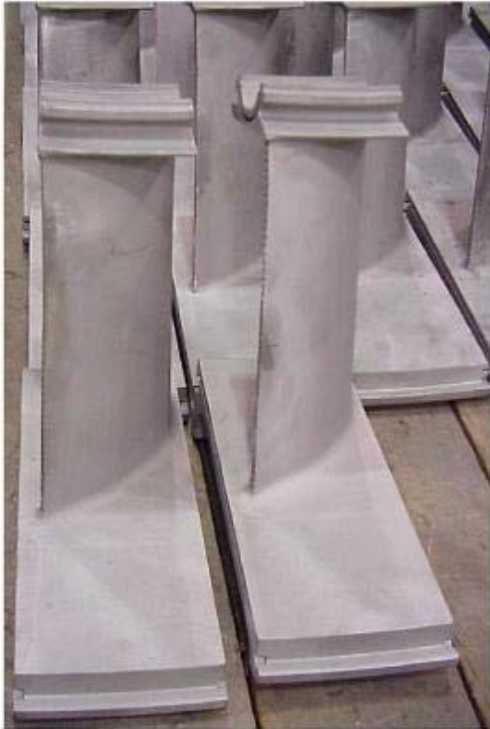
Figure 37 - V84.2 row 2 vane after complete repair including heat treatment and MCrAlY coating.

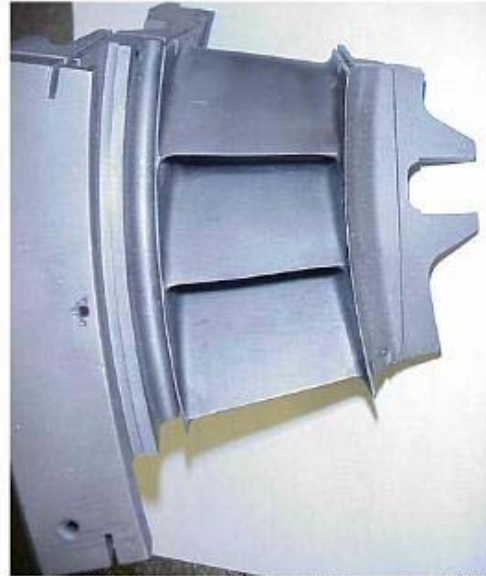
Figures 38 and 39 show the Tornado, 2nd stage stator segment after complete repair including heat treatment and Sermaloy J coating. (Sermaloy J is an aluminide coating that is proprietary to Sermatech International, Inc.)

Figure 38 – Tornado, 2nd stage stator segment after complete repair including heat treatment and Sermaloy J coating.

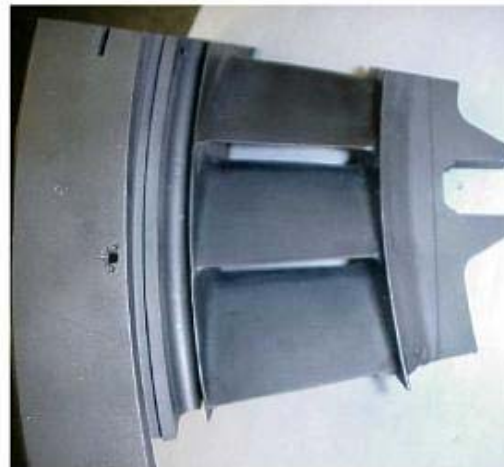
Figure 39 – Tornado, 2nd stage stator segment after complete repair including heat treatment and Sermaloy J coating.

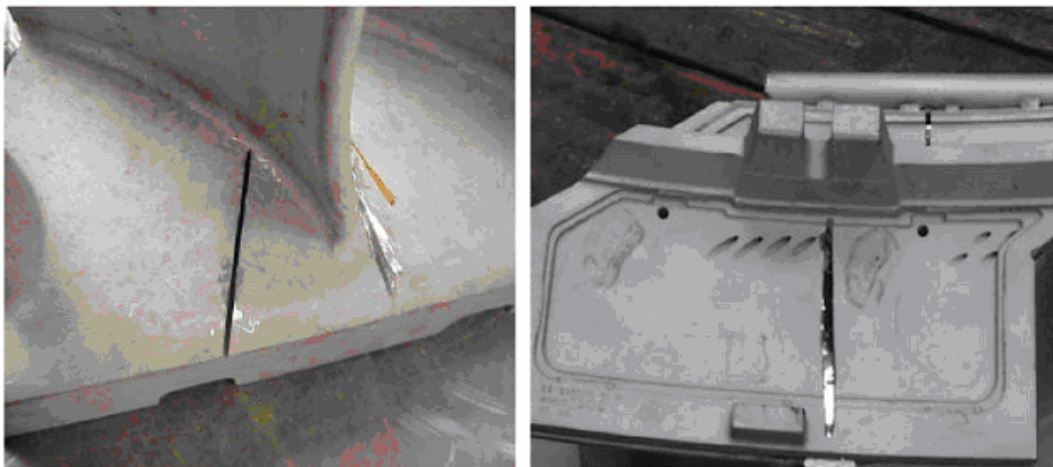
Figure 1: Ground out cracks on an X-45, W501F, Row 3 vane. Figure 2: Ground out cracks on an FSX-414, GE Frame 7EA vane.

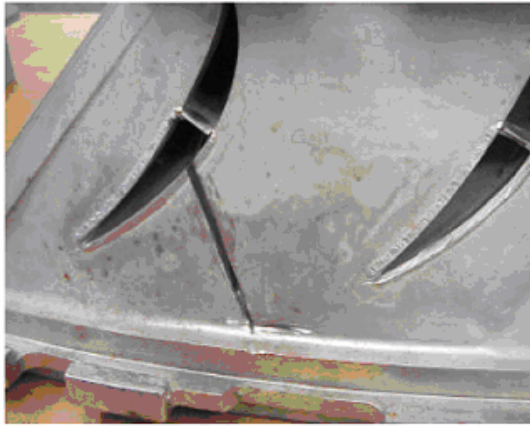
Figure 3: Ground out cracks on an X-45, W501F, Row 3 vane.

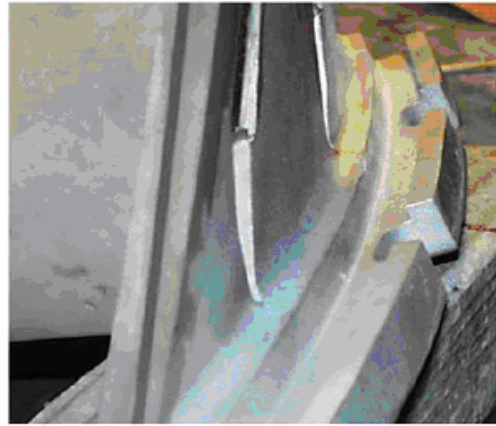
Figure 4: Hook fit area, which need to be built up.

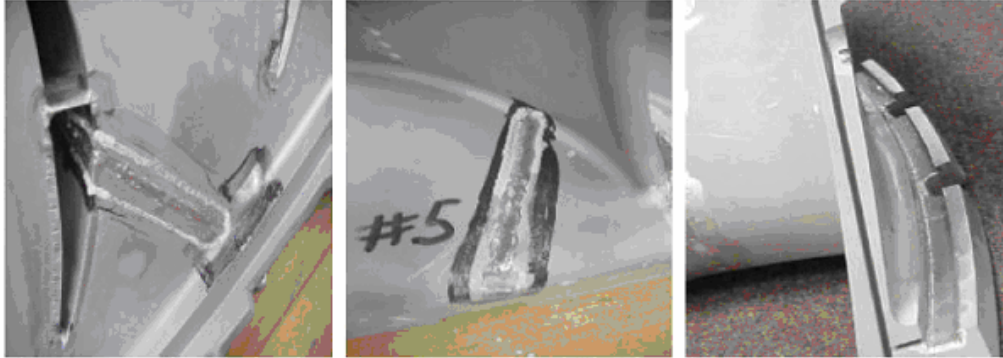
Figure 13: Brazed repaired region. Figure 14: Brazed repaired region. Figure 15: Brazed built up hook-fit

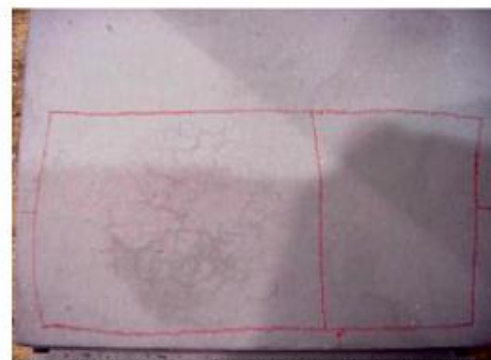
Figure 1 – Typical craze cracking on the Siemens V84.2, Row 2 vane.

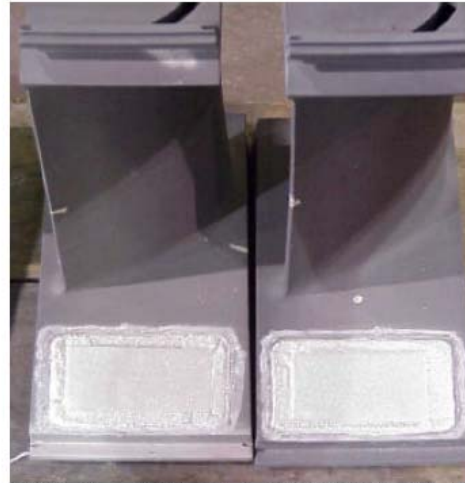
Figure 16 - V84.2, row 2 vanes repaired with the alternative wide gap braze process.

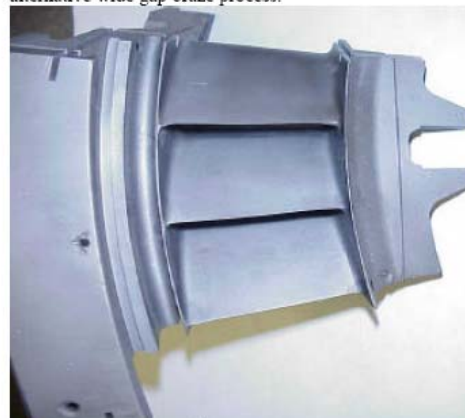
Figure 17 - Tornado, 2nd stage stator segment after complete repair including heat treatment and Sermaloy J coating.
