# Arnot's readiness to prevent a Pike River disaster

Paper written on project work carried out in partial fulfilment of B. Eng. (Mining Engineering)

## Synopsis

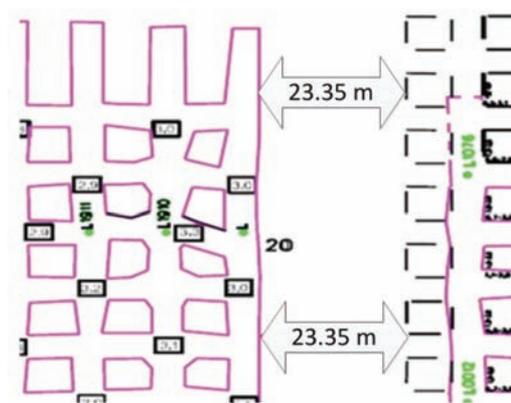
Figure 1—Mining layout showing barrier pillars

- *COP requirement*—Barrier pillars should be spaced 15 m apart.
- *Actual*—From Figure 1 it can be seen that the barrier pillar spacing separating panels averages 23.35 m, thus complying with the COP

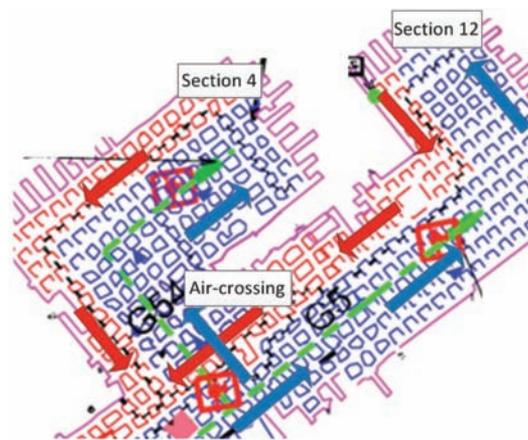
Figure 2—Air-crossing separating ventilation districts

- *COP requirement*—Each section should have its own ventilation district with a separate set of ventilation controls
- *Actual*—It can be seen from Figure 2 that Section 4 and Section 12 have separate ventilation districts, which means each section has separate intakes as well as return airways. The air flows are kept separate by making use of walls and air crossings, thus complying with the COP

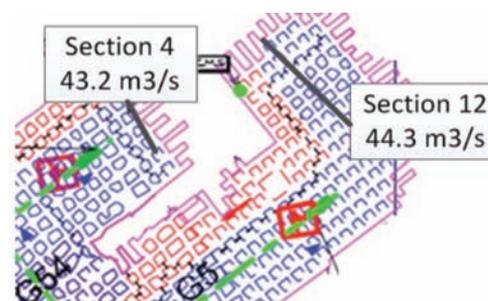
Figure 3—Section 4 and Section 12 layout and air flow rates

From Figure 3 it can be seen that that sections 4 and 12 comply with the COP. The air flow in Section 3 was measured as 46.9 m<sup>3</sup>/s, thus also complying with the COP.

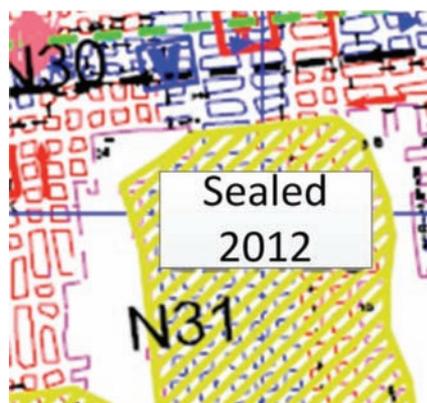
Figure 4—Example of sealed and unsealed abandoned panels

- *COP requirement*—Abandoned panels should be sealed off or ventilated until they are sealed off. Where they are still ventilated, the air flow velocity in the LTR should be greater than 0.5 m/s
- *Actual*—From Figure 4 it can be seen that panel N31 is abandoned and thus sealed off as required by the COP. Figure 5 shows an abandoned panel that is still being ventilated prior to sealing off. The air flow velocity is 1.1 m/s, thus complying with COP.

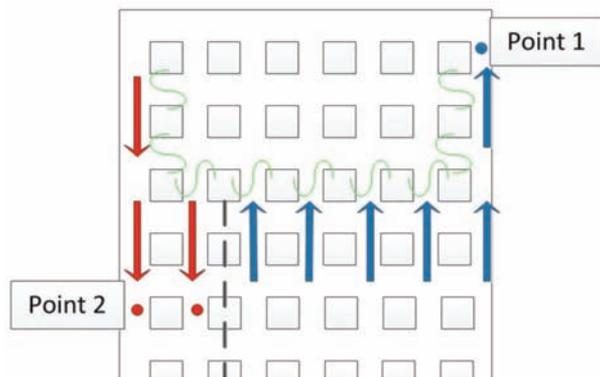
Figure 7—Layout of a basic section at Arnot

The scoop/line brattice efficiency can be calculated by comparing the quantity of air entering the section (point 1, Figure 7) to the quantity of air leaving the section (point 2). As an example, if the amount of air entering is 1.6 m/s and the amount leaving is 1.6 m/s, the efficiency will amount to 100 per cent.

It is recommended that the efficiency be maintained equal to or greater than 70 per cent.

From Table VI it can be recommended that the scoop/line brattice efficiency on Section 4 must be drastically increased, since this low efficiency results in less air being supplied in the last through-road. Section 12 can also consider improving their efficiency. Section 3 has the highest efficiency, but it is still nevertheless recommended that more effort be put into minimizing the number of readings below 70 per cent efficiency.
