A STUDY OF THE PEDESTRIAN PUBLIC WAYS IN SÃO PAULO CITY CENTRE, BRASIL, FOCUSING ON WHEELCHAIR USERS

S H T VIZIOLI, G C BRUNA¹ and P T PERES²

KEYWORDS: Post-Occupancy Evaluation; accessibility; wheelchair; downtown São Paulo

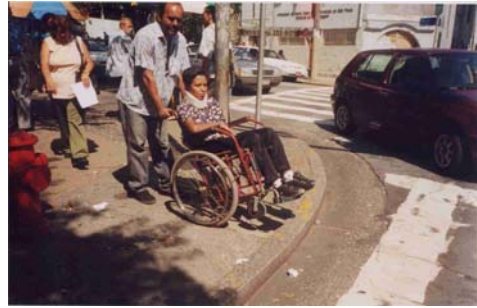
Activities in the downtown areas by day are intense and contradictory, and the transitory population is much larger than the residential population. Two types of uses are perceptible: the formality of services versus the casualness of the streets (Figure 1). The presence of basic public services in the area is well known, but the weakness in the residents' protection has caused a reduction of the downtown population. Figure 2 shows an example of an architectural barrier – no kerb ramp.

Figure 2: Route from the hospital to the subway station of Santa Cecília – without kerb ramps close to the pedestrian crossing. Photo: SHTV/2003

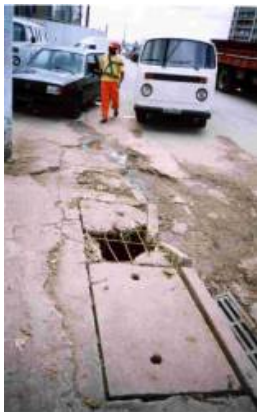
Figures 3 and 4 and show examples of the poor conditions in the area, such as the surfaces of the sidewalks and the pedestrian streets.

Figure 3: Gutter in poor state. Photo: SHTV/2004

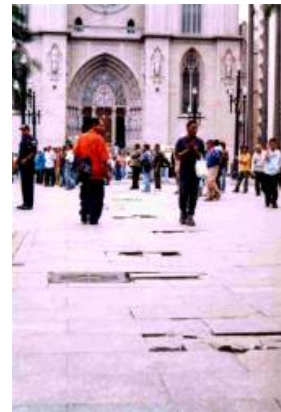
Figure 4: Sé square, loose granite slabs. Photo: SHTV/2004

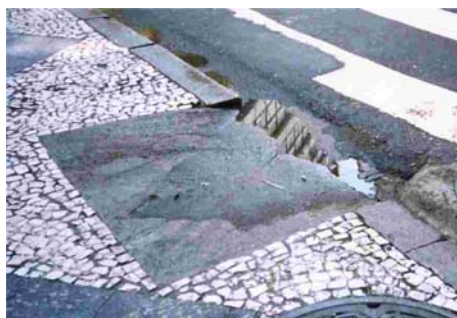
In some cases it could be verified that there had been an attempt to eliminate the barrier of the different levels of the ground with kerb ramps; however, as shown in Figures 5 and 6, it is not enough to build a ramp if the interface between the ramp and the street is still a large obstacle due to the water puddles accumulating through inadequate drainage, or due to a surface full of holes.

Figure 5: Kerb ramp not aligned with the street. Photo: SHTV/2004

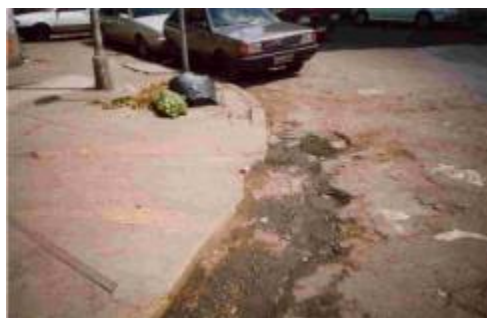
Figure 6: Kerb ramp according to the norms, but the street surface is full of holes. Photo: SHTV/2004

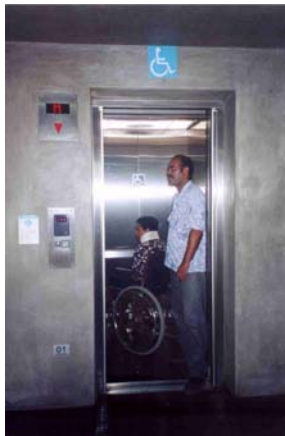
Projects such as these are pilots, and it is still necessary to make a lot of adaptations for the wheelchair user to use the subway in all stations. Although stations such as Santa Cecília and Barra Funda have special elevators for disabled people (Figure 10) as well as ramps with warnings, stations such as Sé, which connect two of the main subway lines, are not accessible to wheelchair users, as they have neither elevators nor ramps. Contradictions exist: in a station with an elevator, the gap between the train and the boarding platform is larger than the front wheel diameter of a wheelchair, which denies unaided access as shown in Figure 11.

Figure 10: Elevator in subway station for disabled people. Photo: SHTV/2003

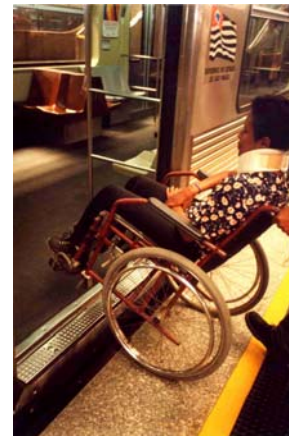
Figure 11: Gap between the train and the platform. Photo: SHTV/2003
