# A CONTRACTOR'S PERSPECTIVE ON BITUMEN RUBBER ASPHALT MANUFACTURE AND PLACEMENT

Herman I J Marais

Technical Director, Much Asphalt (PTY) LTD, Main Reef rd (R29), Benoni, 1500,  
South Africa. [herman.marais@murrob.com](mailto:herman.marais@murrob.com)

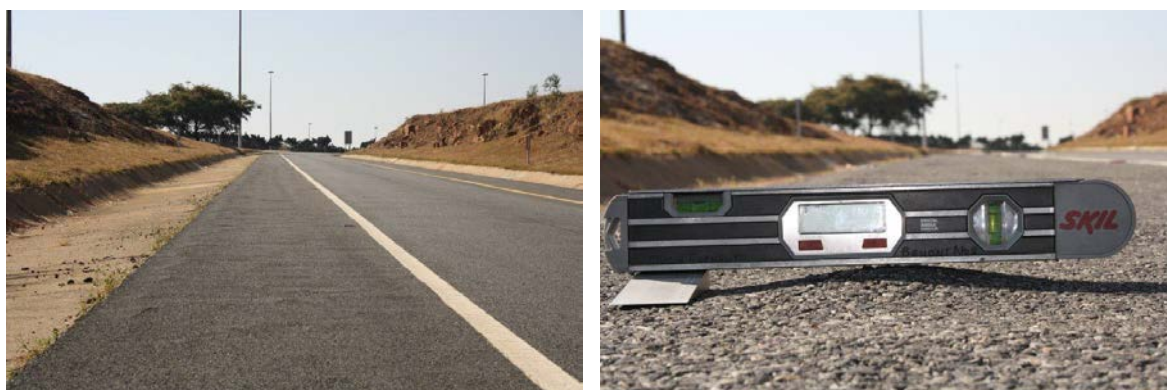
- “Pumping” of fines onto the surface not related to stripping – excessive fines in BRASO;
- Manifestation of small “bumps” on the surface in areas with low traffic volumes such as shoulders and fast lanes – especially on gradients such as super elevations and inclines in summer rainfall areas (see photos 1 and 2);

**PHOTOS 1 and 2: Manifestation of small “bumps” on the surface in areas with low traffic volumes**

The manifestation of the small “bumps” in the BRASO layer is also believed to be attributed to the permeability of the layer. The postulated mechanism of formation of the bumps is that on hot summer days, during typical afternoon summer rain storms, water penetrates the asphalt layer through inter-connected voids. The expansion of the water vapour that is formed due to the high asphalt temperature, results in the asphalt being “pushed up” as the vapour cannot escape quick enough through the same connected voids. This type of defect is not limited to BRASO but has also been noticed on other Open Graded Asphalt Surfacing materials, and normally starts within the first 18 months after construction and becomes progressively worse with time. It is more frequent in less trafficked areas such as fast lanes, shoulders, on inclines as well as super elevations where the gradient of the road results in rain water staying on the surface longer. The “bumps” in less trafficked areas are more pronounced as there is less heavy traffic that can reduce the effect of the interconnected voids - due to post construction compaction -

and can also “push down” the bumps when they appear. This defect is currently under further investigation and will be reported on once investigations have been completed.

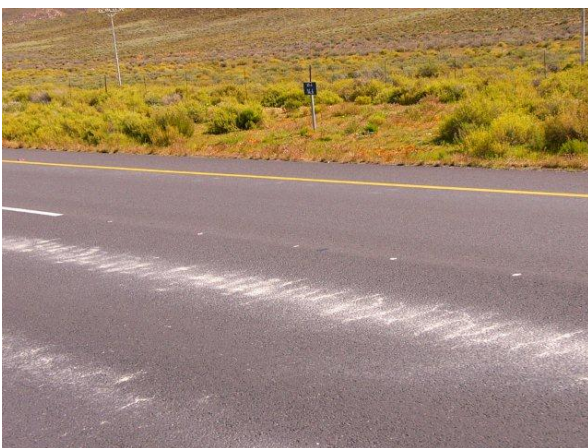
BRASO mixes placed during this time period had varying levels of success and the BRASO constructed in Gauteng in 2006 is performing well with only isolated areas - where the asphalt deformed at highly trafficked intersections – being repaired in the maintenance period. The mixes placed in the Western Cape however started showing signs of premature cracking in the wheel tracks. On the one project the cracking was attributed to frost damage during a very cold spell after winter rain, (almost an unheard of rapid freeze-thaw situation) and the fines that were pumped to the surface (Photo 3) were believed to have originated from the BRASO. At this project localized bleeding also appeared soon after construction but was attributed to construction related issues. On the other Western Cape project cracking appeared on areas where no Stress Absorbing Membrane Interlayer (SAMI) was applied before construction of the BRASO overlay. In the first few years after construction the cracks appeared in winter after rain, but appeared to “mend” itself in summer.

**PHOTO 3 Cracking and pumping of fines through BRASO surfacing in the Western Cape**
