A CASE STUDY OF PERMEABILITY DETERMINATION AT LONGITUDINAL JOINTS ON AN AIRPORT ASPHALT PAVEMENT

E HORAK¹, WJvdM STEYN² and ABM HORAK³

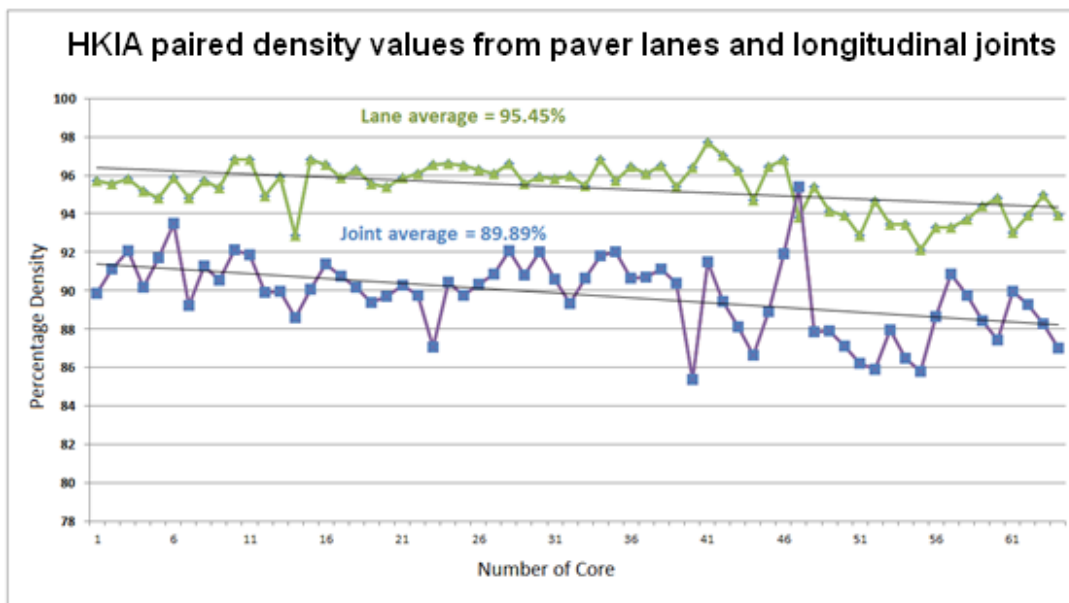
Figure 2. Paired densities from paver lane and joints on HKIA

Figure 2 confirms that the density achieved in the paver lane is on average 95.45% and meeting specifications of 93% minimum. However, the densities obtained at the joints shows that the average is 89.89%. In this case therefore the difference between the lane densities and the joint densities on average is 5.47%. In effect the difference should be measured against the specified 92% minimum. It still means that it is more than the 2% difference which the COLTO specification allows for. This clear differentiation is only possible here in retrospect because the joint densities were treated as a separate data set sample and not included in the analysis of the paved lane mat, as per the quality control plan used. It is clear that the generally high density values would help to pull up the lower values from the joints and still make the specification set with ease.

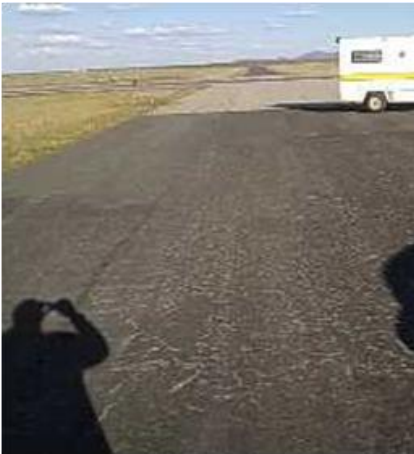
- The white deposits also appeared on the secondary runway treated with the proprietary fine slurry rejuvenator. The white deposit also seemed to accumulate around the hot modified binder used in crack filling applied previously.

<p>Secondary runway at intersection with main runway. White deposits appear around crack seals</p>

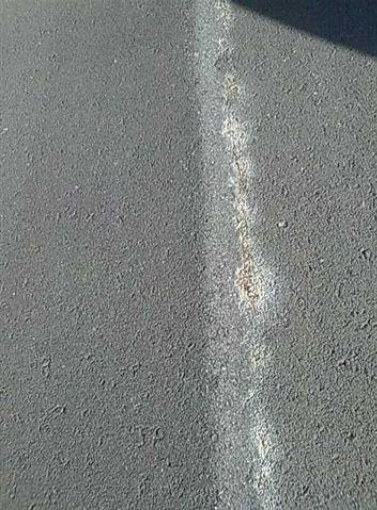
- It is known that the longitudinal gradient of the main runway slopes down from the 08 end to the lowest end at the 26 end in an undulating fashion. It was clear that the white spots were more visible and higher in observations density at the known low longitudinal points leading up to Bravo, Charlie, secondary runway and Foxtrot intersections. High points such as after the secondary runway intersection, where additional structural strengthening also took place by means of deeper mill and replace, showed limited if any white deposit.

<p>White deposit at joint at 08 end (higher end). This area's joints were previously regarded as below specification on density and voids.</p>

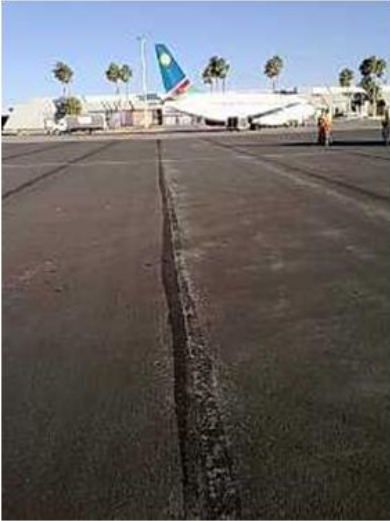
- The white spots appeared on the apron joints as well as the taxiway longitudinal joints. In such cases the joints were treated with a 200mm to 300mm wide fine slurry rejuvenator application due to prior concerns about lower density and higher voids at the joints. In spite of this attempt to reduce the surface permeability the white deposits still tended to appear on these treated joint areas.

<p>Longitudinal joints on apron showing variable white deposits in the joint vicinity and random evidence in the paving lanes. Joints were enriched with a fine slurry.</p>

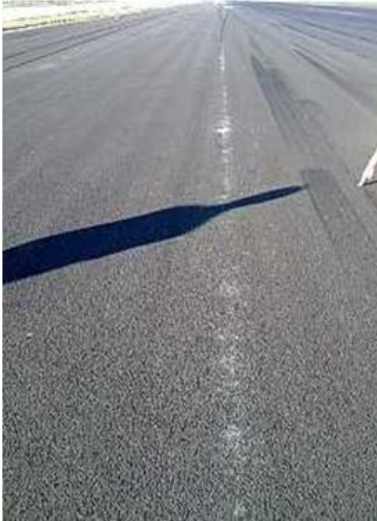
- The white spots also appeared on the shoulder areas treated with a fine slurry type rejuvenator as well as on the ULM areas already laid.
- In the ULM case the white deposits appeared where the AC joints underneath are located and not at the joints of the ULM. Limited, if any, white spots were observed along the ULM joints.

<p>White deposits coming through previously completed ULM not at ULM longitudinal joint, but the AC joint underneath on the 26 end</p>
