# **Failure analysis on retrieved ultra high molecular weight polyethylene (UHMWPE) acetabular cups**

N.D.L. Burger<sup>a</sup>, P.L. de Vaal<sup>b</sup>, and J.P. Meyer<sup>a</sup>

<sup>a</sup>Department of Mechanical and Aeronautical Engineering, **University of Pretoria**, Pretoria 0001, South Africa

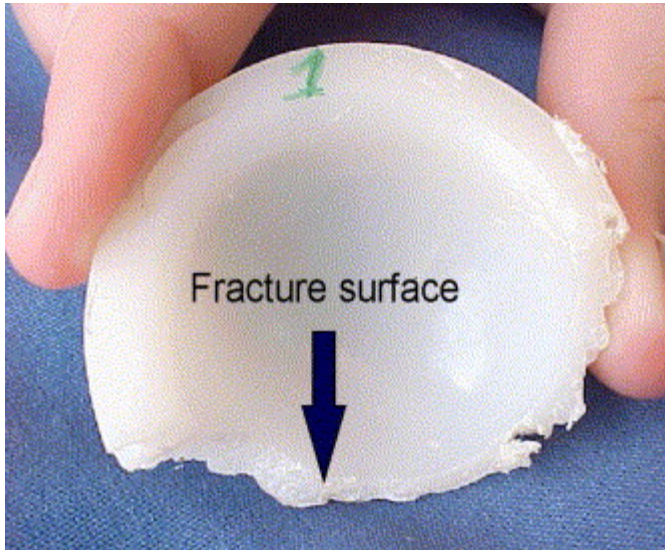
All the retrieved cups showed signs of excessive wear and/or creep. In four cases, there were catastrophic failures. An example of a catastrophic failure is shown in Fig. 2. In the second cup (Fig. 3), something was wrong with the base material, as the material started delaminating within a year after implantation.

Fig. 2. Acetabular cup with catastrophic failure showing fracture surface.

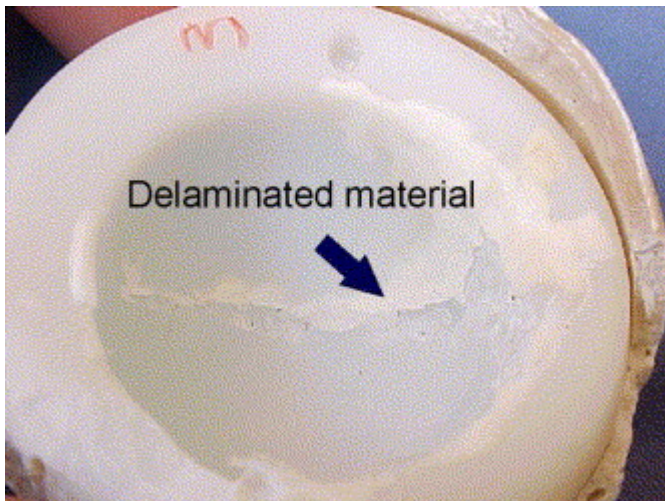
Fig. 3. Acetabular cup with delaminated material visible on inside of cup on bearing surface.

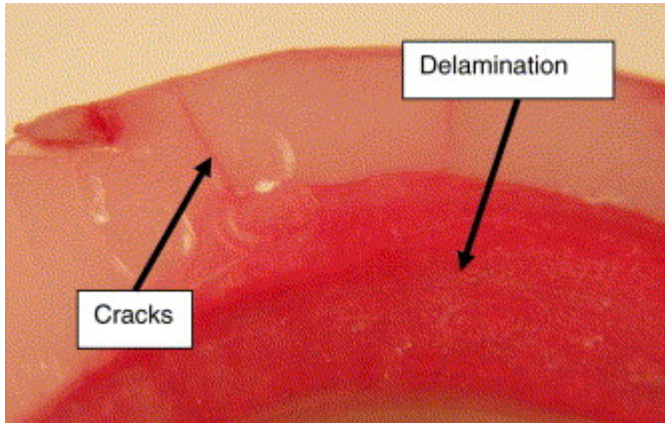
Various metal back acetabular components fitted with UHMWPE liners where cracks were visible on the rim of the cup were retrieved as shown in Fig. 4. Apart from the cracks on the rim of the cup, delamination in the area where the rim meets up with the body of the cup was also visible. This delamination varied from small localised areas to a single retrieved cup where this delamination was on the complete circumference of the cup. A cross section of a cup with this delamination visible is shown in Fig. 5.

Fig. 4. Metal back acetabular cup with cracks and delamination on rim of cup.

From the data presented, it can be accepted that this failure is due to an error either during the design or during the manufacturing process of the metal backing or the UHMWPE liner. As this defect is not a result of the wear mechanism active in vivo, this defect will not be investigated further.

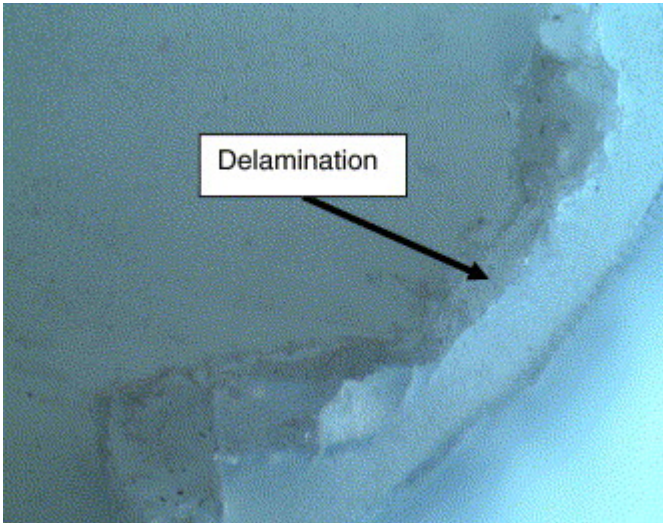
Fig. 5. Cross section of acetabular cup showing delamination on the rim of the cup (magnification 20×).

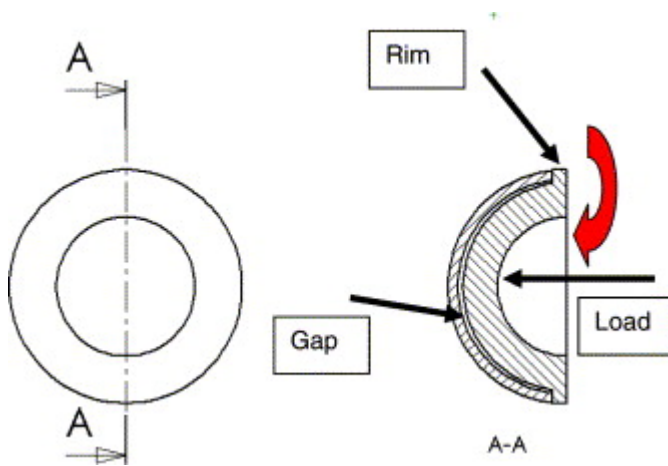
Fig. 6. Schematic layout of UHMWPE liner not fitting snugly into metal backing.

As can be seen from Fig. 6, there is a small gap between the UHMWPE liner and the metal backing. The load coming into the bearing area will now deform the cup resulting in a bending moment with the corresponding bending stress in the rim of the cup. As the patient is walking, this load will vary according to the load profiles as defined in literature [16], [17] and [18], resulting in a dynamic load input into the rim of the UHMWPE that can lead to the fatigue failure that is manifested in the form of cracks and the delamination of the rim interface.

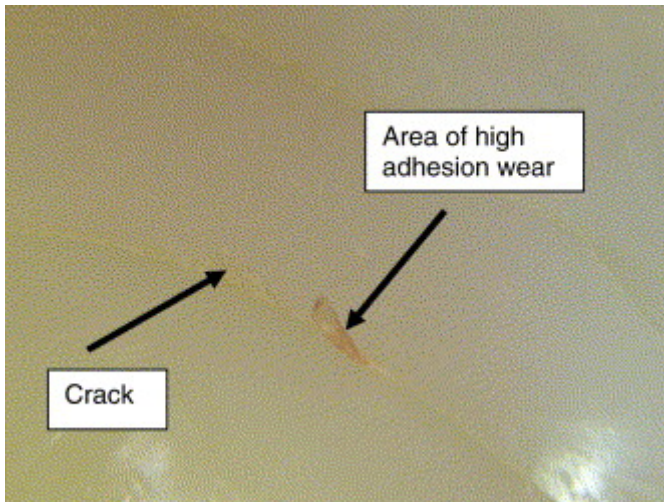
Cracks inside the bearing area can lead to the catastrophic failure of an acetabular component as can be seen in Fig. 2. Cracks in the bearing area are fairly common as can be seen in Fig. 7. On closer examination, making use of dye penetrant spray and the use of an electron microscope, the origin of these cracks can be established. The cracks originate in areas where severe adhesion wear has taken place. A crack starting from an area of adhesion wear can be seen in the electron microscope picture as presented in Fig. 8.

Fig. 7. Crack on bearing surface on inside of acetabular cup.

From the data presented it is most probable that the root cause for the formation of the cracks on the bearing area is the uneven removal of the surface of the bearing area by means of adhesion wear. This uneven removal will result in stress raisers in the form of craters which under the continuous dynamic loading will result in the formation of cracks.

It can be concluded that the cracks on the bearing surface are secondary to the formation of areas of uneven material as a result of adhesion wear. The formation of these areas is investigated further and will be discussed later.

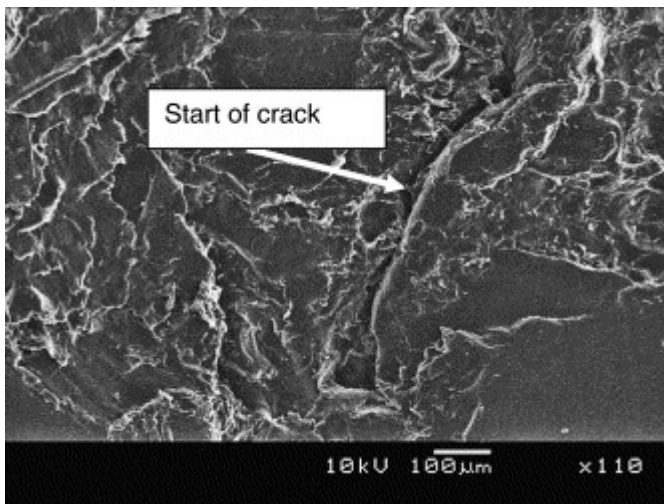
Fig. 8. Electron microscope analysis of adhesion wear area (magnification 110×).

Under the electron microscope (Fig. 8), it would seem that as the top layer of the material is being ripped away from the base material by adhering to the femoral head, craters are formed giving rise to areas with high stress concentrations. A crater under the surface after the removal of the top layer of material can be seen in Fig. 9. Under the dynamic loading conditions, these stress raisers will lead to the formation of long cracks, which can lead to catastrophic failures of the acetabular component.

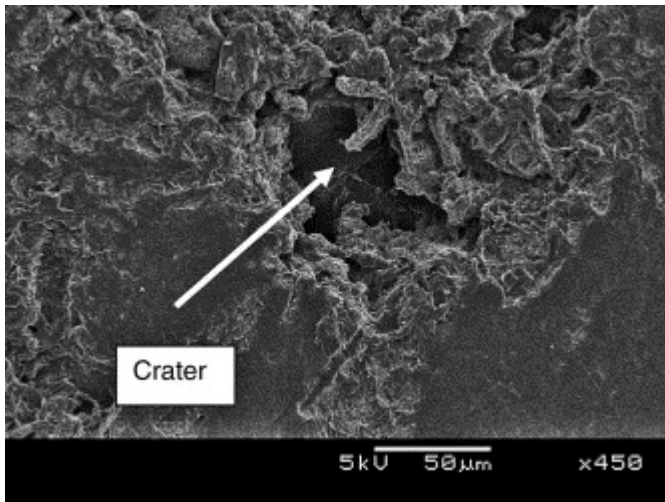
Fig. 9. Crater under the surface after adhesion wear (magnification 450×).

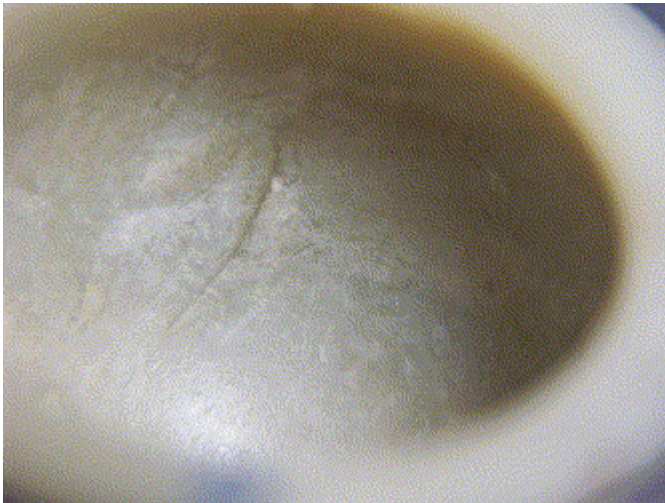
The entering of foreign particles (third body) into the bearing is not that uncommon. These particles normally originate from the PMMA cement with which the implant is fixated. An acetabular cup with severe signs of third-body wear is shown in Fig. 10. In this specific case glass ionomer cement was used for the fixation of the implant. This type of cement is no longer in use and has been replaced with PMMA cement. This type of defect is not a direct result of the active wear mechanism in the acetabular cup and is therefore not investigated further.

Fig. 10. Acetabular cup with severe scratches on inside.

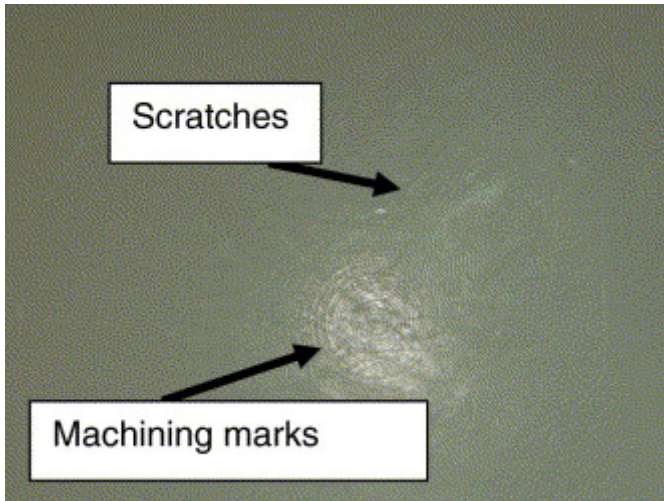
In all the acetabular components retrieved, scratches as a result of the normal wear products floating around in the bearing area can be observed. The majority of these scratches are too small to see visually and it can only be seen under a magnifying glass. Throughout the literature reference is made to multidirectional fine scratches [19], [20] and [21], which are not easily visible to the naked eye. An acetabular cup with multidirectional fine scratches under a magnification of 20× can be seen in Fig. 11. (Note that the original machining marks are also visible in the Fig. 11.)

Fig. 11. Acetabular cup with multidirectional fine scratches and with machining marks still visible (magnification 20×).

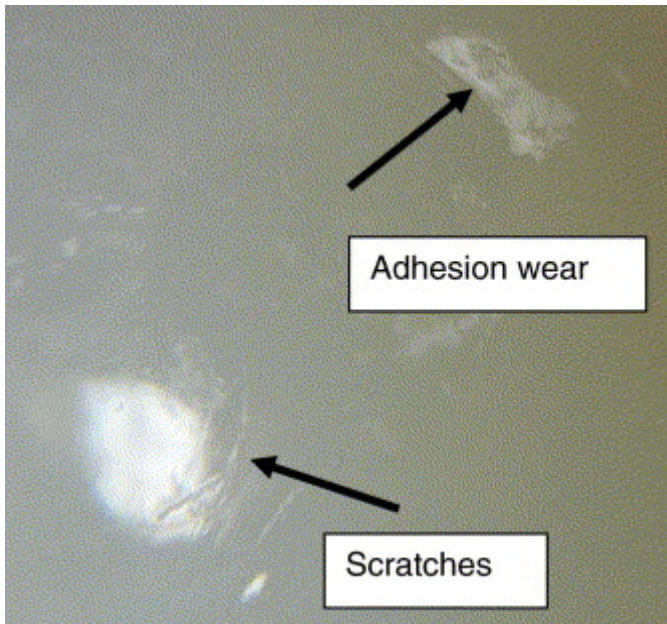
Scratches visible to the naked eye are also seen in some of the retrieved acetabular cups. When inspecting the acetabular components with a magnifying glass, treating it with dye penetrant spray and investigating under an electron microscope, the size and magnitude of these scratches become evident. The first impression is that this type of scratch must be the result of a third-body particle floating around in the bearing area. An acetabular cup with this type of scratch is shown in Fig. 12.

Fig. 12. Bearing area with signs of large scratches and an area with adhesion wear.

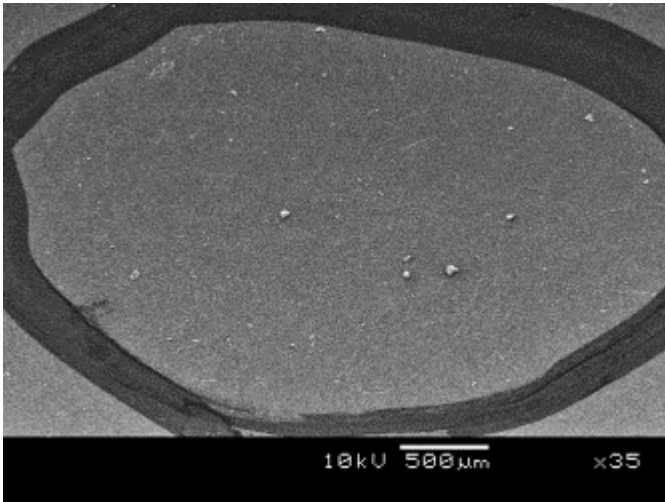
Under the electron microscope, it is observed that these scratches are not fine, multidirectional scratches, but are scratches that had been formed by debris floating around in the joint. The scratches as indicated in Fig. 12 under higher magnification in the electron microscope can be seen in Fig. 13. The scratches have been encircled to facilitate the finding of scratches under the electron microscope. In the area of the scratches, a number of white dots are visible, which would appear as if they are pieces of PMMA cement that had entered the bearing area causing the resulting damage. In Fig. 14, the path of one of these particles can be seen under higher magnification with the end clearly visible where the particle came to a standstill. The final path of the particle is visible in Fig. 15, showing the ploughing marks of the particle as it was destroying the bearing surface.

Fig. 13. Scratches on bearing surface with white particles visible (magnification 35×).

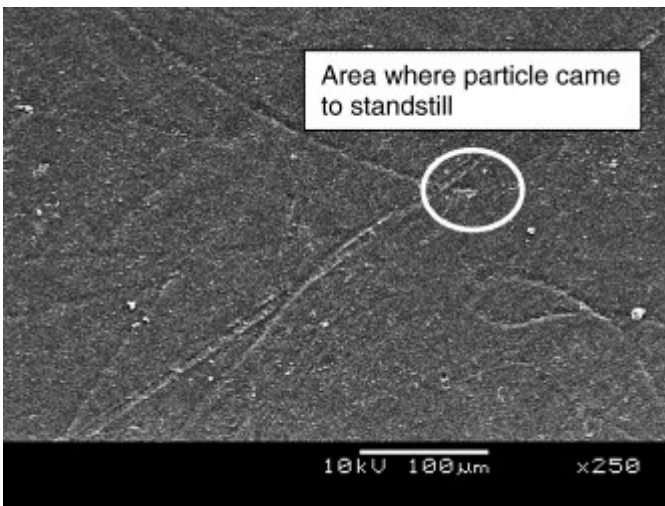
Fig. 14. Scratch mark on bearing surface (magnification 250×).

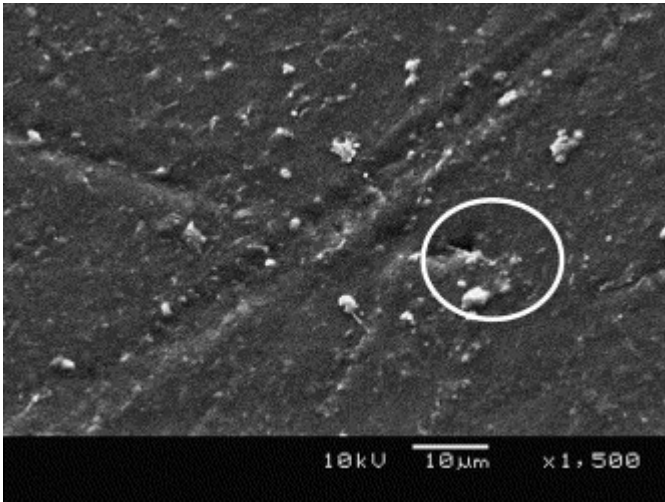
Fig. 15. Final position of particle causing damage to bearing surface (magnification 1500×).

If the areas encircled in Fig. 15 and Fig. 16 are compared, it shows that there is no foreign particle present that could have caused the damage as seen. There is even wear debris trapped around the ploughing mark that is the same as the base material, UHMWPE.

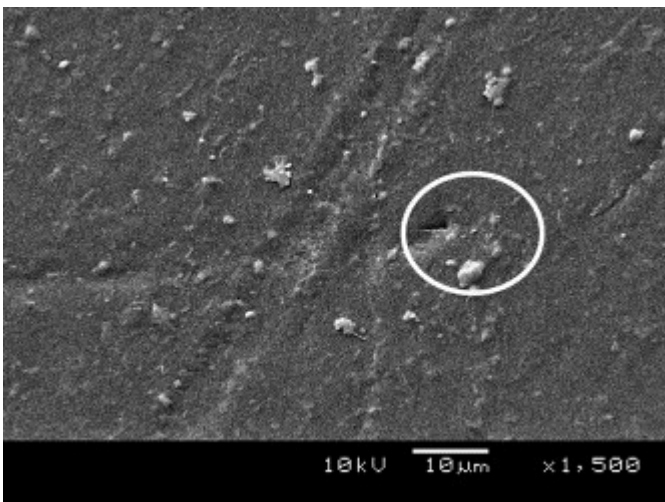
To eliminate PMMA as a third-body wear particle creating the scratch, a back scatter analysis was performed to establish the presence of any foreign particle at the end of the scratch. The back scatter analysis is shown in Fig. 16.

Fig. 16. Electron microscope back scatter analysis of scratch (magnification 1500×).

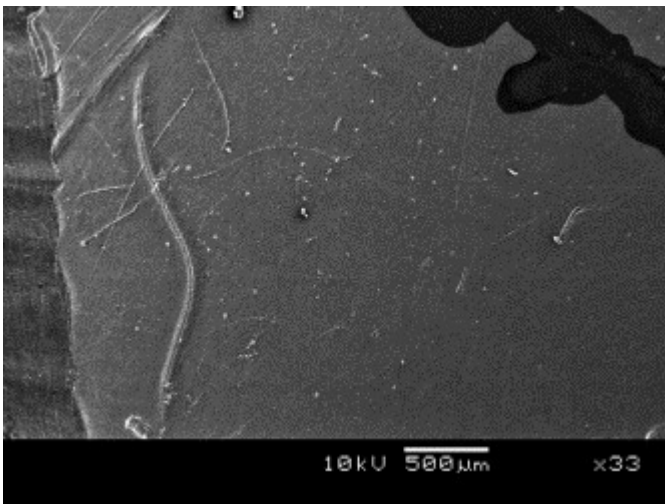
A further analysis was done on another spot in the same acetabular cup as shown in Fig. 17. This analysis was done closer to the area of adhesion wear. The main scratch can be seen in Fig. 17 with the final damage enlarged in Fig. 18.

Fig. 17. Scratch on bearing surface (magnification 33×).

In both these scratch marks, the damage was not caused by a foreign body, but by a wear particle generated during the in vivo use of the implant. The conclusion can be drawn that no foreign body is present in the wear scar. When the damage to the acetabular cup is compared to the wear debris retrieved from tissue surrounding the joint, the resemblance is clear. Typical debris retrieved from the same patient is given in Fig. 19 and Fig. 20.

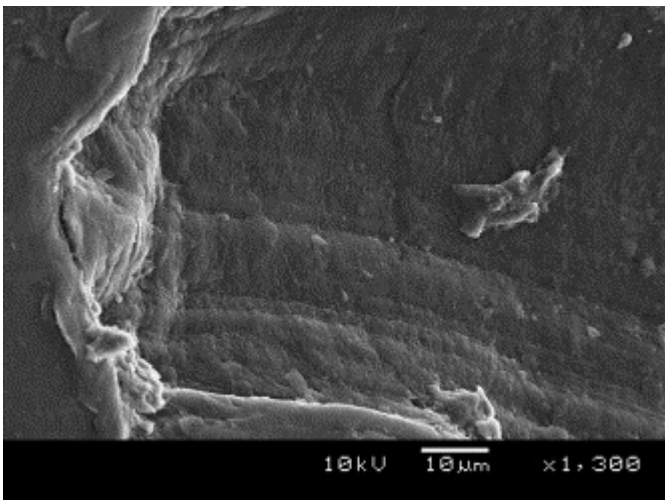
Fig. 18. End of scratch on bearing surface (magnification 1300×).

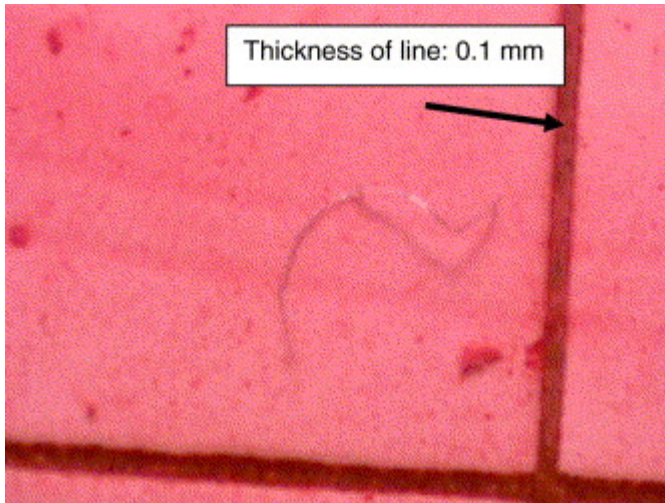
Fig. 19. Whisker-like debris retrieved from patient (magnification 20×).

The shape and the appearance of these items of debris suggest that both the whiskers and the droplets were formed under excessive heat conditions. From the literature survey, follows that for UHMWPE temperatures above 40 °C should be avoided, with short time (seconds) peak temperatures of 80 °C given by the manufacturers as the absolute maximum [22] and [23].

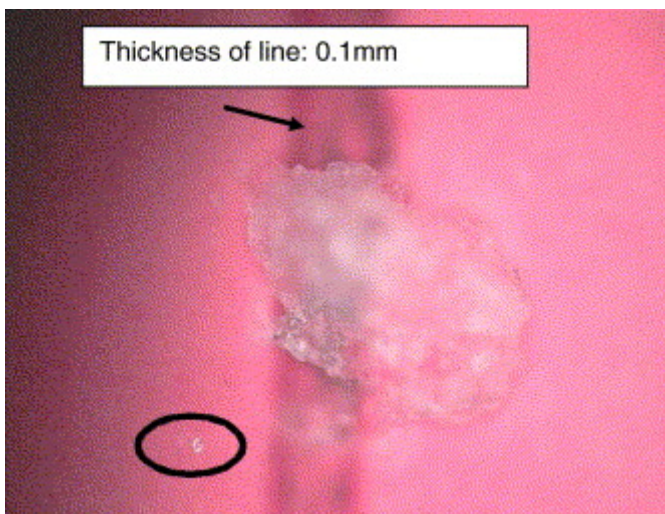
Fig. 20. Debris retrieved from patient (magnification 40×).

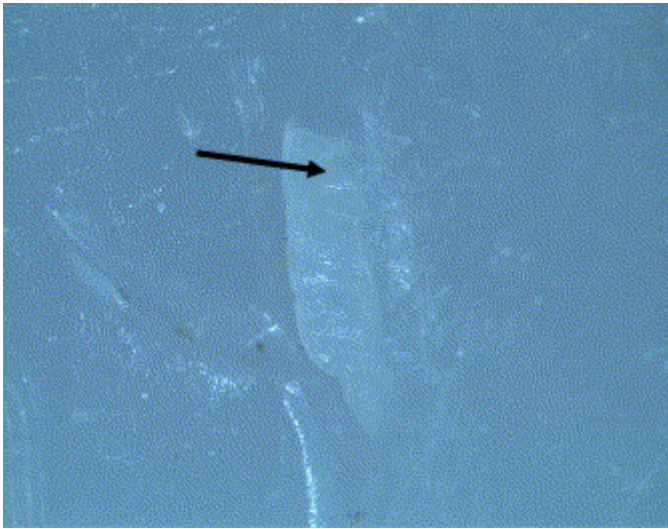
During visual observations, areas of material that had plastically flowed under the prevailing pressure were identified. An acetabular cup with the type of plastic flow mentioned is shown in Fig. 21. Under higher magnification, making use of the electron microscope, a number of these areas of plastic flow were identified (Fig. 22 and Fig. 23).

Fig. 21. Plastic flow of material visible in cup (magnification 10×).

If the higher creep data at elevated temperatures [24] together with the analysis of deposited proteins on the inside of the cup, is taken into account with the resulting conclusion of localised elevated temperatures, it is most probable that the only way this type of plastic flow can occur is that the material at elevated temperatures is squeezed out of the high pressure area to an area of lower pressure.

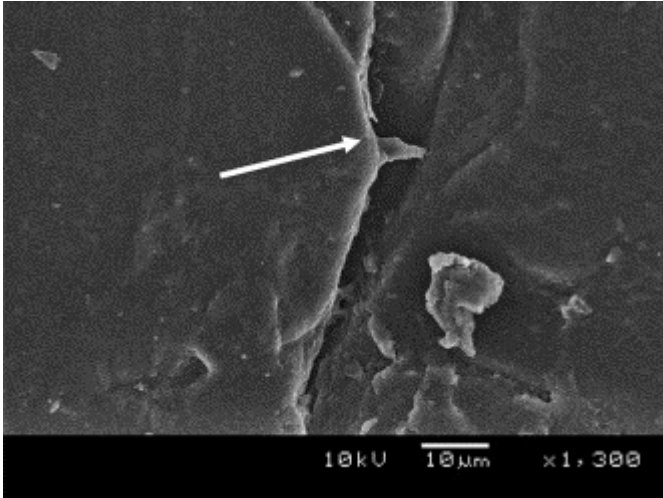
Fig. 22. Plastic flow in acetabular cup (magnification 1300×).

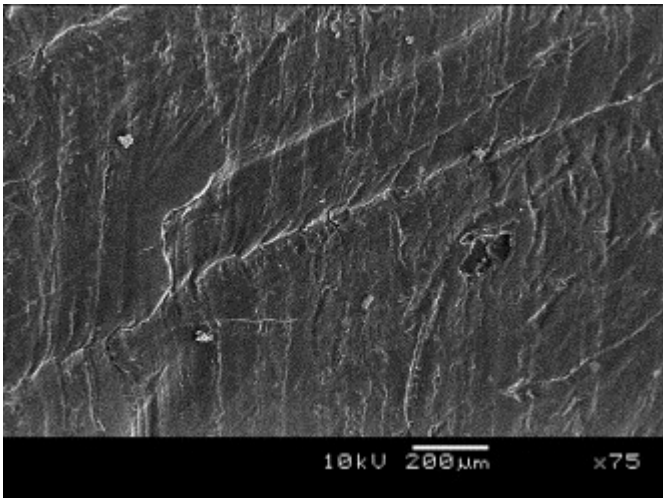
Fig. 23. Area with plastic flow lines visible (magnification 75×).

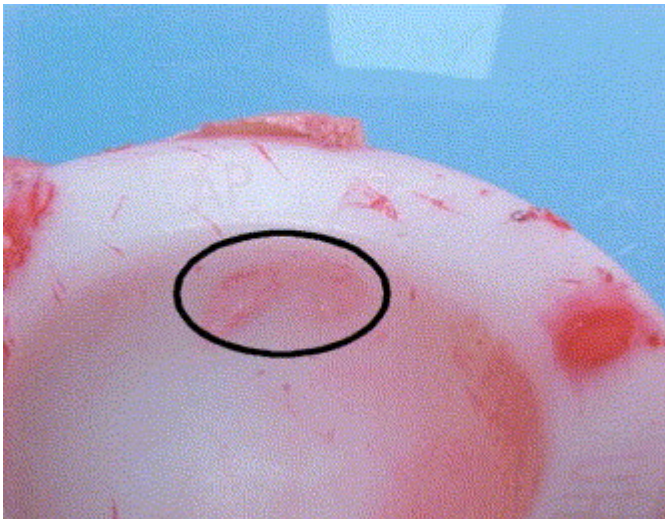
During the initial investigation, areas of adhesion wear were identified. These areas were first identified during the visual examination of the retrieved components as shown in Fig. 12. When the components were treated with dye penetrant spray, these affected areas became visible, as shown in Fig. 24. The areas are characterised by a typical butterfly shape as described by [25], where the surface of the bearing area seemed to be broken up. In some of the cups, the machining marks are also still visible under higher magnification, as shown in Fig. 25. The edges of these areas are very rough and this is indicative of the temperature under which the removal of the material took place.

Fig. 24. Butterfly wear pattern on inside of acetabular cup.

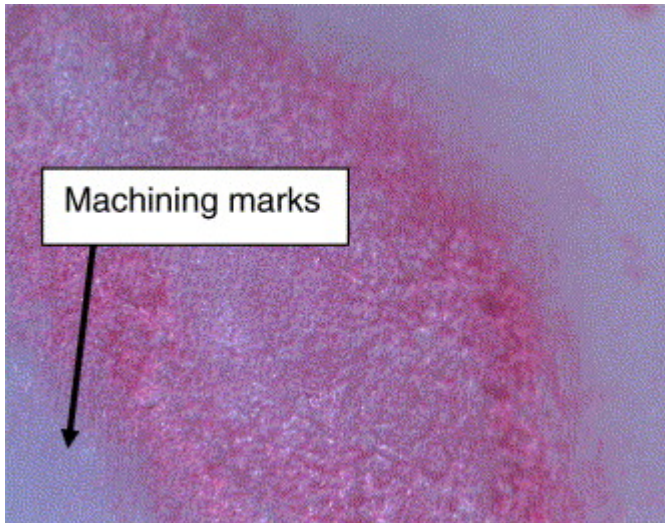
Fig. 25. Area with adhesion wear (magnification 40×) and machining marks still visible.

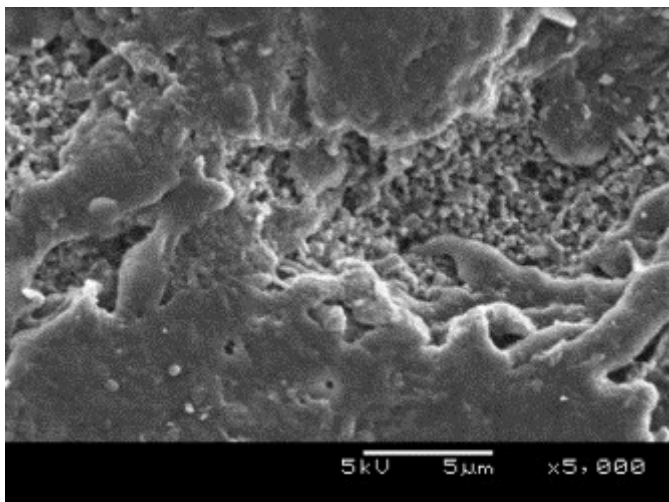
The area with adhesion wear, as indicated in Fig. 12, was then further investigated making use of the electron microscope. From the data obtained from the electron microscope it is evident that in this area adhesion of the material to the femoral head took place. The surface of the bearing was subsequently ripped, exposing the deeper part of the base material as is shown in Fig. 26.

Fig. 26. Area with adhesion wear exposing the base material of the acetabular cup (magnification 5000×).

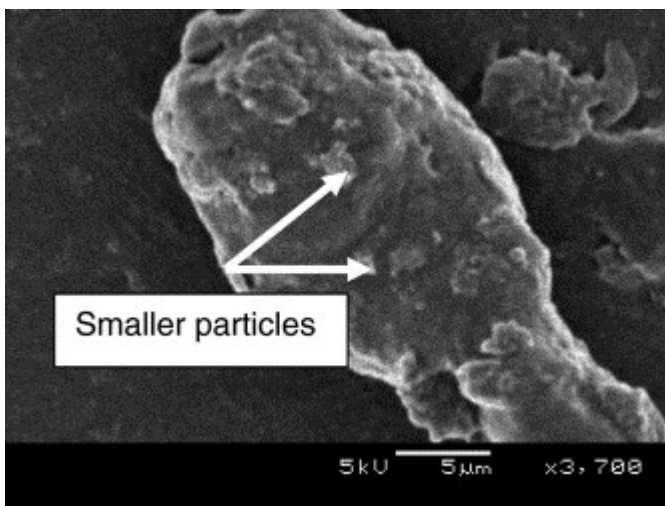
The typical particle that was dislodged from the bearing area is shown in Fig. 27. This is also the type of particle that can result in the scratches, as shown in Fig. 17 and Fig. 18. Examining the particle closely (Fig. 27) actually reveals a number of smaller particles that were dislodged and is now adhering to the outer part of the bigger particle. It must be noted that although the particle shown in Fig. 27 was worked out of the high-pressure high-temperature area of the bearing, it was again attached to the base material when the pressure and temperature dropped sufficiently.

Fig. 27. Wear particle with smaller particles attached to it (magnification 3700×).

The mechanism for the formation of this type of particle can therefore be described as a snowball effect where the smaller particles, which were sufficiently softened by the prevailing heat and pressure, adhere to the bigger particle as this was rolling or skidding along on the inside of the acetabular bearing.

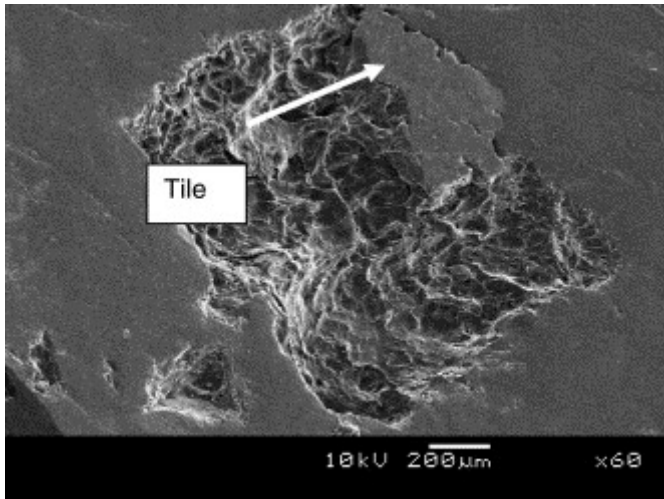
A second type of adhesion wear was identified where the surface layer of the acetabular bearing is ripped off in what looks like tile-shaped wear debris, as shown in Fig. 28. If the defect as shown in Fig. 28 is investigated further under higher magnification, it appears that the tile, as shown in Fig. 29, is almost completely loose and is only attached at the one corner. The moment this tile is dislodged, it will form wear debris (third body) that floats around in the joint area.

Fig. 28. Area with adhesion wear where a particle is still partly attached to base material (magnification 60×).

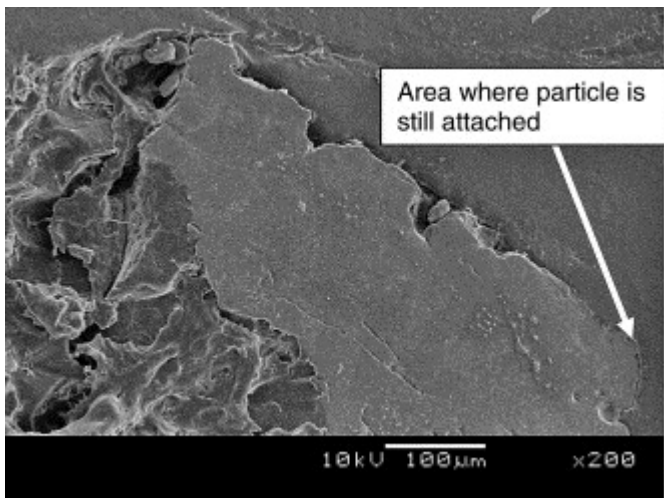
Fig. 29. Adhesion particle about to be broken out of base material (magnification 200×).

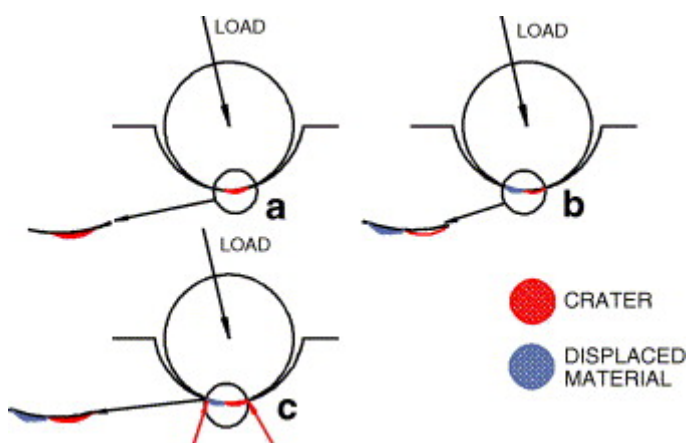
the product of load and speed ( $P \times V$ ) [26]. If the  $PV$  value increases the surface temperature at the point of highest loading increases accordingly. As the temperature goes up, adhesion between the femoral ball and the socket increases with a resultant higher heat input in the high-stress area (see Fig. 30a). A point is reached where the material has softened sufficiently and the adhesion has increased to the point where the bearing material is dragged along by the ball, in a similar manner to a wear particle being dragged along by a shaft in a rotating plain bearing couple. This leaves behind a crater, with the displaced material trapped between the cooler edges of the crater and the femoral head. Loading will flatten the material removed (Fig. 30b) into a wafer with irregular edges as shown by the retrieved particle in Fig. 20. If, on the other hand, a scratch exists under the wafer, there will be a tendency to extrude material along the scratch as a fibre or whisker as shown in Fig. 19. It should be noted that the pressure in the wafer of removed material will be very high as the wafer will, in effect, be forced between the ball and the cup, effectively raising the ball relative to the cup with the load being mainly supported by the wafer. (Note that the flattened wafer can be forced into the bearing surface.) The particles will with time migrate through the bearing to the surrounding tissue.

Fig. 30. Steps in wear debris formation in acetabular cup.

A further aspect to consider is that after a crater has been formed, the edges of the crater will be bearing the highest load, as shown in Fig. 30c. The process described above will
