PART THREE

4. REHABILITATION AND INDUSTRIAL BUILDING TYPES

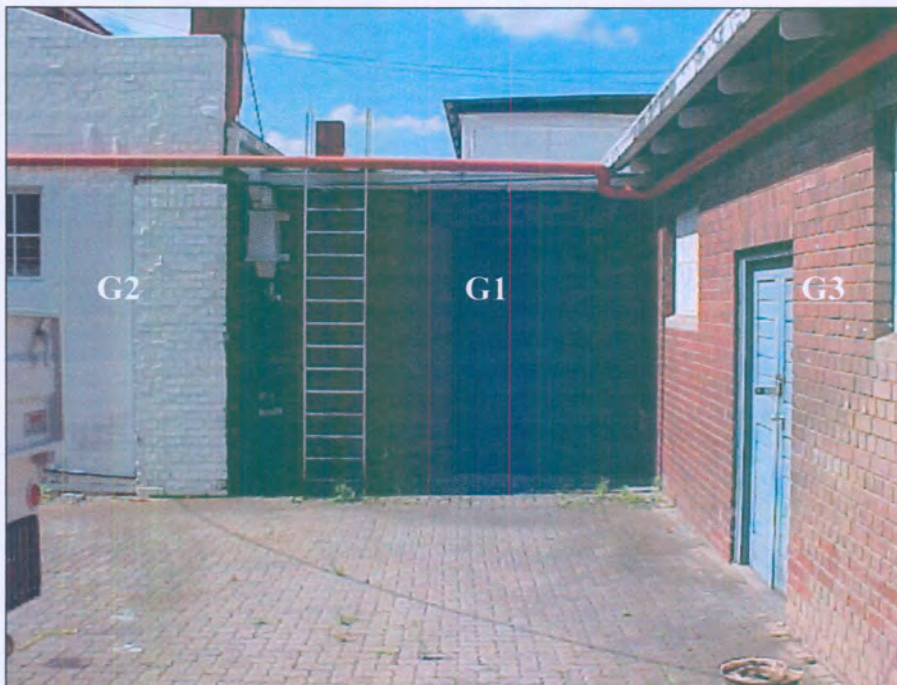
Figure 12: Typical examples of flanked buildings (G1, G2 and G3) (Source: Photo by author)

This study proposes the demolition of buildings A, B1, B2, D4, D5, D6, D7, E, F1, F2, G1, G2, G3, H1, H2, I1, I2, J, L, M1, M2, O1 and O2 (figure 36). The demolition of these flanked structures reduces the historic material fabric but it is inevitable because they undermine the architecture and the viability of the site. The boundary wall is also due for demolition because it obscures the architecture of the site and in the past it encouraged architecturally unworthy structures such as the erection of the barbeque stand located west of L1 (figure 34).

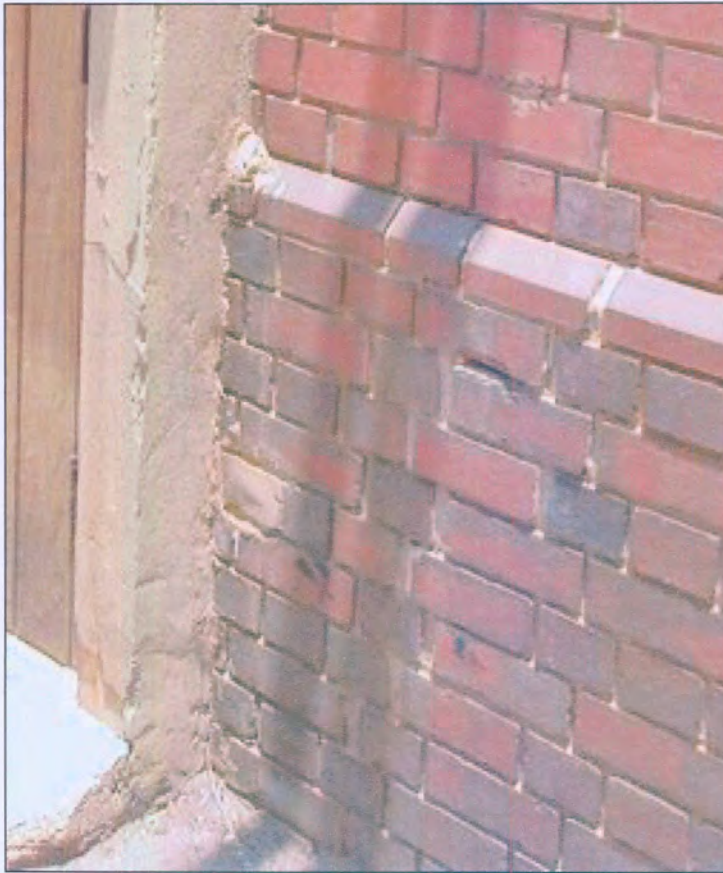
Figure 13: Structural crack caused by attached structure (J) on K2 (Source: Photo by author)

- The width of the cracks, which are classified in three groups of fine (width up to 1.5 mm), medium (from 1.5 mm to 10 mm) and wide (above 10 mm). Figure 13 shows a wide structural crack caused by flanked structure J on K2.

- Investigate whether it is the internal or external wall that has to be repaired. In figure 13 it is the external wall that require repair.
- When repairing external walls, the nature of the brick should be considered in relation to different mortar constructions of jointing (flush, raked or weathered) and pointing (flush, tuck and bastard tuck). These must be documented for the establishment of proper remedial measures during repair and restoration of brickwork.

Remedial measures suggest that cracks can be remedied by cutting out and rebuilding, raking out filling and repair of the material. The measures are applicable to different nature of remedies required under specific circumstances.

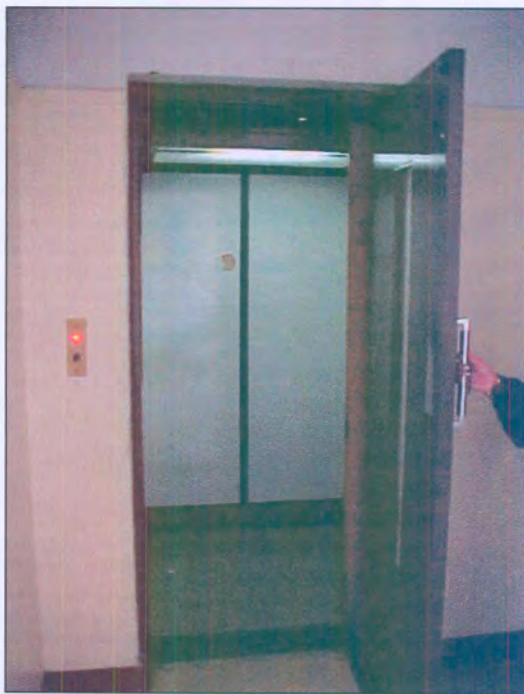
Figure 14 illustrates a lift located on the eastern side of D1 that does not comply with present building regulations and certainly unfavourable for the image of the administration building. Both blocks C1 and D1 require new installation of lifts and elevators, incorporated within a new spatial design.

Figure 14: Lift in building D1 (Source: Photo by author)

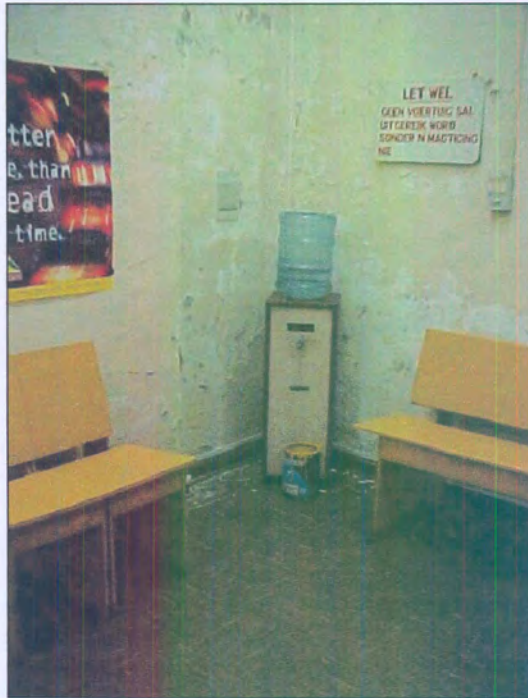
Rising damp is characterised by a descending moisture gradient within a wall from ground level sometimes to a height up to 1.5 meters. The main causes of rising damp are movement of water through capillaries and the amount of moisture absorption usually through the mortar, which also increases the damage caused by the crystallisation of salts. Removing the source of dampness can easily eliminate rising damp. Hygroscopic salts attract moisture from the atmosphere. These salts occur as a result of deposits from the wetting/drying rising damp. Remedial measures suggest that hygroscopic salts be removed by clay poultice.

Figure 17: Capillary moisture (Source: Photo by author)

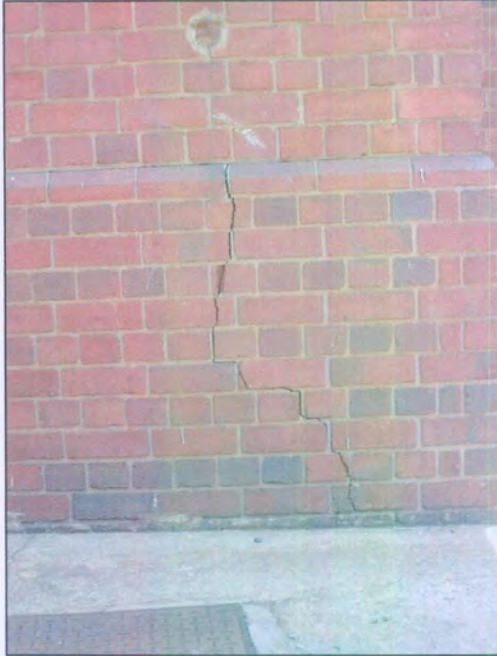
- The route of the crack, whether it passes (usually diagonal) through the brick joint, leaving the brick themselves undamaged, or passes through individual brick as well as joints (figure 18).

Figure 18: Structural crack on block L (Source: Photo by author)

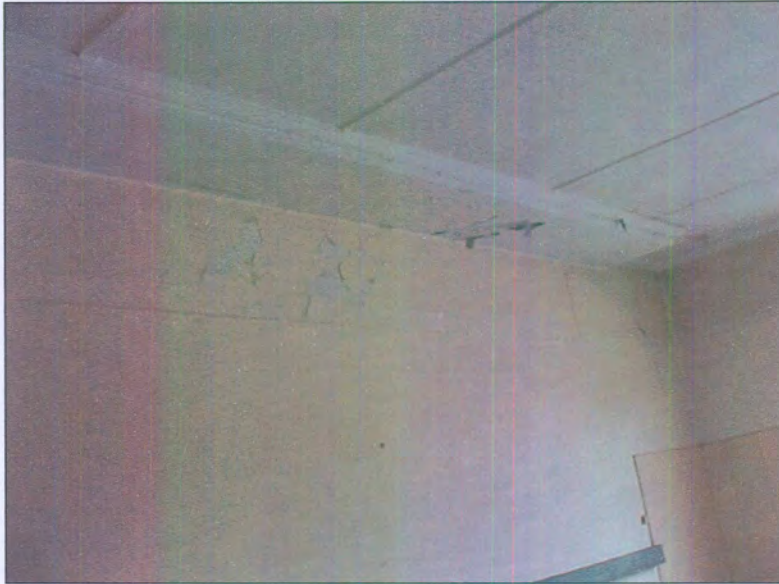
The roof is more likely to need replacement other than any other components of the building. It is evident in most State Garage buildings. The roof is indeed an important place to start an inspection, because water penetration at the roof is usually the most serious cause of deterioration in older buildings. Evidence of roof failure usually shows up inside before it is visible on the outside. At first, damp patches, flaking paint, and actual dripping water on walls or ceiling are the signs of roof trouble (figure 19). A thorough inspection needs to be carried out to determine whether it is the roofing material itself, the flashing or the gutter system that has failed. Sometimes, moisture penetration through the wall is simply a matter of poor drainage, blocked gutters, or backed-up leaders, all of which can be taken care of through routine maintenance (Shopsin, 1986:62 and 113).

Figure 19: Evidence of roof leaking (Source: Photo by author)

Roof insulation may need replacement, especially if it is an older fibre type insulation that does not stand up as well in time as foam types. Sheet metal, if in good shape and if removed carefully, may at times be salvaged. However, this may be risky. If it is galvanised metal, it may be sufficient to warrant discarding. Only aluminium or copper are likely to be candidates for salvage, though this outlast galvanised metal by many years, but at some point will come also to a point of replacement. Replacing the sheet may also require investigation and possibly replacing the battens. In conclusion, a thorough inspection should be carried out to determine whether the roof structure supporting beneath is sound, as to avoid overloading.

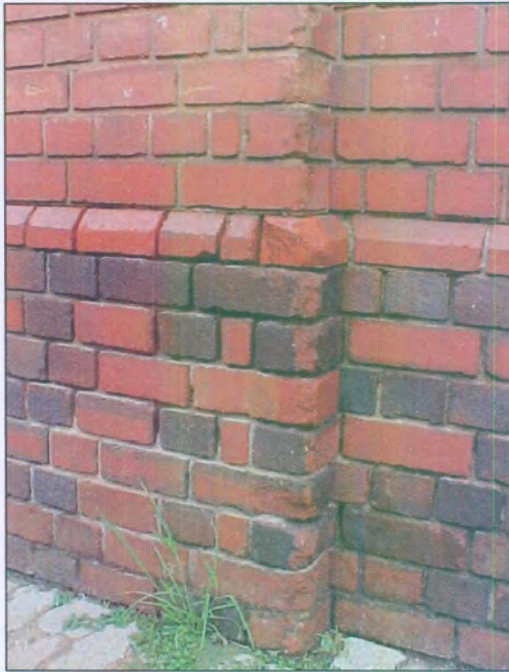
Figure 20: Raked-off mortar on English bond (Source: Photo by author)

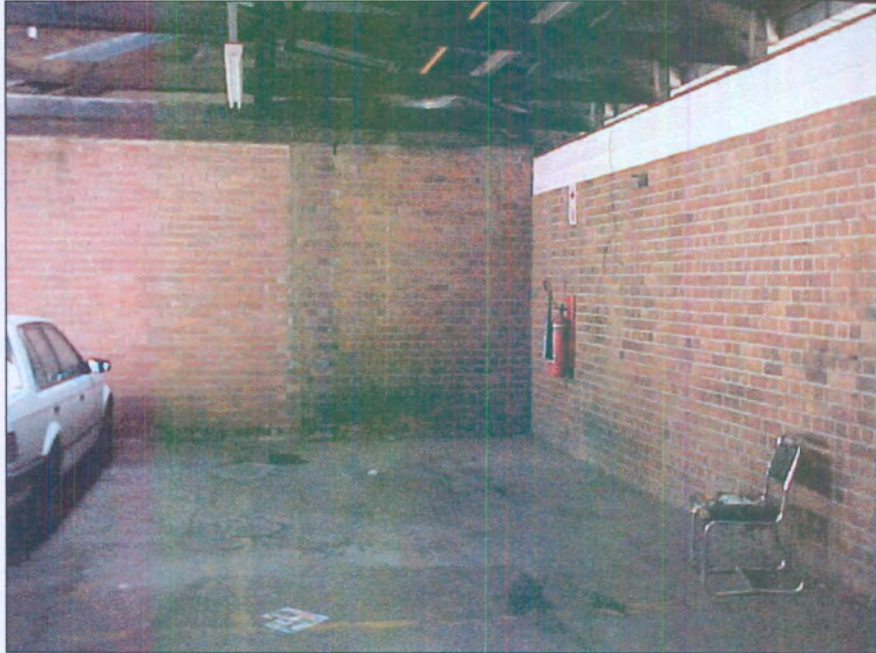
Figure 21: Breaks in masonry (Source: Photo by author)

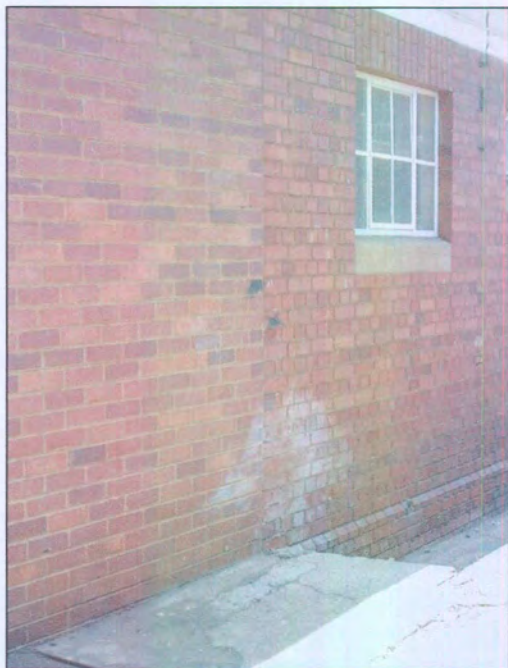
Figure 22: Blocked door opening (Source: Photo by author)

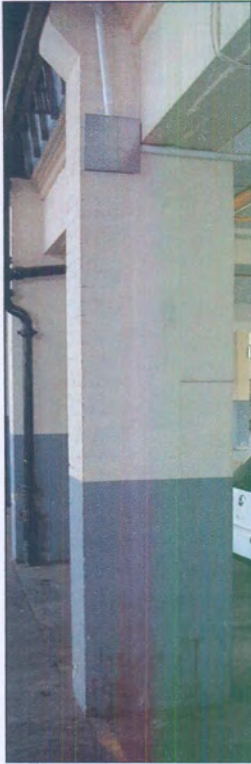
Figure 23: Brick column of D2 attached to concrete column of D1 (Source: Photo by author)

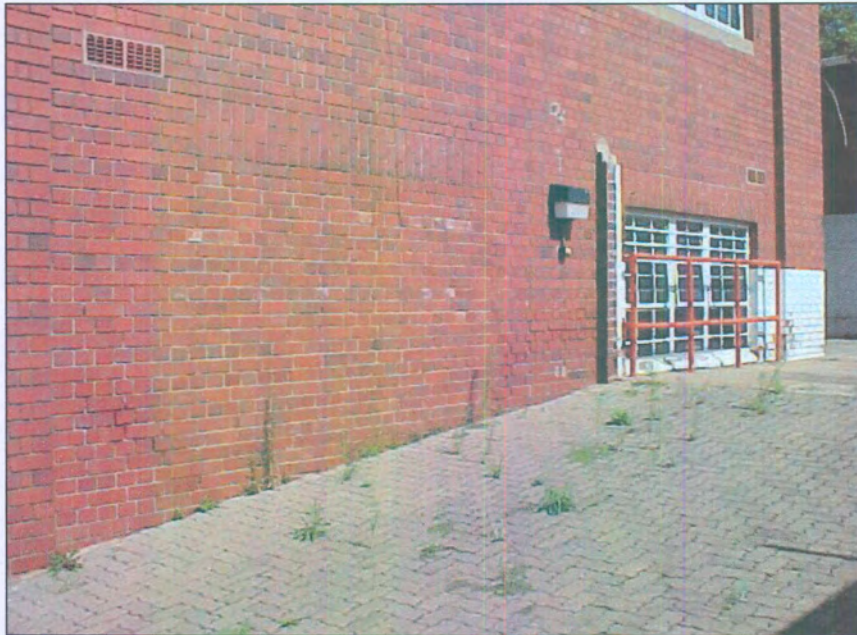
Figure 24: Blocked window opening (Source: Photo by author)
