access audit

an empirical study on accessibility of existing buildings

3.6 Audit: Alkantrant Library and Multipurpose Hall, Lynnwood, Pretoria

3.7 Audit: Constitutional Court Law Library of South Africa, Constitution Hill, Johannesburg

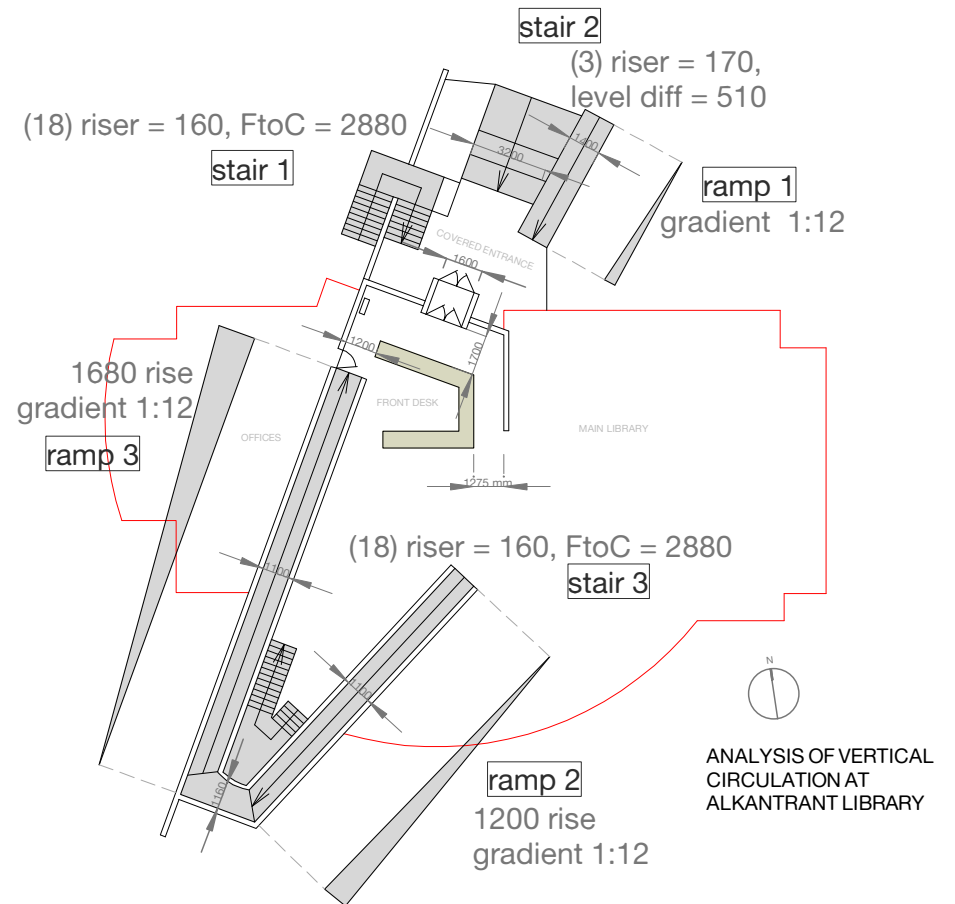
illus. 3.2. Ramp, staircase and steps analysis of the Alkantrant Library

Ramps 2 and 3 do not have handrails on either side. The suggested norm is a handrail on both sides. This presents a challenge for the elderly, the visually impaired and wheelchair users alike seeing as the Listeners Library is located downstairs. Ramp 1 has adequate handrails and balustrades. Stair 1 has good handrail placement and stairs are in nonslip tiles. Stair 3 has an interrupted handrail and sharp corner detail. Stair 2 is only three steps and does not present any challenges. See Illus. 3.2.

Ramps 1, 2 and 3 have a gradient of 1:12 which is the minimum requirement by law. Ramp 3 is a very long distance and rises 1600mm which then needs a landing. At the top end of ramp 3 an opening with a door is in immediate proximity of the end of this ramp. By law and suggested practice it must be placed at least 1200mm away from the end of the ramp. See Illus. 3.2.

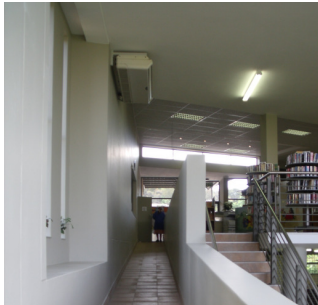
illus. 3.3a Alkantrant Library Ramp 3

The top end of ramp 3 has only 1200mm circulation space which is inadequate for the turning circle of both a pram and a wheelchair, which are the intended users for the ramp, other than the library trolleys.

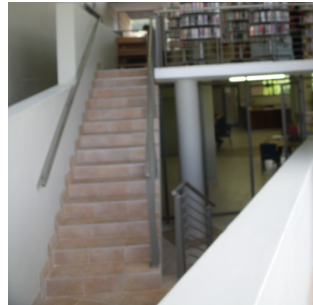
illus. 3.3c Alkantrant Library Stair 3

Signage is generally adequate but is lacking in certain areas. Staff have resorted to A4 printed pages as a quick solution to this problem. No community pin-up board is provided and all notices and advertisements are stuck to the main door which creates a visual barrier when entering the library. See Illus. 3.3c.

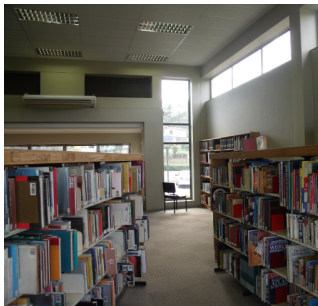
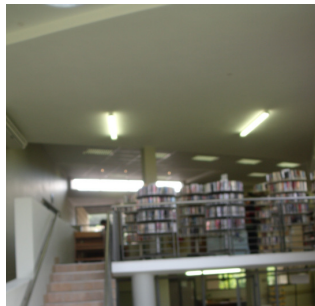
Natural and artificial lighting is adequate and the glass facade is well used for this.

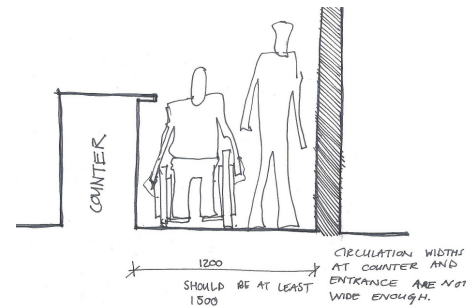
illus. 3.5a Alkantrant circulation width

Counter design does not allow for easy use by children or wheelchair users. Combined with the narrow space this creates a space that is difficult to navigate. Circulation space at the main entrance and main desk is only 1200mm on the eastern side; this does not allow enough movement space for two persons as indicated in illustration 3.5b.

Entrance level change is adequate for wheelchair users, the elderly and visual impaired persons as it presents no trip hazard. The swing doors are not optimal, but are easily operable with good handles. See Illus. 3.5a.

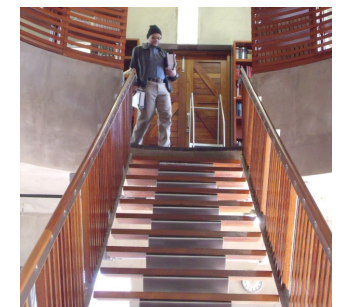
illus. 3.7c Law Library Stair

Natural lighting results in glare on timber surfaces in upper levels due to the gloss finish used. The timber and steel staircase has adequate handrail and balustrade detailing, but the open risers will be problematic for some users.

Stair 2 has two landings and handrails on both sides with closed risers. Stair 2 has open risers and no landing and continues up 18 stairs to the next level and presents difficulty for some people.

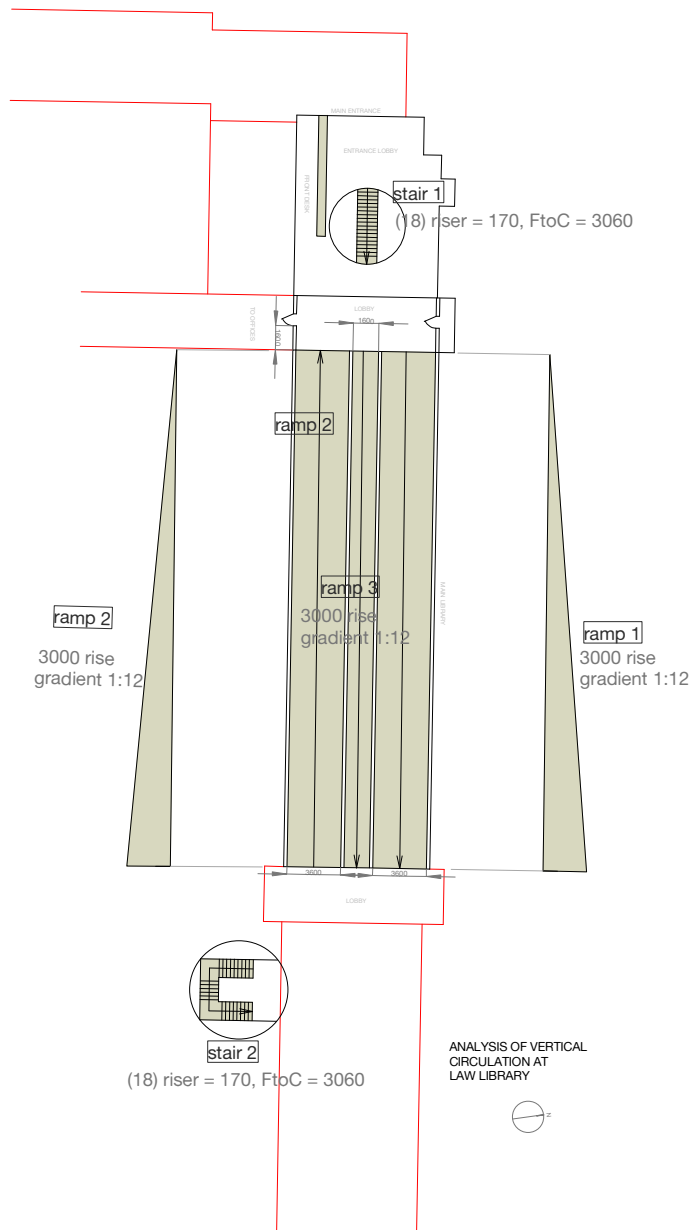
illus. 3.8 Law Library ramp and stair analysis

The Law Library floors consist of three ramps with 1:12 gradients. Ramp 1 and ramp 3 are the same width and have book stacks at regular intervals. The ramp length is 36 000mm and rises 3000mm to the next landing (illus. 3.8). This distance of ramp is uninterrupted and has no landings. Ramp 1 and 3 have a handrail on the one side against the facade. Ramp 2 is the same gradient but has no bookstacks and has handrails on both sides. The floor material on the ramp is nonslip.

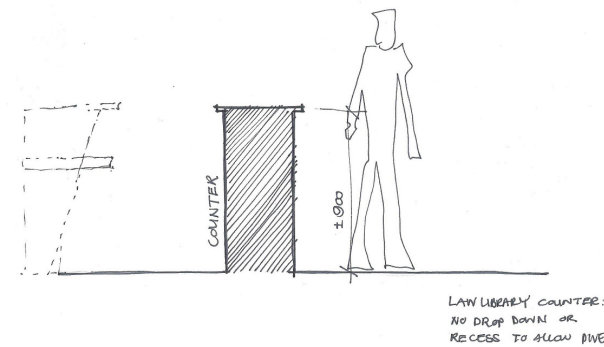
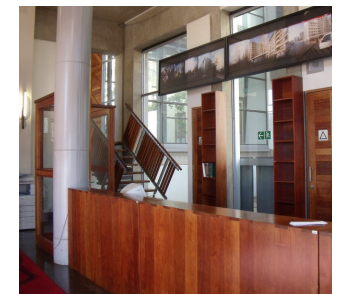
The Law Library's counter is 900mm high and has no recessed vertical panel or a drop down section. The counter is problematic even for shorter people. Circulation around the entrance and counter is ample, because no passage like space exists. See illus. 3.9a. The foyer is freely movable and the floor surface is covered in one material (Law-Viljoen, 2008: 29).

- Gloss finish varnished timber flooring has high glare factor in daytime with natural lighting.
- Counter is at a higher level and does not allow wheelchair bound users

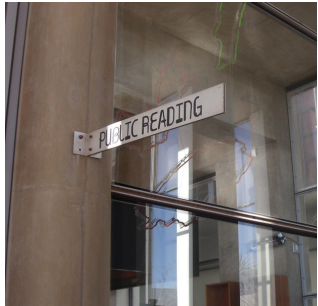
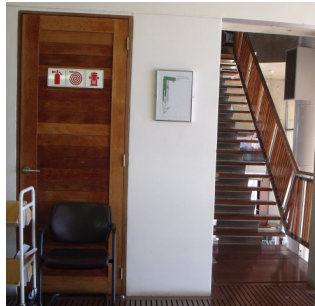
Signage is of legible type face and adequate. Standard pictogram style signage is used elsewhere. See illus. 3.10a and 3.10b.

- Main entrance signage is small, but clear and typeface is legible.
- Standard signage pictograms are used for fire exits, fire houses and extinguisher points.

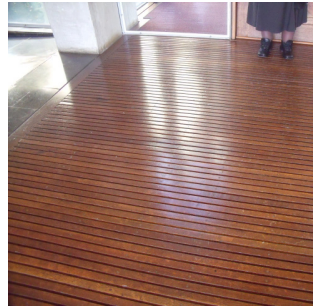
illus. 3.10c Law Library glare problem on floor

Hanging light fitting and desk lamps provide adequate overall lighting and task lighting. Natural light is utilised, but is unfiltered from the inner court yard and presents a glare problem on the glossy finish timber flooring. See illustration 3.10c.
