CHAPTER 5

RETRIEVAL STUDY

5.1 Introduction

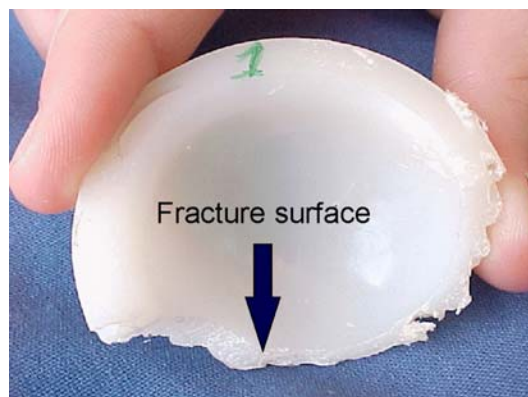
All the retrieved cups showed signs of excessive wear and/or creep. In four cases, there were catastrophic failures. For an example of these catastrophic failures, see Figure 5.1. In the second cup, something was wrong with the material (Figure 5.2), as the material started delaminating within a year after implantation. These details are discussed later.

Figure 5.1: Fractured cup

As mentioned in paragraph 5.2, four of the retrieved cups showed catastrophic failures. The first cup had fractured and it also showed some signs of cracking in other areas. It appears that the fatal crack started from a crater caused by material being extruded from the base material in the main adhesion wear area (See Figures 5.6 and 5.7).

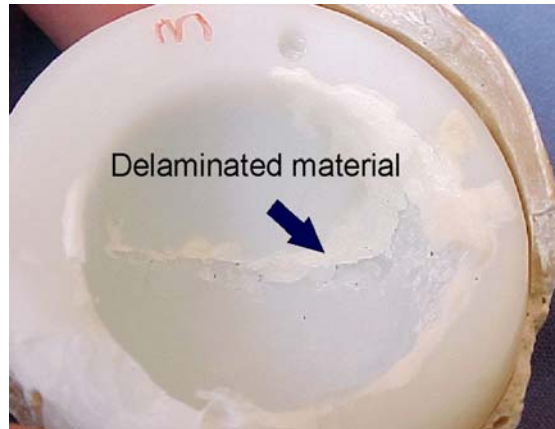
Figure 5.2: A cup with delamination

The cups were treated with dye penetrant to make the defects more visible. The cup, shown in Figure 5.2, failed after only one year in-vivo. When inspected, using a magnifying glass, it appeared that the material was defective and that it had delaminated as can be seen in Figure 5.2. A possible explanation for this delamination is that during the manufacturing process a harder layer on the surface had formed, similar to case hardening in steel. This can be a result of incorrect cooling, incorrect cutting speed or a blunt cutting tool. When the acetabular cup is in service, contact stresses are generated at a distance below the surface (Boresi & Sidebottom, 1985). Repetitive loading may then result in fatigue failure at the depth below the surface where the contact stresses are maximised, causing the top layer of material to delaminate.

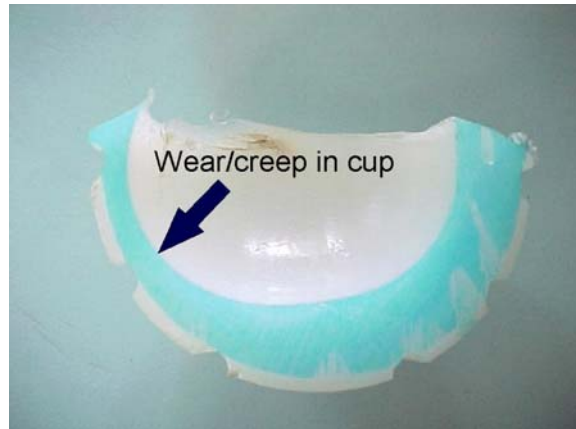
All the cups showed some form of wear and/or creep. It is difficult to distinguish exactly between wear and creep. It was therefore assumed that a combination of both occurred. The extent of wear/creep varies depending on the number of years in-vivo. The position of the maximum wear/creep correlated with data found in literature (Sychterz et al., 1996; Jasty et al., 1997; Schmalzried et al., 1999). Figure 5.3 shows a cross section of an acetabular cup showing the amount of wear/creep and Figure 5.5 provides a schematic presentation of the wear area.

Figure 5.3: Cross section of cups showing an amount of wear/creep

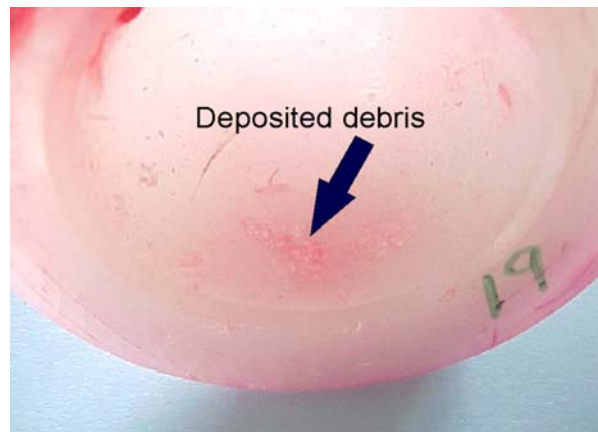
Visible in all of the cups was some form of debris deposited outside the high load area (see Figures 5.4 and 5.5). The debris was attached to the base material and could not be removed. When viewed under a magnifying glass, this debris appeared like “molten” material deposited on a cold surface. Also visible under the magnifying glass were craters and pieces of material with an irregular pattern similar to the surface of an orange. (See paragraph 4.3.3.) At this stage of the investigation, it was felt that this debris holds the key to what is actually happening on the running surface and therefore warranted an in-depth investigation.

Figure 5.4: Deposited debris – coloured with liquid dye penetrant to make it more visible

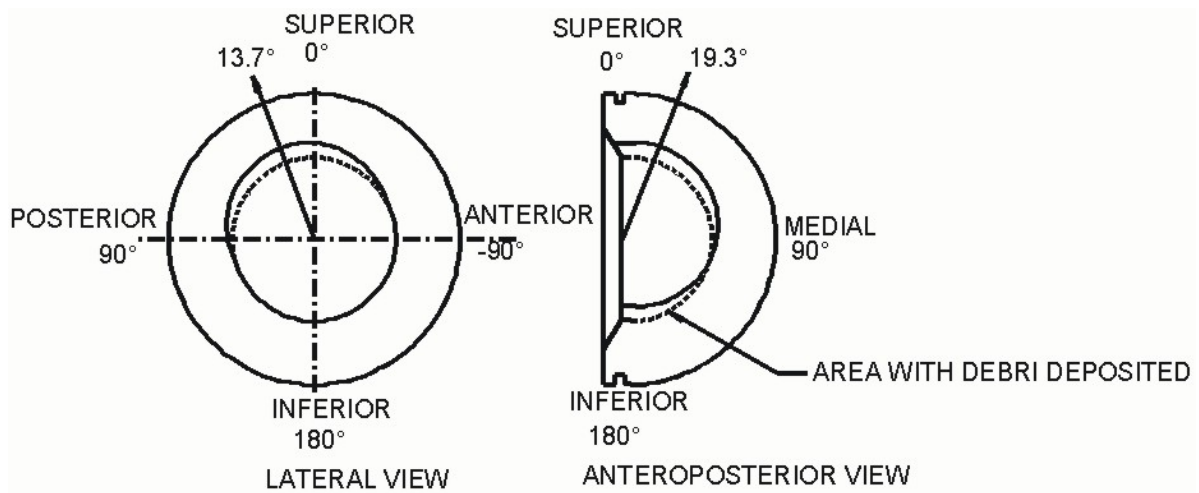
Figure 5.5: Wear pattern in retrieved cups with area of debris deposits indicated

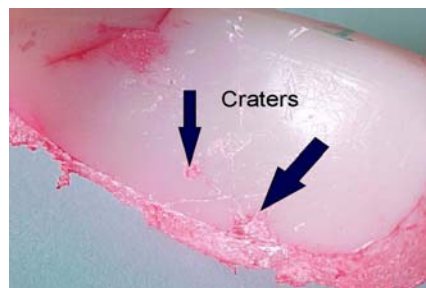
Figure 5.6: Crater in fractured cup

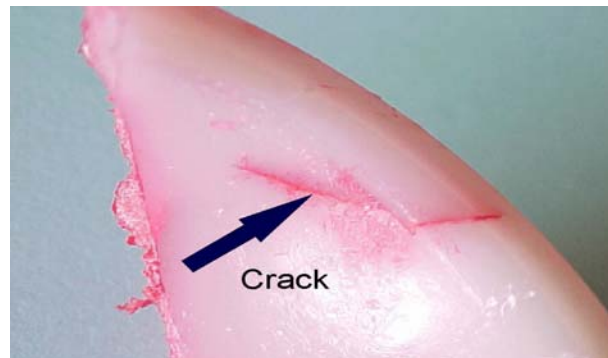
Figure 5.7: Cracking in fractured cup

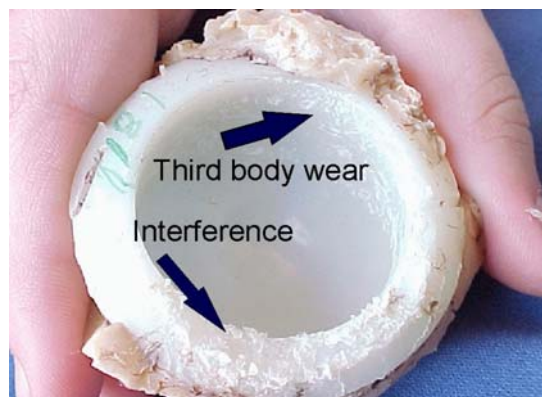
Apart from the wear/creep and the catastrophic failures, a number of other types of failure were identified in the retrieved acetabular components. The first is interference between the acetabular cup and the neck of the femoral component as shown in Figure 5.8. This was caused by misalignment in-vivo. This misalignment may be a result of problems during surgery or, more often, the impingement damage is secondary to a cup loosened due to osteolysis with the resulting movement of the cup causing misalignment. The result is that the neck of the femoral component interferes with the acetabular cup removing pieces of material (UHMWPE and PMMA cement). This debris can find its way into the bearing area where it can cause third-body wear, as discussed earlier. The larger pieces of UHMWPE removed from the rim of the cup, can also cause further osteolysis.

Figure 5.8: A cup with evidence of interference and subsequent damage

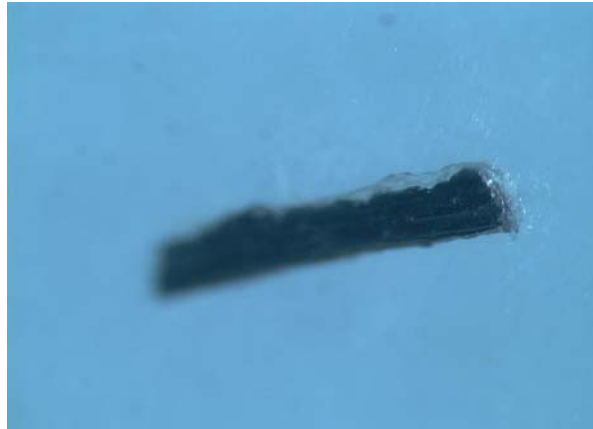
Foreign particles can find their way onto the bearing surface area. In one of the cups, a steel chip or shaving was trapped on the bearing surface and subsequently pressed into the softer polyethylene by the zirconium femoral head as shown in Figure 5.9. The origin of the steel particle is not known, but it can only be from the surgical tools because the femoral head was not manufactured from steel but zirconium and the femoral stem was manufactured from titanium. The piece of steel was embedded in the cup and did not cause the failure. Defects originating from surgical procedures will not be investigated further in this study.

Figure 5.9: Piece of steel embedded in polyethylene (magnification x 40)

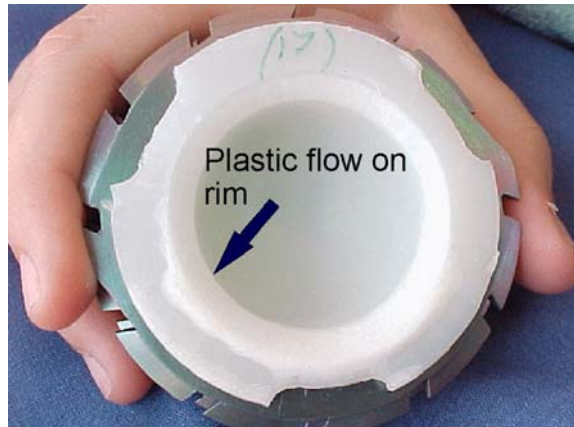
Another defect detected visually was an acetabular cup with severe plastic flow visible round the rim of the cup together with cracks running radially from the area of plastic flow. This is shown in Figures 5.10 and 5.11. The cause of this plastic flow is discussed later. In Figure 5.11, a vernier is held against the “flowed” material to indicate the extent of flow that had taken place.

Figure 5.10: Plastic flow on the rim of cup

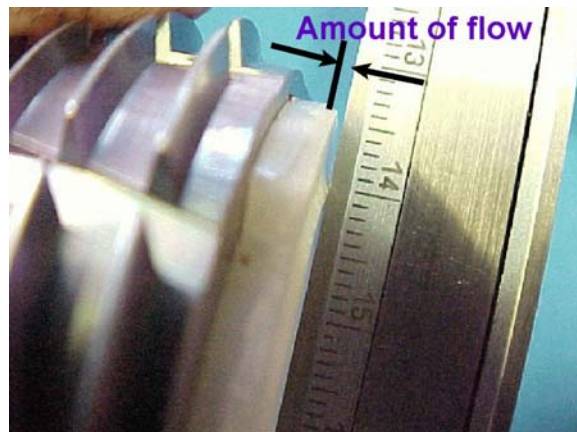
Figure 5.11: Amount of plastic flow

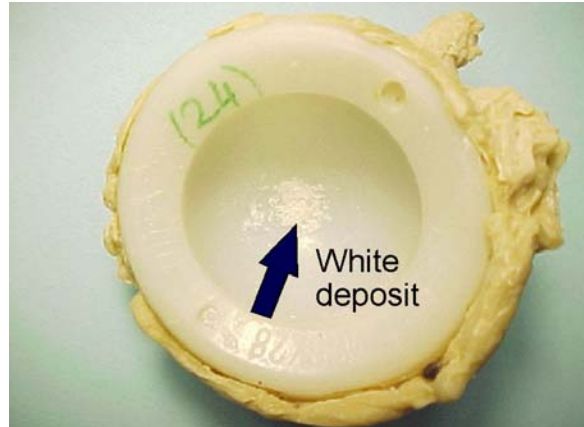
In virtually all of the cups, a whitish deposit was found inside the cup on the bearing area. Owing to the transparent nature of this deposit, it was very difficult to photograph. However, in one of the cups, the deposit was so thick that it was possible to collect and study it using an electron microscope. The deposit was found to be sodium chloride, which was probably deposited after washing the wound and the retrieved component in theatre during revision surgery. (The result of the electron microscope investigation is attached in Annexure B.) This deposit has no influence on the failure analysis of this investigation and will be ignored. Figure 5.12 shows the acetabular cup with the white deposit collected. Also visible in this cup is a slight brown discolouration towards the rim of the cup. The brown discolouration was also

Figure 5.12: White deposits on inside of cup and brown discolouring

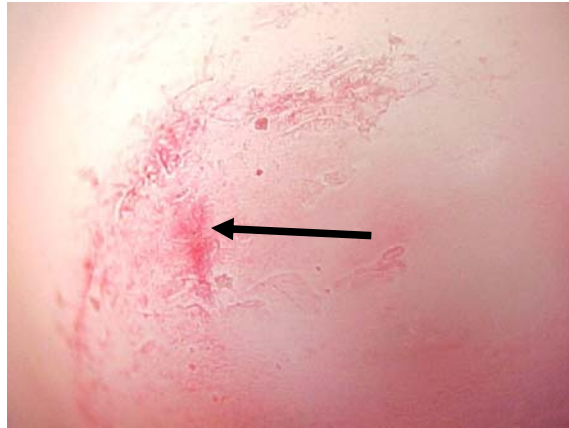
By making use of this technique, all the visual observations made in paragraph 5.2 were confirmed. The material extruded from the bearing contact surface as well as debris removed from the bearing surface during operation can be seen in Figure 5.13.

Figure 5.13: Deposited debris, resulting flow pattern and adhesion wear

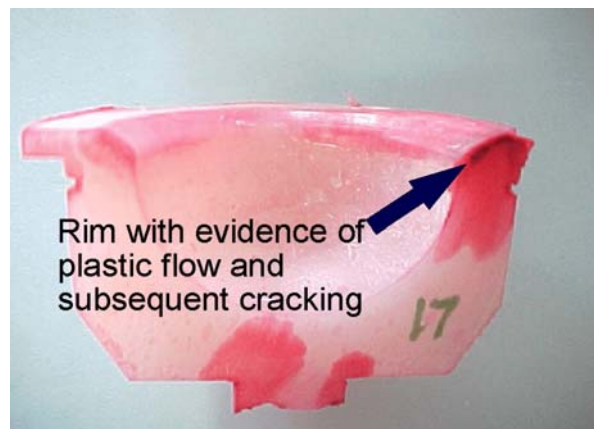
The cup that had shown signs of plastic flow, Figures 5.10 and 5.11, was sectioned before treatment with the liquid dye penetrant. In Figure 5.14, the damage to the rim of the cup can be seen. With the dye penetrant test, it is clear that the material was subjected to conditions of plastic flow and had totally parted with the base material. What is interesting is that the flow had occurred over almost 80% of the rim circumference and not only in the high pressure area.

Figure 5.14: The rim of cup showing plastic flow on circumference of rim

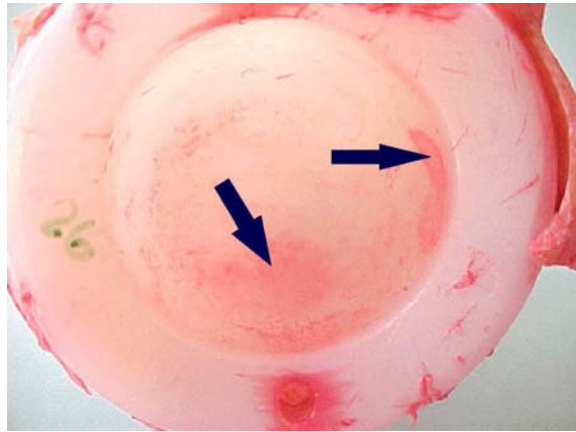
Another feature of the plastic flow that became evident during the dye penetrant tests was that although the running surface looked polished, debris was deposited over the total bearing area. This deposited debris is visible in Figure 5.13. This led to the conclusion that the bearing surface is in actual fact not smooth but “pockmarked” due to debris deposited and then flattened and pressed into the bearing surface. The deposited wear debris is not evenly spread over the bearing surface as can be seen in Figures 5.13 and 5.15. Areas with higher concentrations of wear debris are found. These areas are investigated using a stereoscope, as discussed later.

Figure 5.15: A cup with areas of higher concentration of debris

A further investigation was conducted into what looked like debris deposited on the bearing surface as shown in Figure 5.15. Under close examination with the stereoscope, it was found that the material was not deposited in these areas but that a skin or surface layer of the material was actually ripped off (see Figures 5.28 and 5.29). The machining marks are still partly visible. The extruded edges are also visible. Owing to the hardness and smoothness of the femoral head, these sheared off and flattened particles came loose, as was also found during the experimental tests. The debris showed up as a whitish deposit (see Figure 5.24).

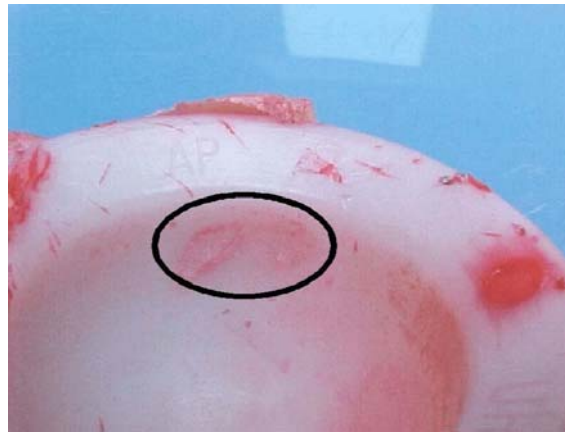
Another defect became clear when the acetabular cups were treated with the dye penetrant spray, namely areas of adhesion wear that had taken place. An acetabular cup with these areas clearly visible is shown in Figure 5.16 with a schematic layout of the positioning of this adhesion wear shown in Figure 5.17. This defect is also investigated further making use of the stereoscope as well as the electron microscope.

Figure 5.16: Close-up of the area of adhesion wear

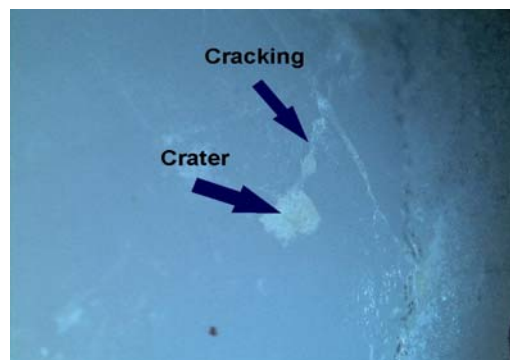
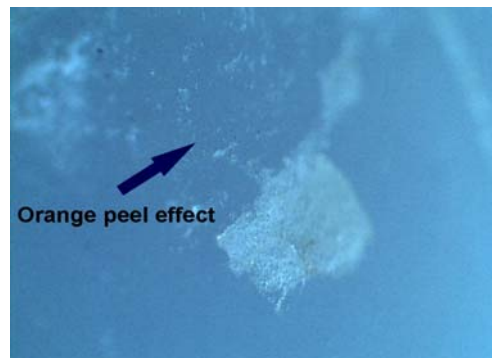
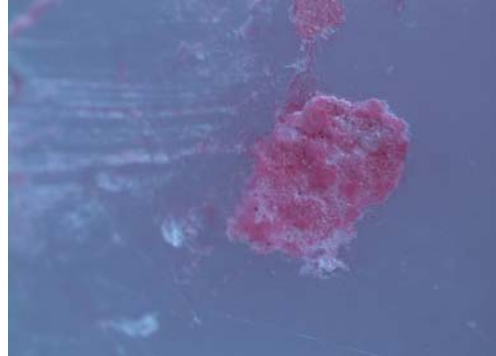
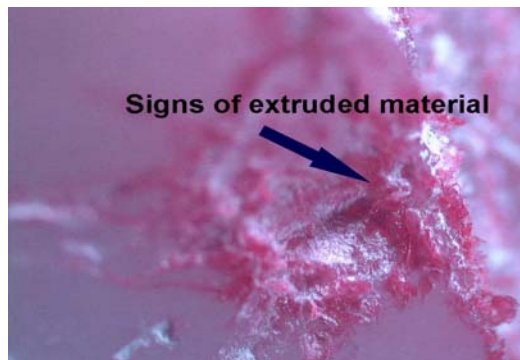
Figure 5.18: Magnification (x 10) of defect before treatment with dye penetrant

Figure 5.19: Magnification (x 20) of defect before treatment with dye penetrant

Figure 5.20: Magnification(x 20) of defect after treatment with dye penetrant

Figure 5.21: Magnification (x 40) of second crater after treatment with dye penetrant

The cracks seen in Figure 5.6 are now clearly visible in Figure 5.18. It is believed that the final fracture occurred after the cracks that had propagated from these defects (Figure 5.21) had extended beyond the critical crack length for this material. Also visible in Figure 5.19 are indications of the orange peel effect, as discussed earlier. Visible in Figure 5.21, is material that was extruded or forced out leaving the crater as indicated by the arrow.

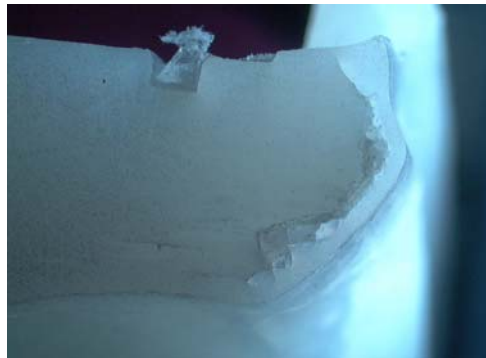
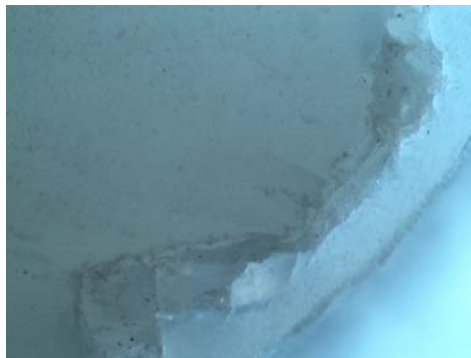
The second failure that was investigated was the cup with material that flowed along the rim of the cup as shown in Figure 5.10. From the stereoscope photographs (Figures 5.22 and 5.23), it is clear that the material that flowed showed signs of separation from the base material. In this case the mass of the patient was approximately 70 kg. If it is assumed that the 32 mm diameter head made full contact, then the maximum pressure on the material is only approximately 1 MPa. This type of defect was found to be common in all of the specific type of acetabular cups retrieved.

Figure 5.22: Magnification (x 10) of defect on rim of cup

Figure 5.23: Magnification (x 20) of defect on rim of cup

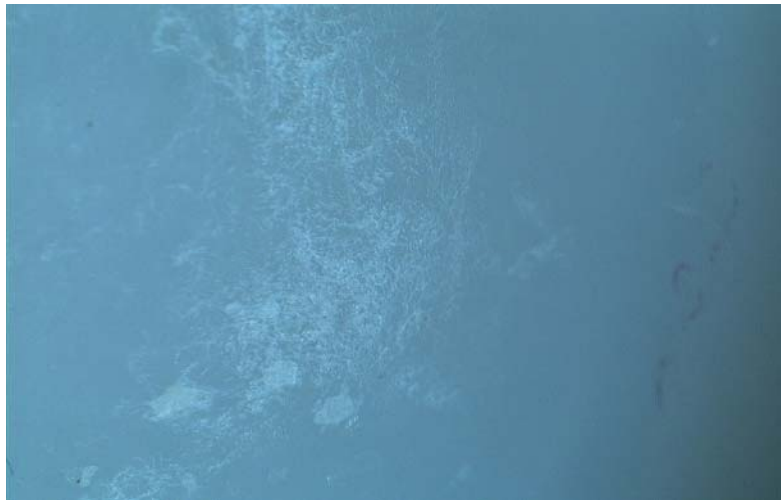
Figure 5.24: Magnification (x 10). From this photograph the white irregular shape of material deposited is clearly visible

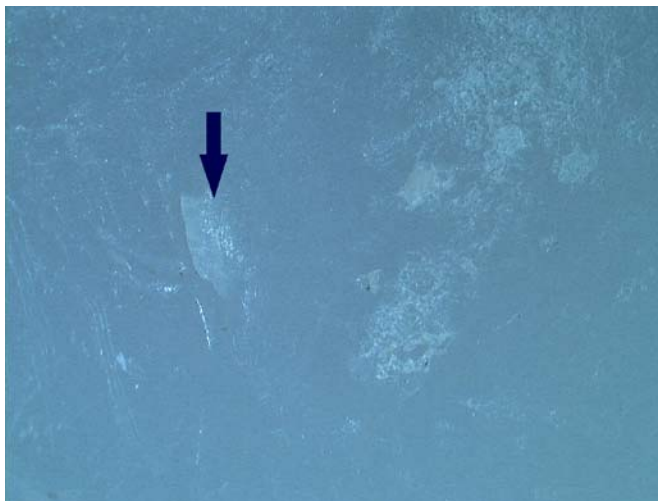
Figure 5.25: Magnification (x 20). The arrow points to a droplet of material which was either extruded from the bearing surface or was flattened after being ripped out of the surface

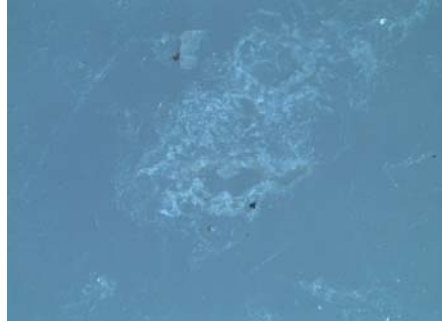
Figure 5.26: Magnification (x 20). The photograph shows softened/extruded debris with what looks like craters in between. Note the irregular shape of the deposit after being flattened by the ball.

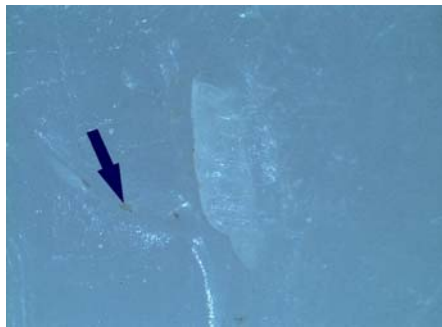
Figure 5.27a: Magnification (x 40): The results from Figure 5.25 are investigated further. It can be seen that the white piece of material appears not to have been totally removed from the base material, as there are no sharp edges on one side.

The indication is that material was extruded from the bearing surface. Some brown discolouring/deposit (indicated by arrow) can be seen in the grooves where material flowed over it. The schematic layout in Figure 5.27b shows a cross section of the described surface phenomenon.

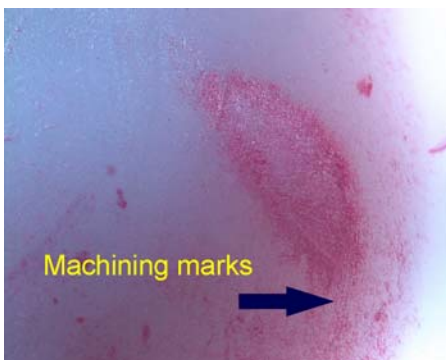
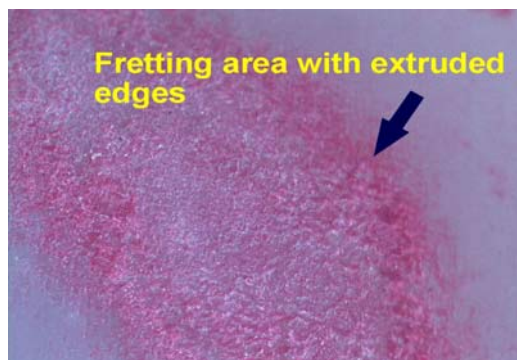
Borne out by this study, is the resemblance between the wear pattern and the “butterfly” stress pattern as calculated and described by Wang et al. (1997) and Bennet et al. (1996), and shown in Figure 5.28.

Figure 5.28: Magnification (x 20) of wear area on bearing surface

Figure 5.29: Magnification (x 40) of wear on bearing surface area

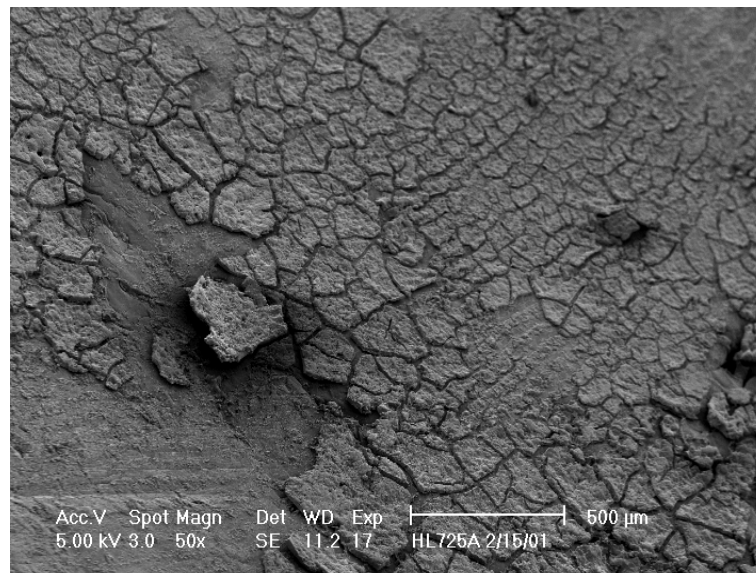
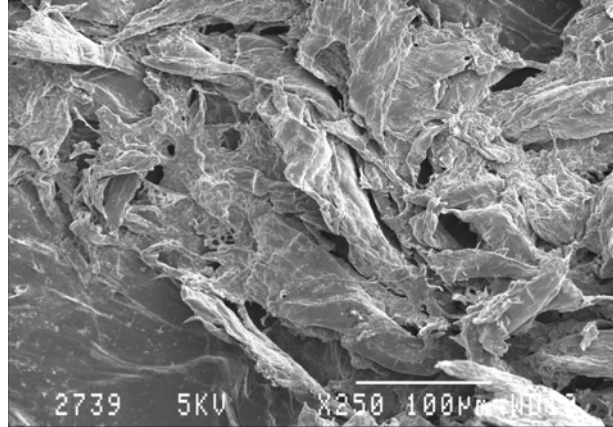
The brown discolouring in the retrieved acetabular cups was then investigated under an electron microscope. This is shown in Figure 5.30. Under smaller magnification, the brown discolouring appears as tiles that are laid down on the polyethylene, while under higher magnification the structure of the brown discolouring is typically that of a protein, as shown in Figure 5.31.

Figure 5.30: Electron microscope investigation of a brown layer on inside of cup (magnification x 50)

Figure 5.31: Electron microscope investigation of the brown layer on inside of the cup (magnification x 250)

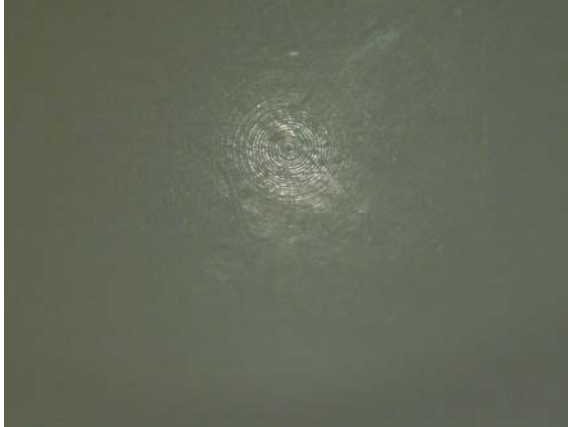
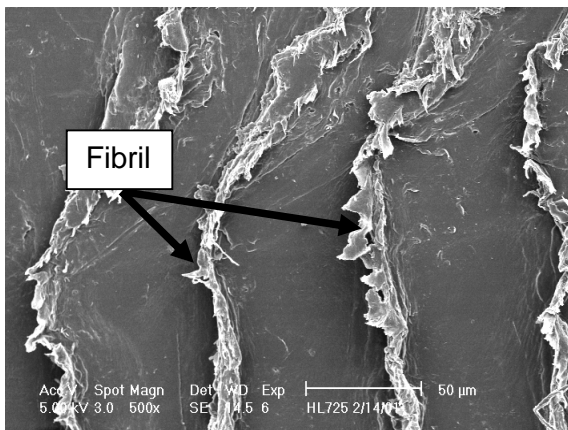
The surface finish specified for manufacturing of the cups is $0.8\mu\text{m}$. The result is a gramophone finish in the cup. This can clearly be seen in Figure 5.35 and with a larger magnification in Figure 5.36. This finish is independent of whether the cup is crosslinked or not, as the crosslinking is done as the final step in the manufacturing.

Figure 5.35: Machining marks visible in acetabular cup

Figure 5.36: Machining marks on inside of cup (magnification x 500)

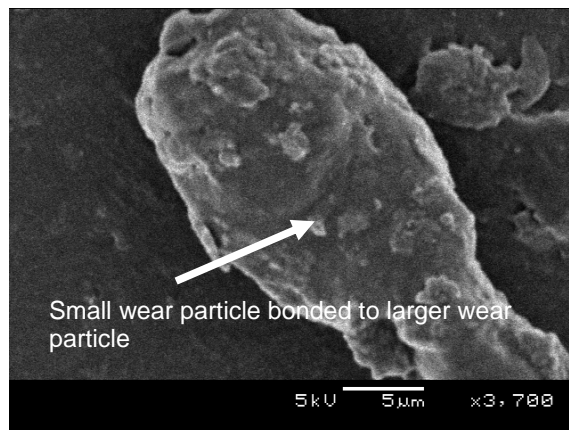
These machining marks with the accompanying polyethylene debris attached to them are now subjected to a fatigue loading when the joint is in operation. This dynamic loading causes a varying shearing action on the polyethylene, resulting

in the separation of the particles. A typical particle separated from the base material can be seen in Figure 5.37.

Figure 5.37: Wear particle entrapped in cup (magnification x 3 700)

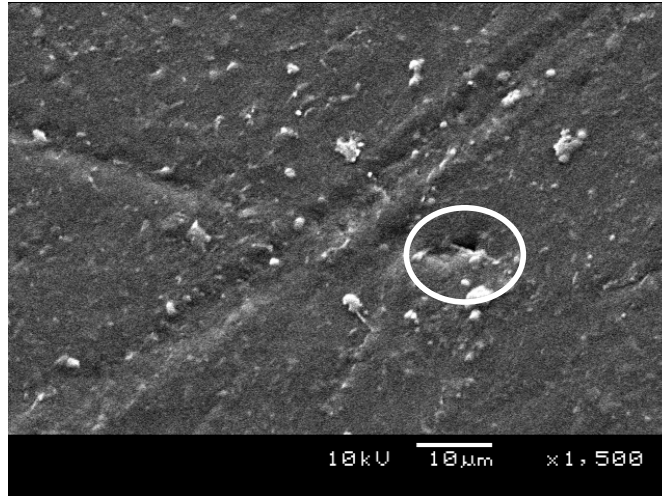
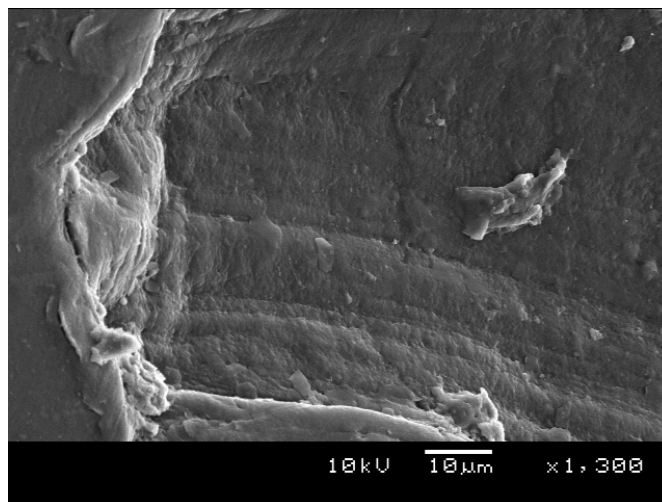
These particles ripped from the base material, result in abrasion wear as can be seen in Figures 5.38 and 5.39.

Figure 5.38: Surface of acetabular cup with scratches due to third-body wear (magnification x 1 500)

Figure 5.39: Abrasion wear on acetabular cup (magnification x 1 300)

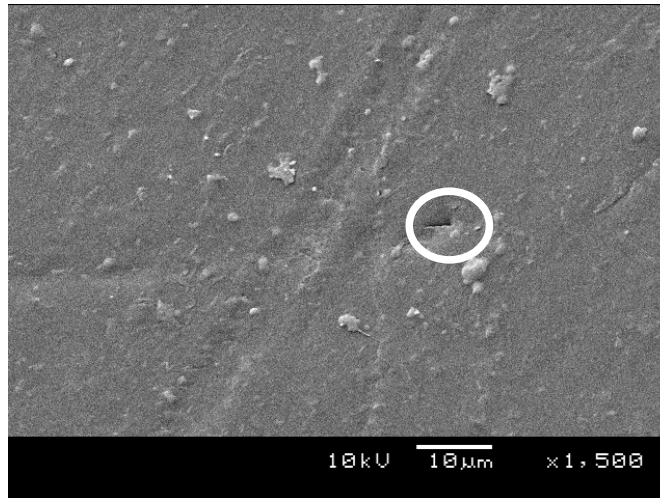
Figure 5.40: Back scatter analysis on wear particle lodged at end of abrasion wear in acetabular cup (magnification x 1 500)

From the back scatter analysis, as presented in Figure 5.40, in conjunction with a stereoscope investigation it can be concluded that the particle responsible for the abrasion wear as shown in Figures 5.38 and 5.39 was indeed an UHMWPE particle that was dislodged from the bearing area as foreign particles are now showing up in the abrasion area. In the area encircled in Figure 5.40, a cavity is also exposed penetrating into the acetabular cup. This type of cavity can create a stress raiser which can lead to early fracture of the acetabular cup.

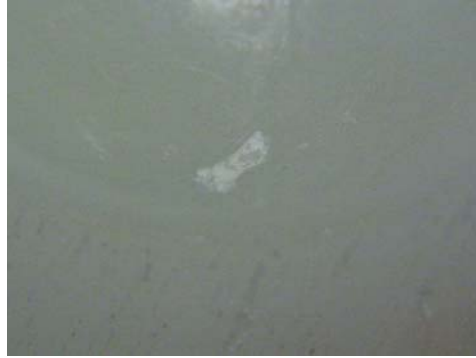
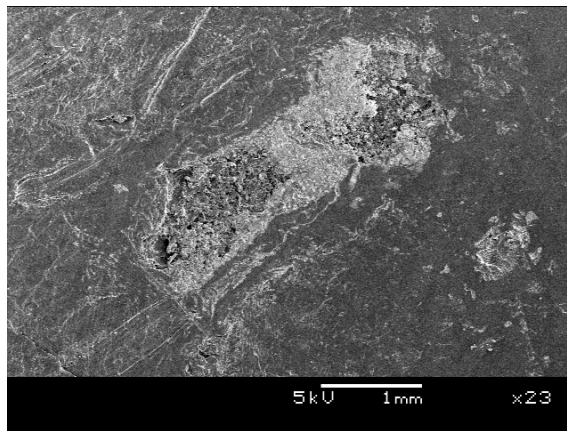
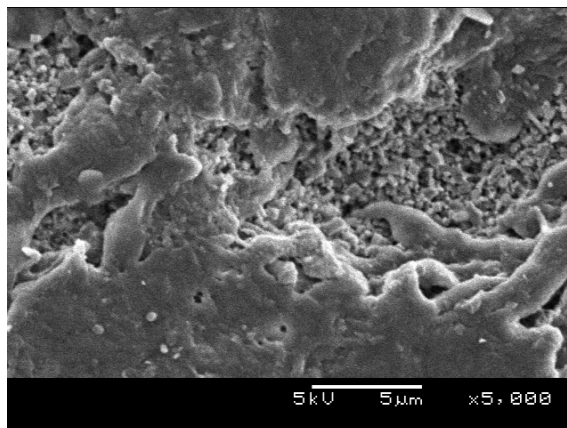
Figure 5.41: Adhesion wear area in acetabular cup

Figure 5.42: Electron microscope photograph of adhesion wear in acetabular cup (magnification x 23)

Figure 5.43: Adhesion wear area under higher magnification (magnification x 5 000)

From the data as presented in Figures 5.42 and 5.43, it is clear that the top layer of the material was ripped off by adhesion to the femoral head exposing the deeper part of the UHMWPE in the acetabular cup.

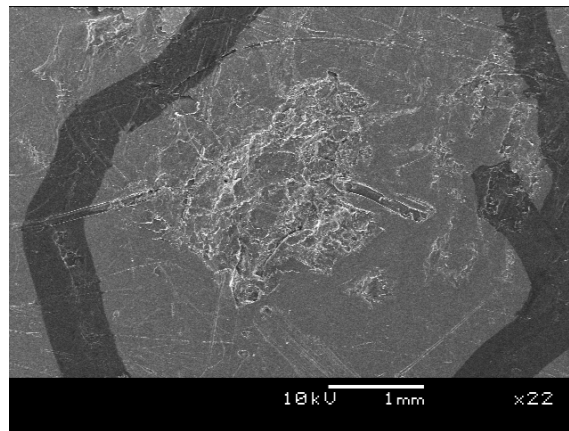
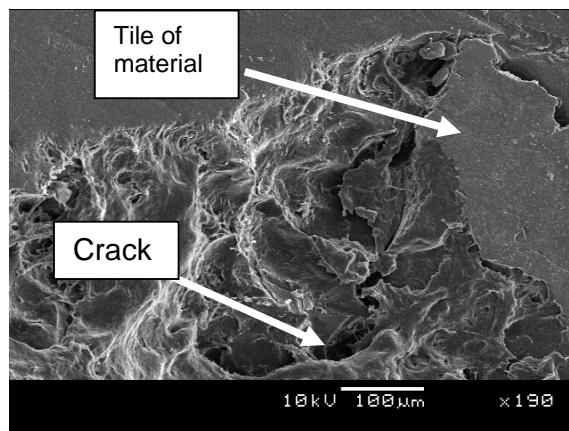
Figure 5.44: Adhesion wear defect under electron microscope (magnification x 22)

Figure 5.45: Adhesion wear under higher magnification (magnification x 190)

In the top right-hand corner of adhesion wear defect as presented in Figure 5.45 again it is clear that the top surface of the bearing area has been ripped off by adhering to the femoral head exposing the deeper part of the UHMWPE. It

would appear that the area was exposed by ripped-off tiles of UHMWPE. A tile at the verge of being dislodged is shown in Figure 5.45. Also visible in Figure 5.45 is the start of a deep crack propagating into the base of the acetabular cup. This crack will likewise create a stress raiser that may lead to early fracture of the acetabular cup.

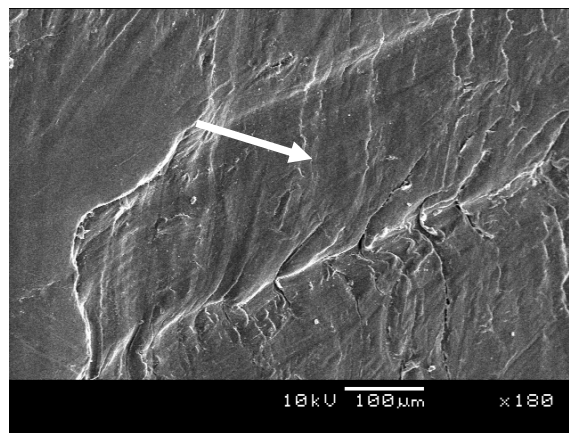
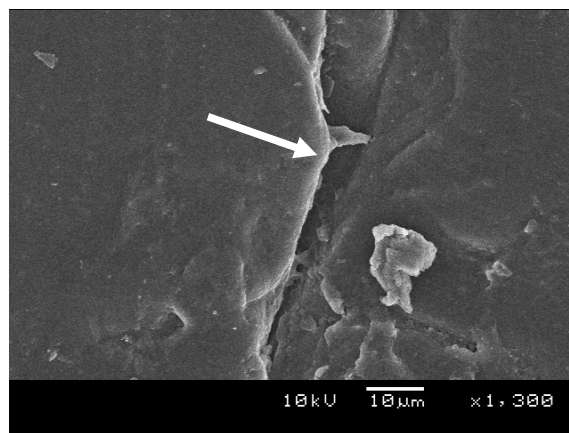
During this investigation, areas where plastic flow of the base material had occurred were also exposed, as can be seen in Figures 5.46 and 5.47.

Figure 5.46: Acetabular cup with visible plastic flow on bearing area (magnification x 180)

Figure 5.47: Plastic flow on bearing area under higher magnification (magnification x 1300)

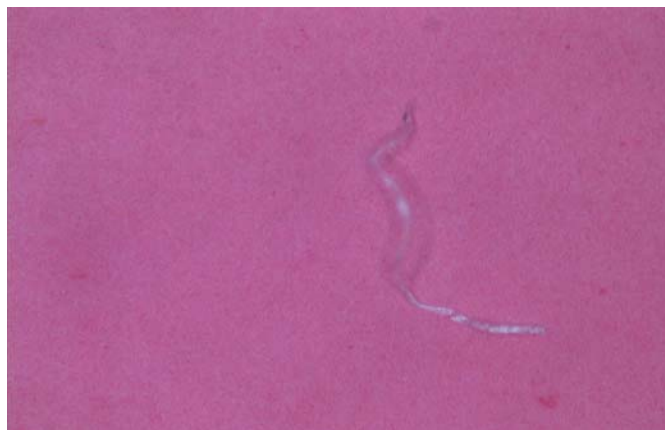
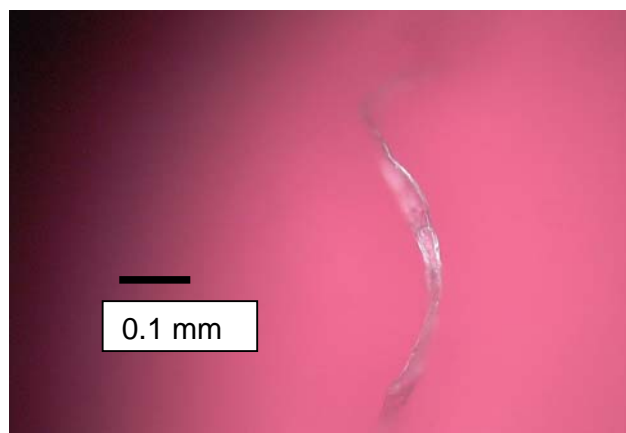
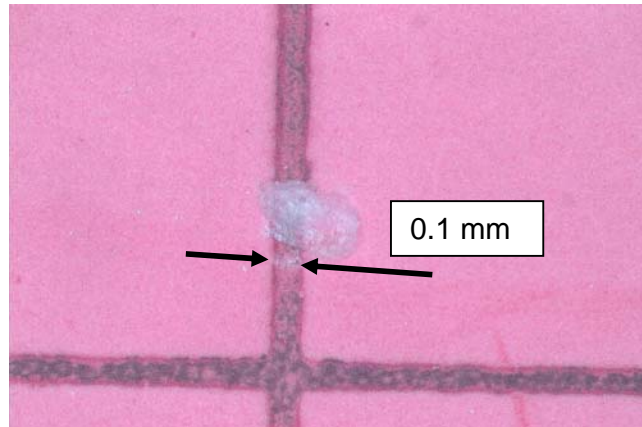
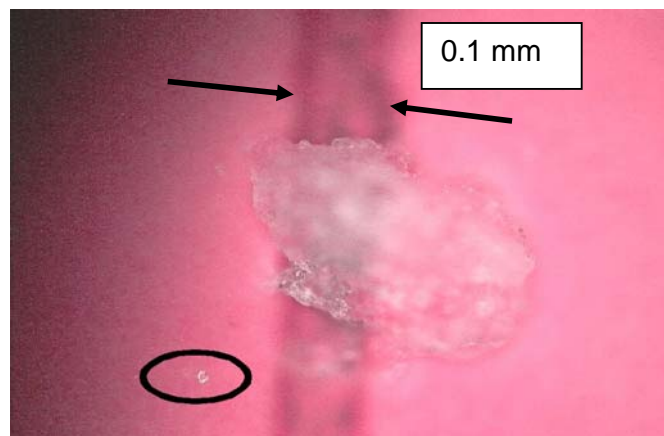
Figure 5.51: Particles retrieved from tissue (magnification x 40)

Figure 5.52: Retrieved particle (magnification x 100)

Figure 5.53: Retrieved particle (magnification x 40)

Figure 5.54: Retrieved particle (magnification x 100)

It should be noted that although particles smaller than $1\ \mu\text{m}$ are also visible, the particles shown in the above Figures are quite large. The large particle in Figure 5.54 is approximately 0.3 mm long. The small particles look like droplets rather than products of normal wear. One of these droplets can be seen (encircled) in Figure 5.54.
