THE EFFECT OF DISCONTINUITIES ON THE ERODIBILITY OF
ROCK IN UNLINED SPILLWAYS OF DAMS

MSc

Sofia Pitsiou

December 1990

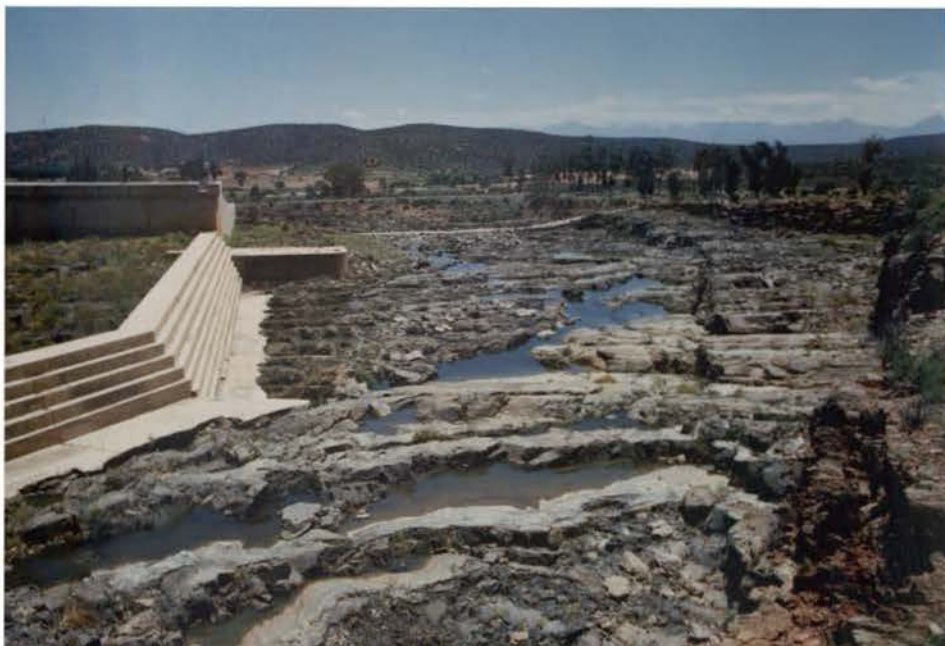
Plate 2 Erosion of the rock mass in the unlined spillway channel (Van Schalwkyk).

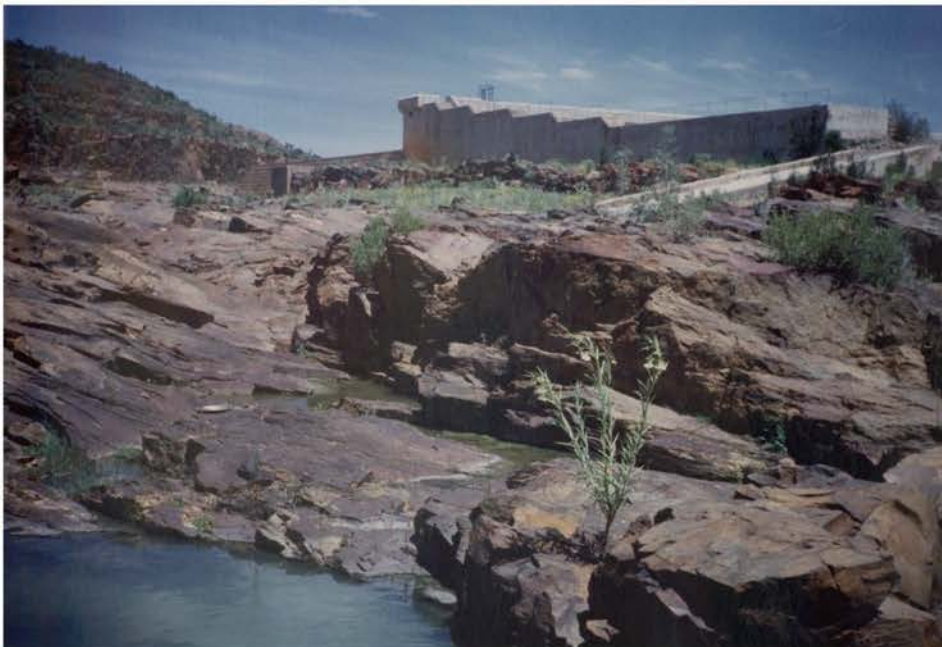
Plate 3 Erosion in the area downstream of the concrete road crossing the spillway channel.

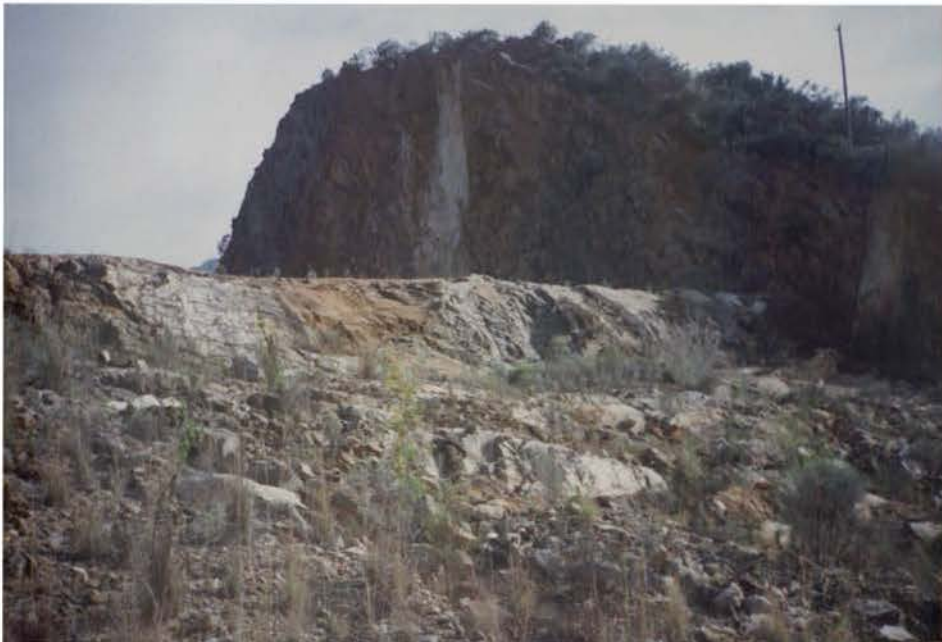
Plate 5 Extensively jointed rock mass with interbedded zones of clayey material on the flanks and in the floor of the channel.

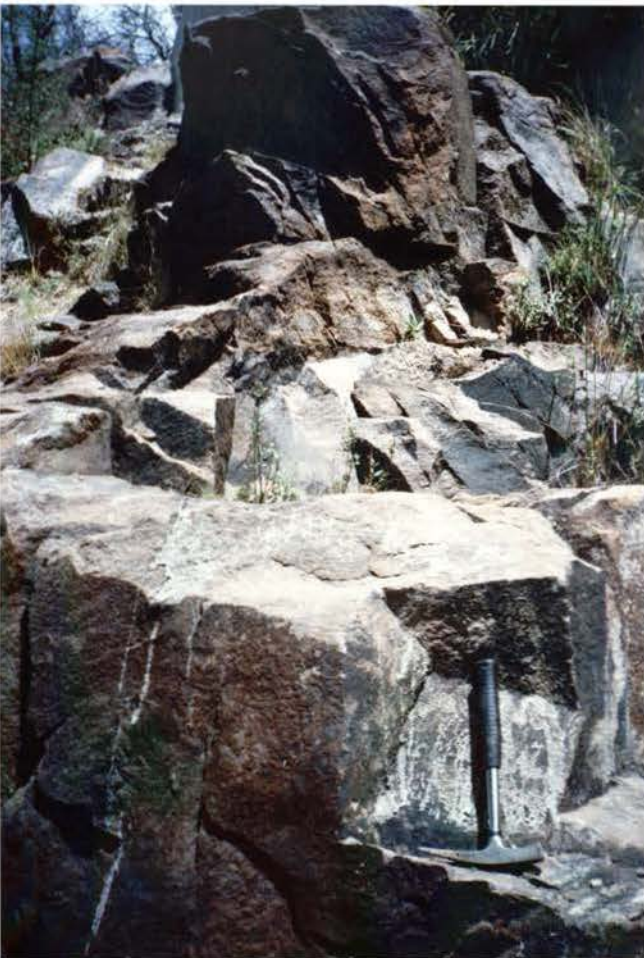
Plate 7 Removable rock blocks formed by slightly continuous, undulating joints.

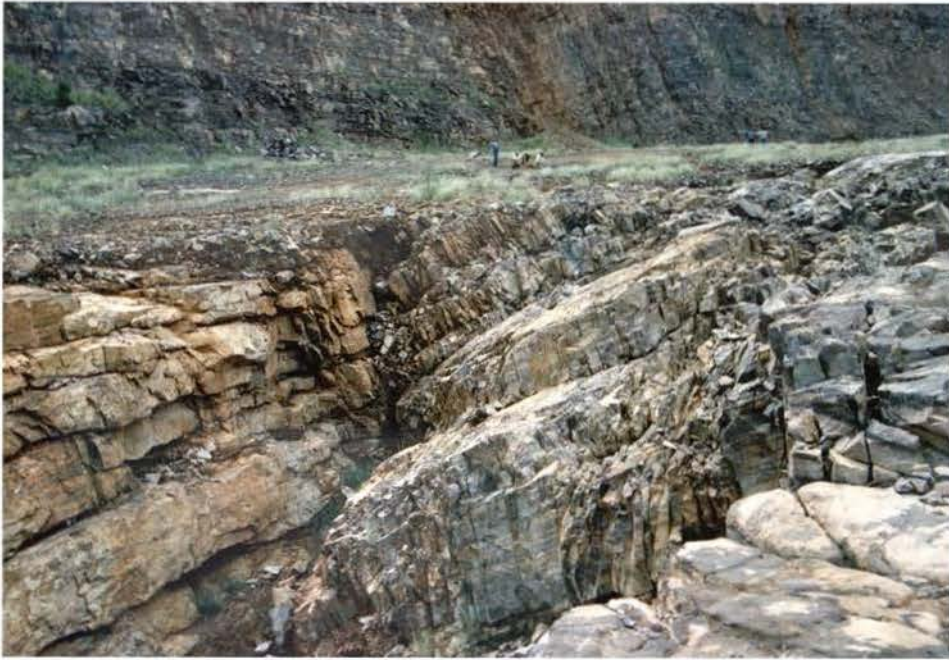
The faulting, presence of open, closely spaced joint sets and the long period of water flowing along vertical and sub-horizontal discontinuities, are some of the factors which gave rise to the erosion process. Faults in the channel introduce non-uniform conditions, causing concentrated movement of the water mass flowing along the channel and differential behaviour of the rock mass. Further erosion can eventually result in damage to the downstream side of the dam and the outlet work, as water is channelled along the eroded trench against the left wall of the spillway during overflow conditions. The rock on this flank is susceptible to further erosion and eventual breakthrough. Backfill downstream of the spillway wall has also been eroded, leaving foundation rock exposed. For remediation purposes, a number of concrete walls constructed across the eroded gorge (founding on solid rock) and backfilling of the compartments with the largest possible rock blocks, grouting of the voids with cement and protection of the immediate downstream area against undercutting, were proposed by Barnard (1986).

Plate 9 Scoured gorge in the spillway channel, closely related to the faults occurring on the right wall (Van Schalkwyk).

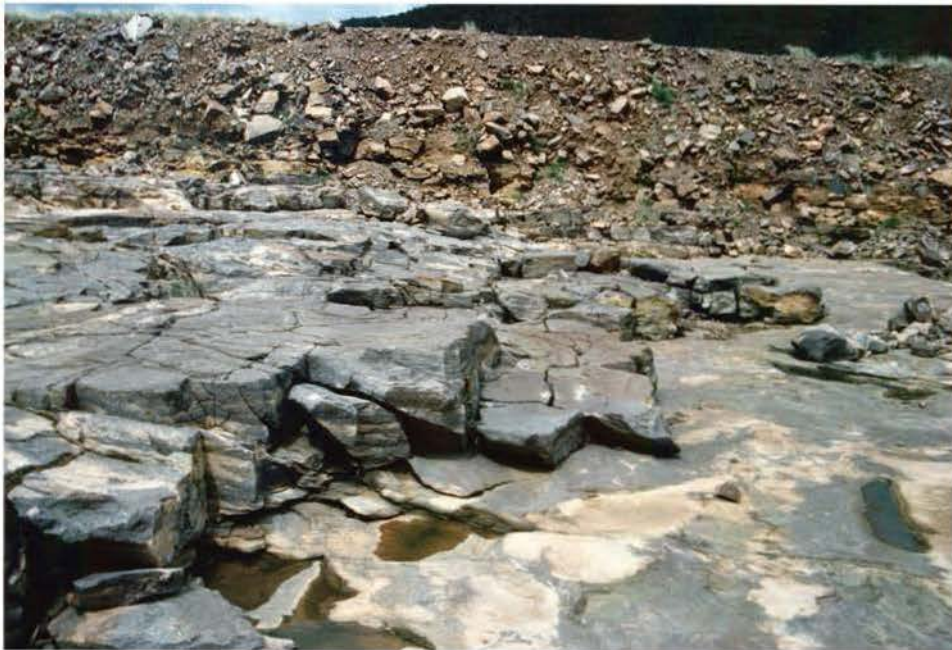
Plate 10 Closely spaced, open joints forming removable rock blocks (Van Schalkwyk).

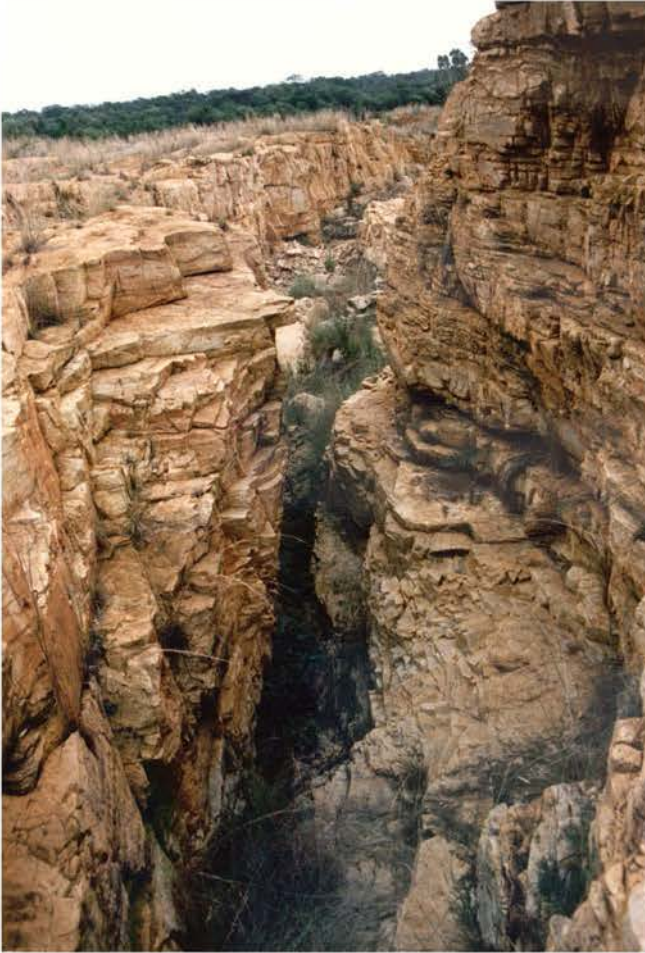
Plate 12 Jointed rock forming the sides of the scoured gorge.

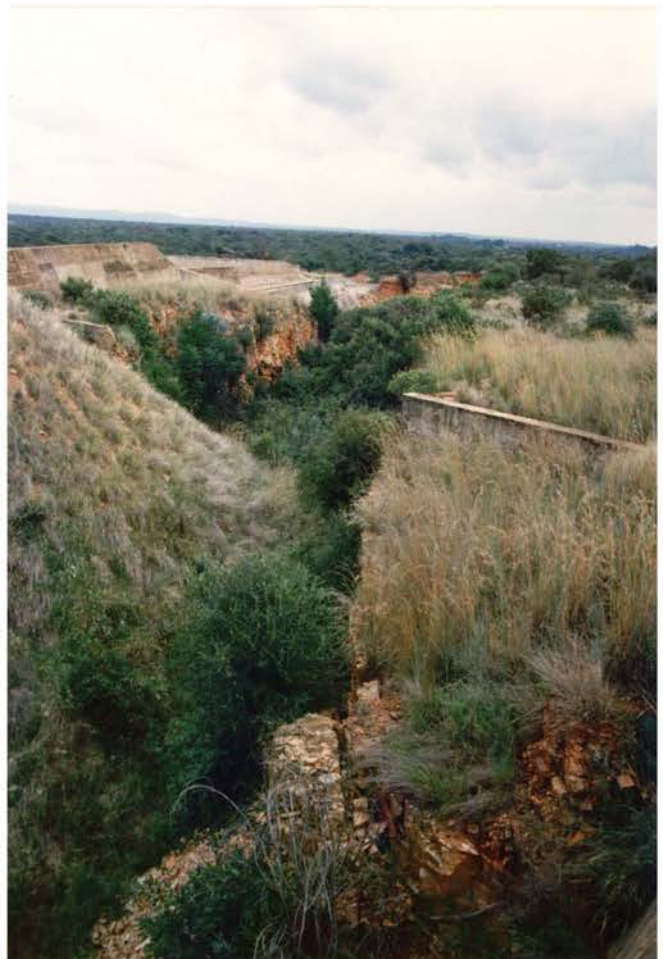
Plate 13 Old spillway structure which failed in 1936 after water discharge (Van Schalkwyk).

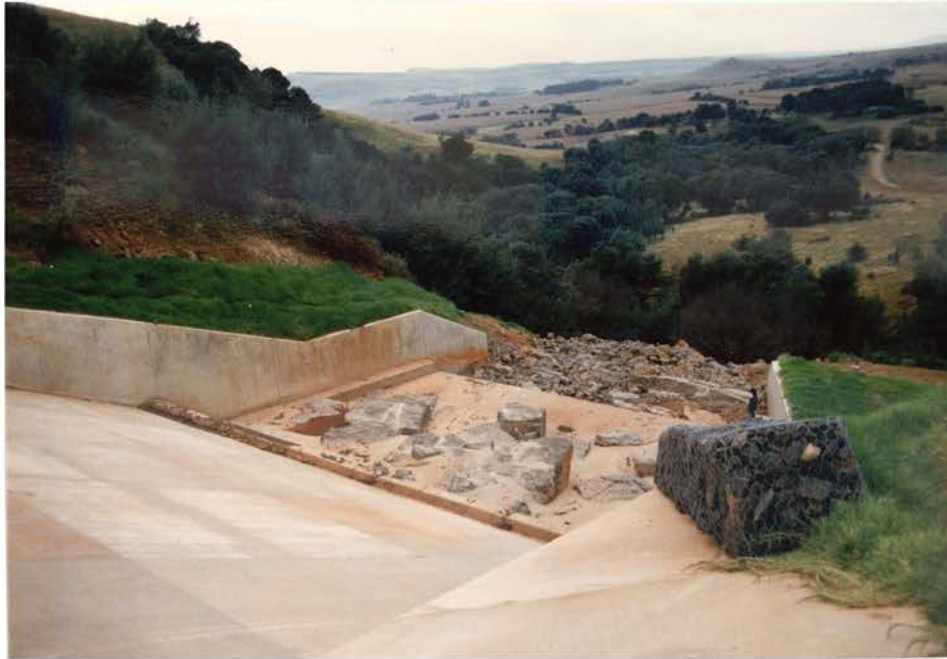
Plate 14 Bell Park Dam - Spillway after repair work (Van Schalkwyk).

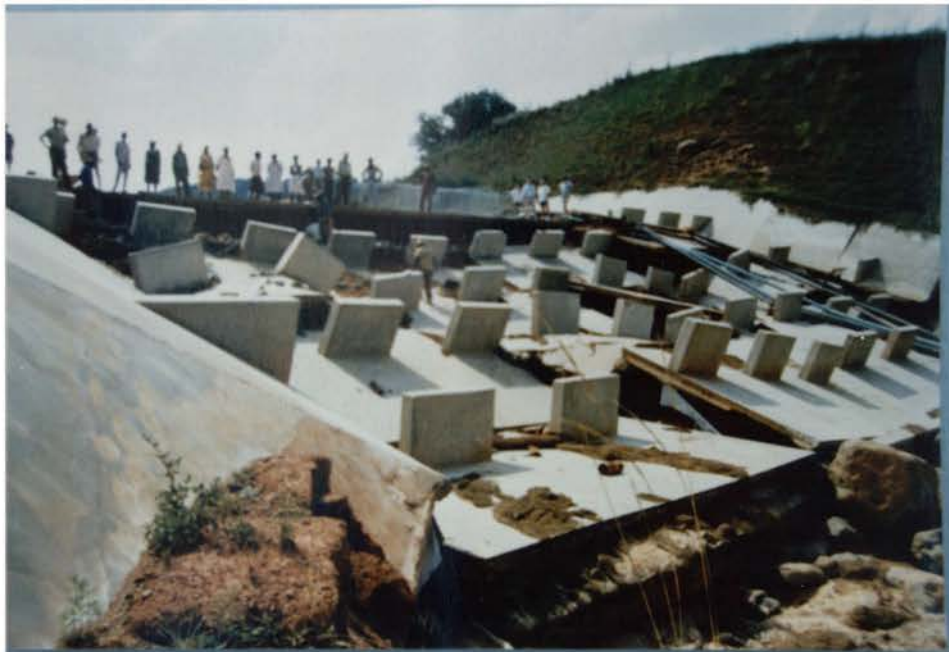
Plate 15 Damage to the spillway slab.

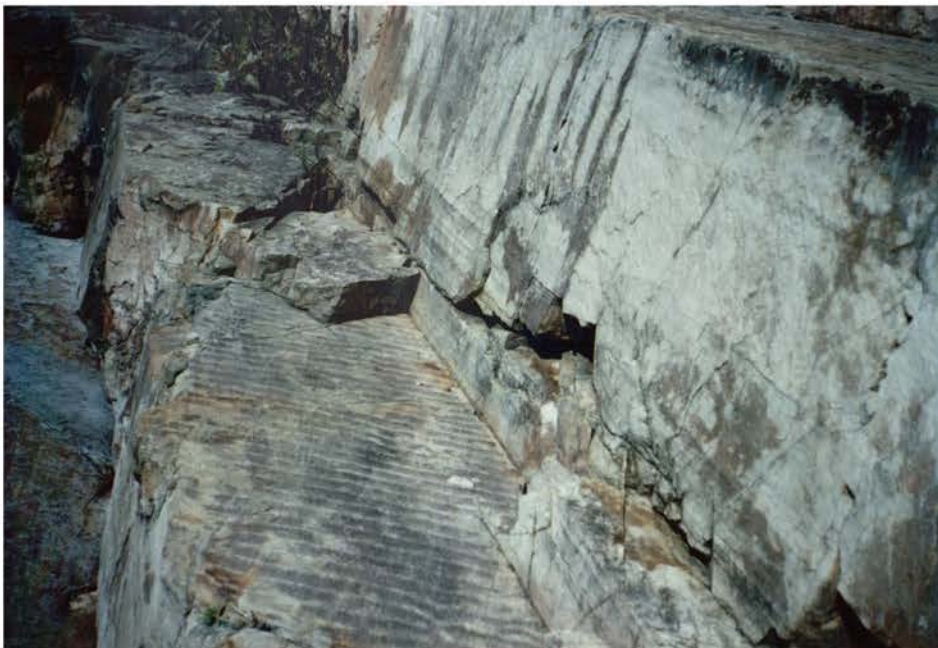
Plate 17 Steps and ridges in the spillway channel due to jointing

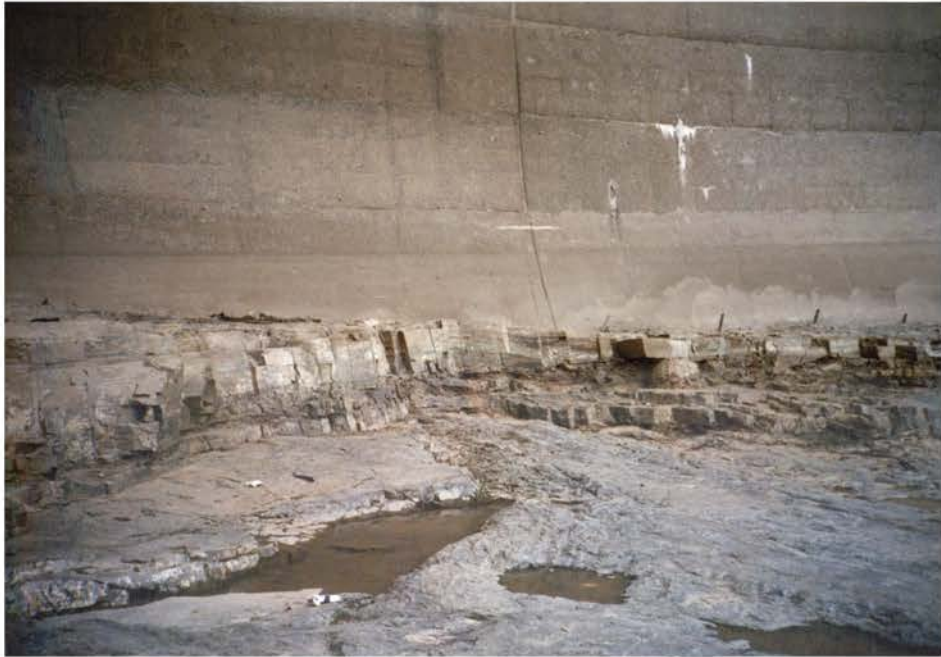
Plate 19 Jointed shale overlying dolerite rock mass downstream of the right spillway arch.

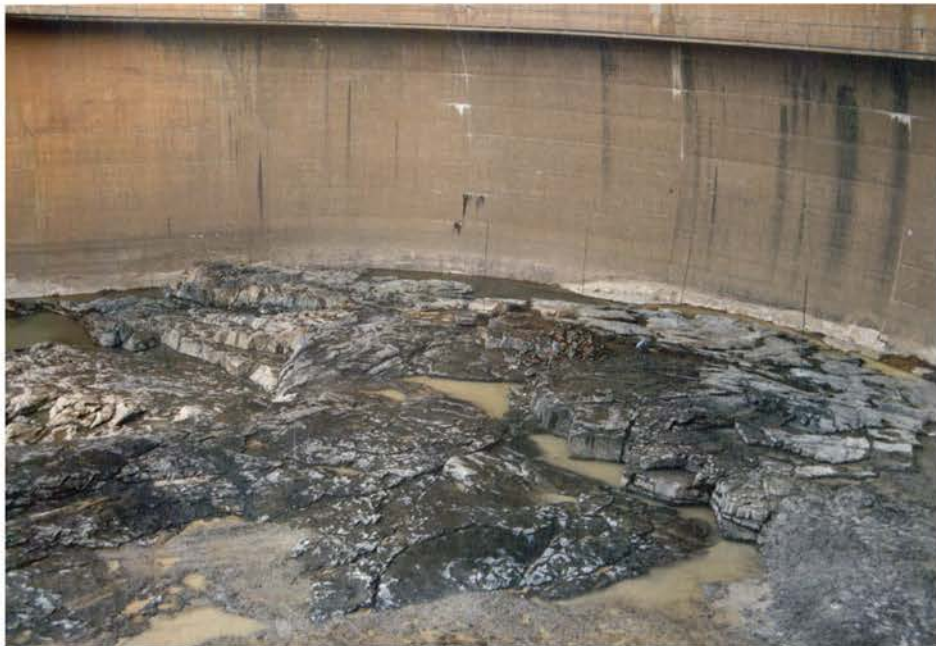
Plate 20 Jointed dolerite downstream of the left downstream area (Van Schalkwyk).

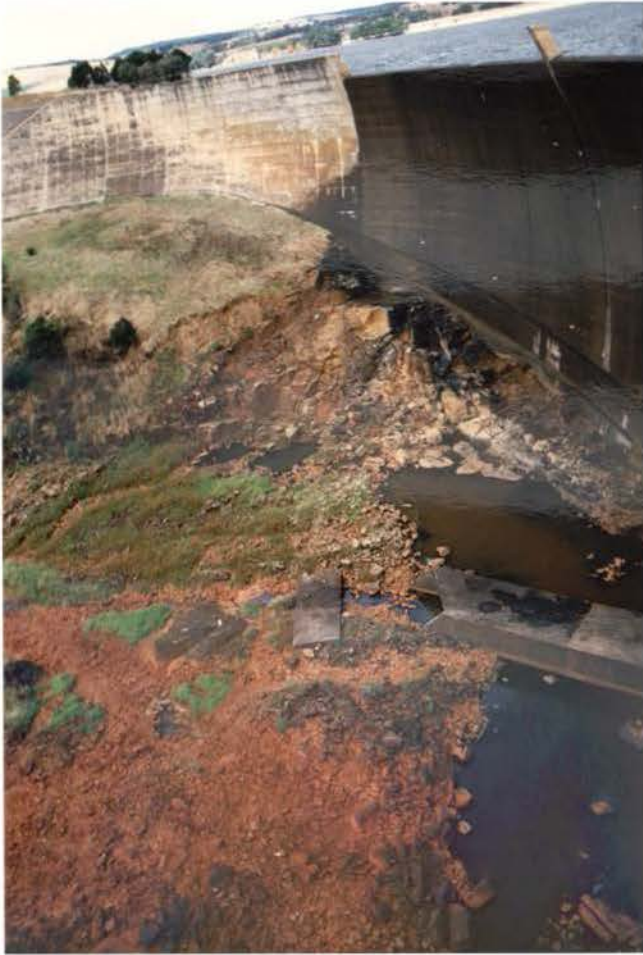
Plate 22 Removal of the topsoil downstream of the arch in the central and right flank areas (Van Schalkwyk).

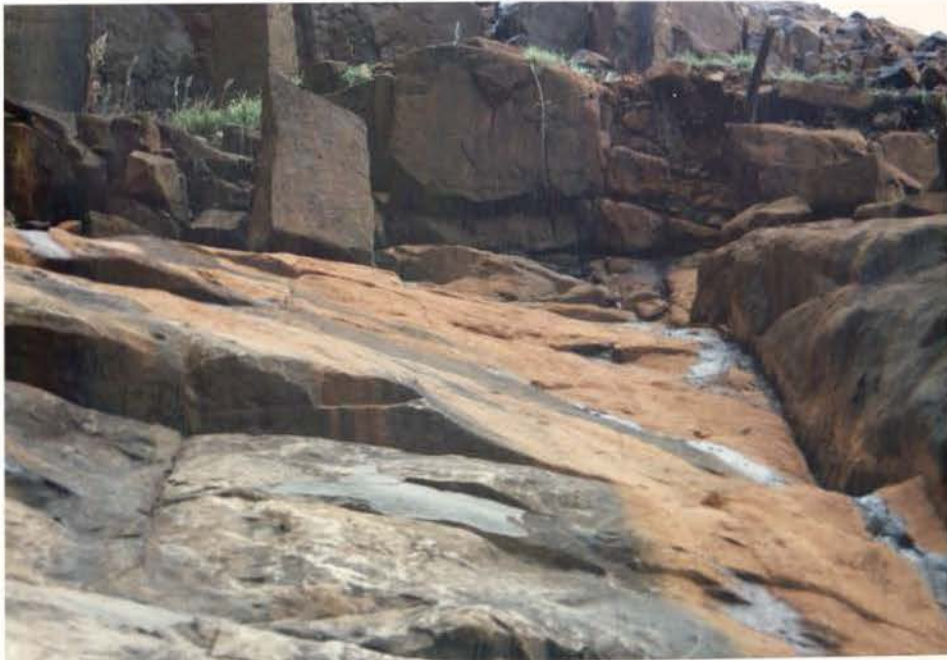
Plate 23 Depth of erosion from the original ground depth, on the left downstream area of the arch.

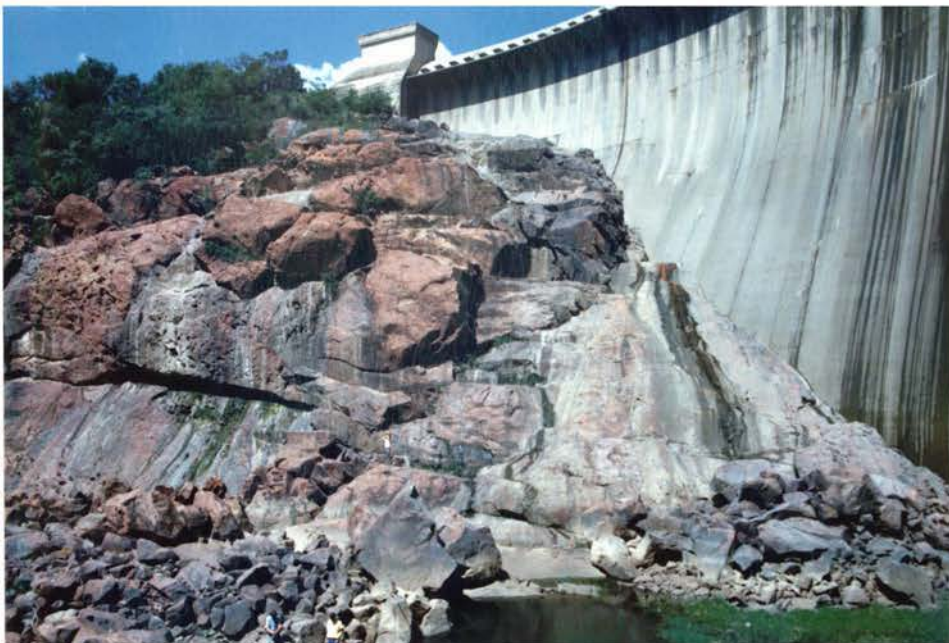
Plate 25 Rock blocks of various sizes formed by many joint sets - Stress relief joints dipping at right angles to water flow direction (Van Schalkwyk).

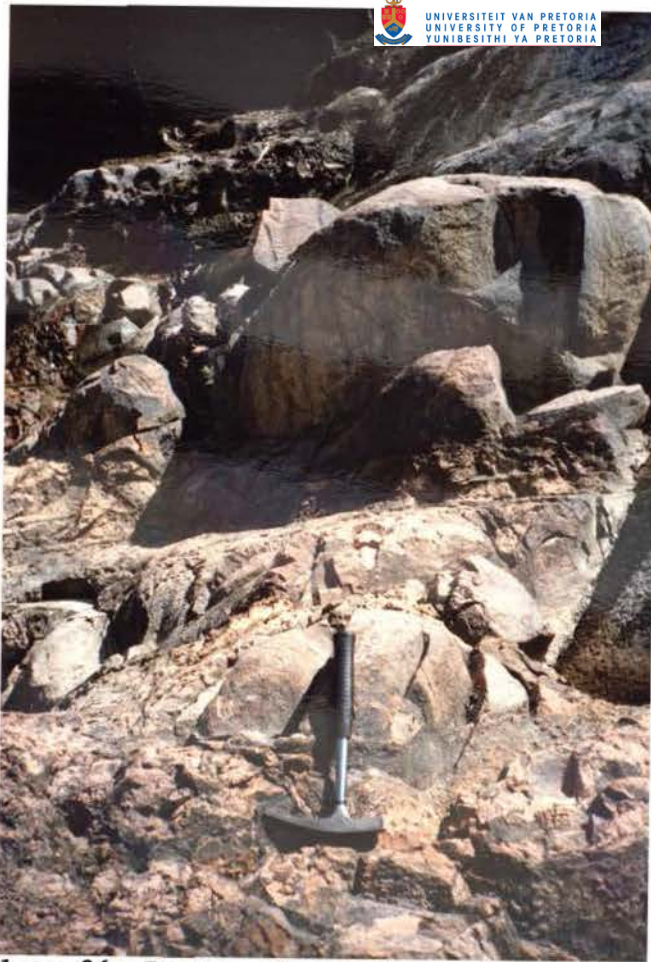
Plate 26 Zones of weathered felsite including unweathered jointed rock on the left side downstream of the arch.

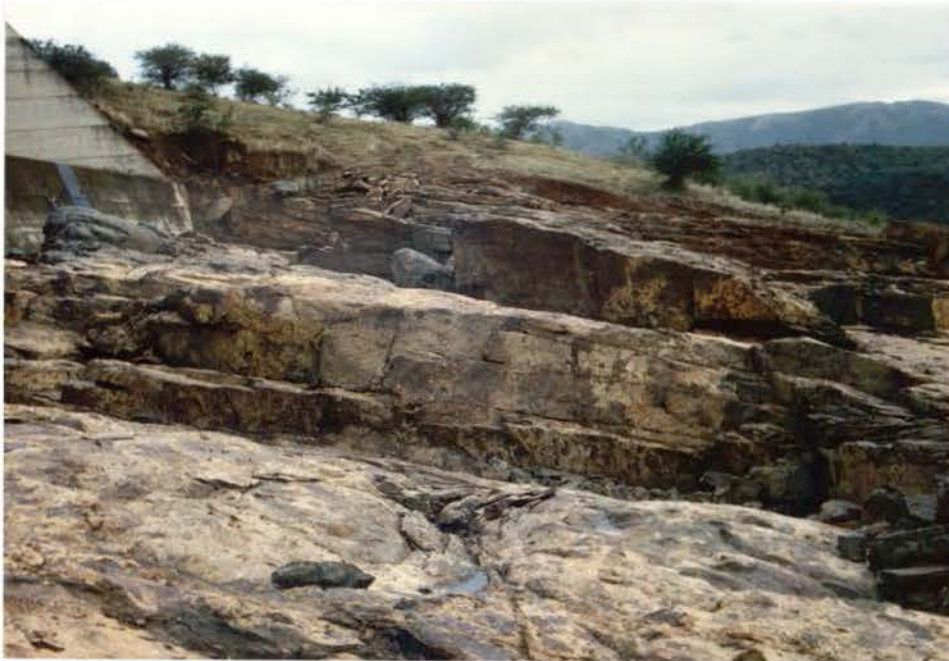
Plate 28 Extensive erosion of the jointed tillite downstream of the spillway (Van Schalkwyk).

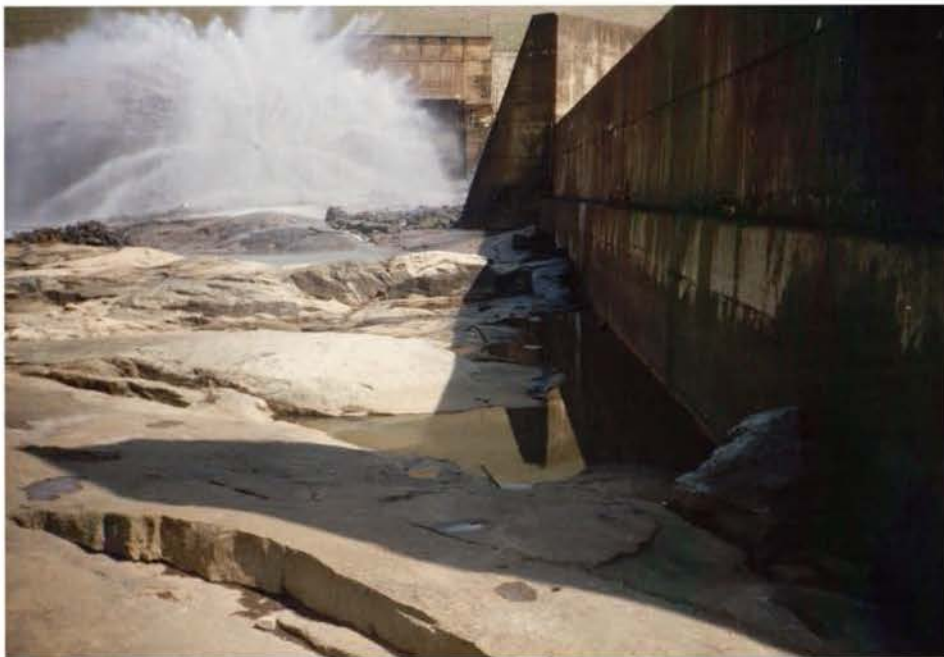
Plate 30 Granitic rock mass with undulating, rough joint planes.

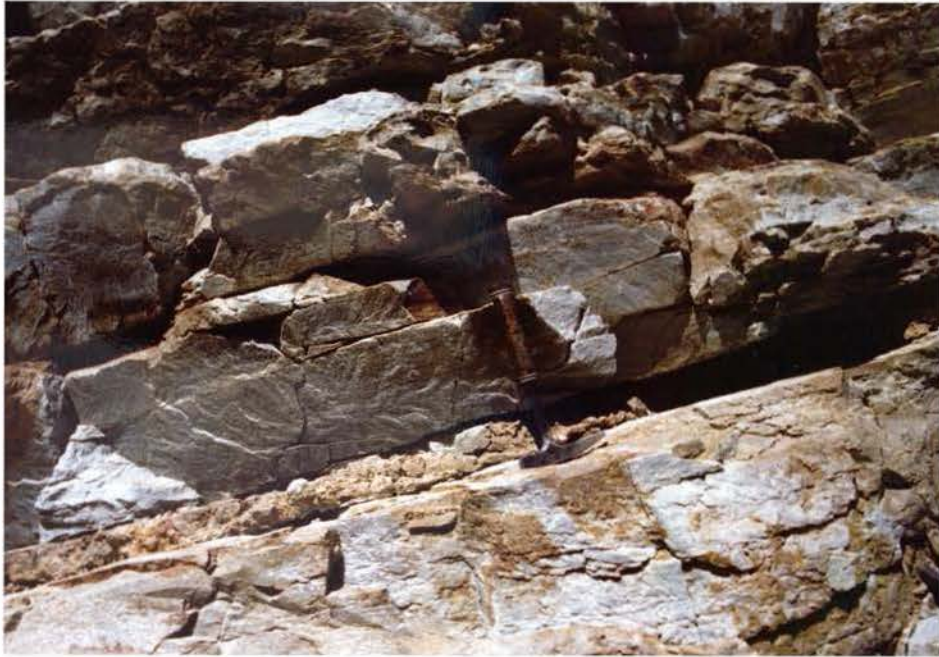
Plate 32 Brecciated rock between quartzitic beds (Van Schalkwyk).

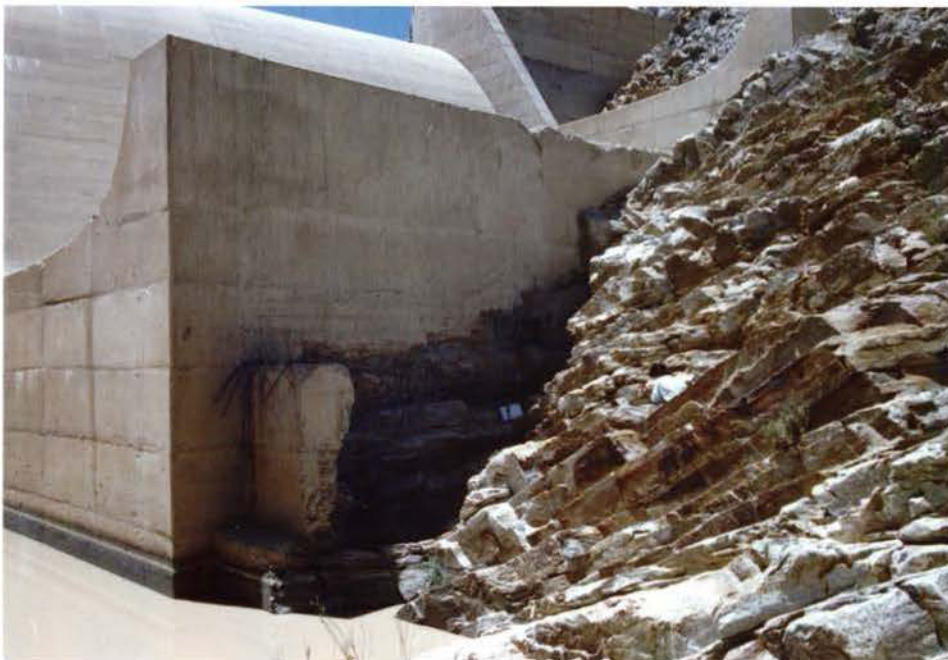
Plate 33 Erosion of the quartzites downstream of the bottom flip bucket (Van Schalkwyk).
