# POTGIETER STREET: ROAD SAFETY PROJECT

Vorster, H.D.<sup>1</sup>, Coetzee, J.<sup>2</sup> and Viljoen, D.<sup>3</sup>

<sup>1</sup>City of Tshwane Metropolitan Municipality: Roads and Stormwater Division,  
PO Box 1409, Pretoria, 0001.

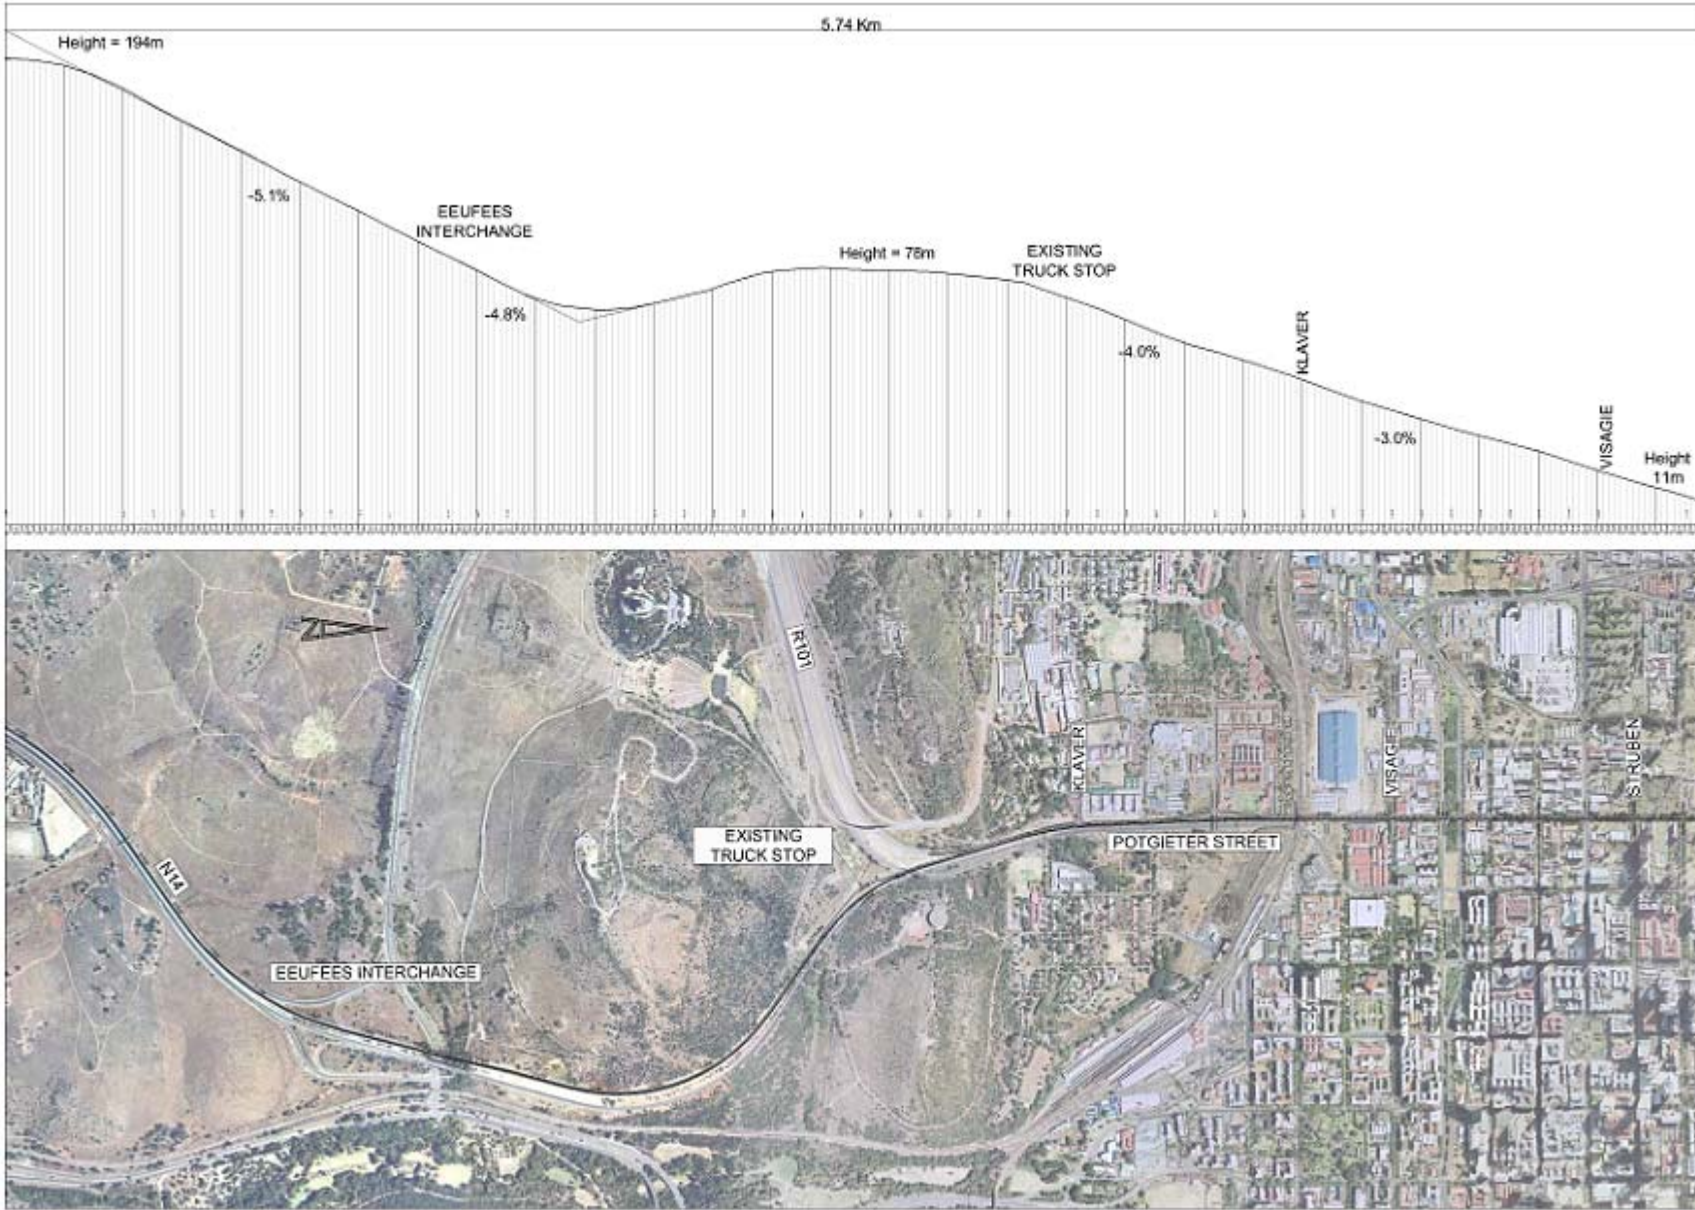
Figure 1. Layout of study area and long section of the N14 and Potgieter Street.

The study area included an eight kilometre section of the N14, starting just before the pipe bridge at Snake Valley across the N14 down to the Bloed Street / Potgieter Street intersection. A section of the R101, approximately 4 km south of the Pretoria Central Prison, was also included in the study. The road alignments are shown in Figure 1.

The vertical alignment of the N14 consists of a total fall of approximately 180 m over a distance of 5,7 km. From the pipe bridge down to the Eufeefes Road bridge is a steep downgrade of 5,1%, followed by an uphill over a short distance, followed again by a relatively steep downgrade again of 3,5% to 4% from the truck stop to the end of Potgieter Street. A long section of Potgieter Street is also shown in Figure 1.

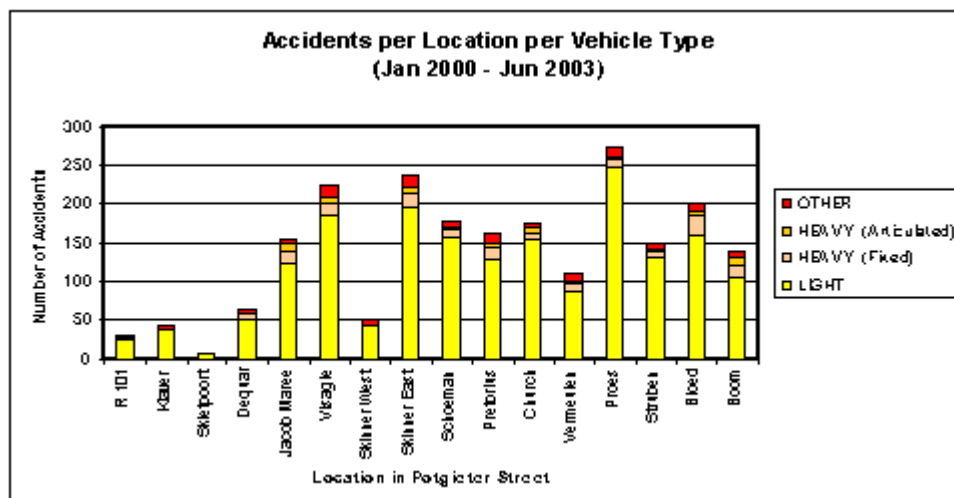
**Figure 2. Accidents per location per vehicle type (Jan 2000 - Jun 2003).**

The types of vehicles involved in accidents along Potgieter Street are shown in Figure 2.

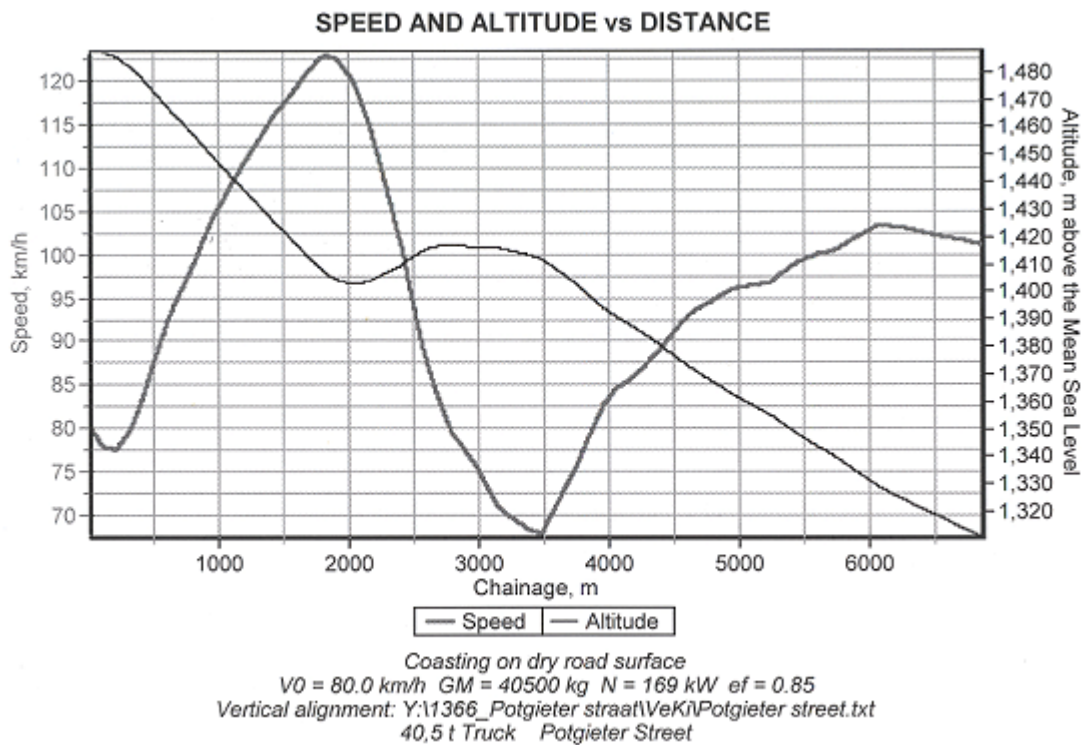
**Figure 3. Speed profile: N14.**

- A heavy vehicle arriving at 80 km/h at the Pipe Bridge on the N14, would reach a speed of 124 km/h at the bottom of the first downgrade and would go over the second hill and reach a speed of 103 km/h at Bloed Street. The speed profile of this scenario is shown in Figure 3.

- Even at a very low speed of 10 km/h at the Pipe Bridge, the heavy vehicle would still go over the first hill, reaching 56 km/h at the truck stop and 80 km/h at the first traffic signal. The deduction that can be made from this is that even if a vehicle drives slowly on the first downgrade, but does not have low gear engaged and the brakes fail somewhere along the downgrade, it will still go over the first hill and enter Potgieter Street at a dangerously high speed.

- A truck that has stopped at the truck stop, and whose brakes fail immediately thereafter, will reach a speed of 95 km/h at the bottom of Potgieter Street. The rate of acceleration on the second downgrade of 3,5%, is however, significantly less than on the first downgrade of 5,1%, as can be seen by the slope of the speed profile in Figure 3.
