HIGH SPEED, REAR END, PARTIAL OVERLAP CRASH TEST OF A LARGE SEDAN AND STATIONARY COMMERCIAL TRAILER

C PROCTOR-PARKER and R STOPFORTH

Accident Specialist / Stopforth Mechatronics, Robotics and Research Lab,
University of KwaZulu-Natal, Durban, South Africa.

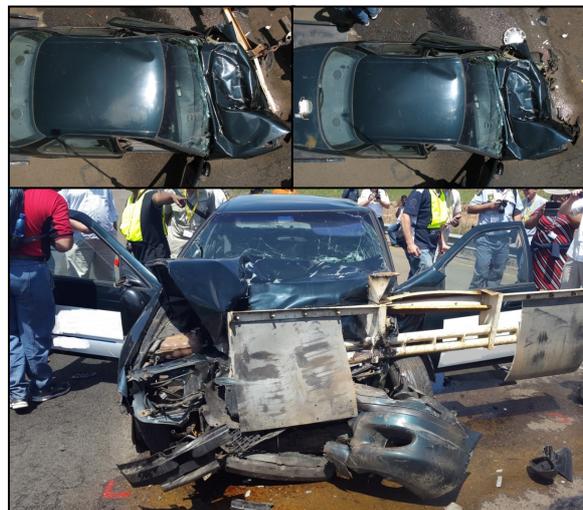
Figure 9: Damage to the Bullet vehicle

The damage to the Bullet vehicle was catastrophic and was expected given the parameters (Figure 9). Notably, modern vehicles are designed to absorb impacts and to collapse, however to maintain the general integrity of the occupant compartment, this appears to have occurred.

The consideration of the damages to the vehicles in respect of measuring the damages, could provide further insight into the speed of the vehicle. The Bullet vehicle damages measured right to left at 0.55 m from ground level, at bumper leading edge height, with measurements of; 1 – 0.53 m; 2 – 0.56 m; 3 – 0.60 m; 4 – 0.64 m; 5 – 0.69 m; 6 – 0.74 m, 7 - 0.35 m and a total crush width of 1.02 m (Figure 11). Cursory application of the measured damage (crush) sees a speed suggestion of 62.8 km/h (Vomhof, 1988) and as low as 46.3 km/h for a typical six point crush analysis.

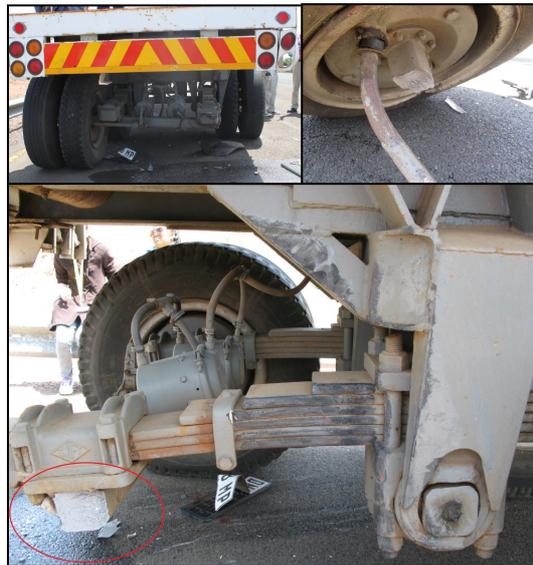
Figure 10: Damage to the Target vehicle

The damage to the Target vehicle is arguably minor to moderate and was expected given the parameters (Figure 10). Notably, the underride bar had totally separated. The two left side mounting bolts between the lower end of the chassis bracket and underride bar

sheered. The right side chassis bracket sheared off at the mounting point between the main mounting bracket and chassis itself, at the point of the welded connection. The entire structure of the underride bar separated from the Target vehicle as a complete unit (Figure 9).

The rear axle had sheared off at a position on the outer side (right side) of the suspension spring mounting brackets (Figure 10), separating the complete right side dual wheel combination. Minor damage to the rear right taillight housing had occurred. Besides these damages, very little further damage to the trailer appeared evident.

Although not unseen, it is somewhat unusual to see the Axle having sustained such catastrophic damages (Figure 10 and Figure 17). A more common result being the laceration and deflation of the tyre/s and perhaps even the damaging of the rims and even the damaging of the hub and various wheel mounting components. The Axle determined as a Swift, 92 mm square solid bar axle (9 ton). Axle strength along with tyres are major factors considered during the design of a trailer, the axle and tyre combinations being the major factors in the permissible load mass of the trailer. The particular axle on this trailer being that of a now defunct axle manufacturer, Swift Axles, as such no specific detailing could be obtained for the particular model.

The *possible weakness of the two vehicles considered*, notes that the Target main structural chassis appears to have suffered no damage. As already highlighted, the key weakness being the inappropriate securing of the rear under-ride and therefore not performing to the maximum. The limited deformation space between the rear under-ride and the rear most wheels is also a notable factor. To this end, the South African National Road Traffic Act, Regulation 218 and the South African National Standards Document (SANS 1055:2007) as well as other international specifications, should be kept in mind and referenced when considering a case. It may be a consideration that further specific evaluation against the results could provide some guidance to improvement of safety in respect of minimum mounting specifications and perhaps clearances to allow for suitable deformation.

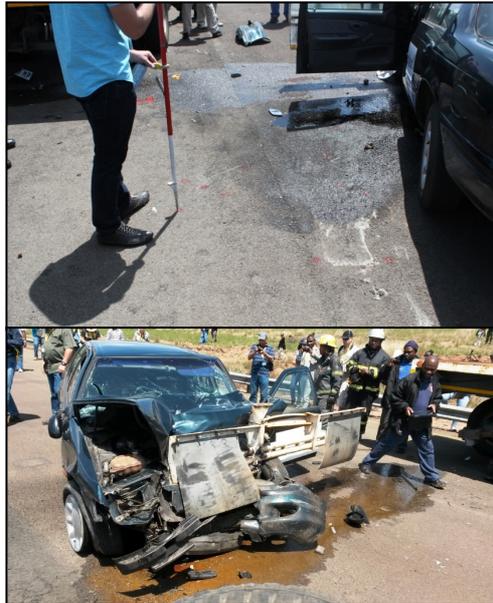
Figure 12: Liquid spill from rupture sump and other vessels

Liquid spill, typically as a result of vessel damage, such as the radiator, sump, water bottle and gearbox or even CV joints, almost always results from the Bullet vehicle. The initial impact of the sump, with the road surface causing rupture of the vessel and therefore the initial liquid (oil) spill at the immediate area of the sump and road surface contact. The movement of the Bullet from impact to rest resulted the continued deposit of the liquid debris along this path.

The resting position allowing the further draining and development of the liquid soak patch at that point. All factors located and evident to a large extent as seen in Figure 12.

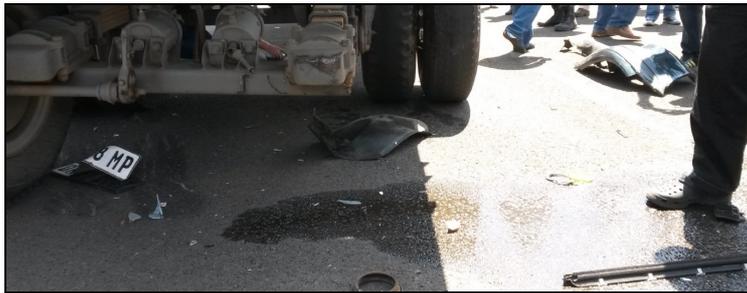
Figure 13: General debris

Some shards of glass, paint and small Bullet vehicle component pieces were noted as strewn around the general area, as seen in Figure 13. Although these may not be specifically recorded in each of their positions or specification, their presence were notable as this forms part of determining the general area of a crash. In certain cases these could serve to assist in determining what vehicles were involved, if for example there was a colour matching or glass fragment matching undertaken.

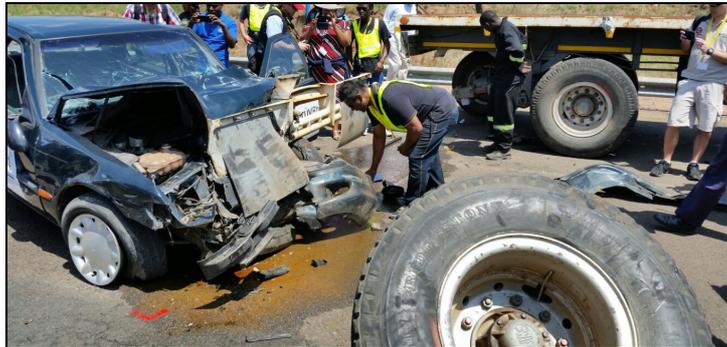
Figure 14: Specific debris

It is noted that there is a total separation of the entire right side, dual rear wheels, to a position ahead of the bullet vehicle and to the right of both the target and bullet vehicle. The wheels have separated as a result of the snapping of the axle, at a position on the outer side (right side) of the suspension spring mounting brackets. Noting the orientation of the Bullet vehicle laterally (partial overlap) at impact and to the rear of the target, indicates that the approximate centre line of the bullet vehicle and therefore the engine, would have been in the general centre line of the two rear right side wheels at impact.

The wheel combination has separated and essentially become a large section of vehicle's debris from the target vehicle. Even though the wheel combination has largely remained unscathed, there were evident impact markings on the tyre and tyres remained inflated (Figure 14).

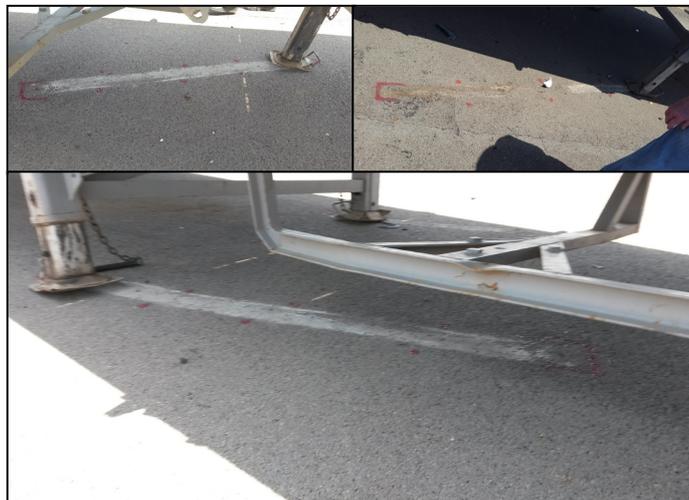
Figure 15: Scratches and scrapes

Minor (yet typical) scratch and scrape marks were noted and recorded at the area of the front left suspension area of the bullet vehicle, directly to the left of the position of the sump contact position (Figure 12 – Total station Staff position indicates). The lower suspension components bottomed out against the surface. In this particular scenario, the trailer landing legs left very distinct marks highlighting their point of origin and the movement as the target was propelled and subsequently their position of rest (Figure 15).

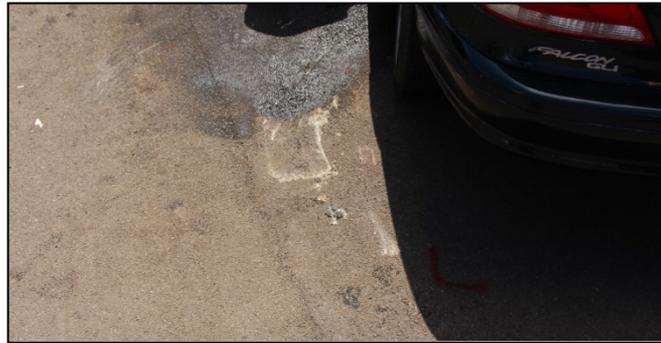
Figure 16: Scratches and scrapes

A relatively severe combination of scratch and scrape marks were created by the shape and longitudinal orientation of the sump of the engine (Inline, six cylinder) of the Bullet. The sump engaging with the road surface as the vehicle bottomed out (Figure 12 and Figure 16). Note the slight curvature of the sump scratch marks, consistent with the movement of the vehicle. The associated liquid spill of the engine oil is evident where the sump (vessel) ruptured and the liquids largely following the post impact path of the Bullet. This notable evidential factor allows the extremely accurate positioning of the Bullet vehicle.

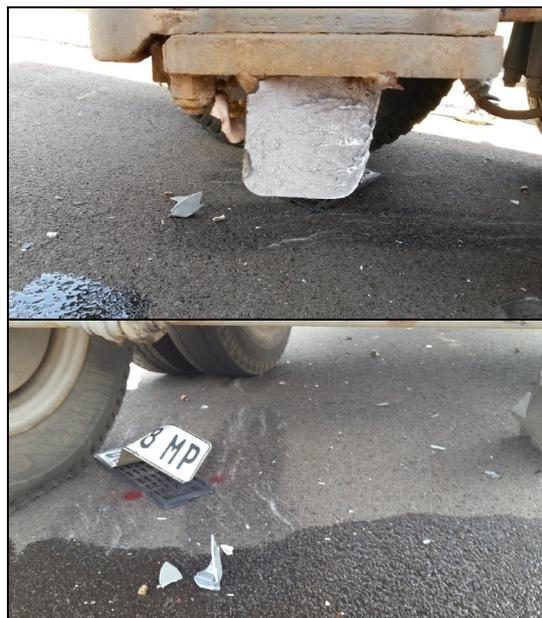
Figure 17: Tyre scrub marks from point of origin to rest

As the Target vehicle has moved, so the engagement of the tyres with the road surface from their point of origin to rest have created impact scrub marks (Figure 17). Tyre marks would be more common as landing legs would not normally be employed. The detailing of the tyre marks would also form part of the distances required for possible calculative processes undertaken. No tyre marks were notable from the Bullet vehicle. Given the severity of the impact and the resulting deflated front right tyre (the left side remained inflated), it would reasonable have been assumed that severe impact loading tyre scrub marks would have been evident.

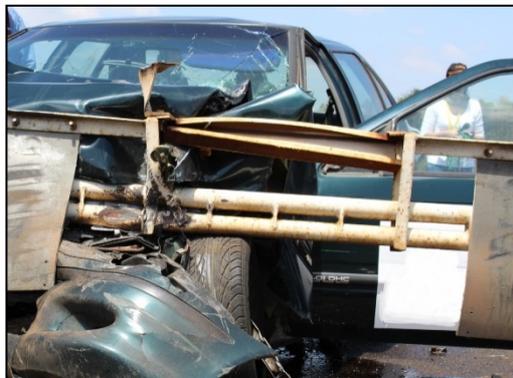
Figure 18: Underride bar & mounting bracket separation

The total separation of the underride bar as a complete unit is somewhat unusual. It is perhaps more common that severe bending of these units incurred or part of it is decimated / separated. Closer inspection revealed the primary welding of the two main mounting brackets, connected to the rear main structure cross member of the trailer (Target), was poor. Welding was only along one edge of each bracket interface to the chassis and likewise with poor penetration and overall concentration (ASME, 2010).

The underride separated with the left side bracket remaining secure to the chassis at the primary mounting point (welded). The lower section of this left side bracket separating from the underride, where the two mounting bolts are located, sheered. The right side, main mounting bracket sheering from the main chassis mounting point on the Target trailer chassis (Welded), yet the lower section of this left side bracket remained connected (two bolts) to the underride (Figure 18).

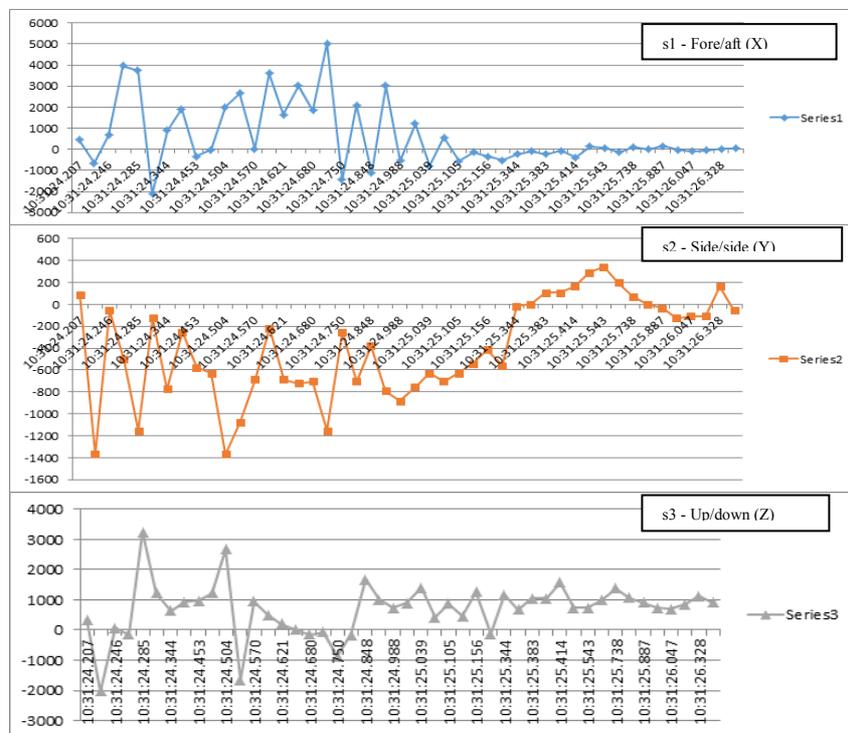
Figure 20: Target vehicle telemetry

Nonetheless, the Target vehicle readings (Figure 21) peaked at 5 g (Series s1 - fore and aft (X)). Such high readings are not surprising, given the high speed impact and largely direct inline impact and largely forward displacement of the Target. An approximate 1.4 g lateral reading was recorded (Series s2 - Side/side (Y)). Such readings are not surprising, given that there was rotation and lateral displacement of the Target.

An approximate 3.1 g was recorded in an upward direction (Series s3 – Up/Down (Z)). Such readings are not surprising, given that the front end of the Bullet vehicle is relatively

low and largely collided at a level just lower than the centre line of the rear tyres diameter of the Target and into the rear underride bar.
