CRACKING OF THE ASPHALT SURFACING OF THE LONGEST SUSPENSION STEEL BRIDGE IN CHINA

WANG XIAO, CHEN XIAN-HUA, CHENG GANG and HUANG WEI

Transportation School of Southeast University.
No. 2, Si Pai Lou Street, Nanjing, China, 210098.

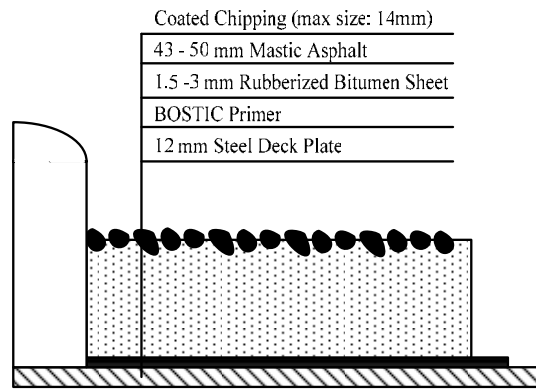
Figure 1. Asphalt surfacing on the steel deck plate of Jiangyin Bridge.

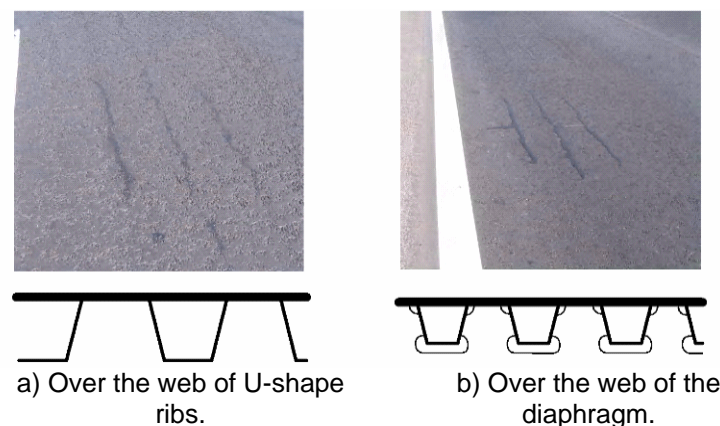
Longitudinal hairline cracks were observed in the surface over the webs of the ribs several weeks after the bridge was first opened, as shown in Figure 2a. During the first winter, transverse cracks were also found over the webs of the diaphragms and deck, as shown in Figure 2b. The longitudinal cracks were 0.5 to 2 m long and 0.3 to 1 mm wide, while the transverse cracks were about 0.2 to 0.3 m long. A few transverse cracks were also observed in the centre lane.

Figure 2. Surface cracks in mastic asphalt in the winter of 1999.

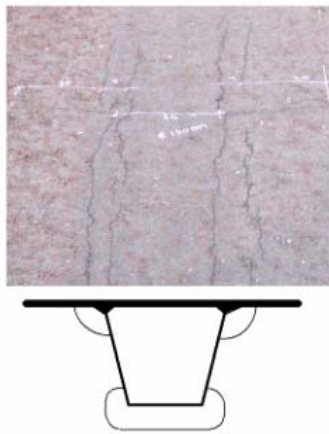
Further longitudinal cracks occurred 50 – 80 mm next to the former ones a year later, as shown in Figure 3. The length of these longitudinal cracks increased to 3 – 5 m, with a maximum cracking width of up to 2 mm. The pavement on both the inside and centre lanes was found to be cracked.

Figure 3. Longitudinal parallel cracks with transverse cracks (November 2001).
