1 IDENTIFIKASIE Gebou 11.2

Provinsie:	Transvaal	
Distrik:	Middelburg	
Naam:	Botshabelo Sendingstasie	
Gedeelte:	Motse-woongebied	
Huidige Gebruik:	Geen	Bron: Waarneming
Oorspronklike Gebruik:	Woonhuis	Bron: L Swiegers
Datum van oprigting:	na 1865	Bron: M Naudé
Skepper/bouer/maker:	Oorspronklike eienaar self	
Dokumenteerder:	C Dracoulis

1 IDENTIFIKASIE Gebou 11.12, 11.13, 11.14

1 IDENTIFIKASIE Gebou 11.27, 11.28, 11.29

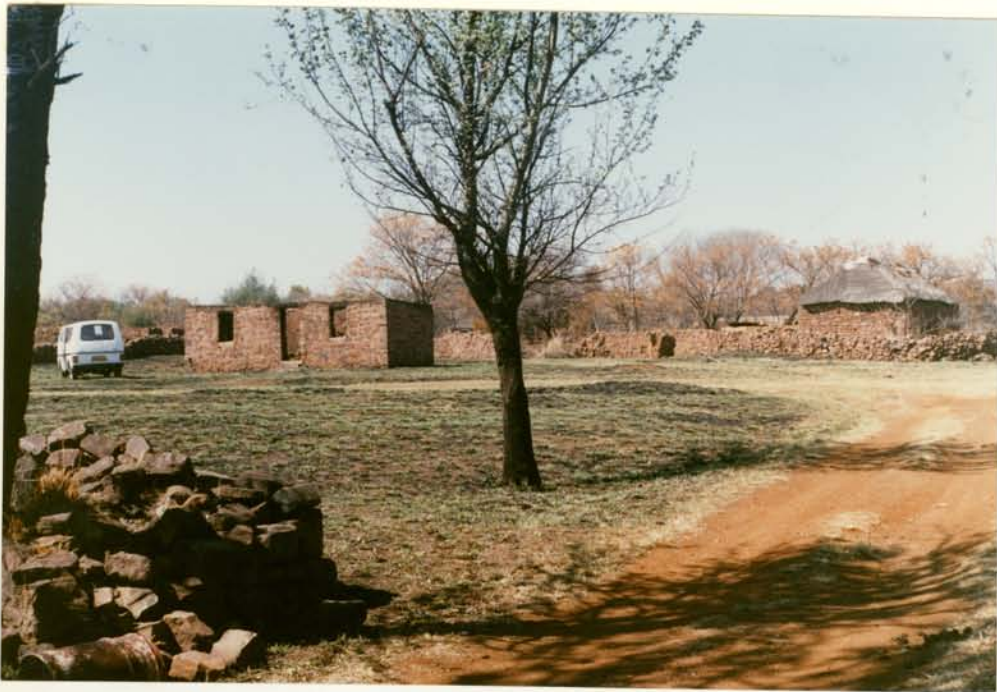
1. BUILDING 11.2.

3.1. Rectangular stone building with thatch roof, now razed by fire. It is smaller than most other houses in this area and also simple in plan. There are two interior walls of plastered brick. There are wooden window and door frames. The building is not surrounded by any boundary walls and sits alone in its environment (photo 1).

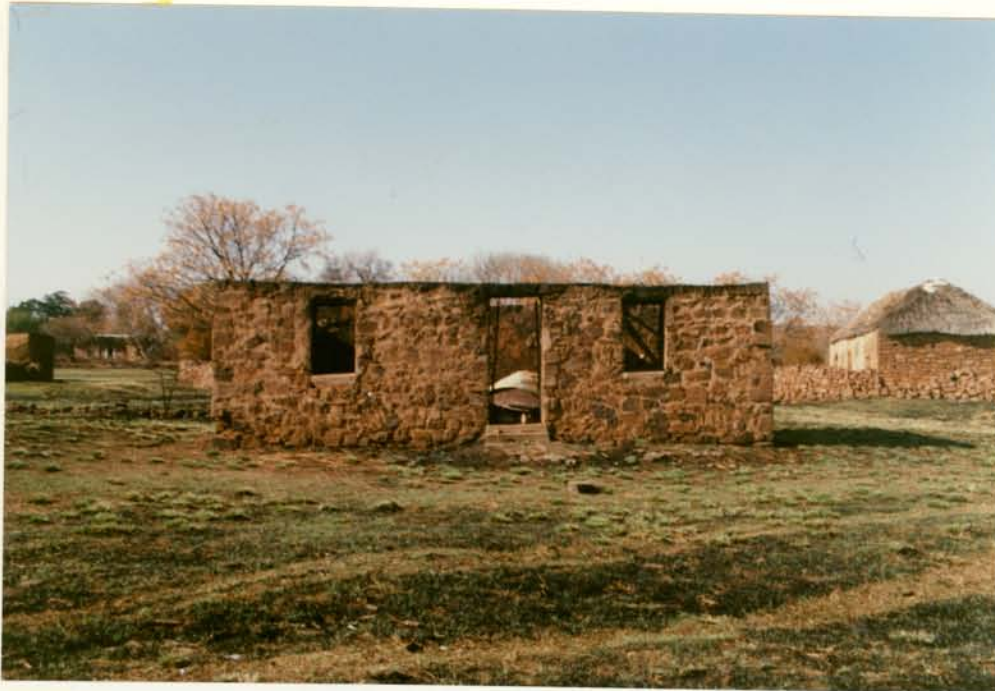
2. NORTH ELEVATION OF BUILDING 11.2.

This small house [?] is typical (2): Central doorway between two windows (not really symmetrically placed) in the main (north) facade leads to a single space, which has later been subdivided into three rooms by means of plastered brick walls (plan & 5). It seems as if the central room was the kitchen. Here we find the remains of a chimneypipe cut through the wall (south elevation).

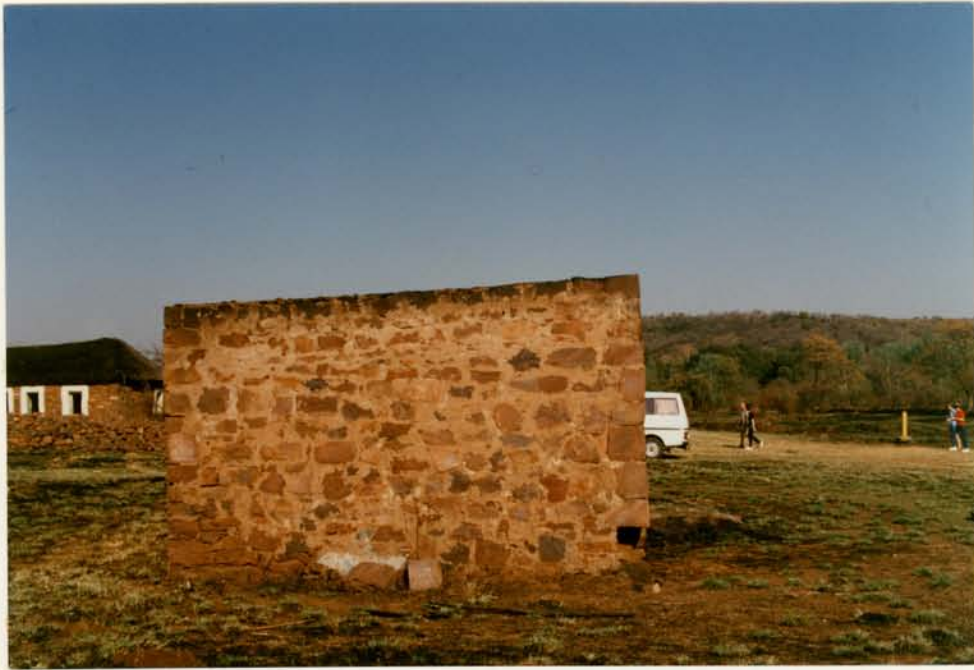
FIGURE 3. EAST ELEVATION OF BUILDING 11.2.

There are two possibilities of how the building could have been constructed (3 & 4). The stones (which are not even in size) could have been packed on top of each other after which the cavities were filled with dagha to form an even surface.

The stones could also have been dry packed. When the wall became unstable, mortar was used to stabilise it. In support of the latter theory are the dry packed toothing stones (quoins) on corners (3).

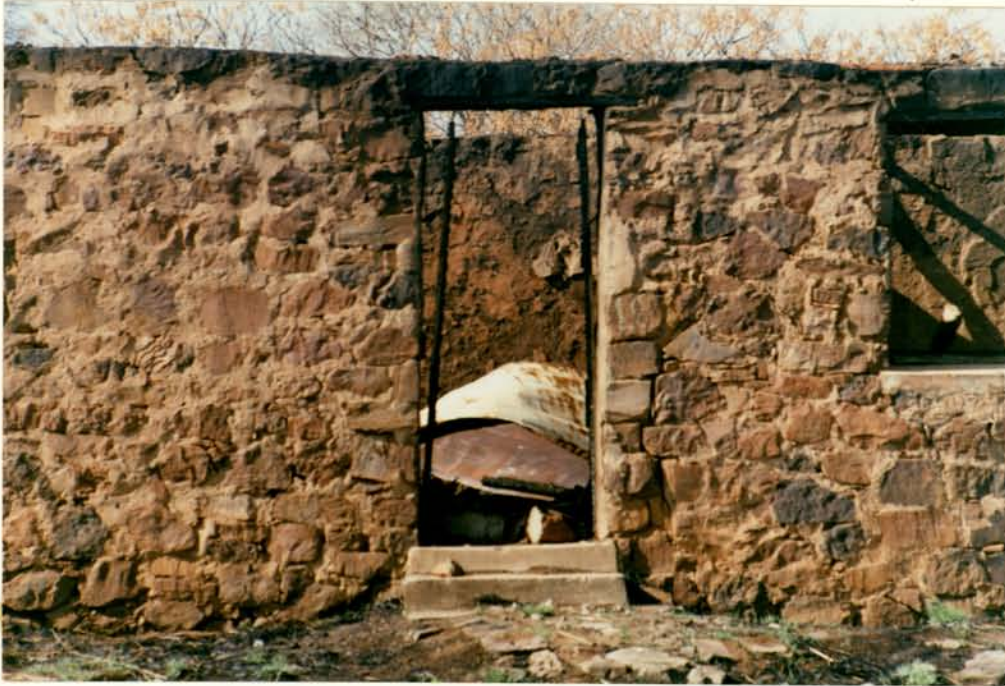
4. DOOR FRAME ON NORTH ELEVATION OF
BUILDING 11.2.

Remains of doors and windows. Compare with similar buildings to determine the possibility of type.

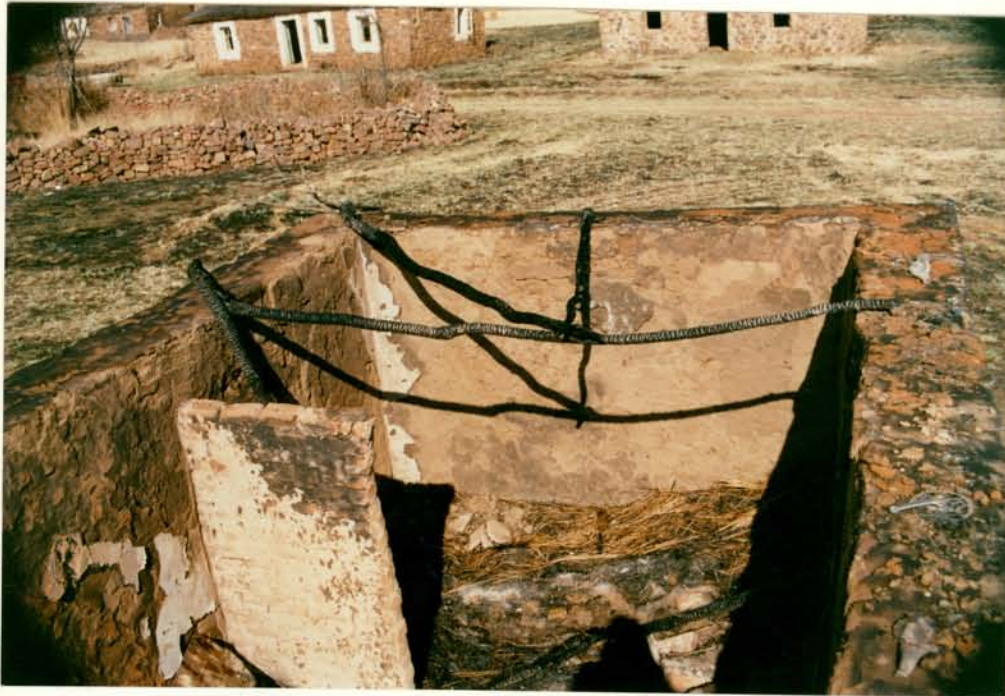
Originally one room and later separated into three by brick walls which do not reach the full height of outer wall. There are no doors inside the building. The openings between two walls serve as an entrances to adjoining rooms. The door and window on the south side are filled up with stone.

5. BURNT TRUSS ON WEST SIDE OF BUILDING 11.2.

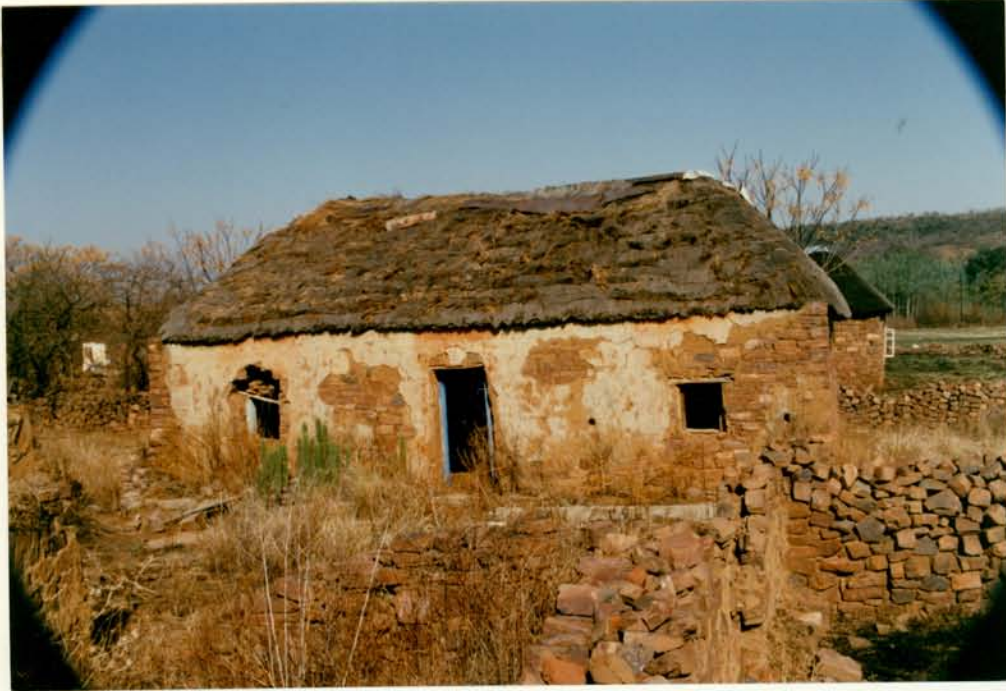
1. EAST ELEVATION OF BUILDING 11.12

- 3.2. Building 11.12 (1) is also built of stone bedded in mortar. Only the east facade and the interior of the building is plastered. The window frames are made of wood and are painted light blue. Openings were closed with wooden shutters with half of the shutters painted blue (6). The thatch roof still exists. The interior is subdivided in three rooms by means of plastered brick walls. Contrary to expectations but still in line with many other examples (eg 11.40, 11.35, 11.30), the house does not face the road or other houses like 11.3 and 11.11 directly across the road. The symmetrical facade, which it presents to the courtyard (east), may have been plastered at a later stage. Like the group (11.30-11.33) buildings are used to create private yards and the whole complex seems to have been enclosed with 'werfmure' to form a very definite property. An interesting detail is the scaffolding [?] holes visible on the northern facade (2).

The building (11.12) is in a fair and restorable condition, but many important elements such as lintols over doors (11.14) and windows are on the point of collapsing. They should be propped until they could be restored.

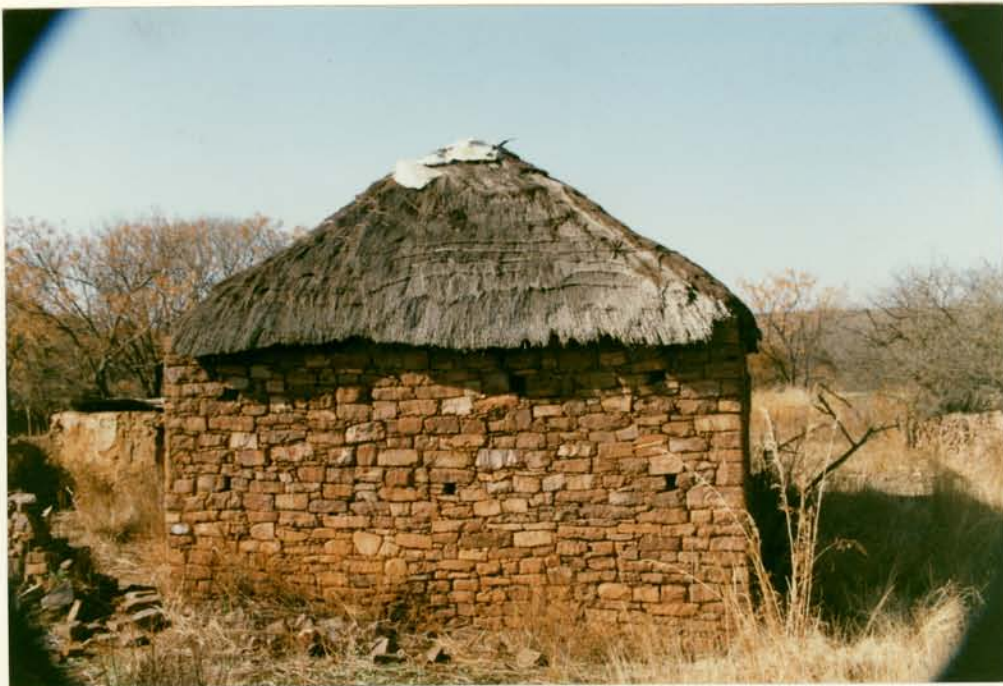
2. NORTH ELEVATION OF BUILDING 11.12
WITH HOLES IN THE WALL

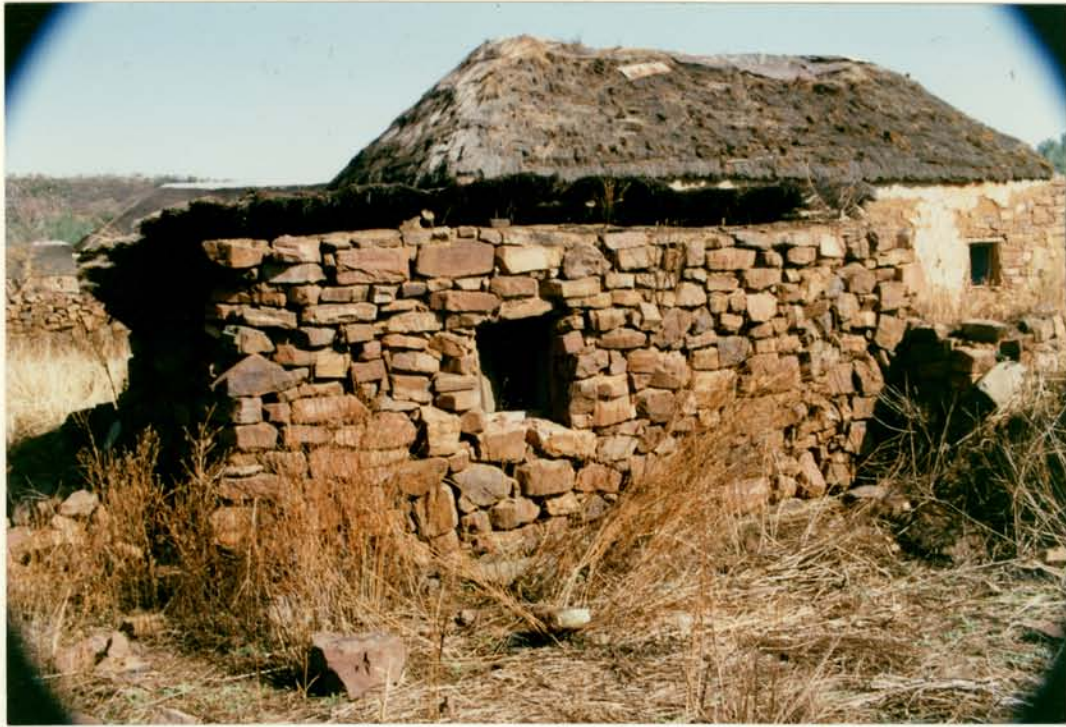
- 3.3. Building 11.13 is smaller than 11.12, is made of stone and is plastered on the northern facade. The door and window frames are light blue in colour. The thatch roof has collapsed (3).

PHOTO 1.3. EAST ELEVATION OF BUILDING 11.13 WITH COLLAPSED ROOF

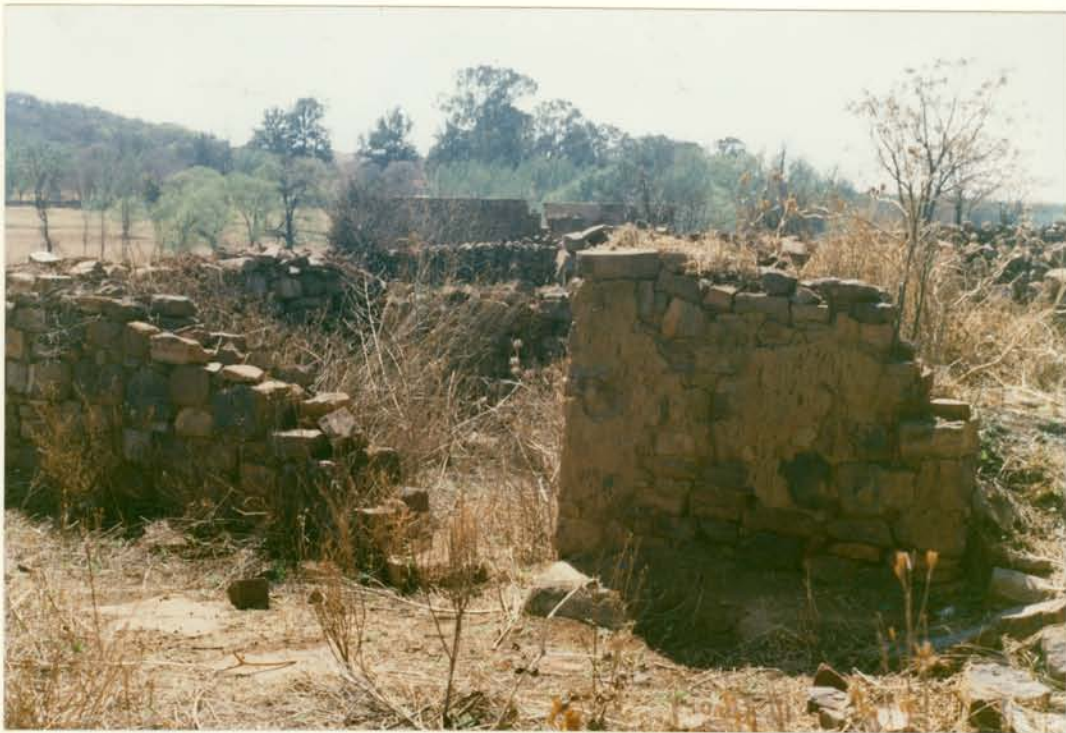
PHOTO 1.4. REMAINS OF 11.14 FROM WEST SIDE

- 3.4 Kontekstuele besonderhede: Landmerk of bydrae tot groep, straat, oop gebied, buurt of plek
- 3.1. The garden is enclosed and the buildings are connected by stone walls in a definite attempt at creating a northern courtyard. Building 11.14 was probably used as a store. It is made of stone bedded in mortar, the walls are not plastered. The top windows remain and there is a large opening that could have been the entrance. This building probably had a thatch roof (photo 4).

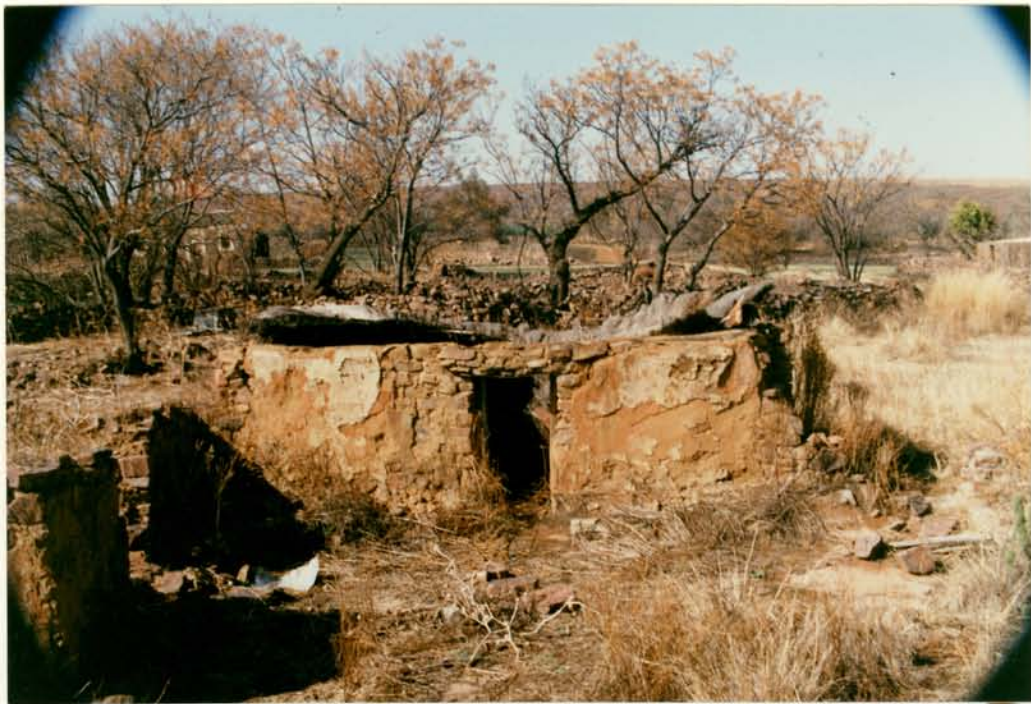
7. COW DUNG PLASTER CAN BE SEEN TO THE RIGHT OF THE DOOR OPENING ON THE NORTH FACADE OF 11.13.

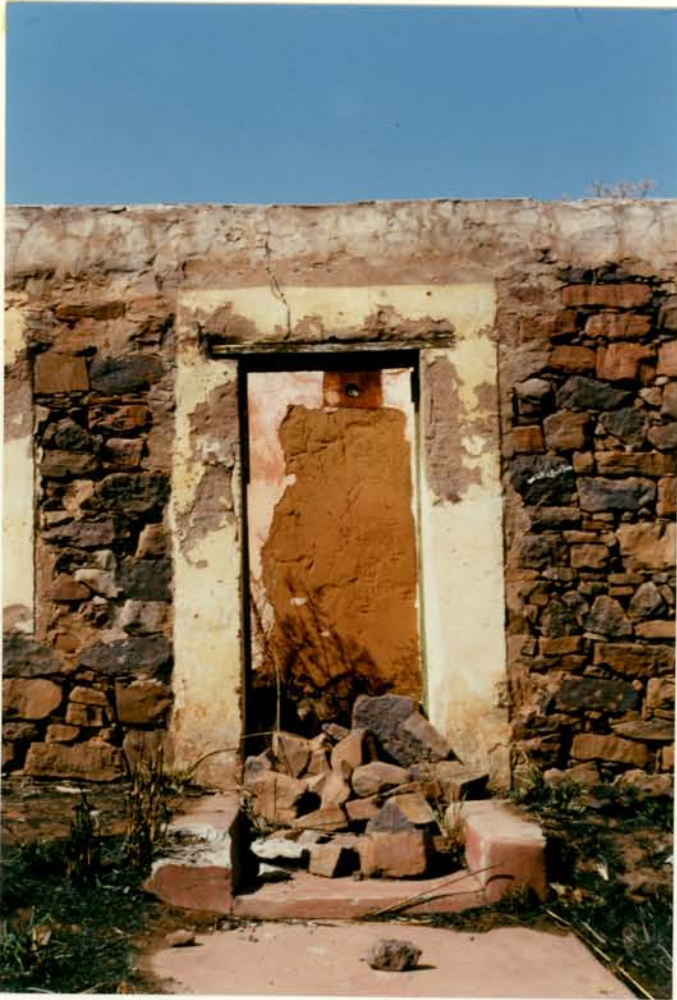
7. FRONT DOOR OF 11.28.
CHIMNEY PLATE CAN BE
SEEN ON INSIDE WALL.
