## IDENTIFIKASIE Gebou 30.1

Provinse:	Transvaal	
Distrik:	Middelburg	
Naam:	Botshabelo Sendingstasie	
Gedeelte:	Motse-woongebied	
Huidige Gebruik:	Geen	Bron: Waarneming
Oorspronklike Gebruik:	Woonhuis	Bron: L Swiegers
Datum van oprigting:	na 1865	Bron: M Naudé
Skepper/bouer/maker:	Oorspronklike eienaar self	
Dokumenteerder:	V Terblanche

## IDENTIFIKASIE Gebou 11.15, 11.16, 11.17, 11.18

## IDENTIFIKASIE Gebou 11.23, 11.24, 11.25, 11.26

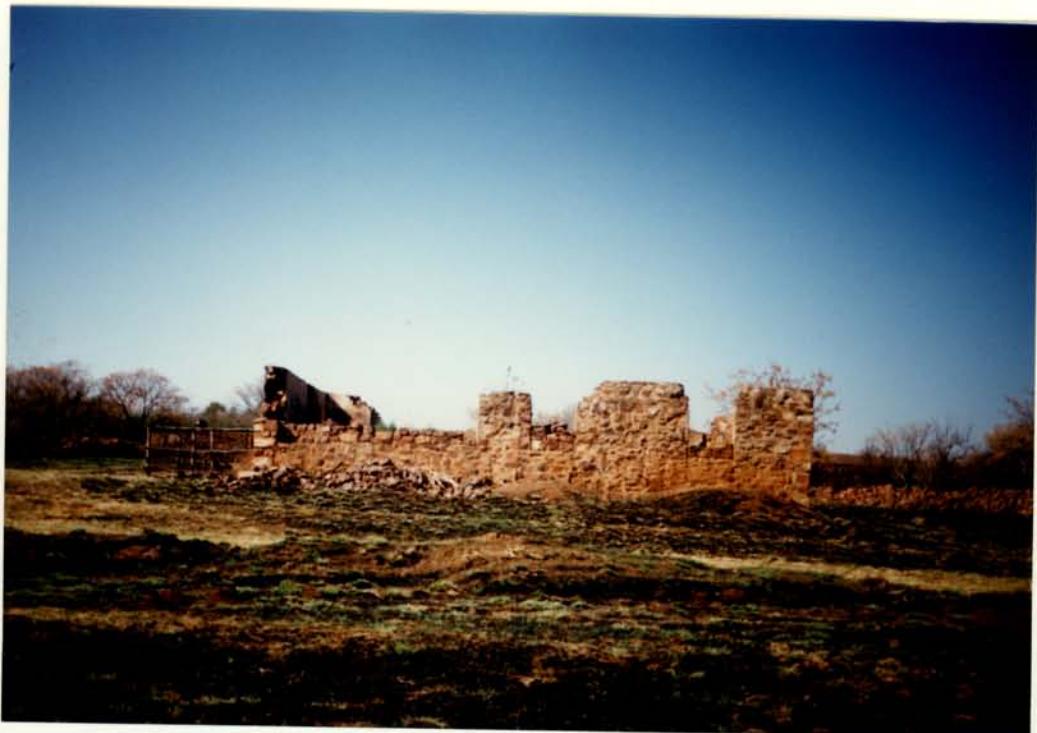
1. The remains of the building

Although this building is in a state that is virtually unrestorable it should be studied to determine whether the main entrance was always south, whether it had more than one internal wall and whether it was used as a house.

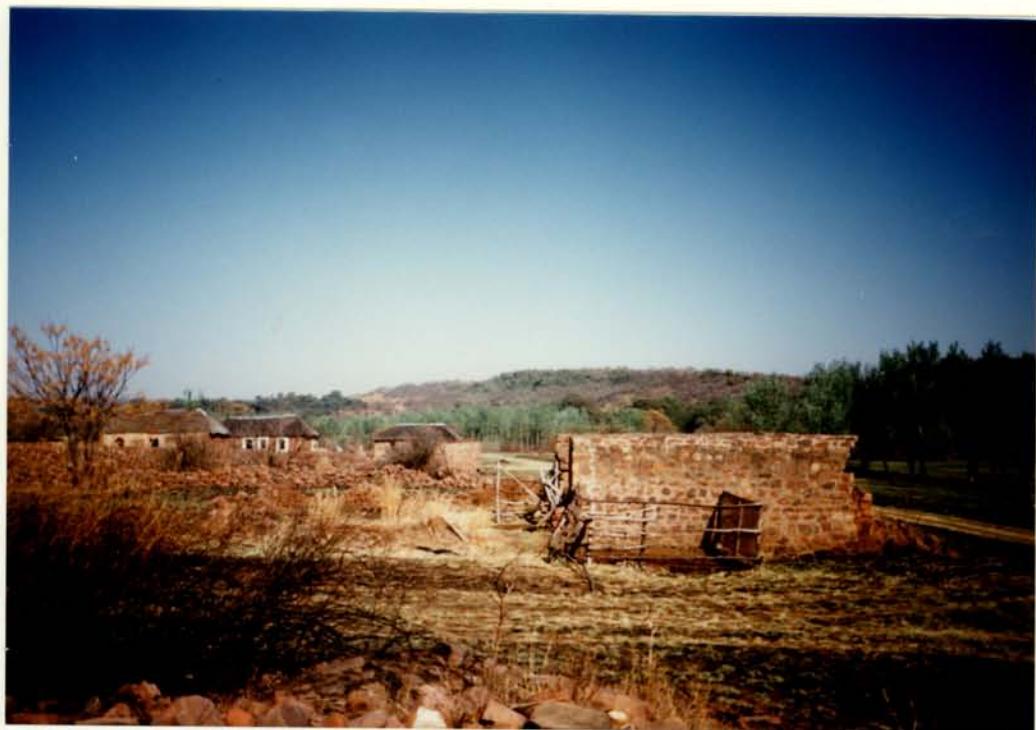
2 The single building which lies  
on the outskirts of the village.

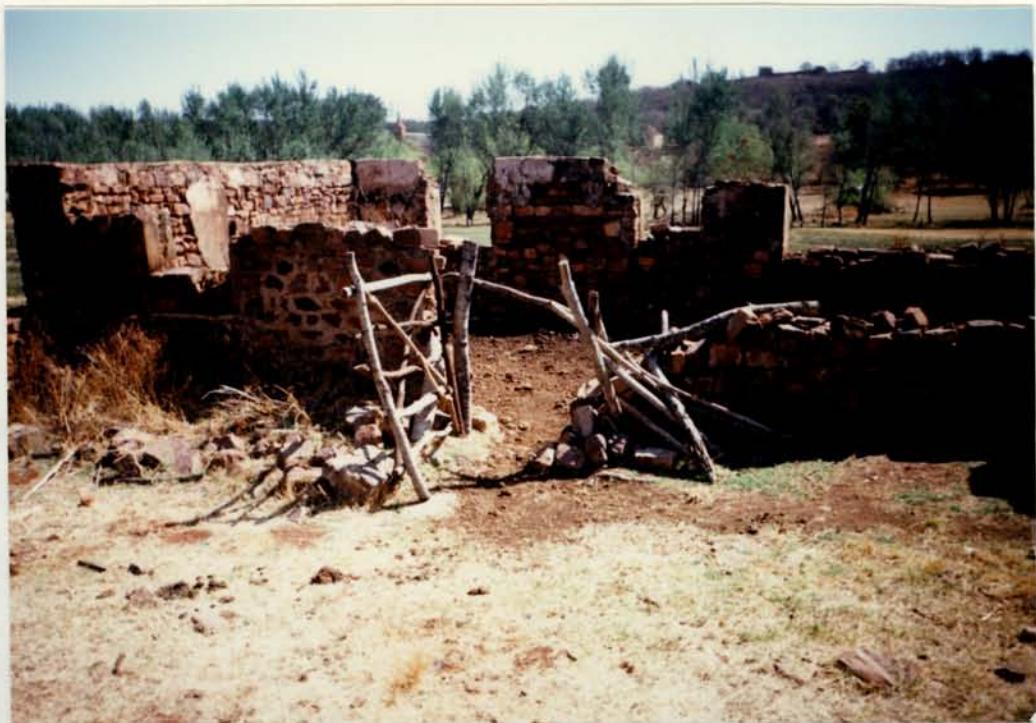
3. The door frame and window frames have been removed. The only entrance is found in the southern wall.

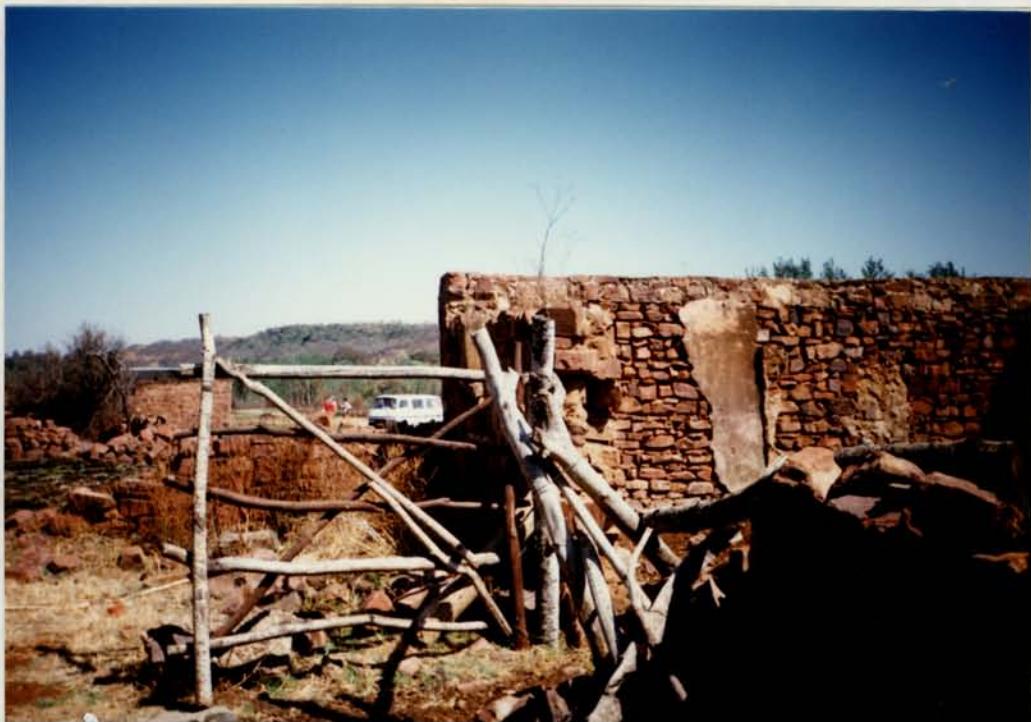
4. Little remains of the internal finishing, the is evidence of internal walls though none remain.

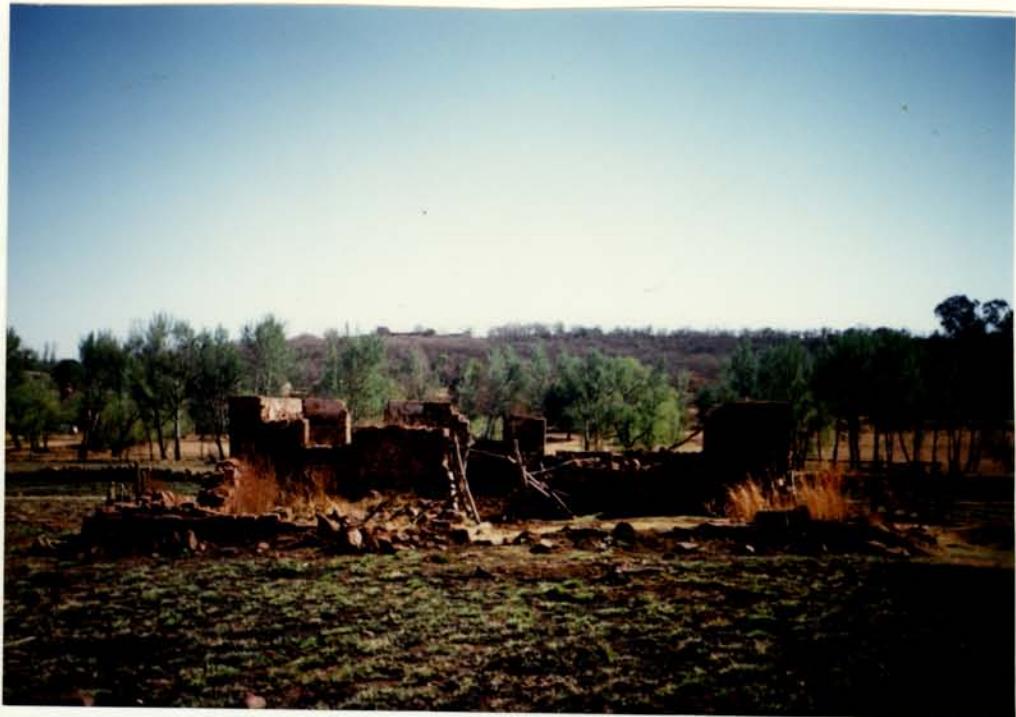
5. The once house ,now cattle kraal is in ruins.  
The garden wall is distinguished by the loose  
rubble.

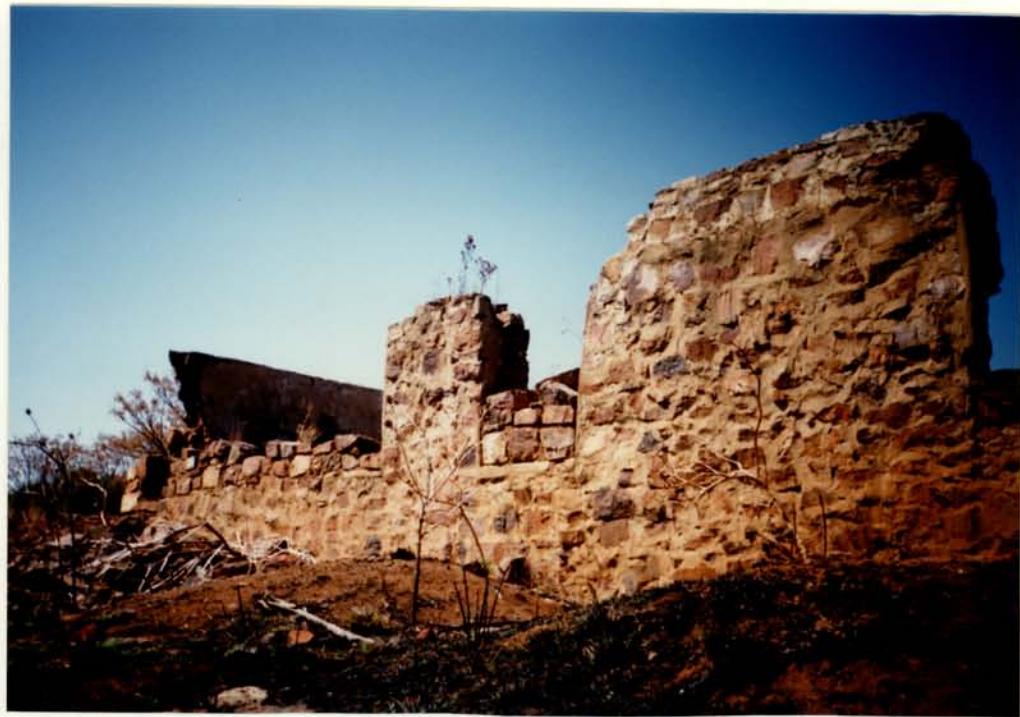
6. Here the additional 400mm which ha~~ve~~ been  
added on to the wall is evident.

- 5.1. An additional 400 mm has been added to the height of the walls. This appears to have taken place after the previous roof burnt down and the house(?) was converted to a cattle kraal (photo 6).

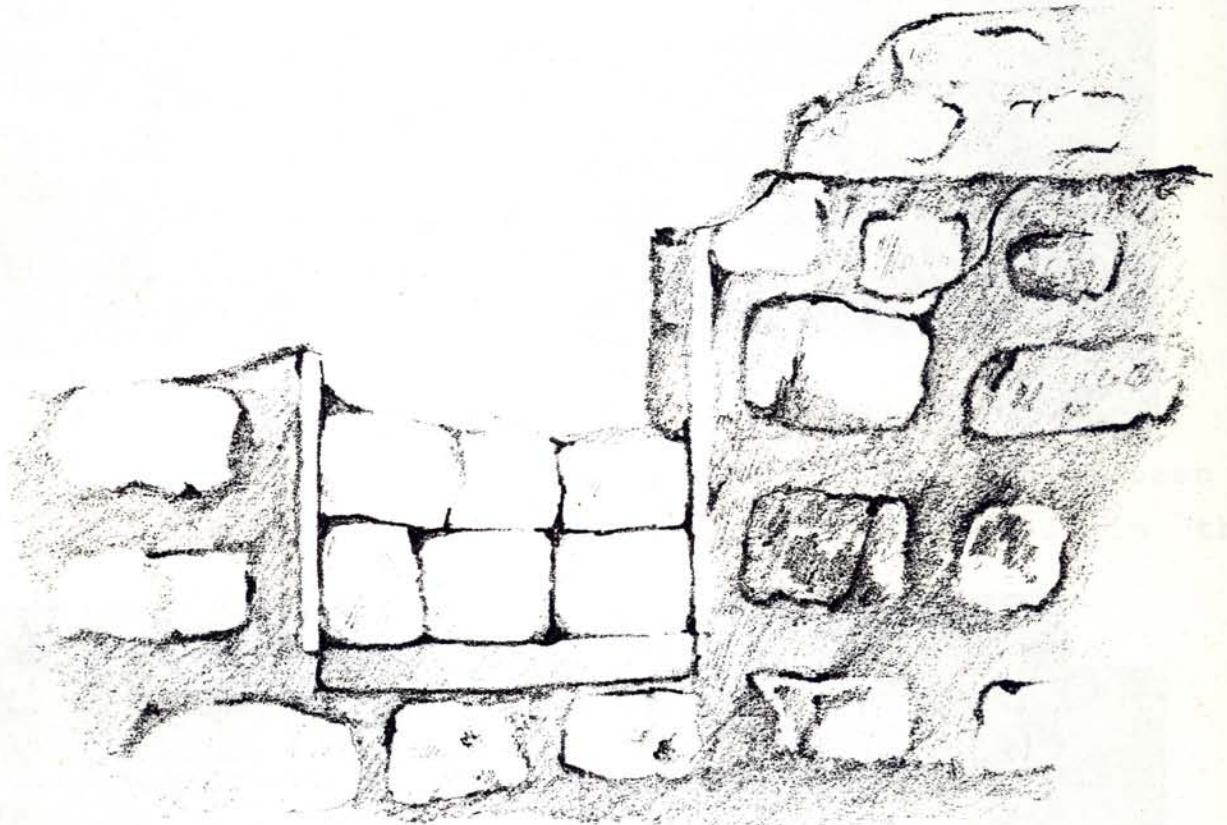
DRAWING 1 It appears that an additional 400mm was added to the wall height. Here it is also possible to see the remaining window finishing. The windows have been built up.

- 5.2. The windows have all been closed up with a stone and mortar construction (6 & drawing 1). The construction in the western wall is different to that in the remaining windows. It is the only one which is still completely intact. The type of stone used in closing up this window is far more irregular and the amount of mortar far greater. This alteration is similar in materials and construction to that of 5.1.

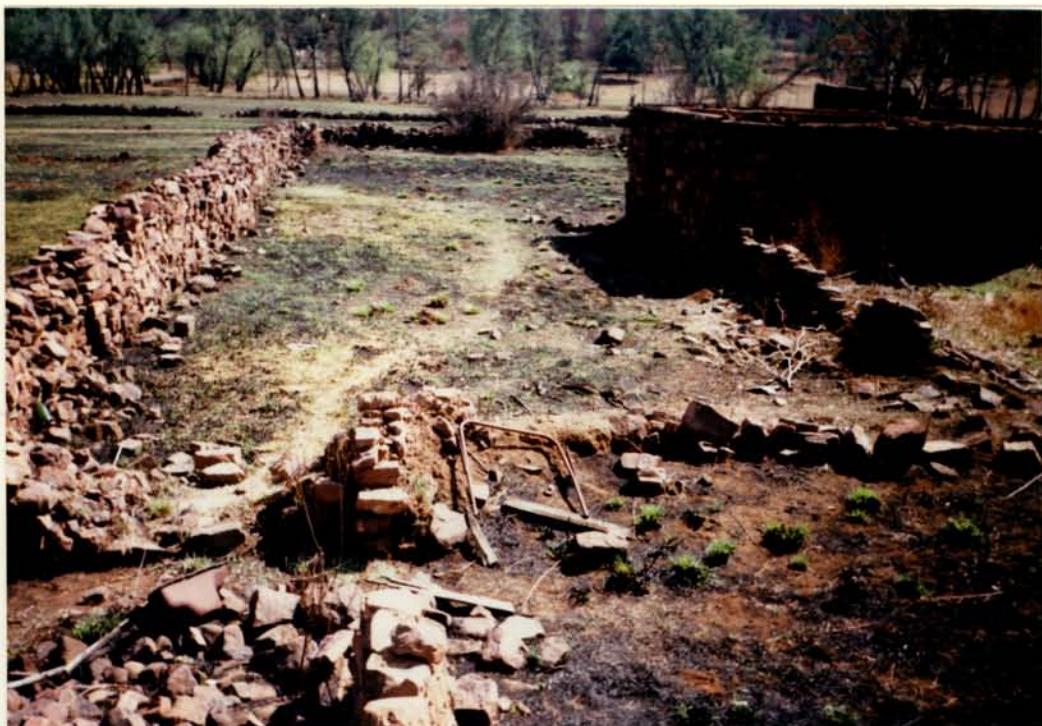
1. Verbrokkelende muur.

Bokante van mure is besig om te verniel as gevolg van reënindringing. Hulle behoort beskerm te word.

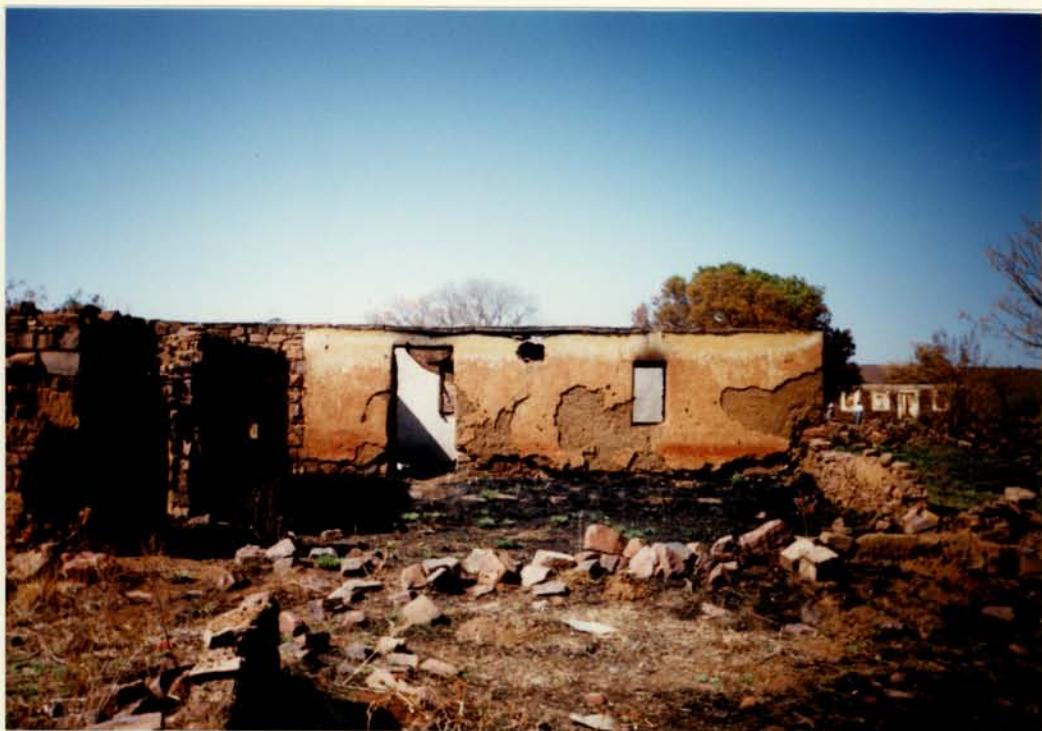
- 3.2. Die boustyl is in navolging van die Europese tradisie deur die plaaslike bevolking opgerig en vertoon dus nie die eie argitektoniese gebruik en kunde eksplisiet nie. Die muurkonstruksie is van plaaslike materiaal naamlik klip en klei, en getuig van goeie vakmanskap. Die dakkemateriaal is ook plaaslik verkry en die konstruksiemetode was bekend. Deur- en vensterrame is óf afwesig, óf in 'n swak toestand (2).

2. Geen deur of vensterrame nie.

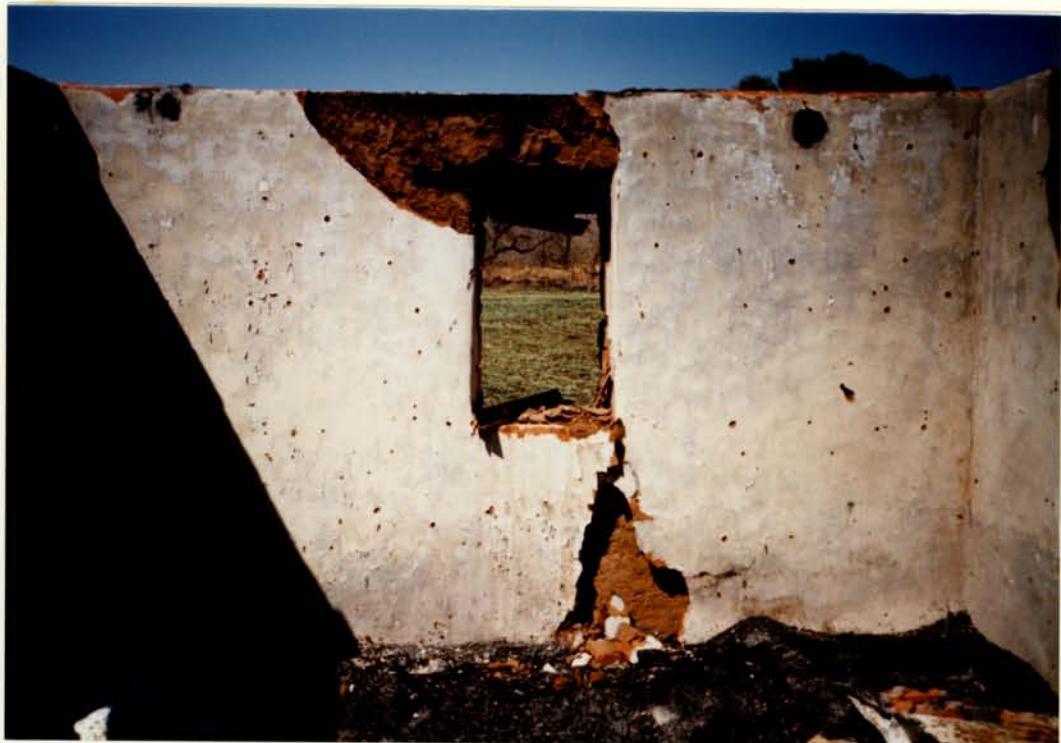
- 4.1. Die dakstruktuur en dakbedekking is in geheel deur vuur vernietig. Daar kan dus slegs aanvaar word dat die woning dieselfde grasdak gehad het as dié van die huise daarom wat beter geboue gebly het. Die posisie van die dakbalke is duidelik as gevolg van die ronde swart gate in die muur (foto 3).
- 4.2. Alle venster- en deurrame van die hoofgebou is in die vuur verwoes.
- 4.3. Die twee kleiner geboue het nog houtlateie bo die ingange en vensters en gehawende vensterrame (4 & 5).

4.4. Die pleister aan die binnekant van die huis het baie beter behoue gebly, maar begin nou ook kraak en afdop (3). Dit lyk asof drie van die vier buitemure nooit gepleister was nie, maar slegs dié sy wat na die binnewerf kyk.

3. Posisie van dakbalke, en binnepleister.

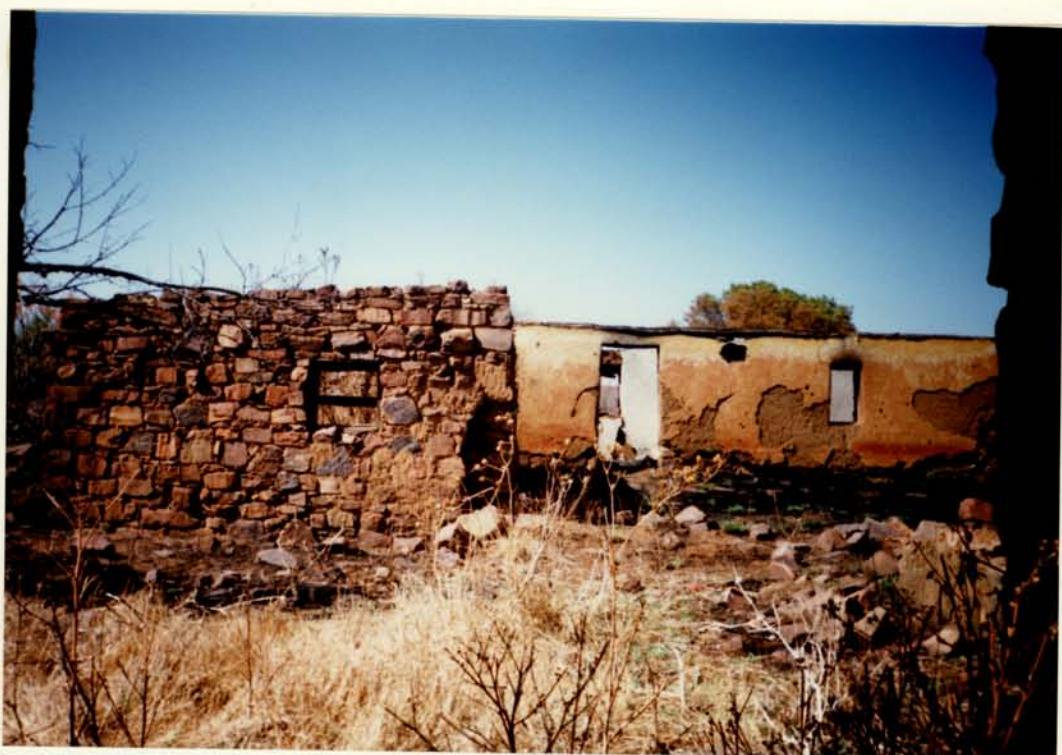
4. Gepleisterde- en ongepleisterde buitemure.

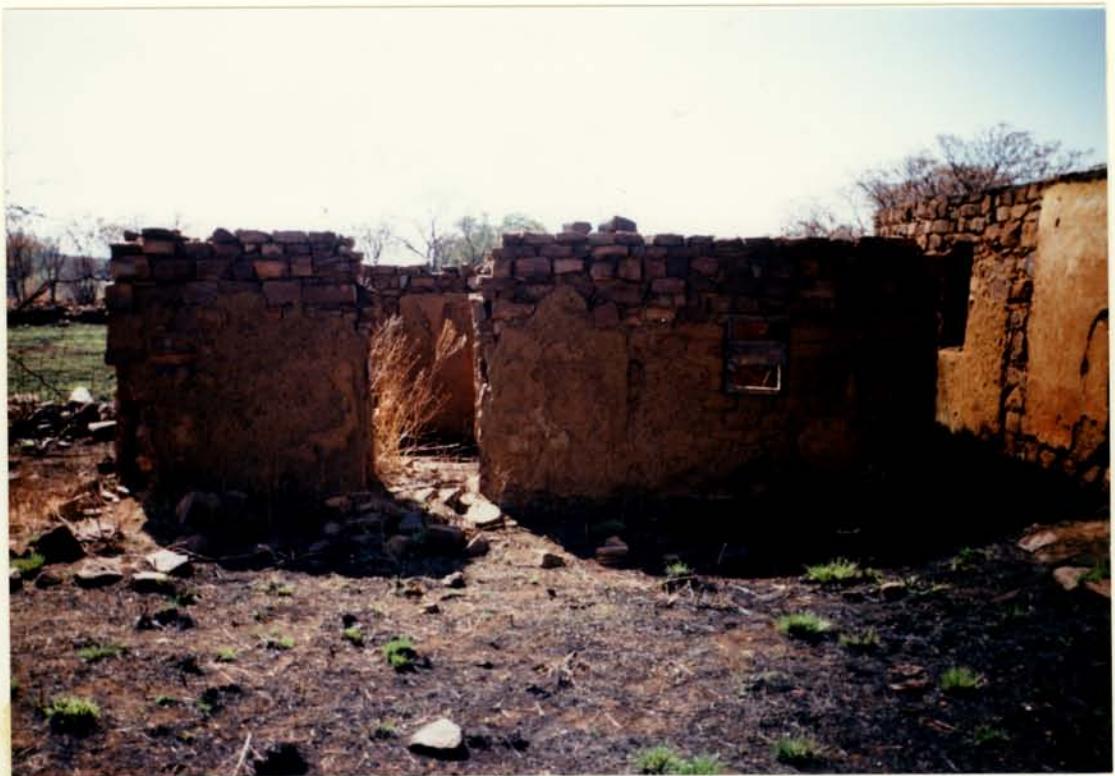
5. Hout vensterraam en latei.

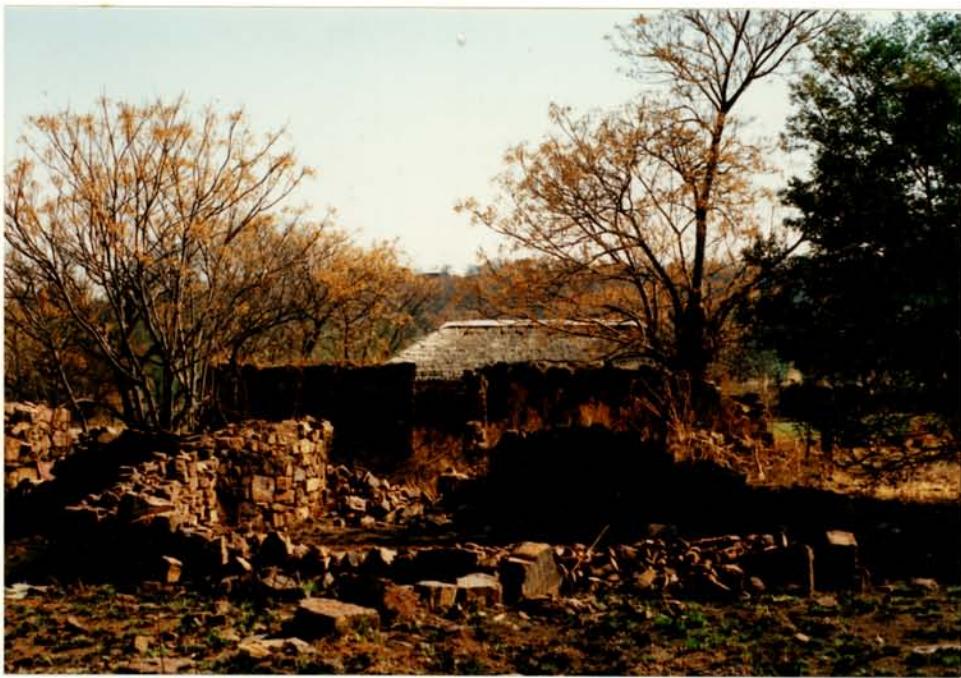
PROBABLY A KRAAL,  
ANIMAL ENCLOSURE  
OR SIMILAR.  
STONES LAY WOKE,  
MIGHT HAVE ORIGIN-  
ALLY BEEN SET IN  
MUD  
THE BAD CONDITION  
IMPLIES EARLY  
DATE OR POOR  
WORKMANSHIP  
(HENCE LESSER  
IMPORTANCE)

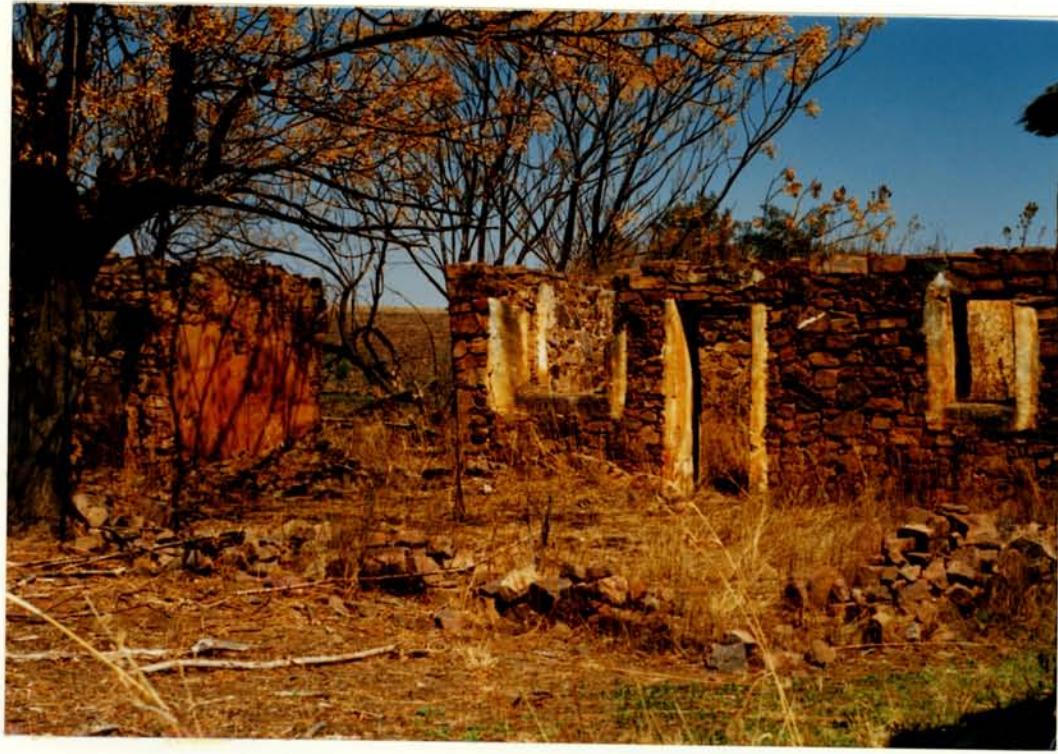
4

BUILDINGS 11.23 & 11.24 . PROBABLY EARLY DUNNINGAS  
NOTE THE BAD CONDITION OF THE GARDEN WALL

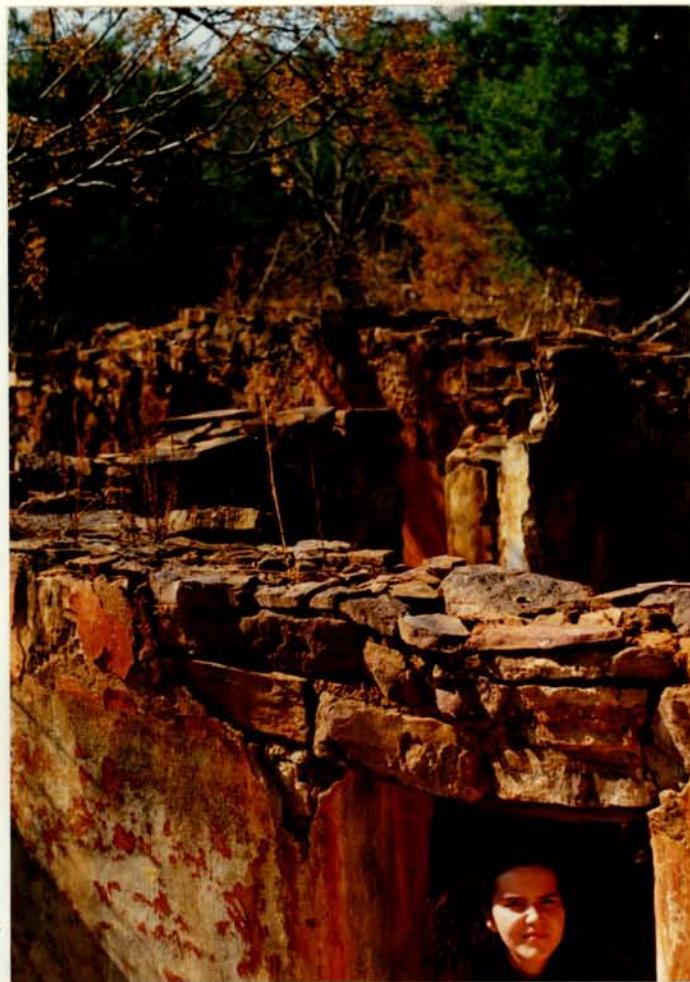
6

PLASTER ON THE INSIDE (II.24)  
NOTE WOODEN LINTEL ABOVE DOOR

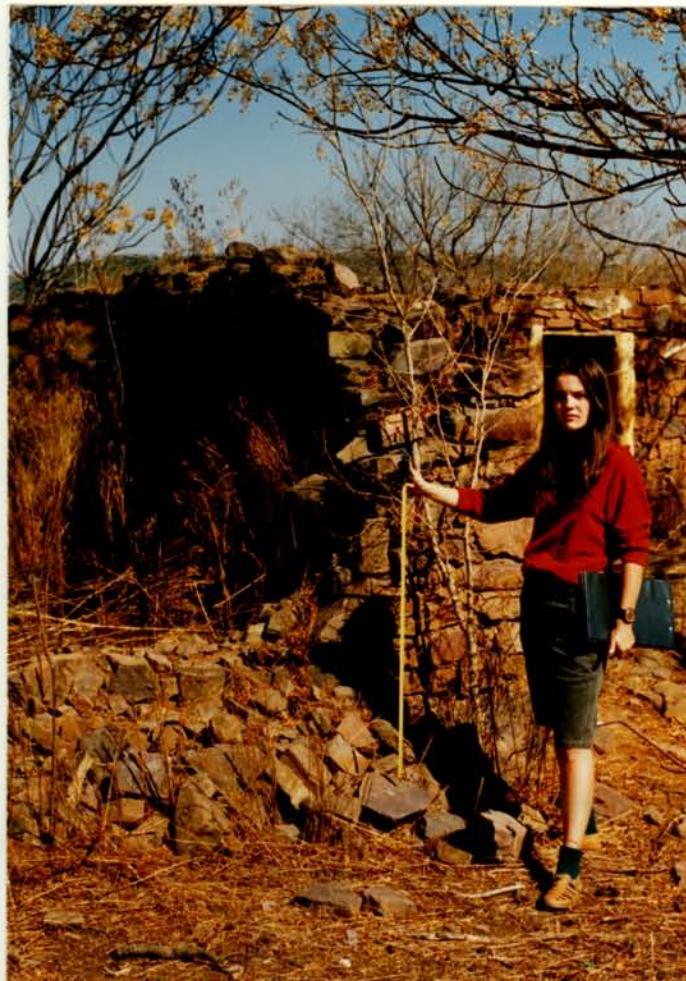
7

II.23 SIDE VIEW (from east)  
ONLY RUBBLE REMAINS OF SIDE &  
BACK WALLS

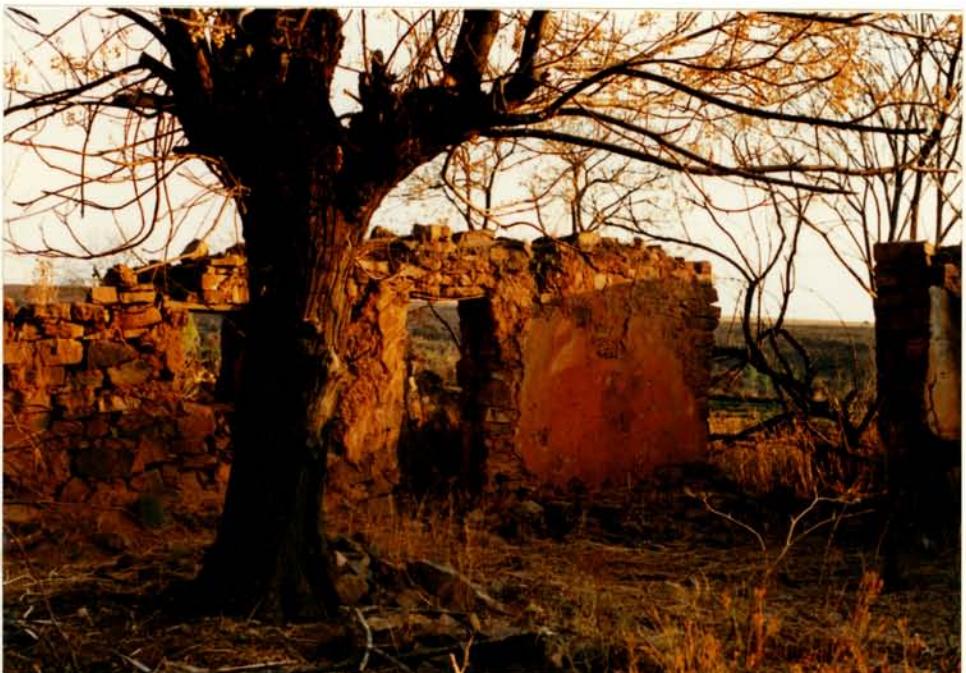
8

11.23 THE BAD CONDITION  
INDICATES EARLIER DATE  
OR LESS IMPORTANCE THAN  
11.24  
NOTE THE REMAINS OF  
PLASTER ON WALLS

NOTE WOODEN LINTELS  
OVER OPENINGS

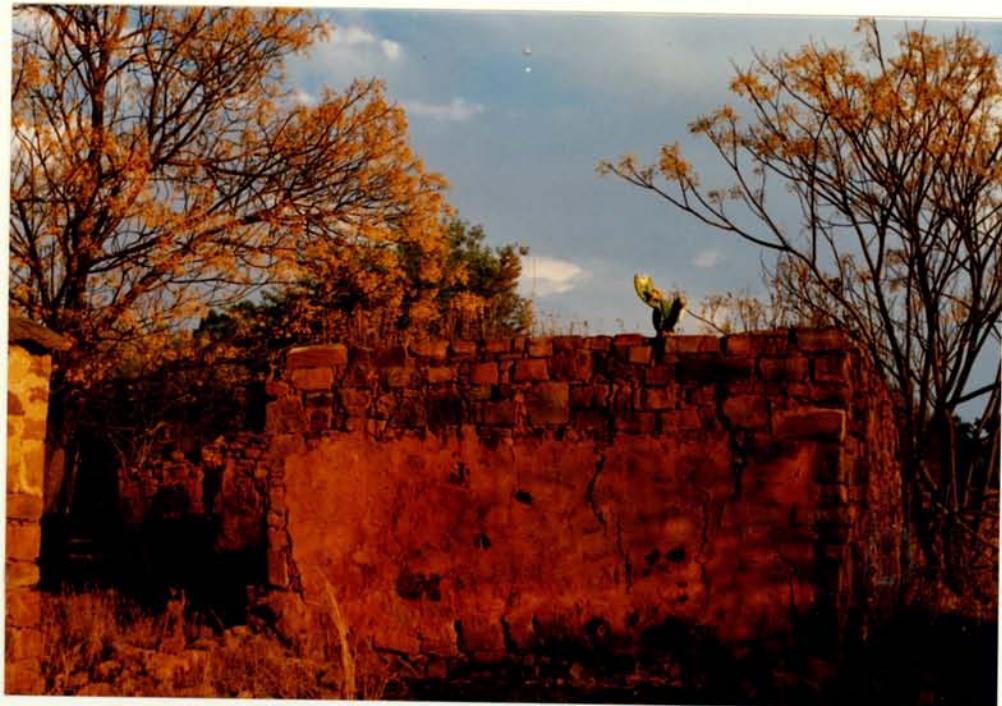
11

MUD PLASTER ON NORTH SIDE  
OF 11.24

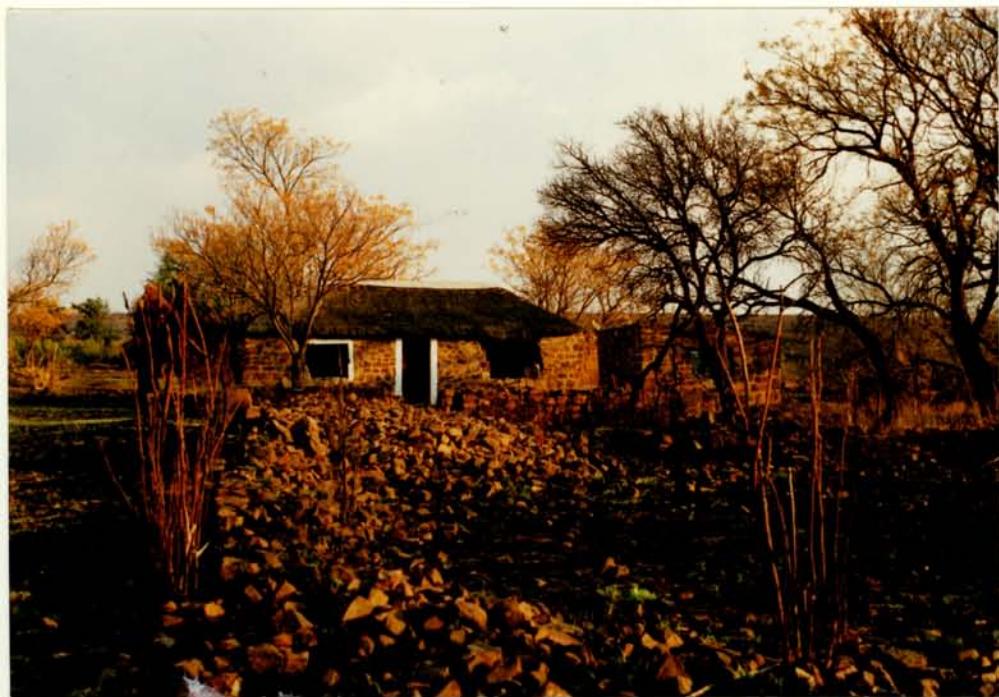
13

OVERALL VIEW OF 11.25  
& 11.26 SHOWING RUIN  
in FRONT

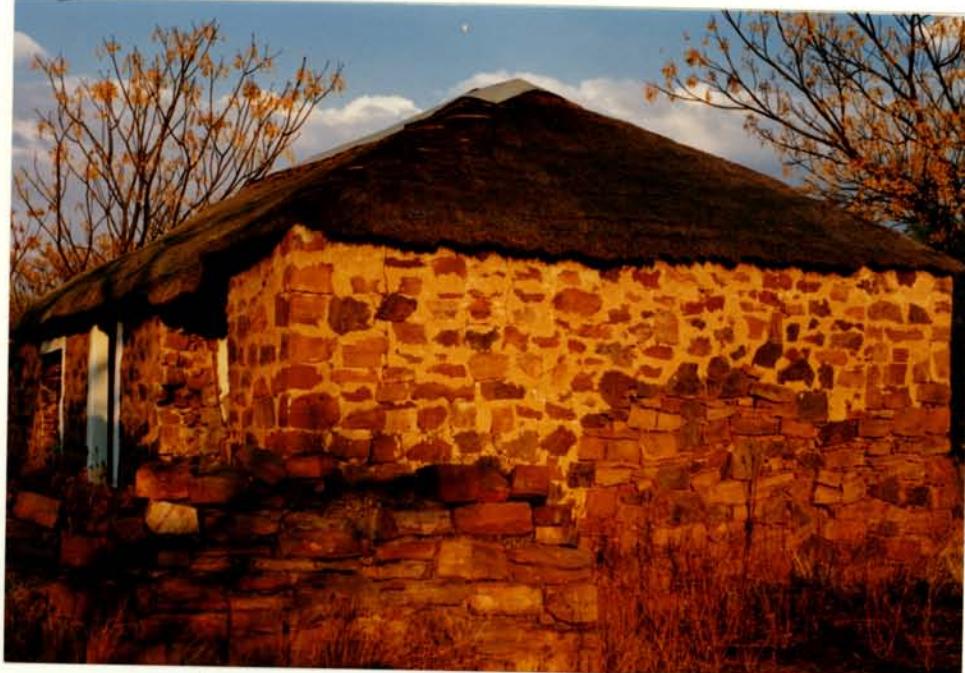
15

Building 11.25: In some places the mortar has fallen from between the stones, thus revealing construction very similar to 11.23 & 11.24 (15). The window openings have no frames left and are in quite a bad condition (the lintol over the western one has collapsed and the window opening is so enlarged that the inside wall is visible). The doorway has remains of what was once a wooden rebate. The floor is cement and in good condition, with a small extention (lower than the inside floor level) just outside the door. The roof is thatched and in a reasonable condition. It has a sheet metal capping on the ridge and the trusses are made of branches rudely nailed together.

MORTAR FILLED JOINTS,  
THATCHED ROOF WITH  
SHEET METAL CAPPING

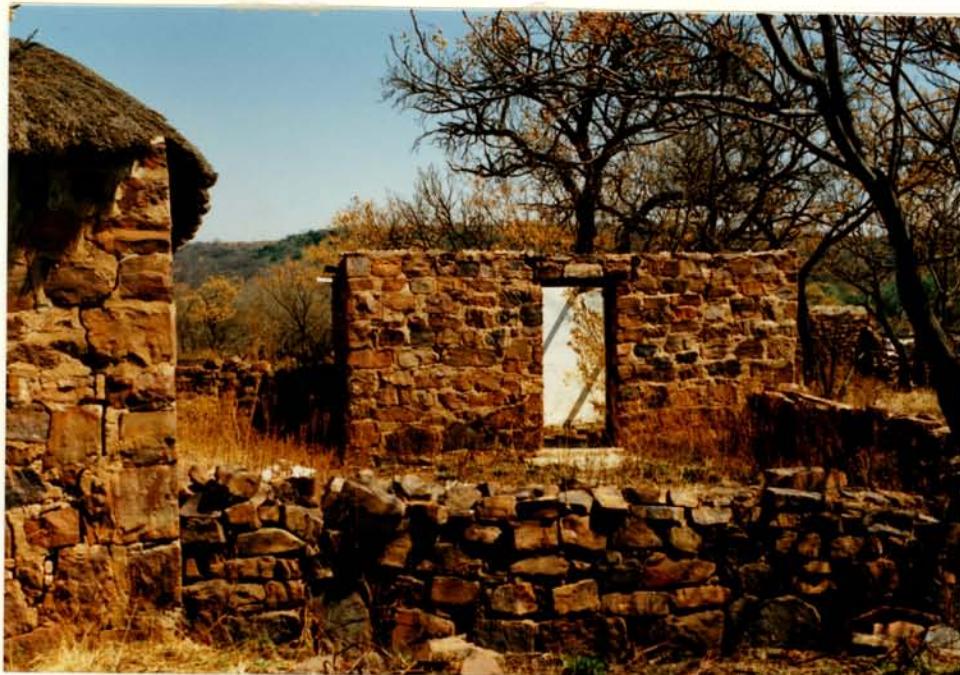
16

The eastern wall of this building is quite severely cracked (especially visible on the inside, but see also photo 16). The two side rooms may have been bedrooms whereas the middle one, as indicated by a small raised area in its corner and a chimney opening (closed up now) in the wall above it - a kitchen.

MORTAR FILLED JOINTS  
OF BUILDING CONTRAST WITH  
THOSE OF GARDEN WALL

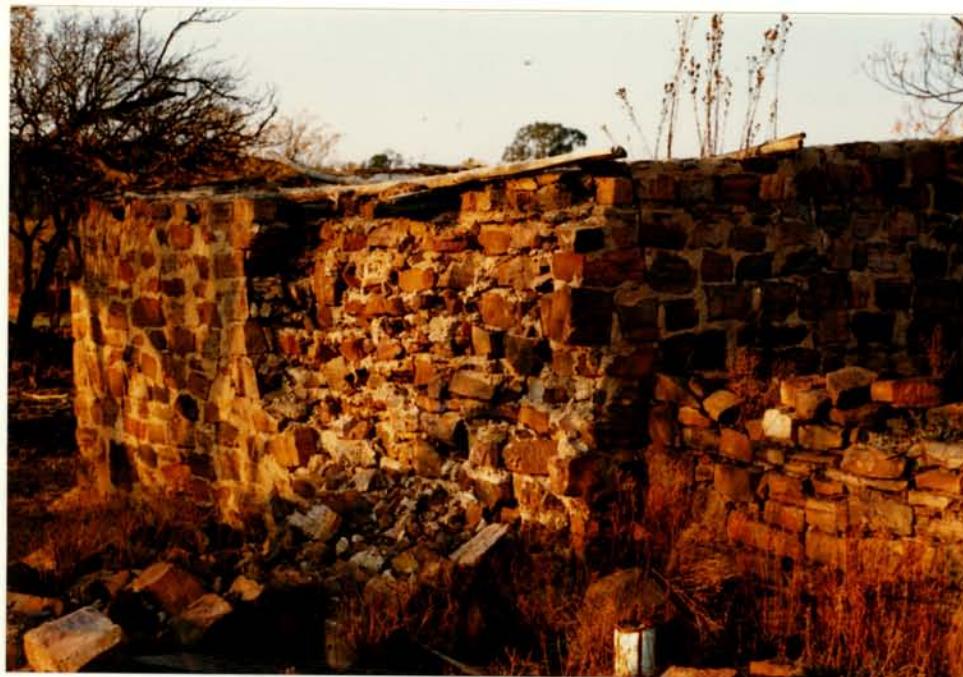
18

WEST WING OF 11.26 SHOWING  
SPLIT WALL & WOODEN  
ROOF BEAMS

Window and door openings, roofs and cracks in walls
