EXPERIMENTAL REHABILITATION OF A ROAD WITH INTRACTABLE SALT DAMAGE WITH A BITUMEN-RUBBER SINGLE SEAL

F NETTERBERG

It is the purpose of this paper to describe the performance of two full-scale road experiments constructed in 1984 in an attempt to rehabilitate this intractable problem using the then new bitumen-rubber.

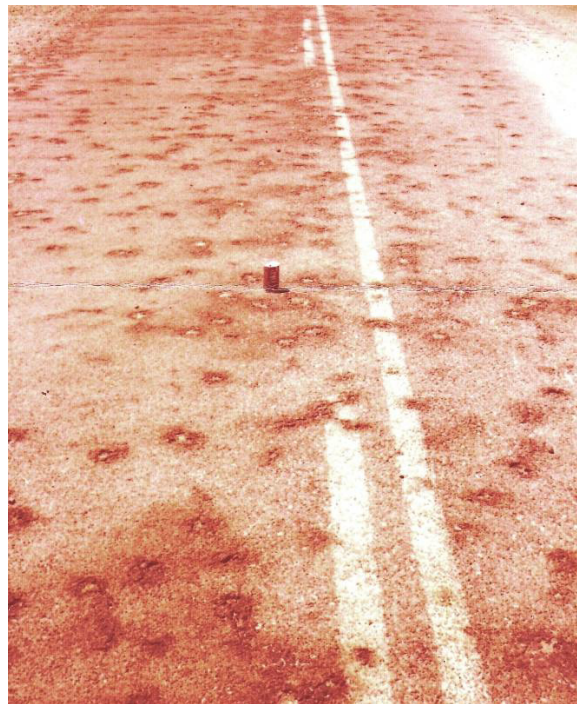
Figure 1: Condition in May 1984 showing damage under little traffic before spraying

Apart from numerous patches, in 1983 the surfacing was seen to consist of a single 7 mm reseat on the old-type 19 mm Cape seal with a total thickness of 20 - 25 mm. The damage consisted of mostly white-stained, cratered blisters averaging about 75 mm in diameter with 50 mm-wide, 20 mm-deep craters (Degree 1 - 2 in TMH 9: 1992 terms) on a varying but average spacing of about 300 mm together with 3 mm-wide cracking on a short starburst to random pattern (Figure 1).

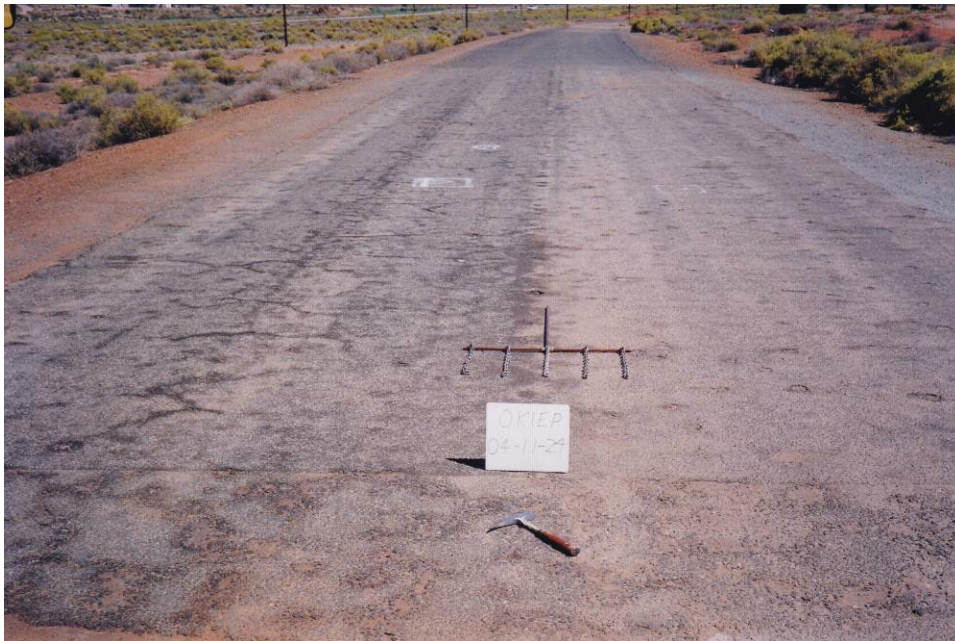
Figure 2: Condition after 20 years in February 1992 after brooming, showing left and right lanes of bitumen-rubber reseal in comparison with unresealed section in foreground, with an ASTM D4580-type chain drag

Whilst both bitumen-rubber reseals had become damaged, they were in a far better condition than the untreated control sections. Most of the blisters were closed in comparison with the mostly cratered and potholed blisters on the untreated sections, whilst cracking was also much less. The higher binder application rate and probably also the prior rolling in the left lane yielded the better performance of the two lanes. Although no

Although by no means a perfect solution, with prior flattening of blisters, digging out and prepatching of craters and potholes, and subsequent maintenance, a bitumen-rubber single seal at a binder application rate of about 3,0 l/m², can therefore be considered as an alternative to reconstruction for the rehabilitation of very severely salt-damaged surfacings on very lightly trafficked pavements

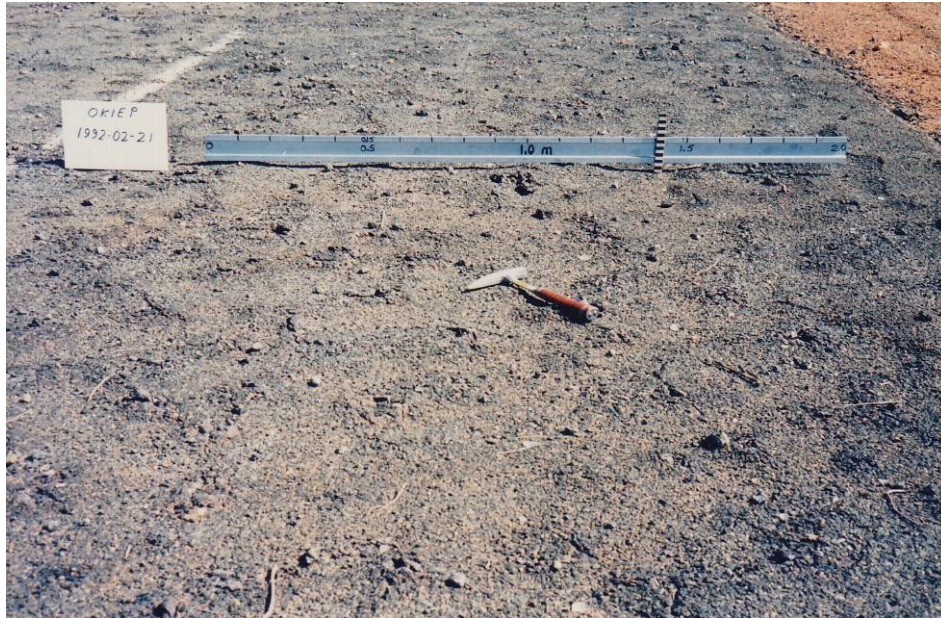
Figures 3 and 4 show the effect in 1992 of no maintenance together with little traffic since 1969 on the remnant section. Under conditions of almost no traffic at all the blistering and cracking had become very severe (Figure 3) whilst even very light traffic had led to even more severe cratering and potholing of the blisters (Figure 4).

Figure 3: Lack of traffic led to blisters up to 30 mm high (but few potholes) on completely untrafficked section

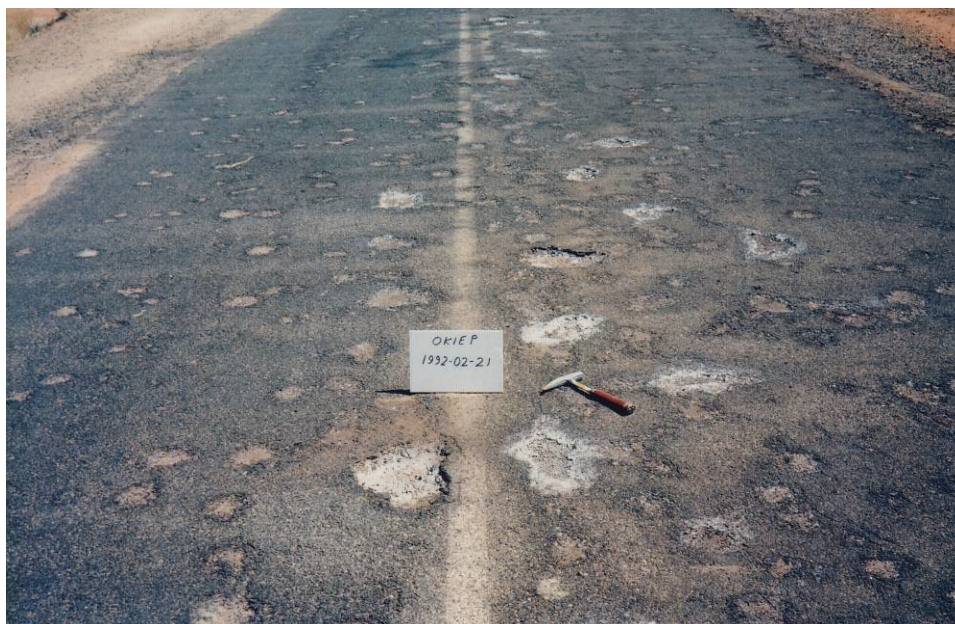
Figure 4: Light traffic and no maintenance caused the blisters to progress to white-stained craters and potholes

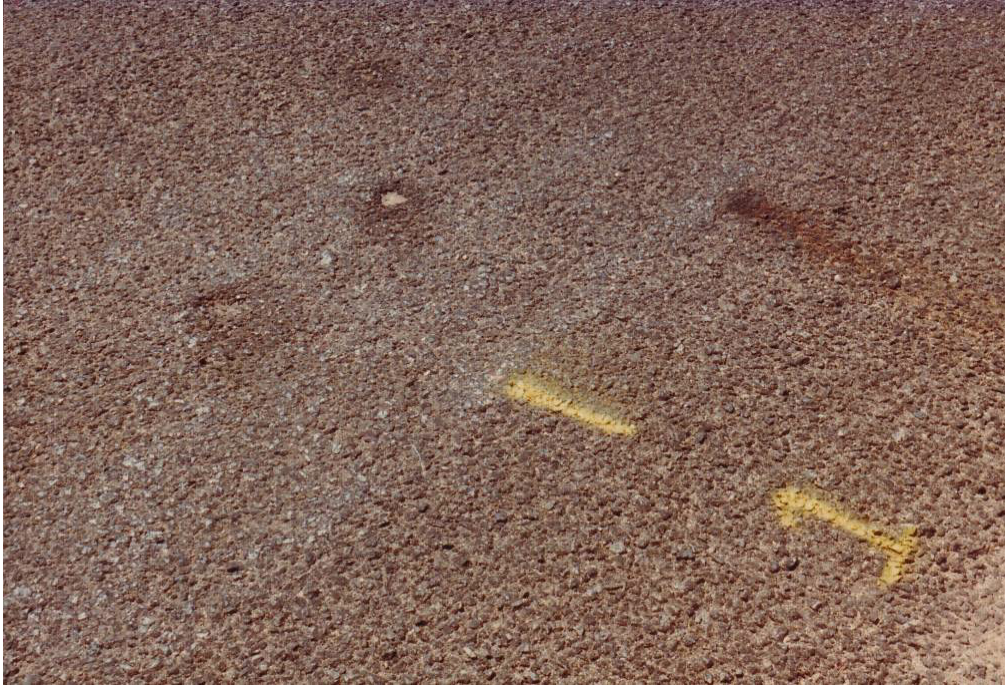
Observations recorded by TOSAS before sealing in 1984 also showed the damage to consist mostly of white-stained craters with an average diameter of 60 mm but ranging between 20 and 110 mm, depths of 20 mm (15 - 30) and a spacing of 800 mm (400 - 1 000) (Figure 5). Occasional blisters up to 12 mm in height at a spacing of 1,0 m (at km 19,879) and dark brown or green stains were also noted. However, no cracks were recorded.

Figure 5: Cratered blisters and brown staining on 1980 13 mm reseal at km 19,997: Average diameter 60 mm, depth 15 mm, spacing 400 mm (TOSAS photo)

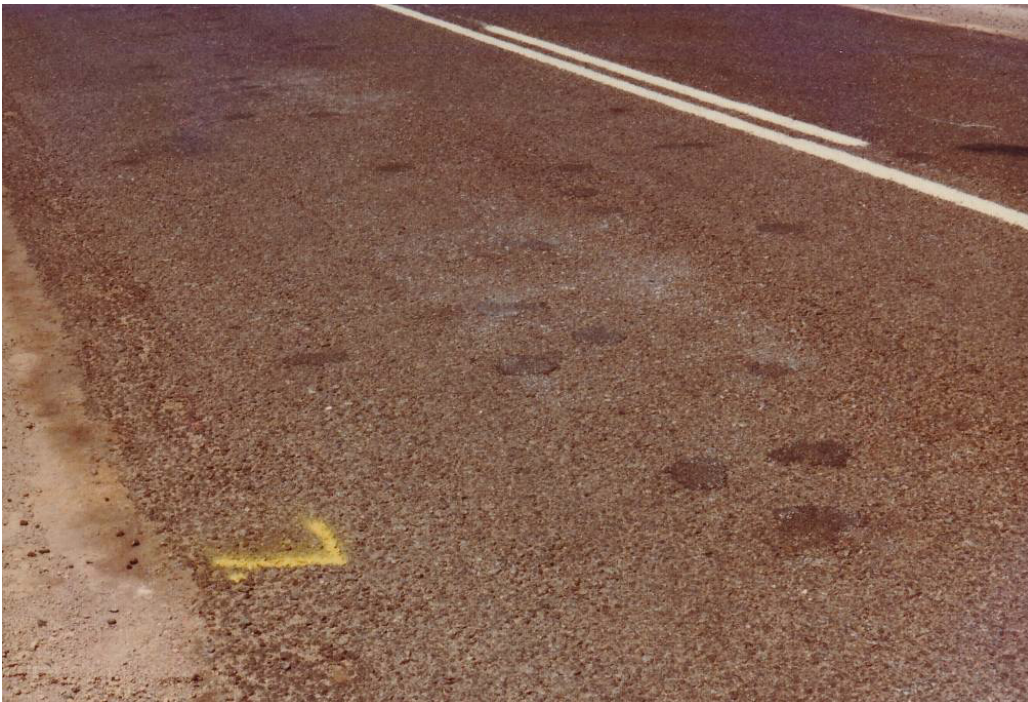
Figure 6: Craters on 1980 13 mm reseal pre-patched with slurry and blisters flattened with steel-wheeled roller at km 19,540 (R) for bitumen-rubber Section 12: Average spacing 400 mm (TOSAS photo)

The craters and potholes were prefilled with slurry and the blisters flattened with a steel-wheeled roller prior to resealing with bitumen-rubber (Figure 6).
