Failure analysis of thin cast A357-T6 centre shell induced by casting defect

Kofi A. Annan^a, Richard Nkhoma^b, Charles Siyasiya^a, Roelf Mostert^a

^aUniversity of Pretoria, Department of Materials Science and Metallurgical Engineering, Private bag X20, Hatfield 0002, Pretoria, South Africa

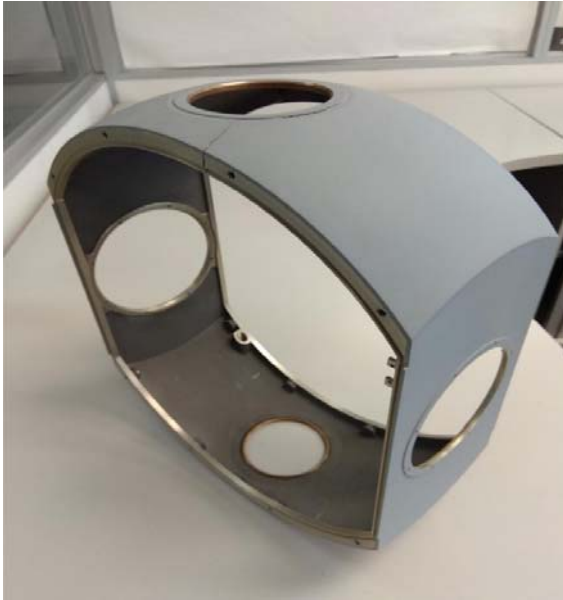
The failed component investigated in the current work was a centre shell used as a housing unit for a component. This shell failed prematurely during torqueing process. The applied pressure during the torqueing process was 0.04 MPa even though the operating pressure of the shell is 0.145 MPa. Fig. 1 presents the image of the failed centre shell used in the investigation showing the crack (arrowed) that was observed. The continuous crack line was visible to the naked eye as shown in the figure.

Fig. 1. Image of the fractured centre shell showing the crack.

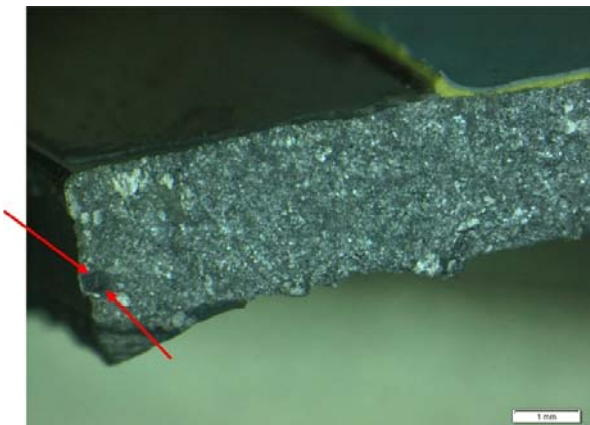
The crack was carefully opened by inserting the shell in a G-clamp; physically separating it into two halves making the fractured surface visible. Upon exposing the crack, the surface was observed under stereo for detailed information concerning the crack. A stereo image of the fractured surface of the shell is shown in Fig. 2. As can be seen the fractured surface depicts typical brittle failure by crack initiation. A close examination indicated that the crack initiated at the edge of the ring and followed by catastrophic failure.

Fig. 2. Stereo image showing the fractured surface of the component and the point of crack initiation.

It is evident from the stereo image and SEM analysis that the crack initiated from the pores located close to the sample surface, a mechanism described as failure dominant pores in aluminium alloys [17], [19].

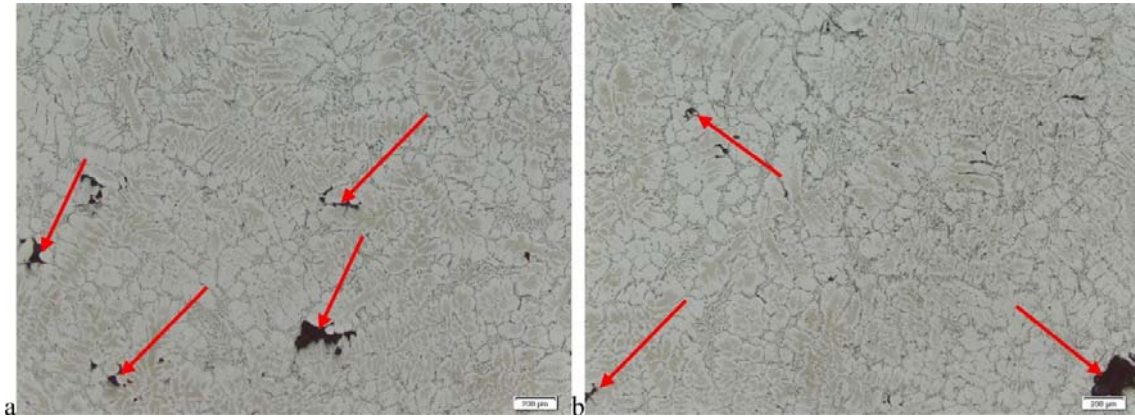
Fig. 3 shows an optical micrograph of the A357-T6 microstructure that was etched with Keller's reagent. Metallographic examination showed that the basic constituents of the cast A357 comprises of a primary Al matrix together with an Al + Si eutectic located between the secondary dendrite arms. The optical micrograph clearly shows evidence of porosity as indicated on the figure by arrows. The microstructure is hypoeutectic, consisting of primary

phase (Al) and Al + Si eutectic between the dendrite arms which formed during the solidification process. The eutectic regions were also the favoured location for defects such as porosity. As shown in the Figure, it is evident that the white phase (Al) primary phase exhibits the dendrite morphology and the grey phases (Al + Si) eutectic in the grain boundary. It is also noted that the porosity occurred along grain boundaries appearing in a web-like structure that extends from porosity boundaries possibly resulting from eutectic solidification [5], [6], [16]. There was however no difference between the microstructure of the sample taken close to the crack and the one away from the crack as depicted in the Fig. 3a and b.

Fig. 3. Optical micrograph of the samples taken from the component a) close to the crack b) away from the crack.

It is worthy to note that, the dendrite-shaped porosities are largely found to be distributed along the grain boundaries as shown in Fig. 3. Along the grain boundaries are found many tiny pores which are heavily distributed. Within the intergranular region and also along the grain boundaries of the Al matrix are the brittle Si eutectic particles. From the metallographic analysis done, it is clear that the major defects identified is the porosity. As seen, this porosity consists of interdendritic cavities along with chain of branches which exhibit some form of complexities in the microstructure. Fig. 4 shows micrograph of the perimeter of the shell with the paint peeled off observed under the JEOL 840A SEM. The image shows numerous porosity

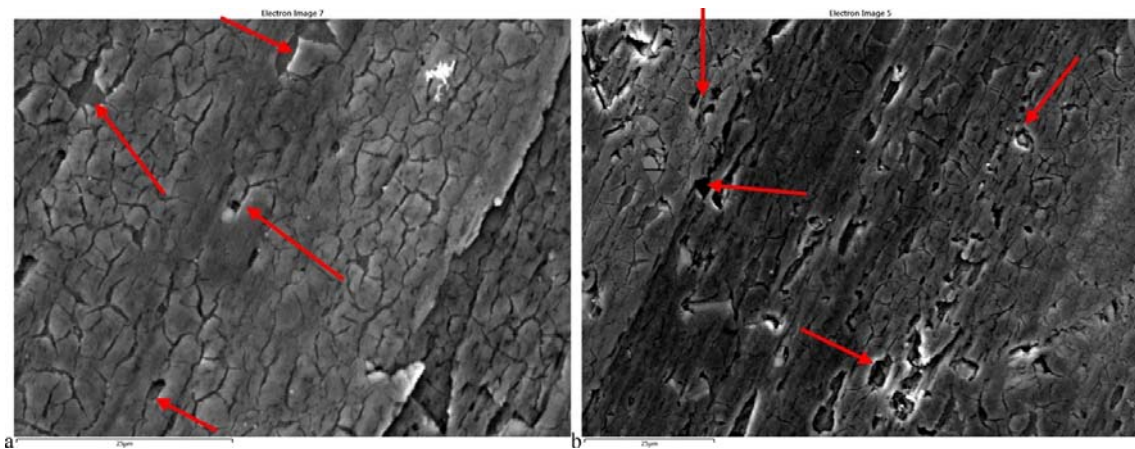
Fig. 4. SEM micrograph of the alloy without paint showing evidence of porosity from the a). Outside and b) inside of the component.

within the material. The micrographs presents detail of the randomly distributed pores which are irregular in shape.

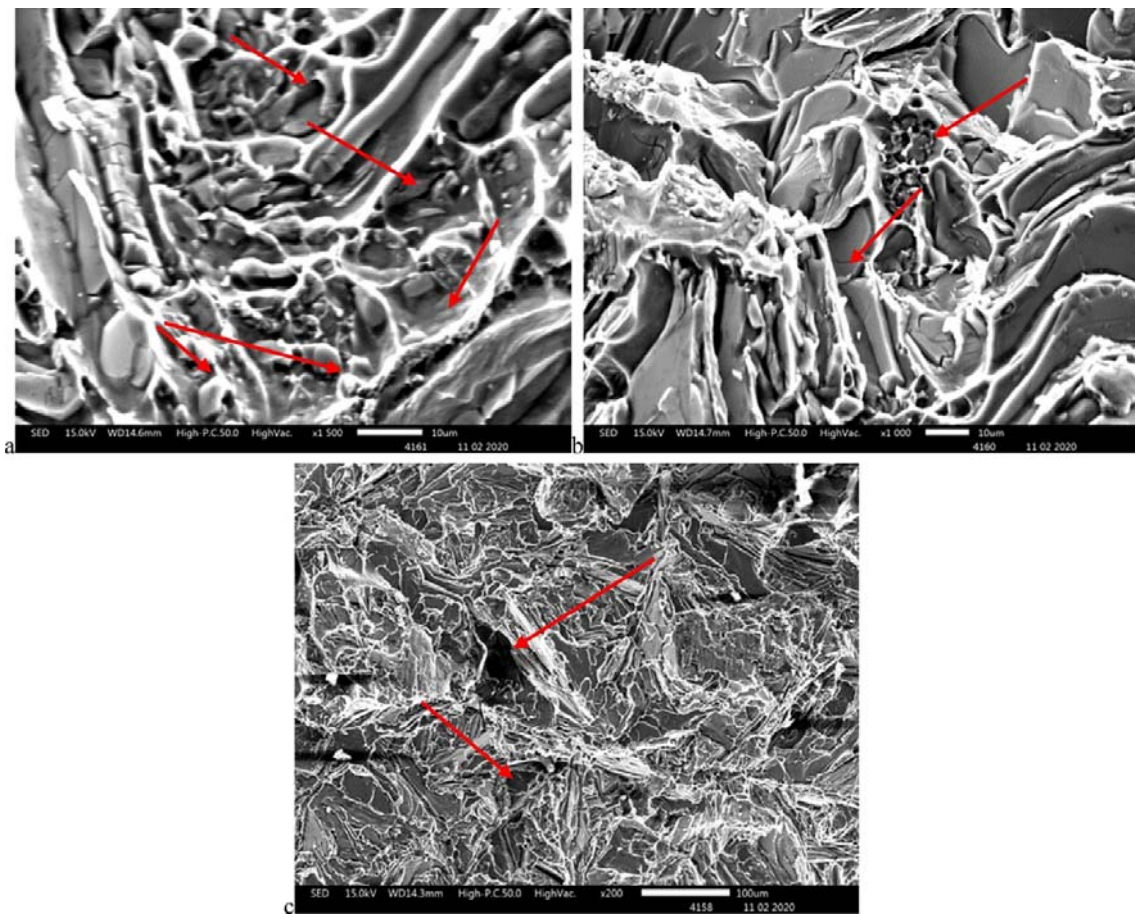
Fig. 5 shows micrographs of the opened crack site showing the surface of the fracture analysed using SEM. The Figure shows a quasi-cleavage feature morphology indicating that the fracture clearly occurred in a brittle manner [14], [20]. Fig. 5a exhibits the presence of micro cracks generated in the material while 5b shows the dendritic “heads”. The fracture of the eutectic silicon particles created flat areas as shown on the micrograph in Fig. 5c. The sites showing micro cracks in Fig. 4a points to the fact that, there are other potential crack initiation sites as a results of casting quality [18]. The image clearly shows evidence of brittle dendrites in the material as in Fig. 4b. The path of the fracture is observed to be through the more brittle eutectic silicon particles which experienced some form of deformation as in Fig. 5c [15], [24]. The fracture pores occurred in the areas with eutectic Si particles in the interdendritic region. The initiated crack propagated along the solidification cells with segregation of eutectic particles leading to fracture and failure.

Fig. 5. SEM micrographs showing evidence of a) Micro cracks b) dendritic heads c) flattened areas.

It is evident that, this failure is not a fatigue failed part but porosity related. Thus the porosity affected the ductility as demonstrated in the tensile test results as well as the irregular crack initiation and its propagation to failure [25]. Metallographic examinations showed large presence of porosity in the cast. The SEM analysis in Fig. 4 further showed microporosity and micro-cracks which are typical in Al cast alloys [14]. With presence of micro-cracks, the porosity made it easy for the initiated crack to grow quickly with little force applied leading to unannounced failure [25], [26], [27]. The porosity observed occurred as a result of the volume contraction during solidification leading to the observed shrinkage porosity. Another interesting observation is the web-like structure which is observed to occur along the intergranular boundaries areas which is able to initiate crack in the material [27], [8]. As shown in the optical and the SEM micrographs, the fracture in the studied cast component

was actually initiated by the cracking of the Si areas with dendrites heads which are brittle silicon areas.

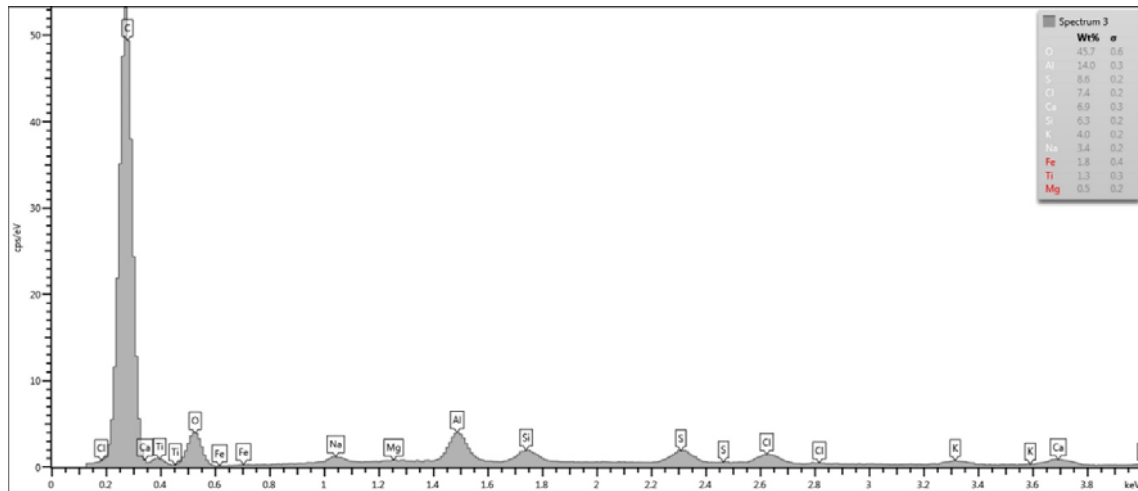
The semi-quantitative EDS analysis technique employed provided a qualitative information on the material as shown in Fig. 6. The information obtained through the EDS confirms the dark portions identified in the optical and the SEM micrographs to the pores other than the composition of the alloy or artefacts.

Fig. 6. EDS spectrum of the A357-T6 alloy confirming the presence of pores in the alloy.
