POOR PERFORMANCE OF COUNTERMEASURES ON A ROAD ON AN EXPANSIVE CLAY ROADBED

F NETTERBERG¹ and F VAN COPPENHAGEN²

ABSTRACT

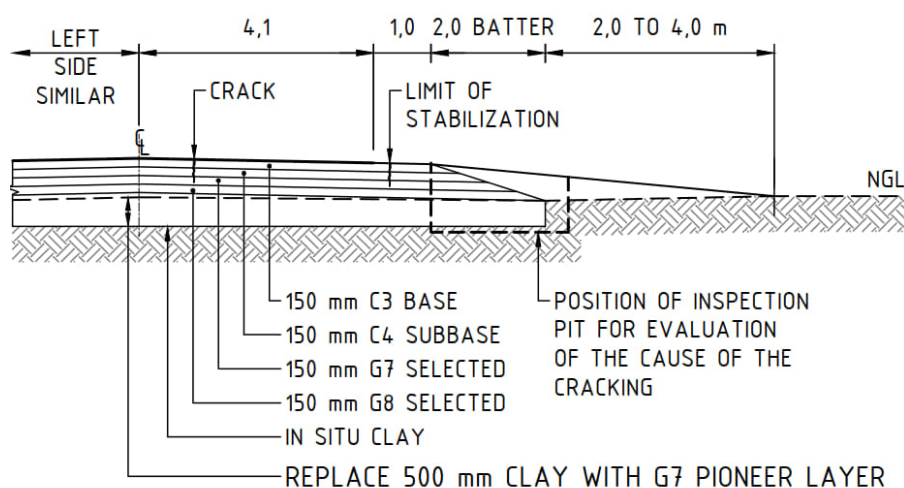
Figure 1: Typical half cross-section of P65/1

- An unavoidable delay between the initial cracking and the crack sealing probably allowed water to penetrate the backfill and the underlying clay.
- The replacement of only 500 mm of clay (as in Figure 1) may have been insufficient in this case.

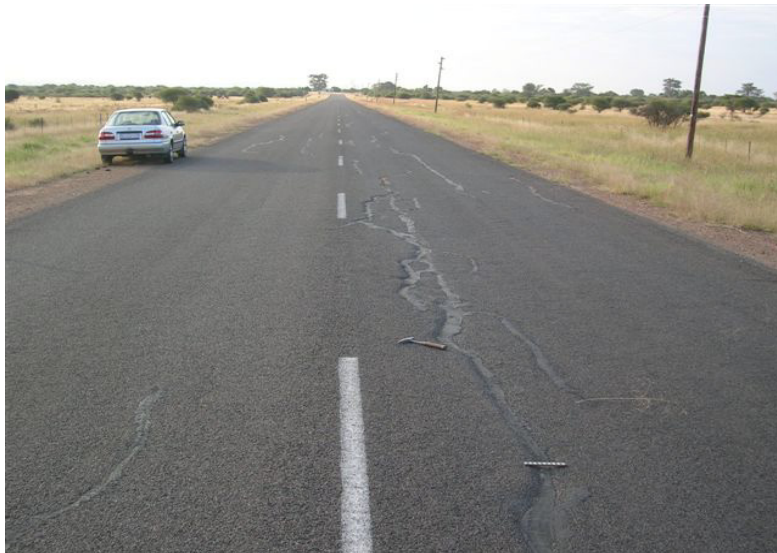
Although longitudinal cracking was also seen elsewhere on this road, very severe longitudinal cracking of Degree and Extent 5 typical of roads on expansive clay roadbeds only occurred over a total length of about 700 m between about km 9 and 10 (Figure 2). (The leaning telephone poles are also an indication of severely expansive clay.) This cracking was up to about 30 mm in width and at least 600 mm deep in places before sealing. Some cracks had reopened and were spalling, and strips of road between the cracks had sunk to a depth of about 10 mm in places.

Figure 2: Longitudinal cracking on road P65/1 near km 9 after three years in April 2009

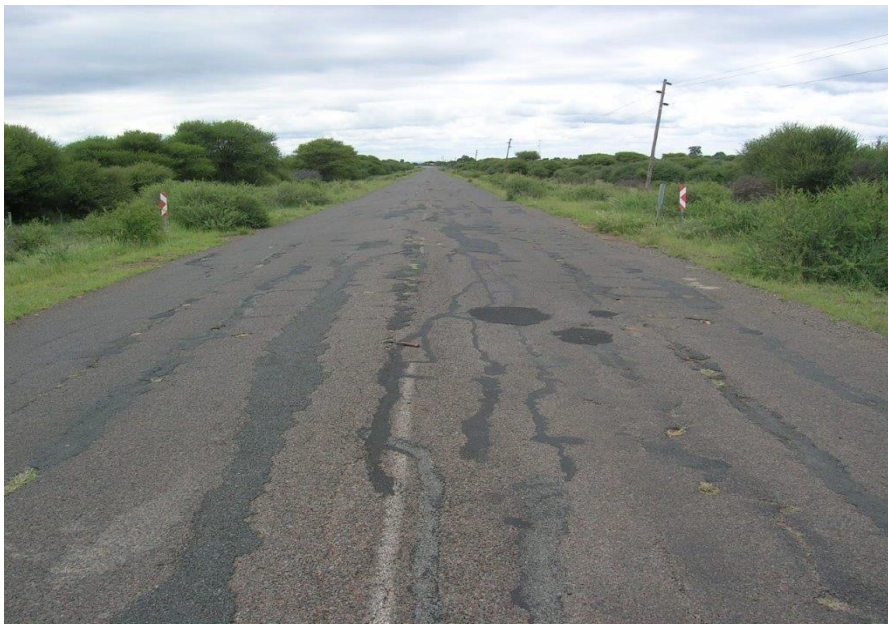
An inspection after 18 years in February 2024 showed that the 1 km section on P65/1 had deteriorated significantly since 2009 and exhibited extensive and severe longitudinal cracking of Extent and Degree 5, varying in width up to about 20 mm with associated incipient potholing and extensive patching and potholing in both lanes, over the worst part (Figure 3). However, the riding quality was fair and the culverts had not apparently heaved, indicating that at least these precautions were adequate.

Figure 3: Condition of P65/1 near km 9 in February 2024 (this culvert had been reinstated due to settlement during construction)
