3.1.2.4 Seekoeivlei Wetland:

3.1.2.5 Zoar Wetland:

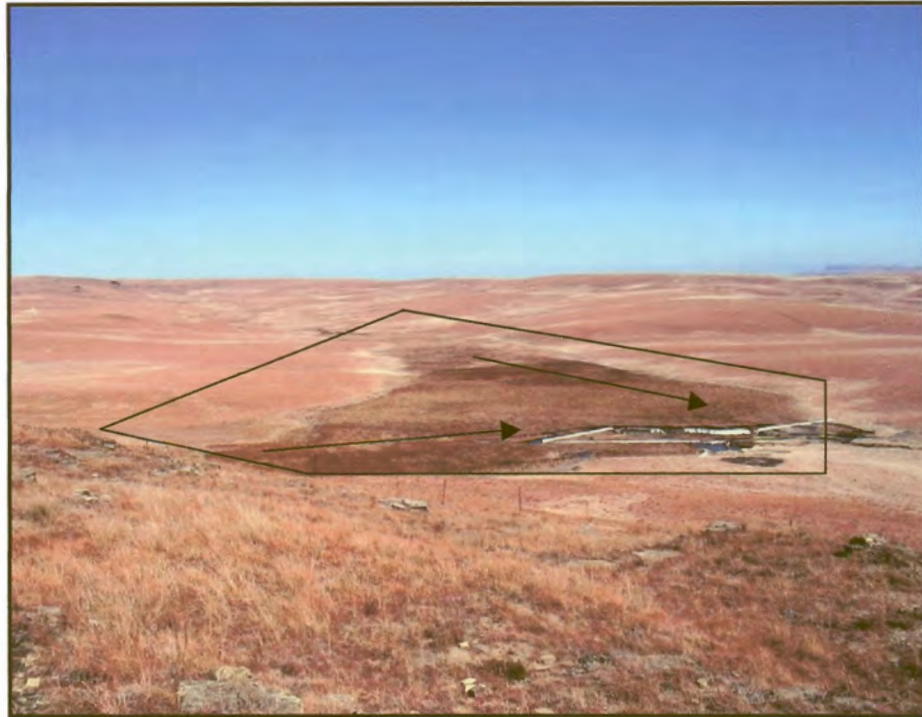
Figure 35: A headcut (consisting of a headcut and a channel) were found in the Wilge River. The remote sensing imagery will focus on the area indicated.

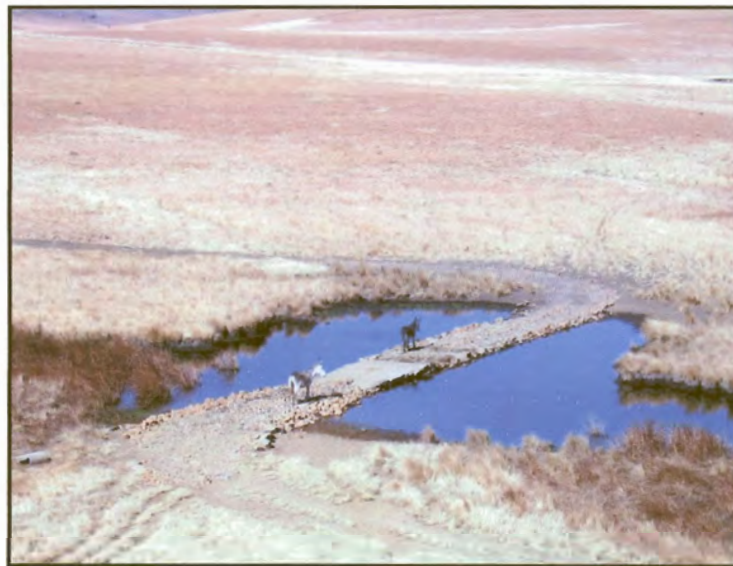
Figure 36: Road crossing downstream of the rehabilitation structure.

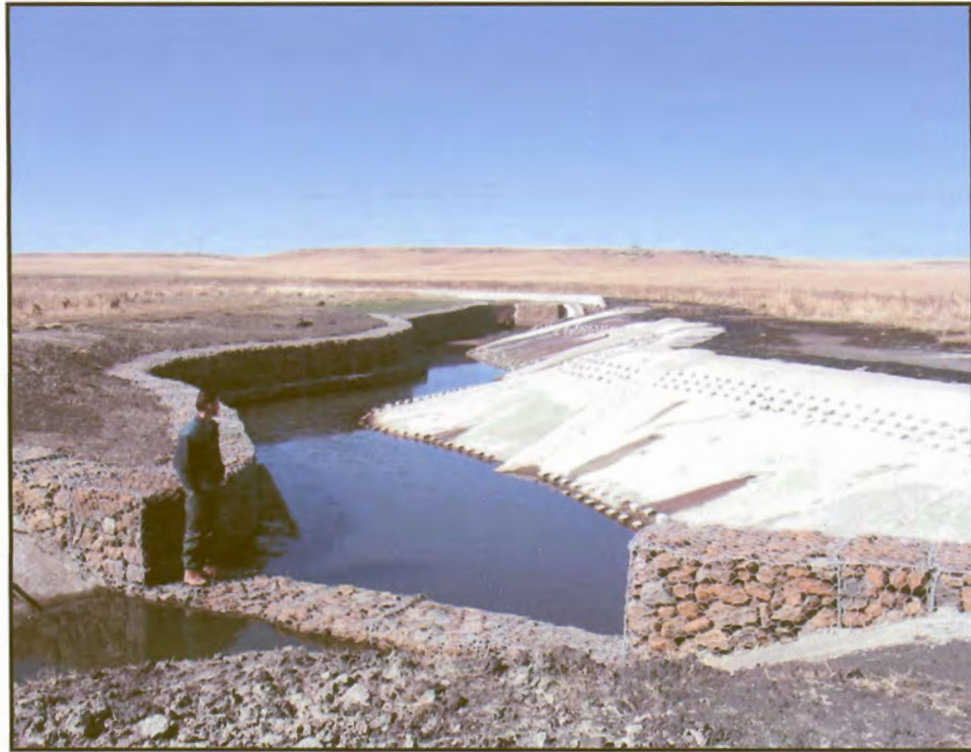
Site no.	Problems	Rehabilitation action	Desired results
<p>1</p> <p>28°13'38" 29°33'31"</p>	<p>Headcut (45 m) and channel (95 m donga) erosion (Figure 38)</p>	<p>Structural erosion control is needed.</p> <p>Headcut:</p> <ul style="list-style-type: none"> - 30 m sloping: hyson cells (1:4), 15 m concrete basin, 100 m soil berm, 300 m fencing and revegetation (Figure 39). <p>Donga:</p> <ul style="list-style-type: none"> - 95 m sloping: hyson cells, 10 m concrete basin, channel plugs: gabions filled with rock. 	<ul style="list-style-type: none"> • Stabilise the headcut • Stabilise headcuts developing on the banks of the channel • Dissipate the energy of floods. • To prevent further erosion of the wetland causing the affected wetland area to be drained.

Figure 38: Close up of the headcut rehabilitation structure.

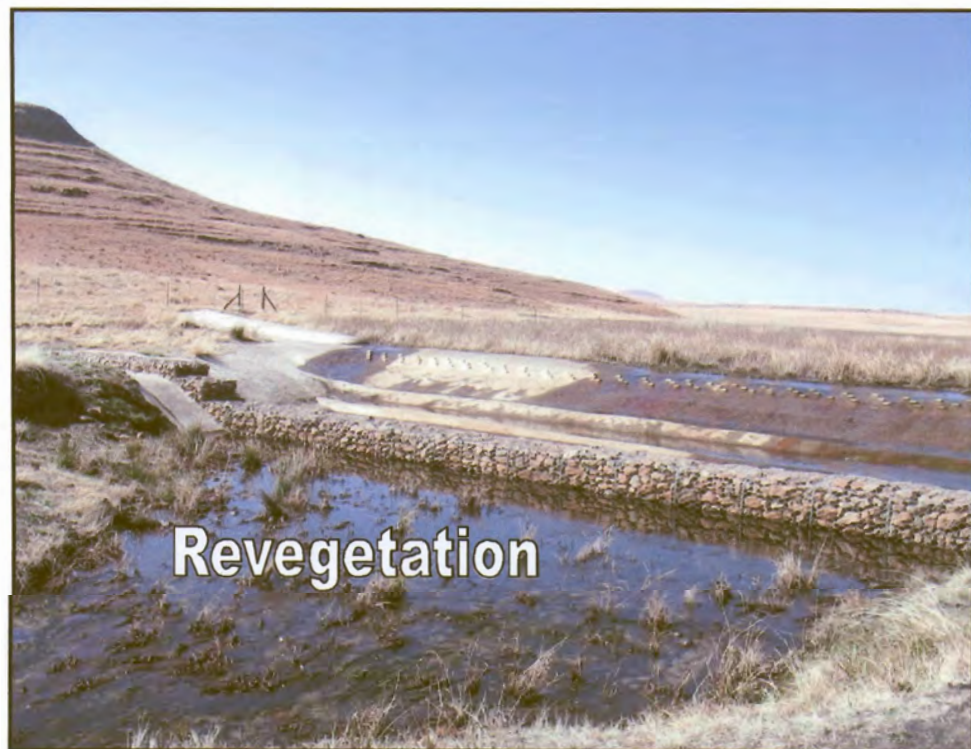
Figure 39: Re-established wetland vegetation in the foreground.

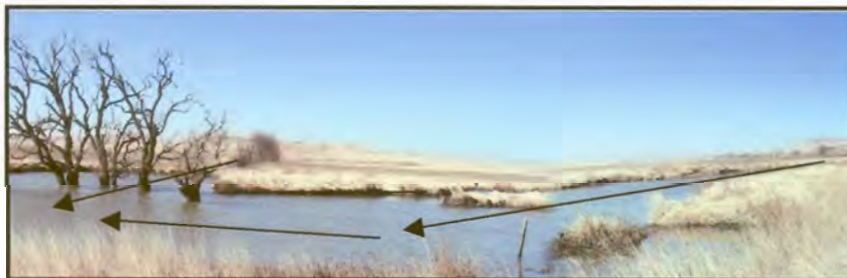
The channels dug by the farmers (Figure 41) caused the Klip River to overflow its banks less frequently. This had a negative impact on the wetland system and wetland functions were lost (Collins and Thompson 1996).

Figure 41: Photo taken at Merel's vlei. This erosion channel forms the main flow of the Klip River.

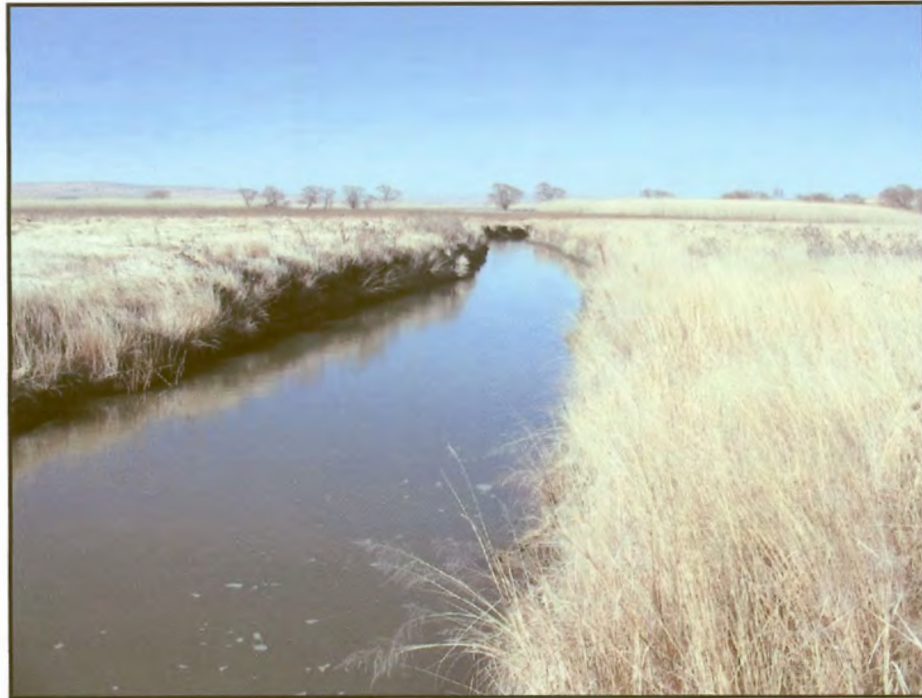
Site no.	Problems	Rehabilitation action	Desired results
1 29° 34' 41" 27° 35' 56"	Drainage channel eroding the wetland (Figure 43).	Concrete weir has been constructed (Figure 44).	<ul style="list-style-type: none"> • Structure must act as a silt trap. • Lift the water table • Dissipate the energy of the floods. • Prevent further erosion of the wetland.
2 29° 34' 47" 27° 35' 33"	Drainage channel eroding the wetland.	Concrete weir (Figure 45) has been constructed.	<ul style="list-style-type: none"> • Stabilise bank erosion (Figure 46). • Structure must act as a silt trap. • Lift the water table. • Dissipate the energy of the floods. • Prevent further erosion of the wetland.
3 29° 35' 06" 27° 34' 57"	Merel's vlei. River channel erosion and bank erosion.	Gabion structure constructed in 1997/8 (Figure 47). Measures to stabilise bank erosion.	<ul style="list-style-type: none"> • Stabilise bank erosion. • Structure must act as a silt trap. • Lift the water table. • Dissipate the energy of the floods. • Prevent further erosion of the wetland.

Figure 43: Site no. 1. Area north of the confluence of the drainage channel that stretches from east to west across the width of the floodplain.

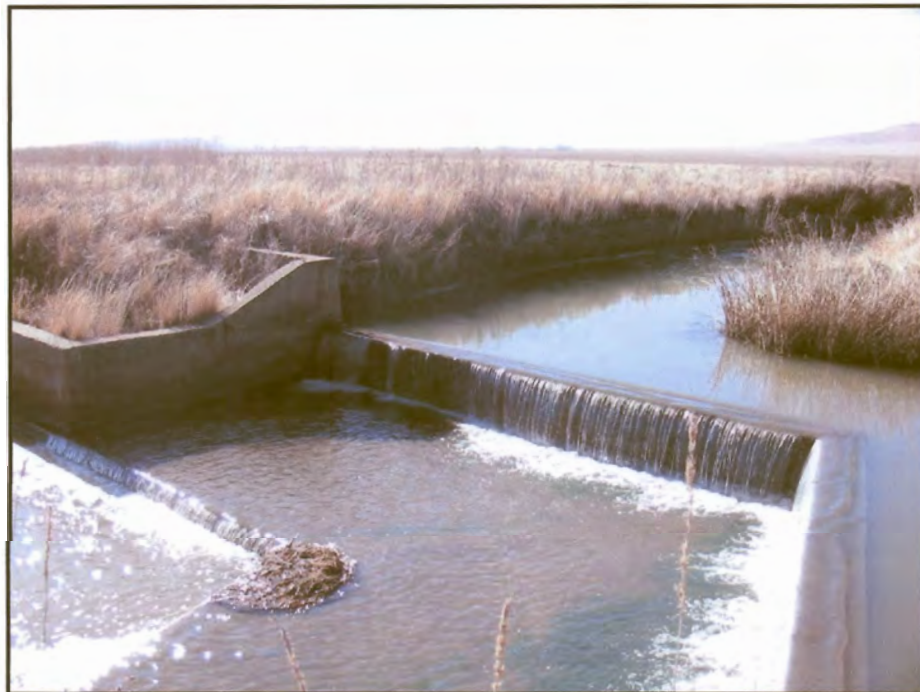
Figure 44: Site no. 1. Concrete weir.

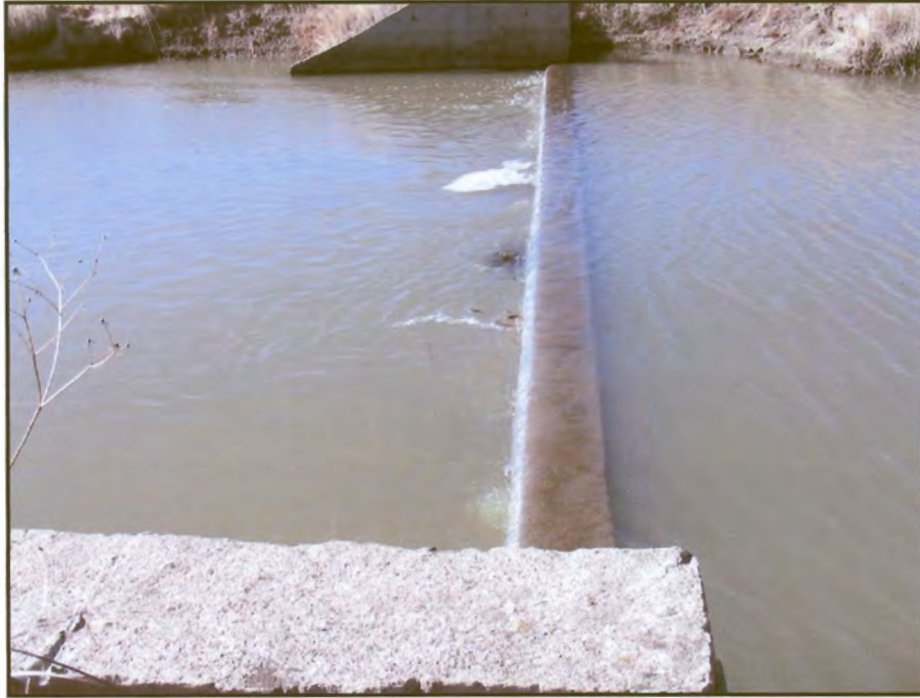
Figure 45: Site no. 2. Concrete weir.

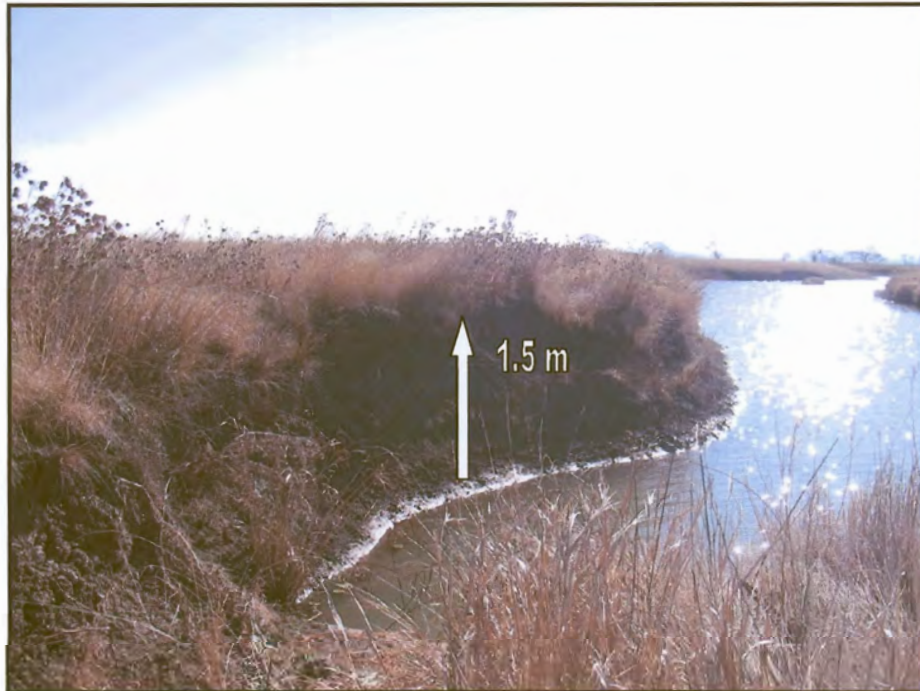
Figure 46: Site no. 2. Bank erosion.

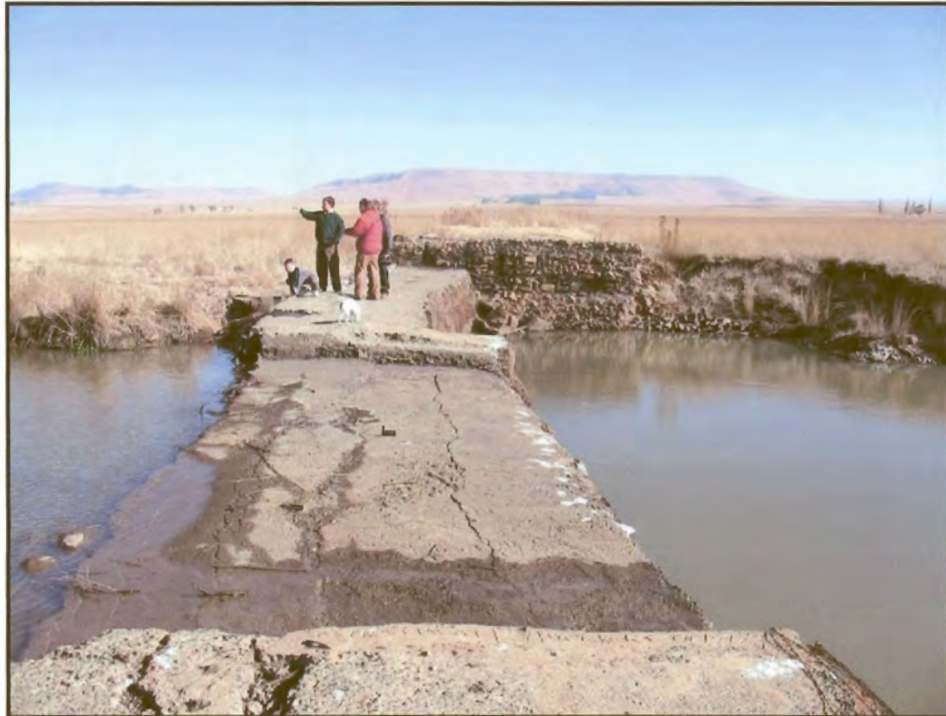
Figure 47: Site no. 3. Merel's vlei. The gabion structure was constructed in 1997/8. Measures were put in place to try and stabilise the bank erosion.

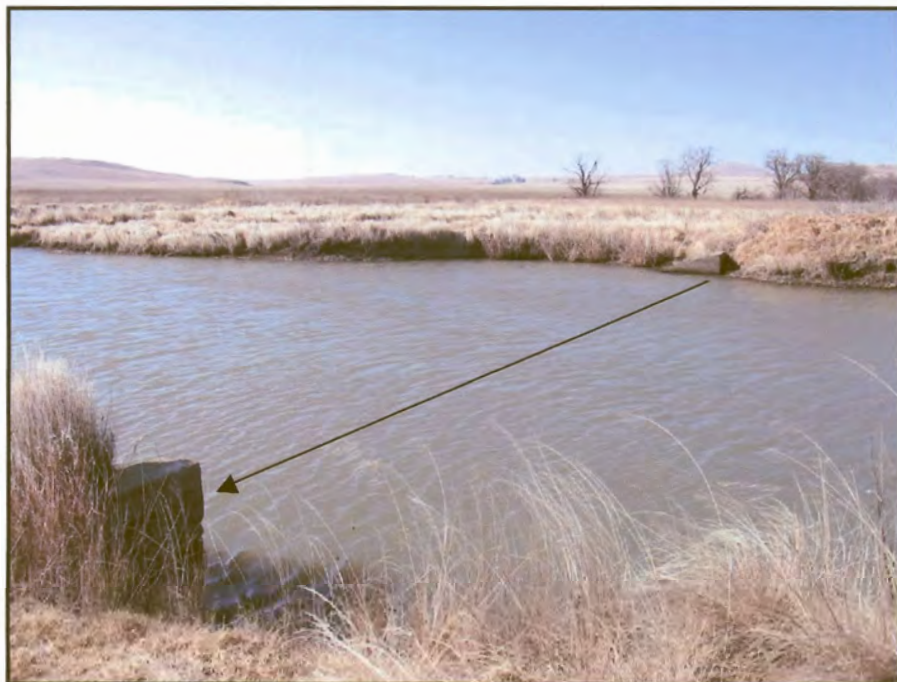
4 29° 35' 04" 27° 34' 59"	Merel's vlei. Channel erosion and bank erosion.	Concrete weir has been constructed and features below the water surface (Figure 48).	<ul style="list-style-type: none"> • Stabilise bank erosion. • Structure must act as a silt trap. • Lift the water table. • Dissipate the energy of the floods. • Prevent further erosion of the wetland.

Figure 48: Site no. 4. Merel's vlei. A small weir drowned below the water surface.

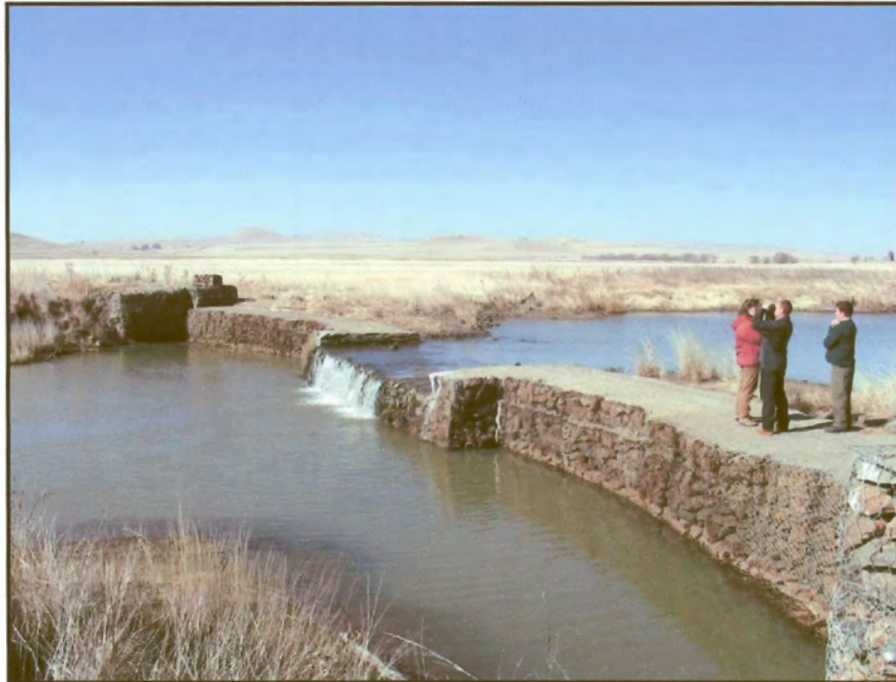
Site no.	Problems	Rehabilitation action	Desired results
5 29° 34' 58" 27° 34' 15"	River channel erosion and bank erosion.	Gabion structure (Figure 49).	<ul style="list-style-type: none">• Stabilise bank erosion.• Structure must act as a silt trap.• Lift the water table.• Dissipate the energy of the floods.• Prevent further erosion of the wetland.
6 29° 35' 10" 27° 33' 48"	River channel erosion and bank erosion.	Lift the existing structure higher and close it up with plugs (Figure 50).	<ul style="list-style-type: none">• Stabilise bank erosion.• Structure must act as a silt trap.• Lift the water table.• Dissipate the energy of the floods.• Prevent further erosion of the wetland.
7 29° 35' 12" 27° 32' 25"	Northern border of the Seekoievlei Nature Reserve. River channel erosion and bank erosion.	Gabion structure in the flow of the Klip River (Figure 51).	<ul style="list-style-type: none">• Stabilise bank erosion.• Structure must act as a silt trap.• Lift the water table.• Dissipate the energy of the floods.• Prevent further erosion of the wetland.

Figure 49: Site no. 5. Gabion structure.

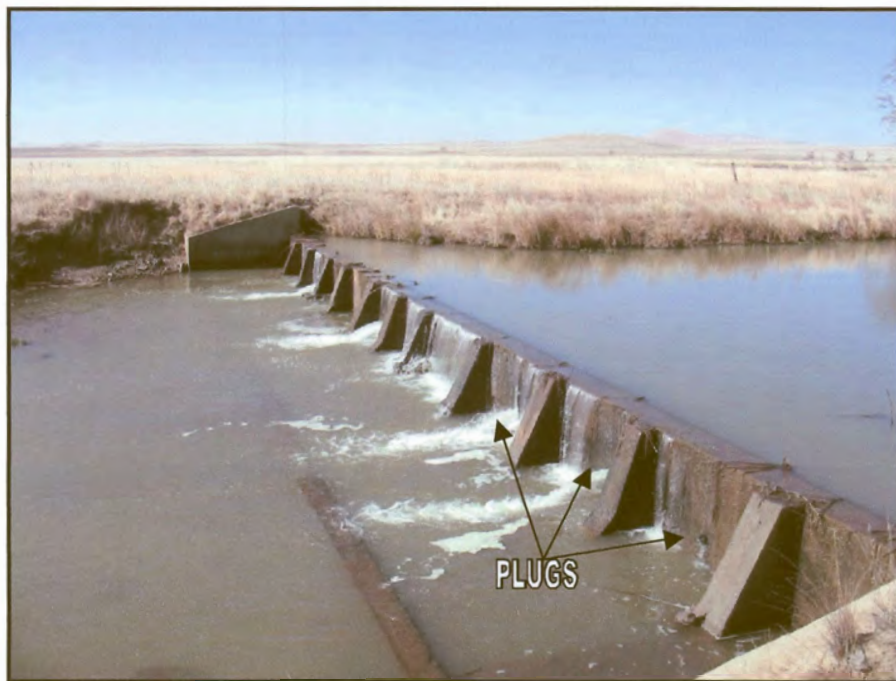
Figure 50: Site no. 6. The work involved lifting the existing structure higher, strengthening the structure and closing the drain holes (1997). Note that most of the plugs have been washed out.

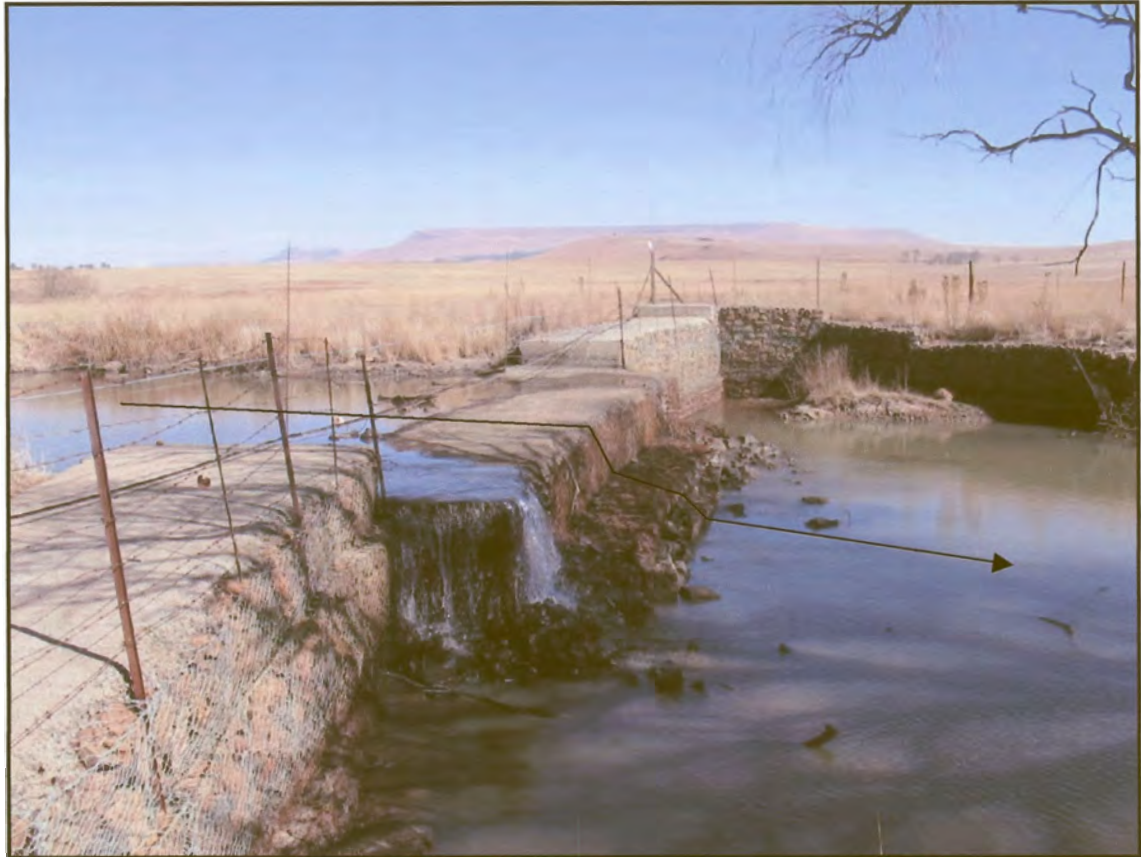
Figure 51: Site no. 7. The Northern border of the Seekoeivlei Nature Reserve. A gabion structure was constructed in the flow of the Klip River to promote the flooding of the floodplain and to raise the water table.

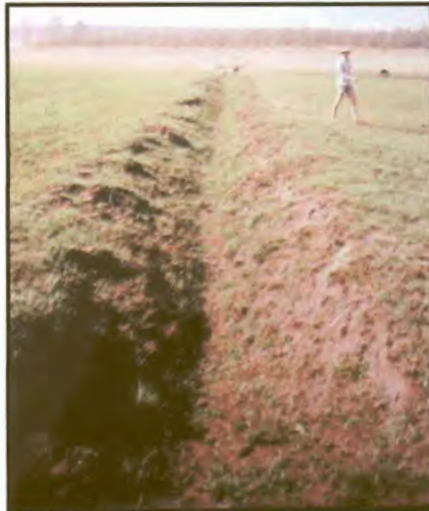
Figure 53: Drain in the wetland before rehabilitation (80 m long and 0.7 m deep). Photo taken from Mondi Wetlands Project report (2000).

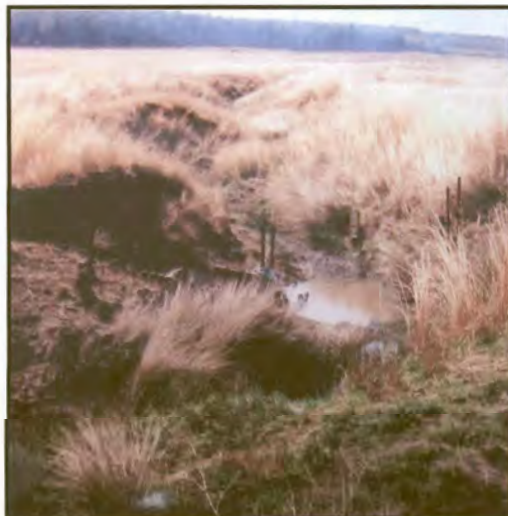
Figure 54: Artificially straightened channel before rehabilitation. Photo taken from Mondi Wetlands Project report (2000).

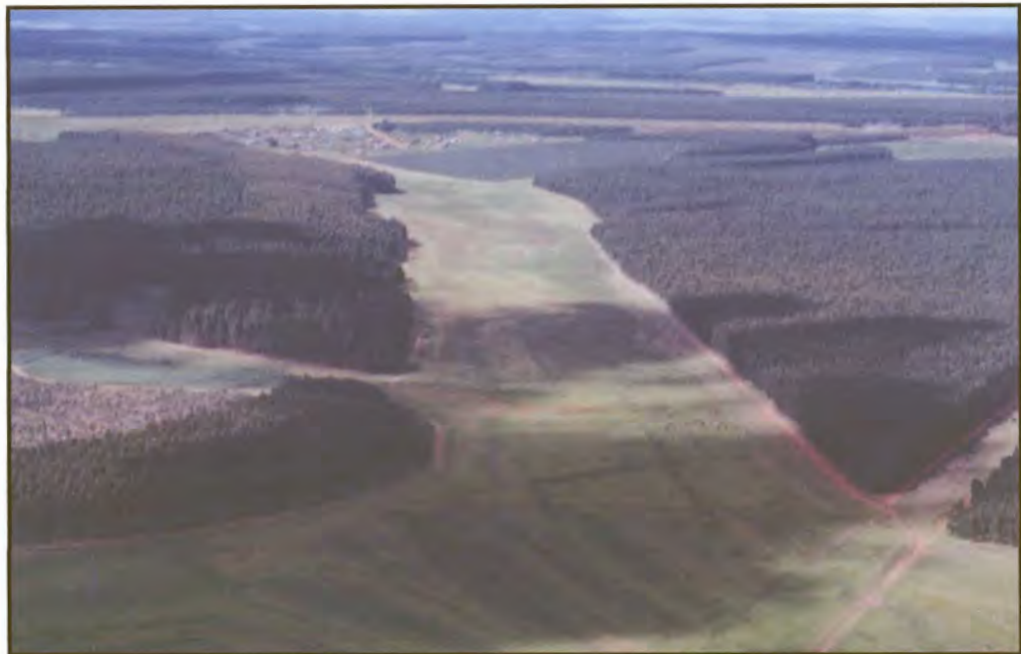
Figure 55: Photo of the Zoar wetland after the plantation trees were removed from the wetland (Photo: D. Lindley).

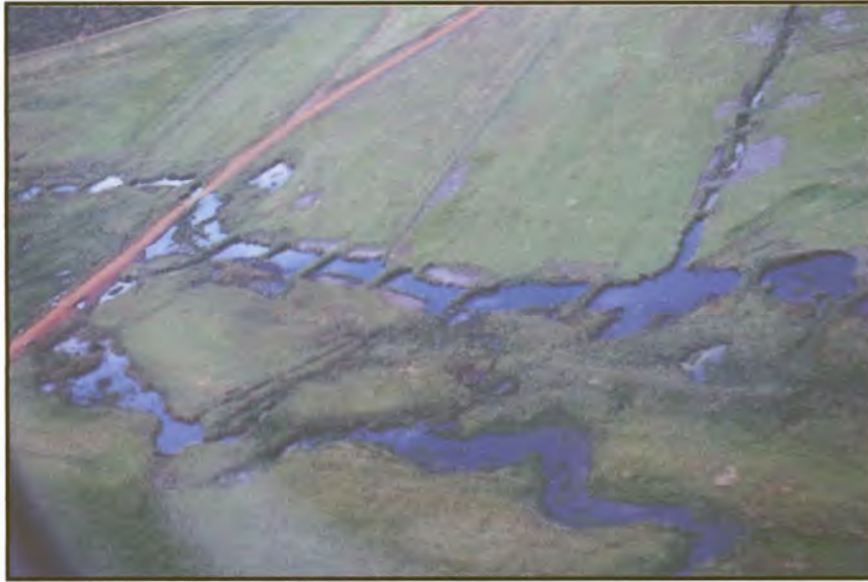
Figure 56: View of a flooded Zoar wetland. Note how the clay plugs act like dam walls (Photo: D. Lindley).

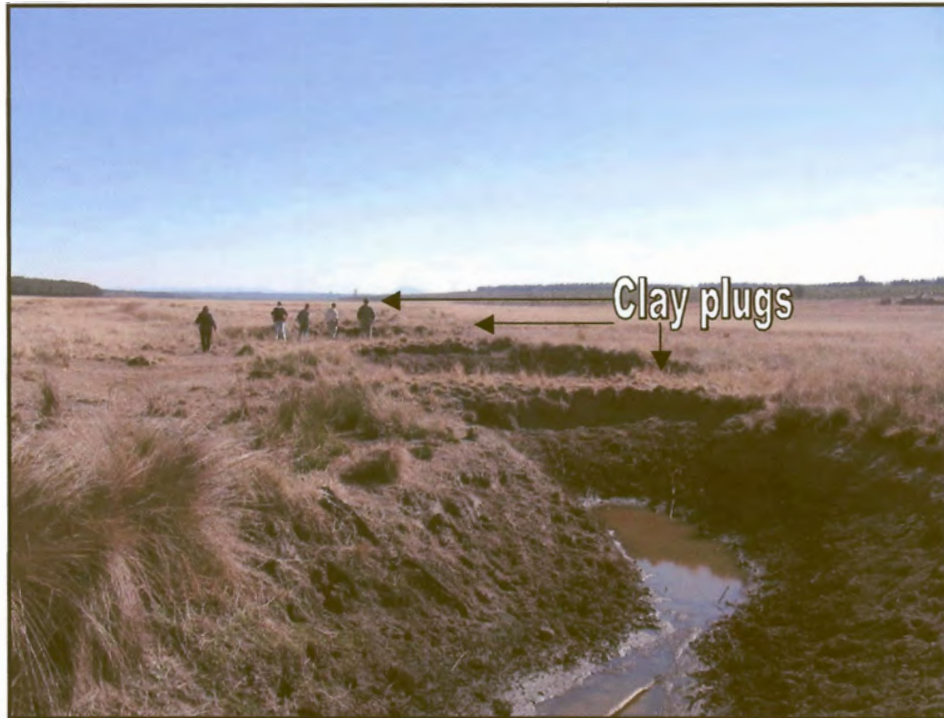
Site no.	Problems	Rehabilitation action	Desired results
<p>1</p> <p>S 30°28' 04.0"</p> <p>E 26°50' 34.0"</p>	<p>Zoar wetland North border. Eroded channel (Figure 58)</p>	<p>Built in clay plugs . The plugs must be keyed into the sides so that erosion cannot form around the plugs.</p> <p>Plugs must be well compacted.</p>	<ul style="list-style-type: none"> • Dissipates the water energy. • Prevent channel erosion. • Spread the water and re-wet the wetland.

Figure 58: Site no 1: Clay plugs in a badly eroded channel at the northern border with private owners.

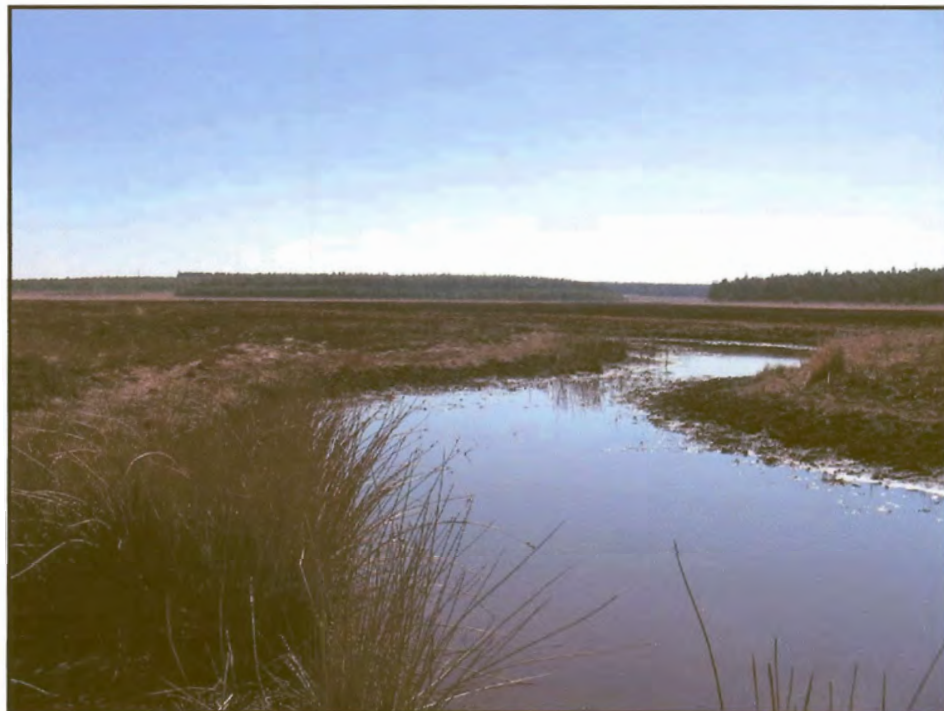
Site no.	Problems	Rehabilitation action	Desired results
2 S 30°28' 17.0" E 26°50' 41.0"	Main natural channel artificially straightened (Figure 59).	Channel must be replaced	<ul style="list-style-type: none"> • Dissipate the energy of the floods. • Prevent channel erosion. • Spread the water and re-wet the wetland.
3 S 30°28' 39.0" E 26°50' 56.0"	Controlled service road cuts through the wetland and compacts the wetland soils resulting in the road acting as a dam wall hindering surface and subsurface flow (Figure 60).	Stop using the road.	<ul style="list-style-type: none"> • Dissipate the energy of the floods. • Prevent channel erosion. • Spread the water and re-wet the wetland.
4 S 30°28' 53.0" E 26°51' 02.0"	Drains (Figure 61).	<p>Ideal time to burn is at the end of winter and the beginning of spring.</p> <p>Built in clay plugs. The plugs must be keyed into the sides so that erosion can't form around the plugs.</p> <p>Plugs must be well compacted.</p>	<ul style="list-style-type: none"> • Spread the water and re-wet the wetland that will result in • Cool fires that are not so damaging to the organic matter/peat accumulating in a wetland. • Dissipate the energy of the floods. • Prevent channel erosion.

Figure 59: Site no 2: Main natural channel.

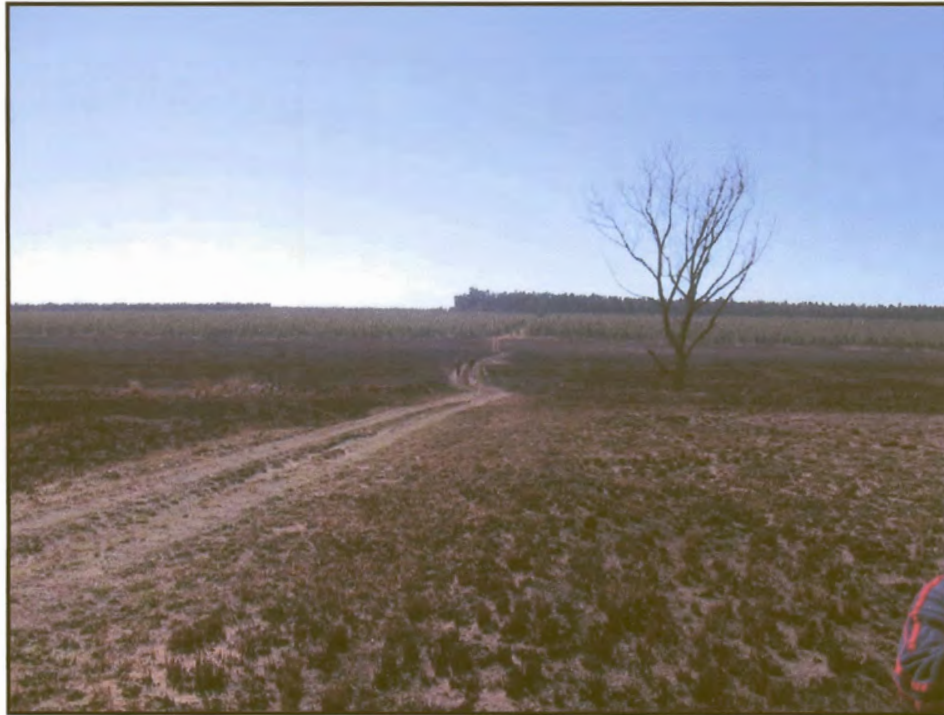
Figure 60: Site no 3: Service road controlled by Mondi Forestry.

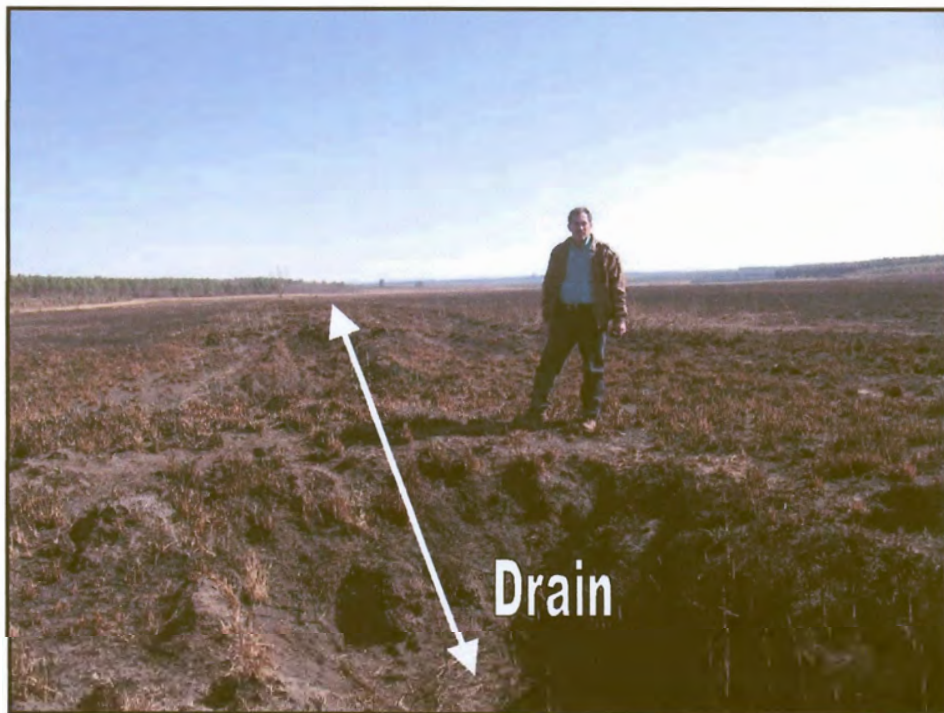
Figure 61: Site no 4: Drains draining the wetland lead to the desiccation of the wetland.

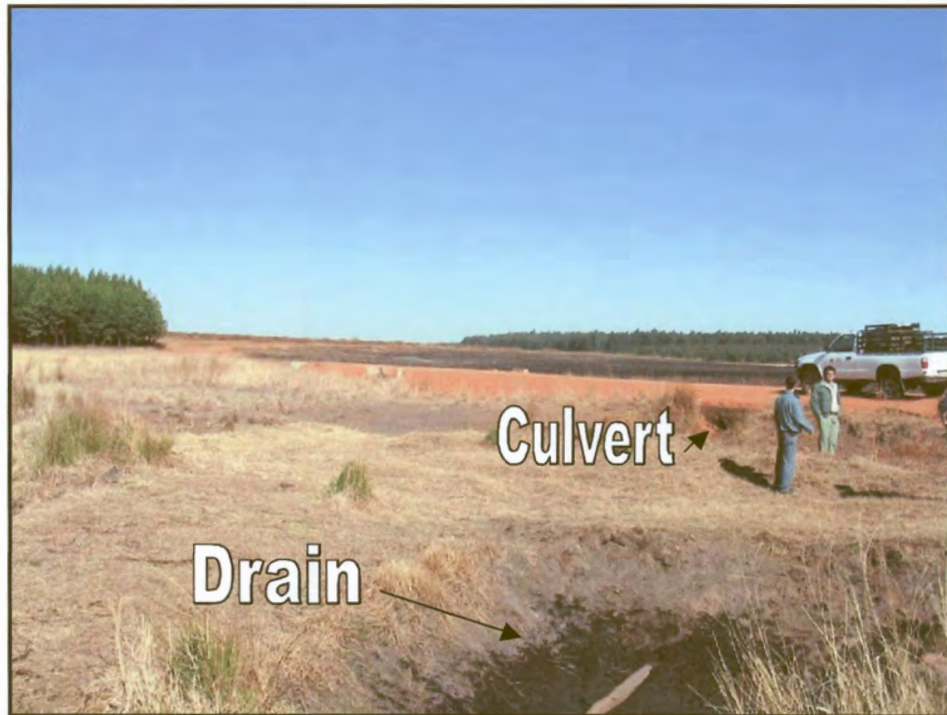
5 S 30°29' 19.0" E 26°51' 07.0"	Dirt road with culverts (Figure 62 & 63). Main drain with smaller drains along the side	<p>Enlarge the culverts underneath the road to facilitate the more evenly spread of water to the wetland downstream.</p>	<ul style="list-style-type: none"> • Spread the water across the width of the wetland downstream. • Stabilise channel erosion.
6 S 30°29' 30.0" E 26°50' 57.0"	Drain inside a (1m wide, 1m deep) tributary feeding into the wetland (Figure 64). They use this tongue as a fire break between the plantations but burned it at the wrong time of the year	<p>Ideal time to burn is at the end of winter and the beginning of spring.</p> <p>Built in clay plugs every 30m and 0.5m broad at the top. The plugs must be keyed into the sides so that erosion can't form around the plugs.</p> <p>Plugs must be well compacted.</p>	<ul style="list-style-type: none"> • Spread the water and re-wet the wetland that will result in • Cool fires that are not so damaging to the organic matter/peat accumulating in a wetland. • Dissipate the energy of the floods. • Prevent channel erosion.

Figure 62: Site no. 5: Dirt road with culverts. The culverts concentrate the flow of the water and cause eroded channels.

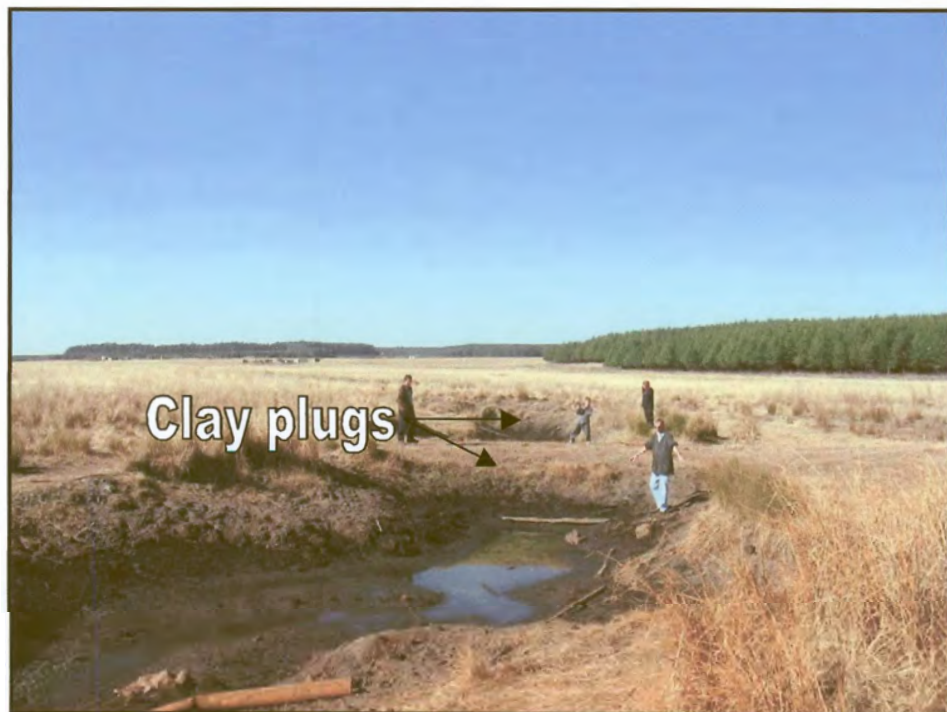
Figure 63: Site no. 5: Main drain with smaller drains along the side. Clay plugs act like dam walls.

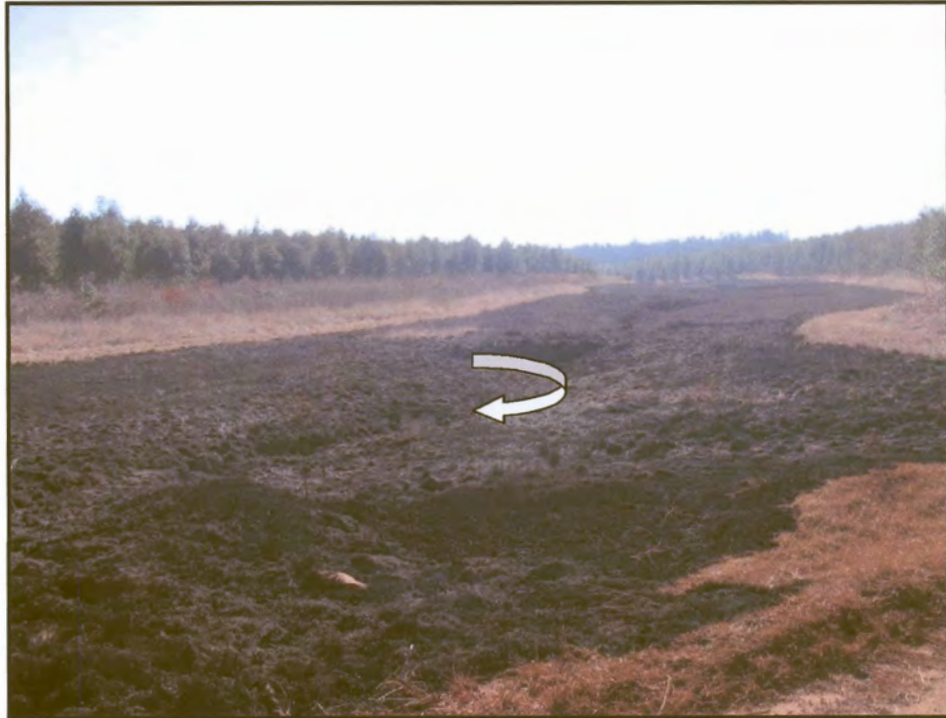
Figure 64: Site no 6: Note the drain in the burned tributary area that feeds into the wetland.

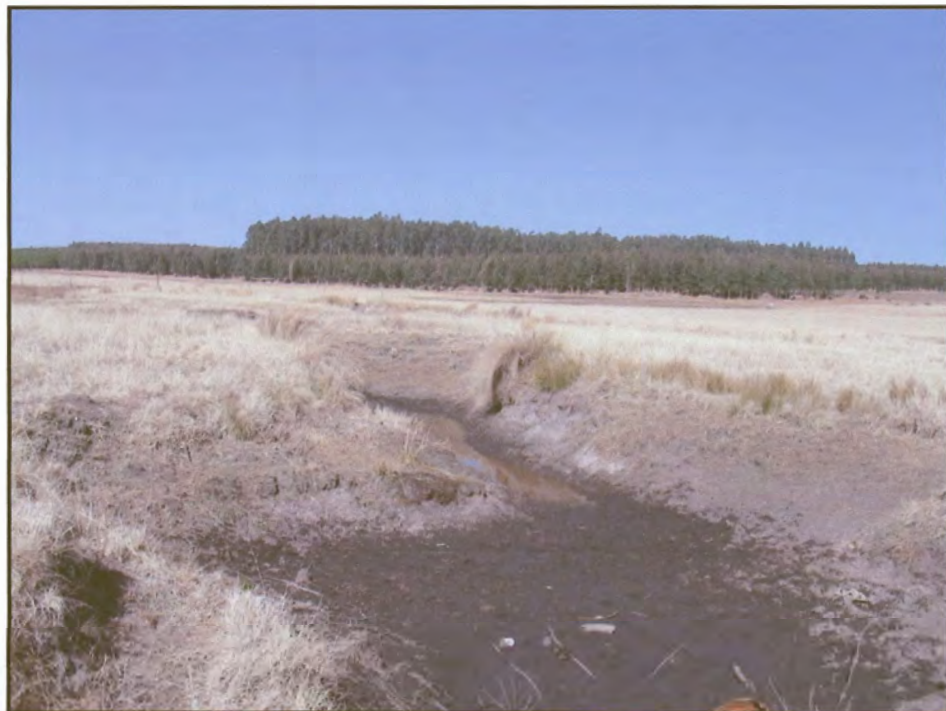
7 S 30°29' 59.0" E 26°51' 23.0"	Zoar wetland South border (Figure 65) of the Mondi fence. Headcut on private property erodes back into the wetland.		<ul style="list-style-type: none"> • Stabilise the headcut erosion • Dissipate the energy of the floods.

Figure 65: Site no 7: Zoar wetland southern border with private owners. Headcut erodes back into the wetland.
