APPENDIX D

PHOTOGRAPHIC RECORD OF HEAVY VEHICLE SIMULATOR (HVS) TESTS
ON PAVEMENTS WITH LIGHTLY CEMENTITIOUS LAYERS

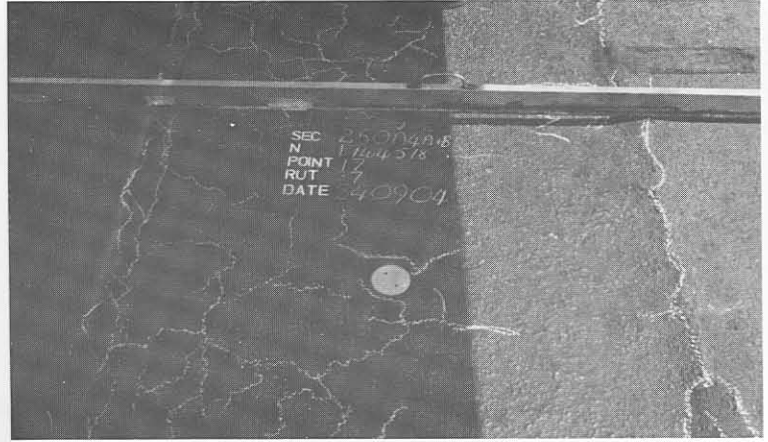
(a) Relatively fine cracks after $1,74 \times 10^6$ repetitions (E80s).

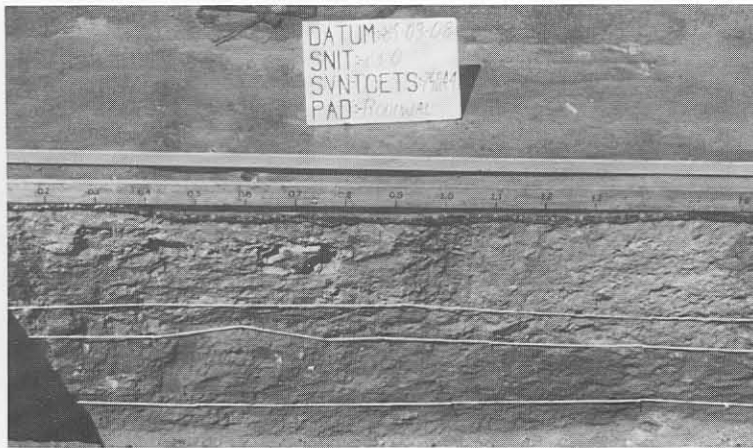
(b) Approximately 20 mm deformation after $2,4 \times 10^6$ repetitions (E80s).

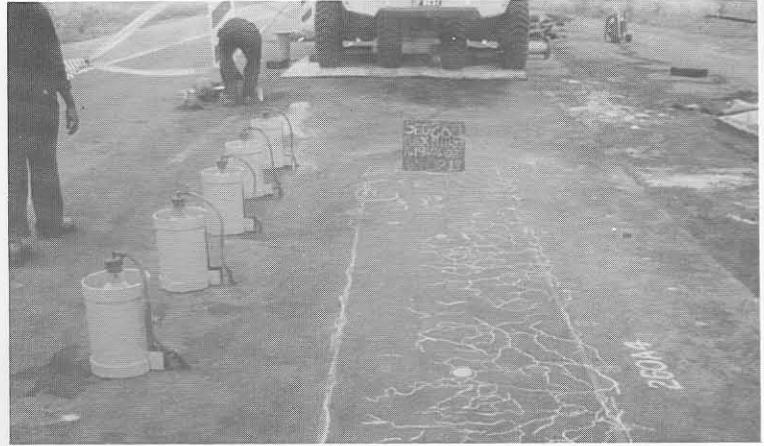
(a) Relatively fine crack pattern after $1,95 \times 10^6$ repetitions (E80s). Note the waterbottels for introduction of depth water (20 mm to 450 mm) on the side of the section at measuring positions 9 to 15.

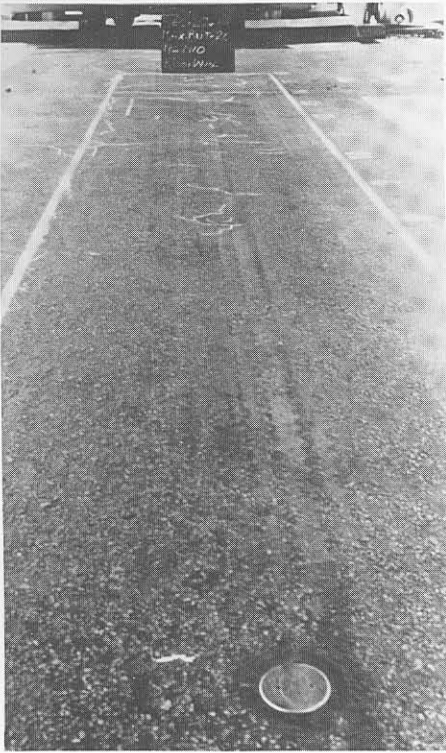
(a) Condition before testing; some fine cracking evident from measuring points 9 to 15 at the start of the test.

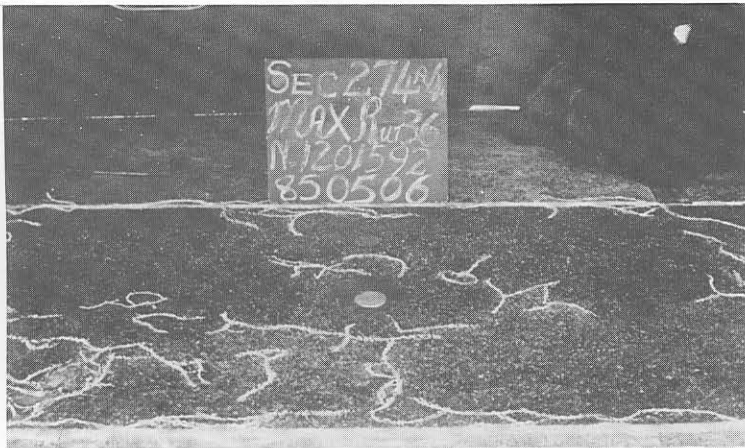
(c) Crack development after $1,20 \times 10^6$ repetitions (E80s).

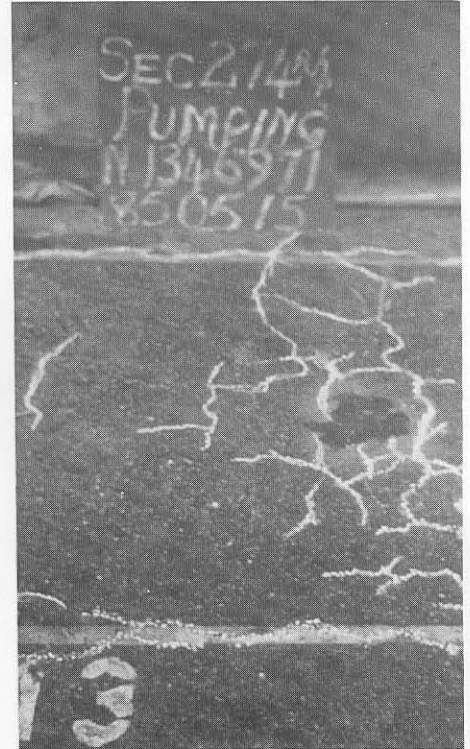
(d) Cracking and pumping after $1,35 \times 10^6$ repetitions (E80s).

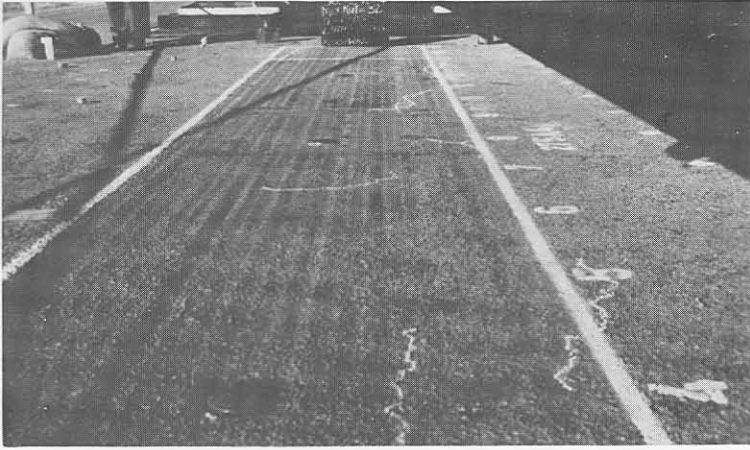
(a) Initial state of section with some cracking at start of test.

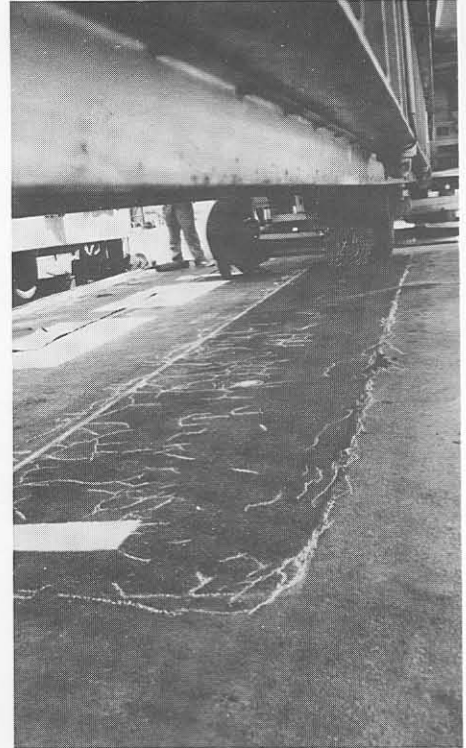
(b) Relatively fine cracking at end of test.

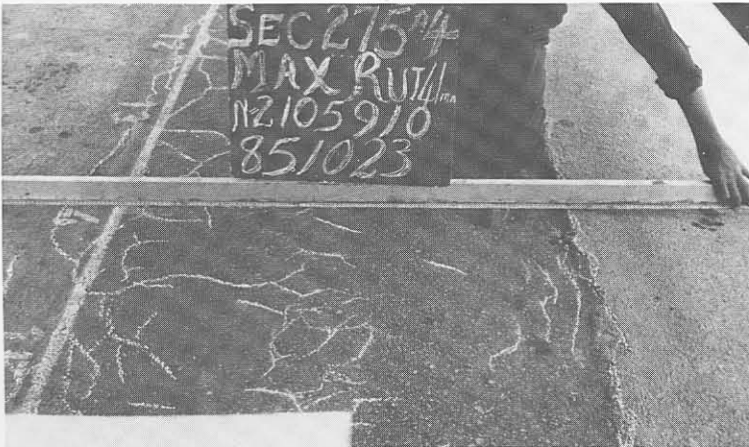
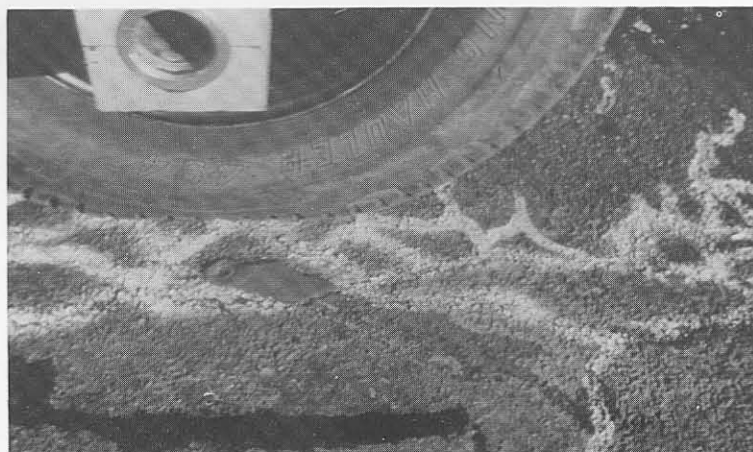
(c) Pumping of the crushed cemented base material.

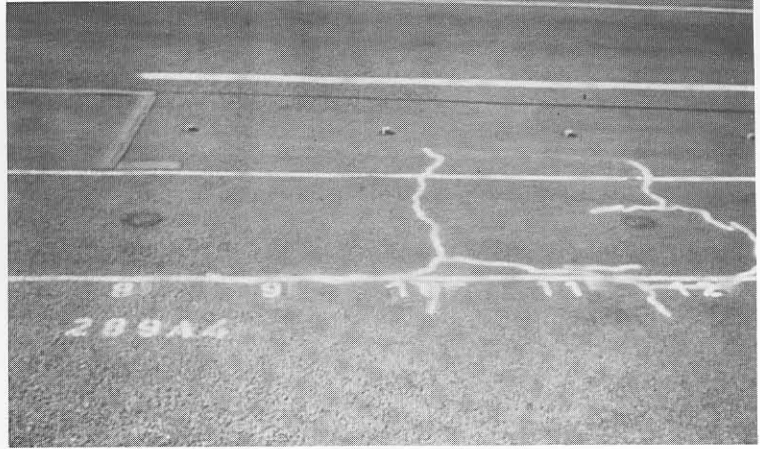
(a) Initial stabilisation cracking before HVS testing.

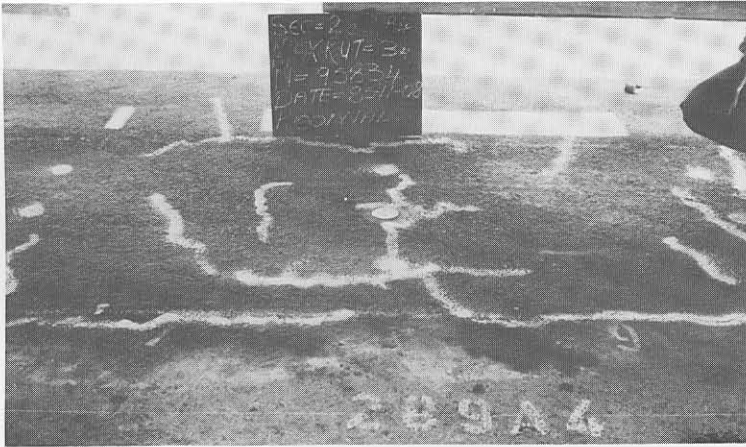
(b) Crack development after 95 834 70 kN repetitions.

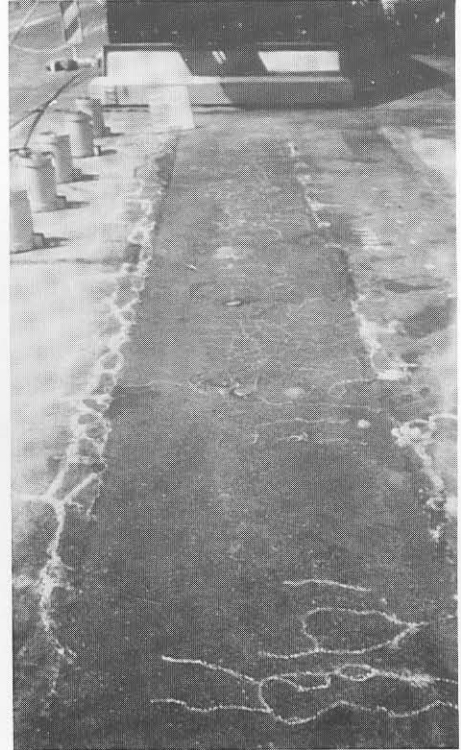
(c) Final cracking and deformation (approximately 22 mm) on section.

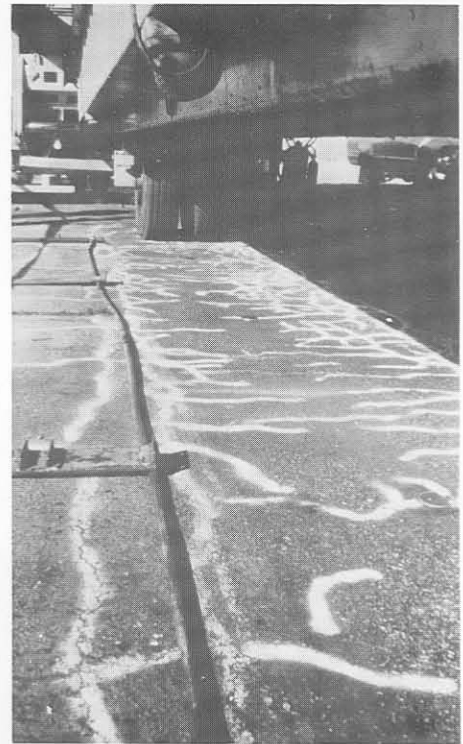
(a) Relatively fine cracking after $1,44 \times 10^6$ 100 kN repetitions.

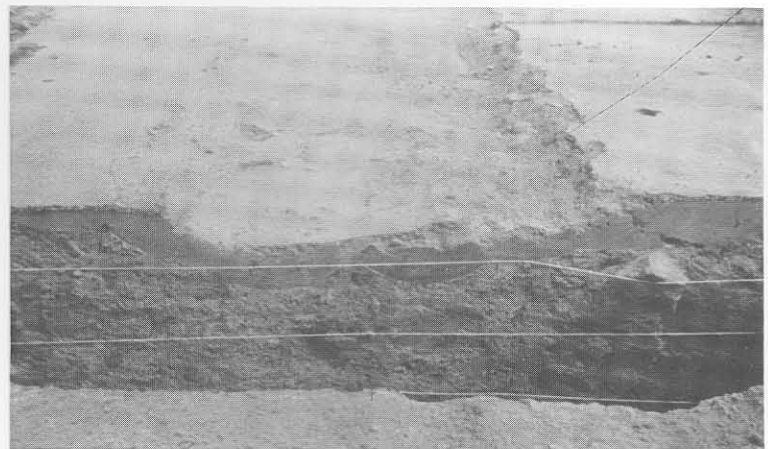
(c) Excessively high degree of potholing owing to the loss crushed cemented base material after introduction of surface water.

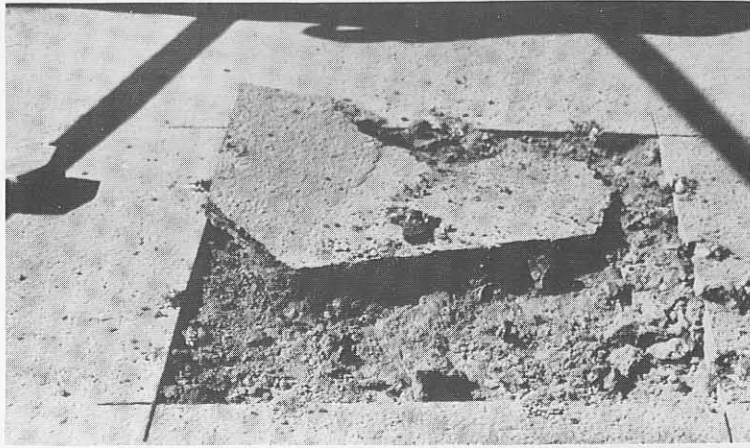
(a) Relatively loose surfacing owing to horizontal cracking in the cemented base.

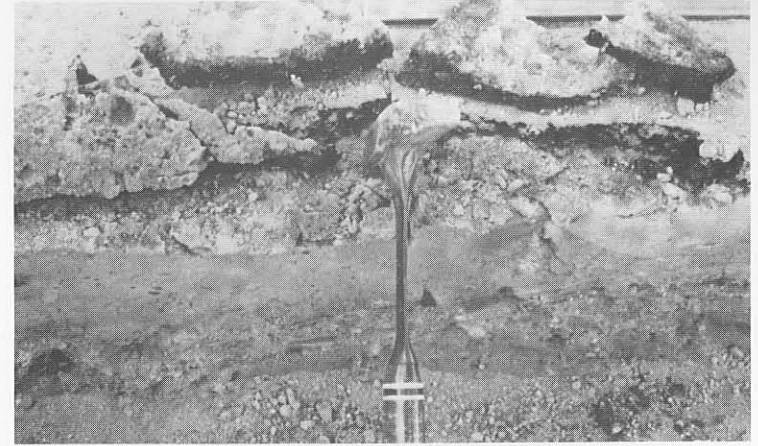
(b) Horizontal cracking in the cemented base, prior to HVS testing.

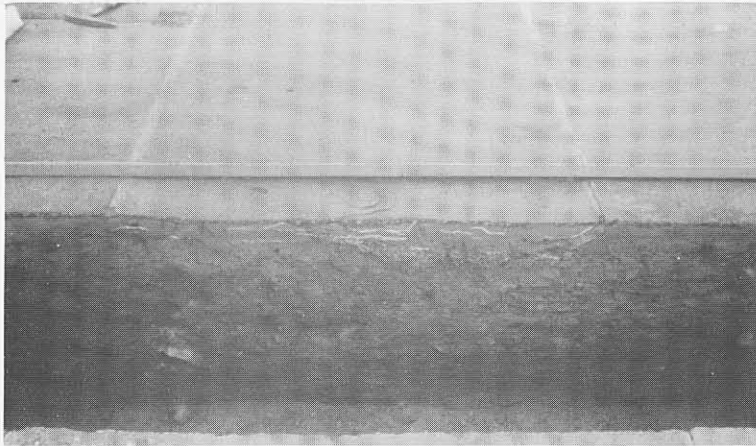
(a) Progress of both horizontal cracking and crushing of the top 50 mm to 75 mm of the cemented base after HVS testing.

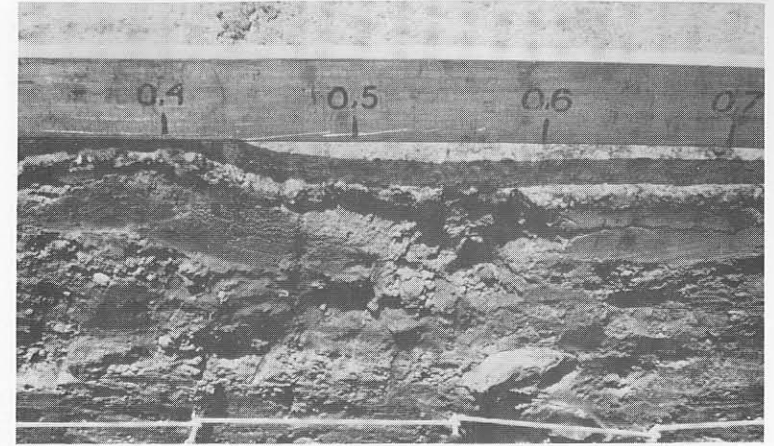
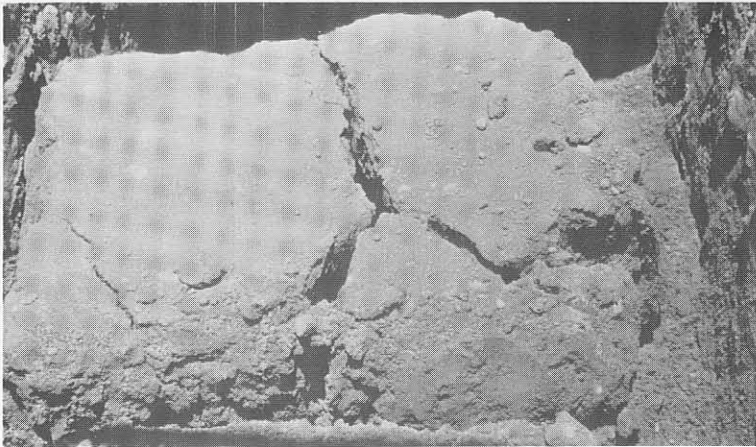
(b) Fatigue cracking in cemented base layer.

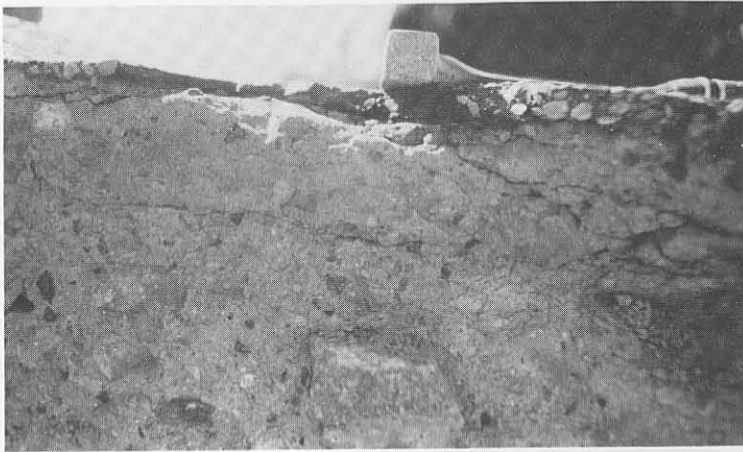
(a) Final crushed state (compression failure) in the top 50 mm to 75 mm of the cemented base layer, after testing in relatively dry conditions.

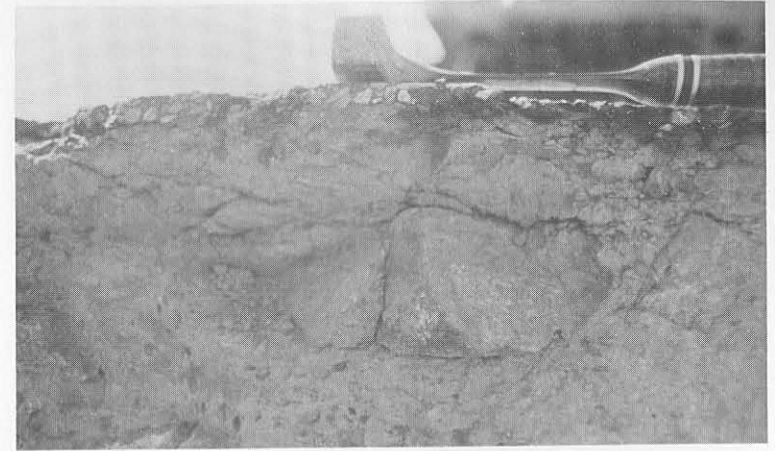
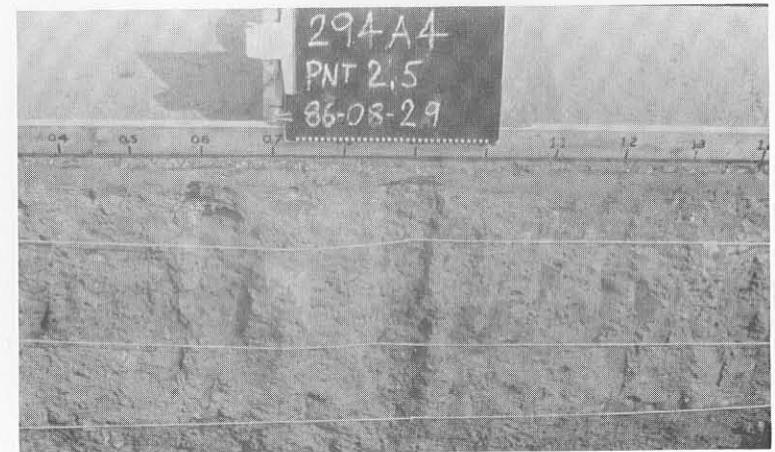
(b) Potholing (approximately 75 mm) and loss of crushed base material after testing in soaked conditions on Section 294A4.

(c) Relatively low deformation (approximately 10 mm) after testing in the relatively dry conditions on Section 294A4.

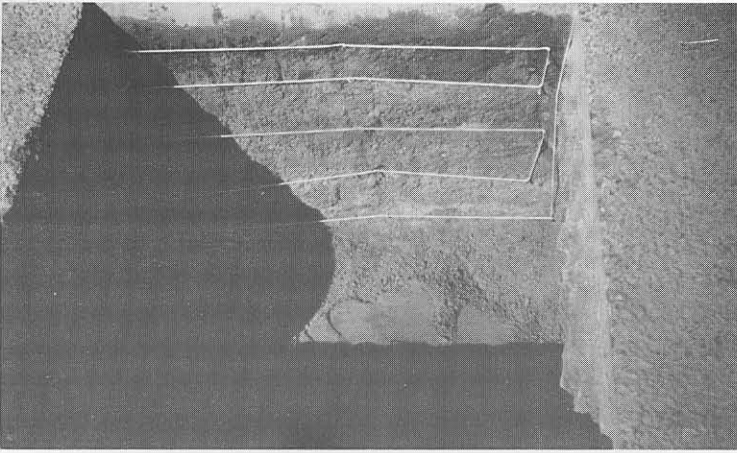
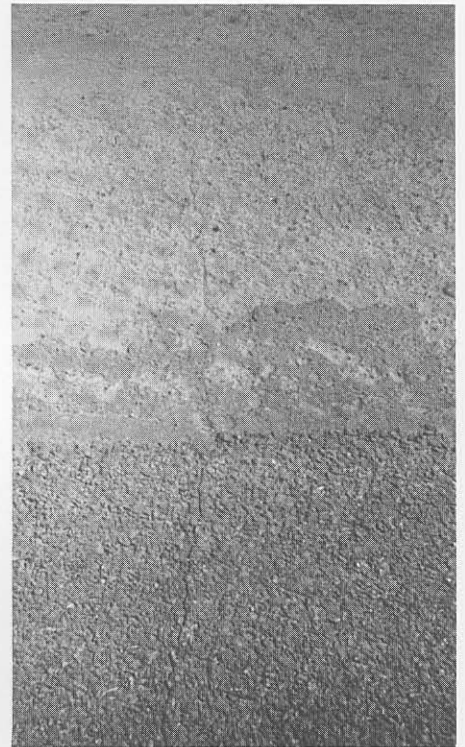
← Relatively weak interlayer, between well cemented base and subbase layer

(b) Stabilisation crack.

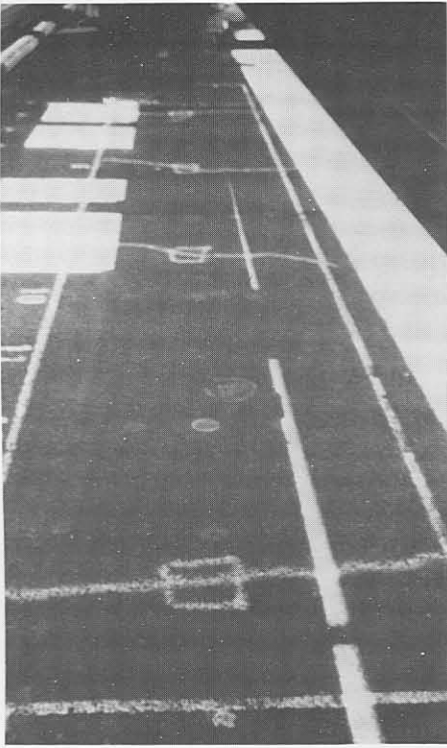
(a) Initial stabilisation cracking at the start of the test.

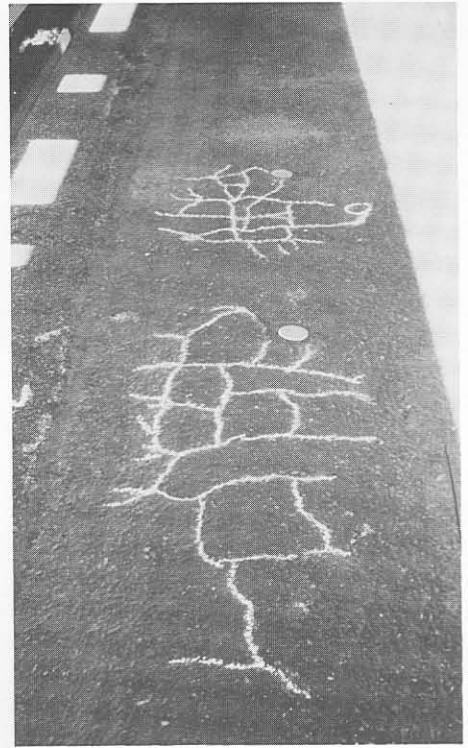
(b) Fatigue cracking (100 mm × 100 mm blocks) after approximately $1,0 \times 10^6$ repetitions (E80s).

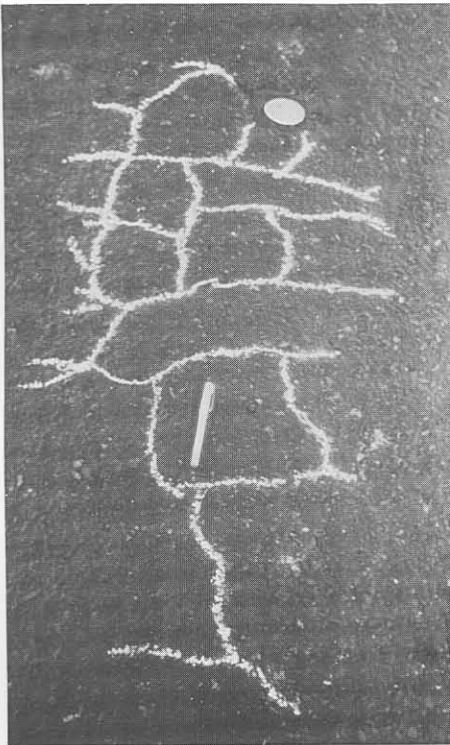
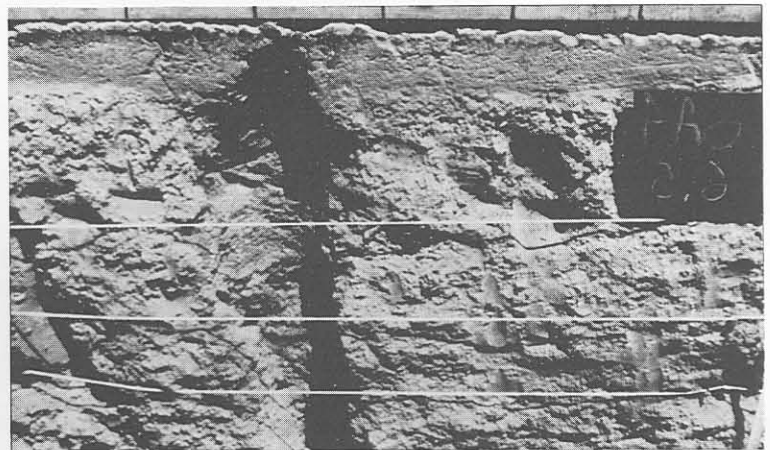
(c) Crushing and deformation (approximately 12 mm) of the cemented base at the end of the test.

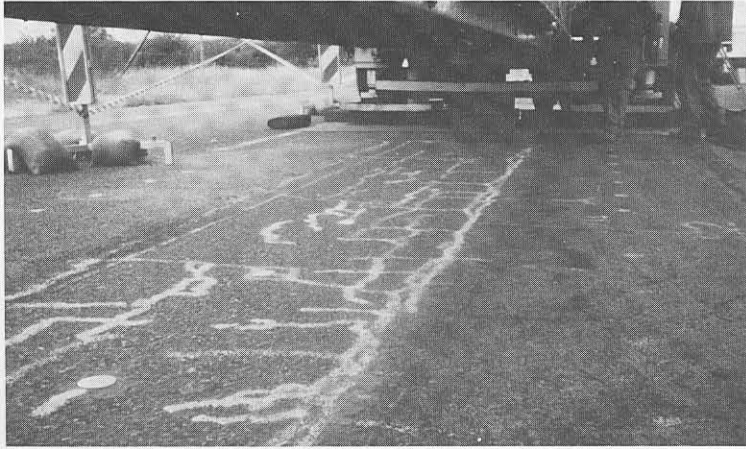
(a) Fatigue cracking after approximately 731 783 70 kN repetitions.

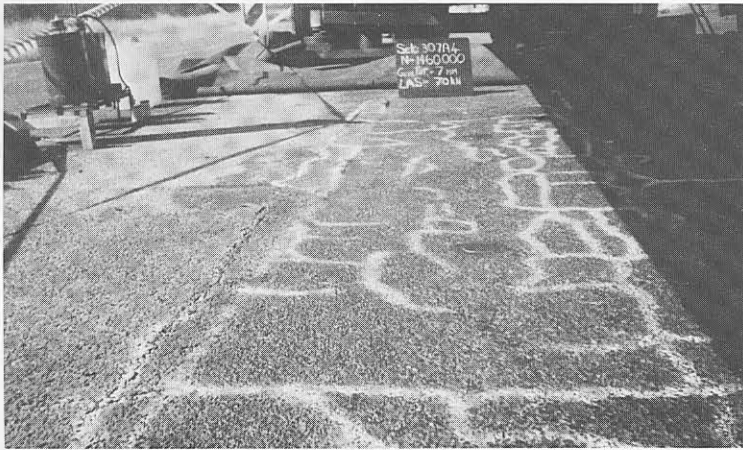
(b) Fatigue cracking after approximately $1,46 \times 10^6$ 70 kN repetitions.

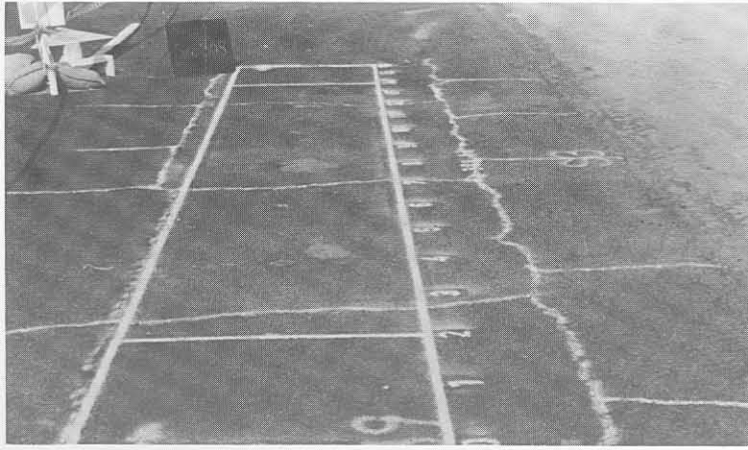
(a) Initial stabilisation cracks at start of test.

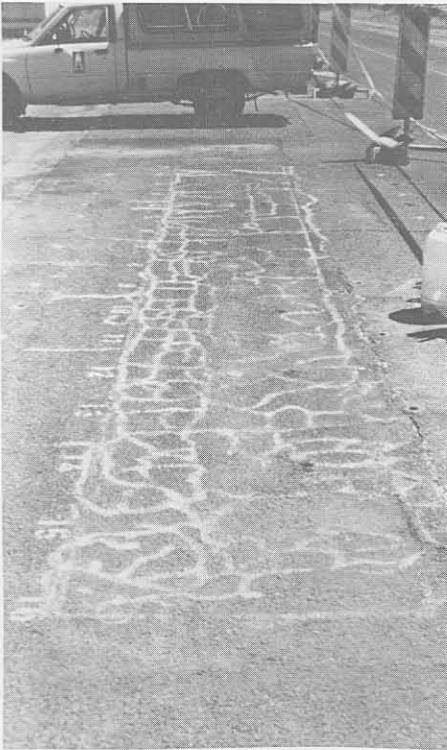
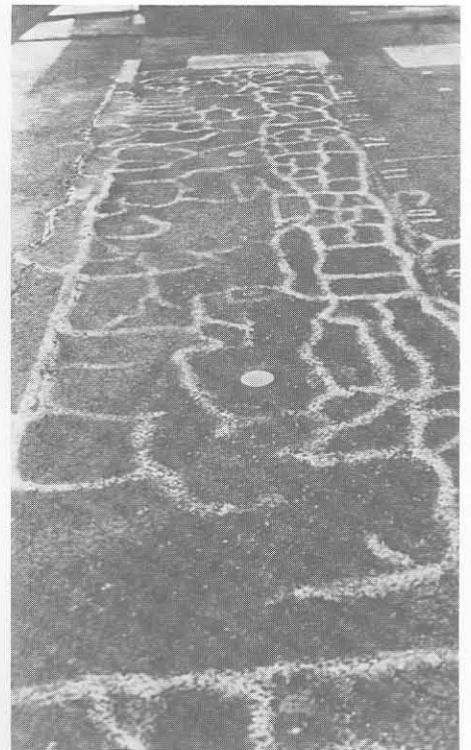
(b) Final fatigue cracking and crushing after approximately $2,64 \times 10^6$ 100 kN repetitions.

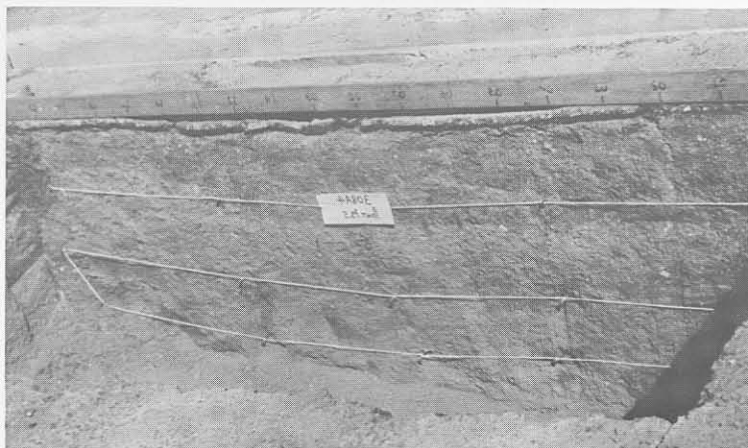
(c) Final deformation (approximately 24 mm) at measuring point 13,5 after approximately $2,64 \times 10^6$ 100 kN repetitions.

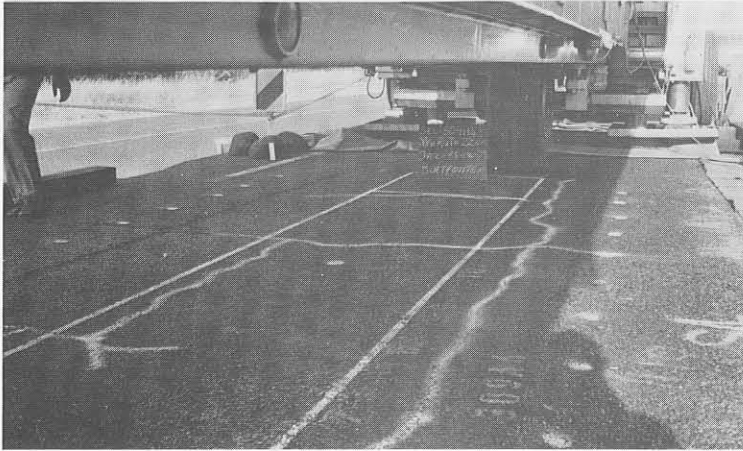
(a) Initial stabilisation cracking at start of test.

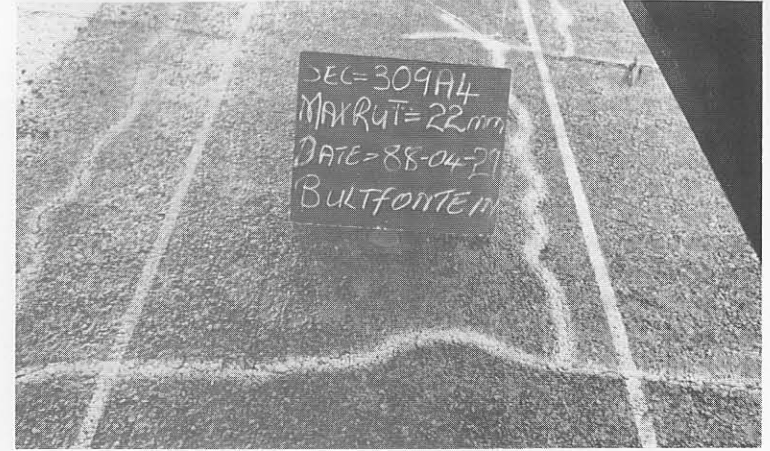
(b) Fatigue cracking and deformation (approximately 40 mm) after 11 331 repetitions of a 150 kN, 1445 kPa single aircraft wheel load.

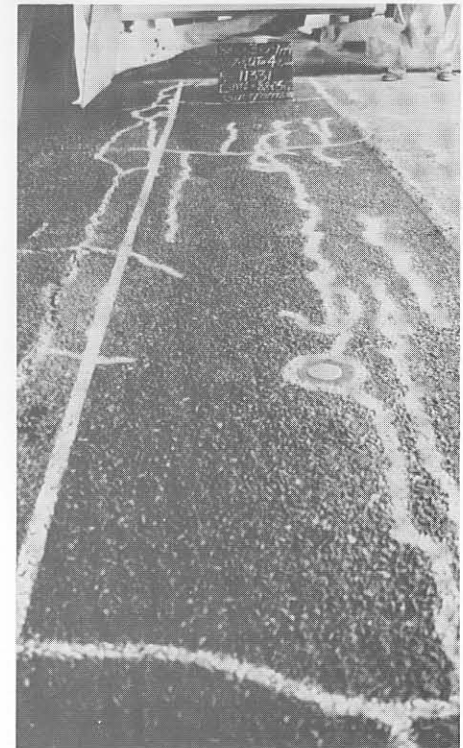
(a) Fatigue cracking and deformation (maximum 40 mm) after 11 331 repetitions.

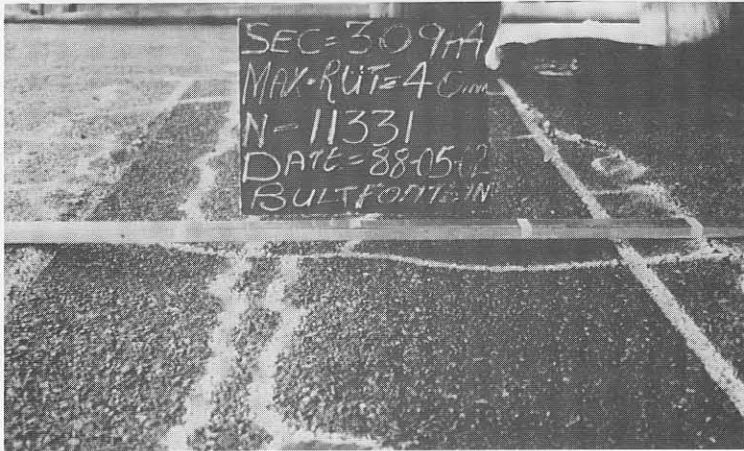
(b) Further fatigue cracking and deformation (maximum 64 mm) after 30 000 repetitions.

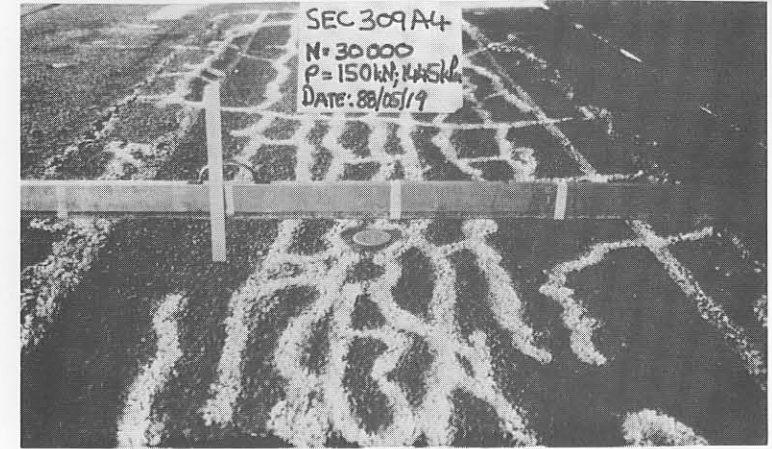
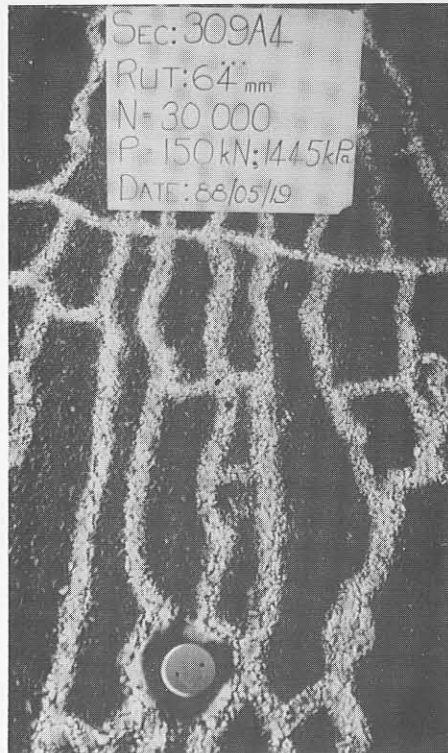
(c) Further fatigue cracking and deformation (maximum 89 mm) after 41 803 repetitions..

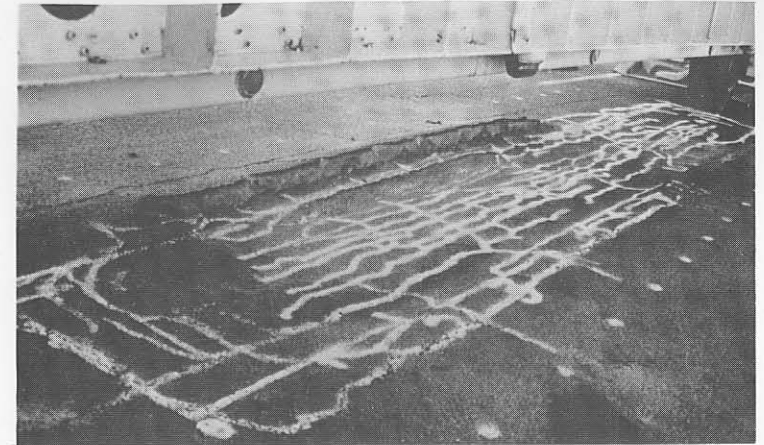
Upheaving of cemented base material outside the tested area, owing to the “punching” of the base material into the weak interlayer, and subsequent horizontal movement of the base material towards the outside of the section

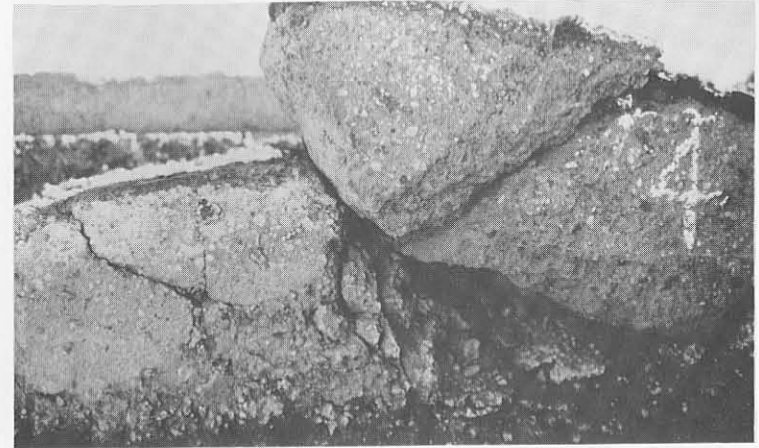
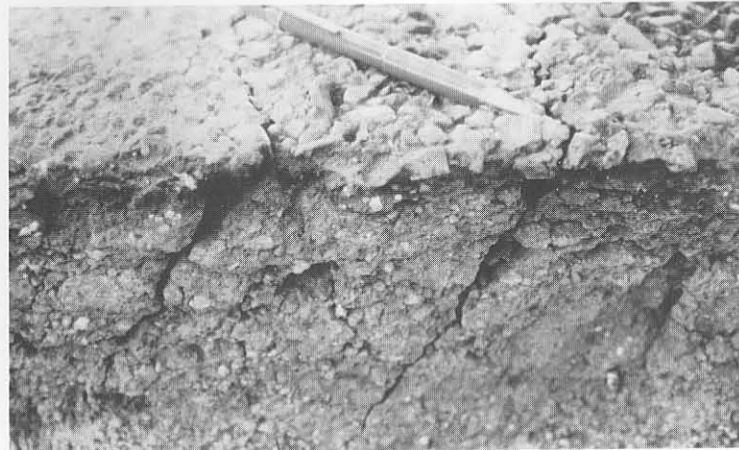
PLATE D.19 RELATIVELY SHALLOW PAVEMENT: ROAD 2212 – EXCESSIVE DEFORMATION DEVELOPMENT DURING THE FINAL STAGES OF TESTING (41 803 REPETITIONS) ON HVS TEST SECTION 309A4 (TRAFFICKING SINGLE WHEEL LOAD: 150 kN; TYRE PRESSURE: 1445 kPa).

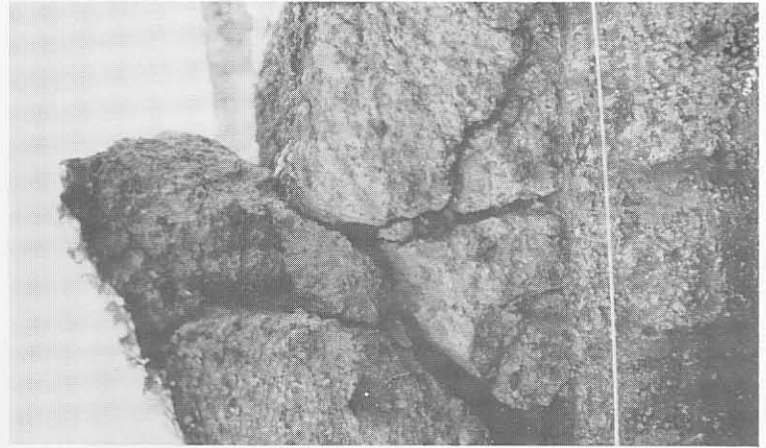
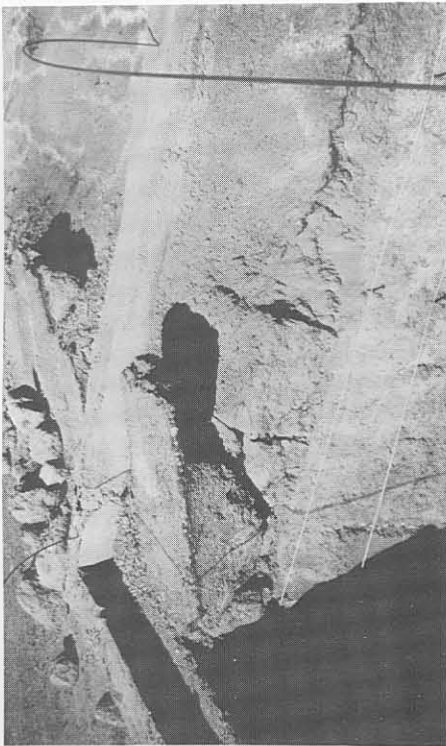
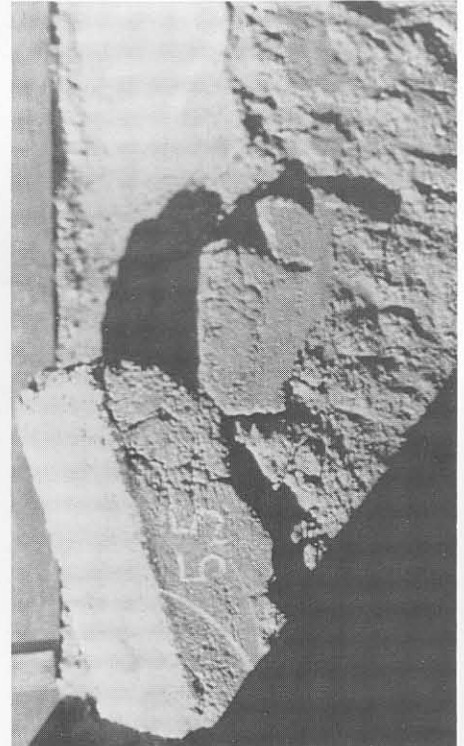
PLATE D.20 RELATIVELY SHALLOW PAVEMENT: ROAD 2212 – EXCESSIVE FATIGUE AND CRUSHING FAILURE AT THE END OF THE TEST (41 803 REPETITIONS) ON HVS TEST SECTION 309A4, MEASURING POINT 4 (TRAFFICKING SINGLE WHEEL LOAD: 150 kN; TYRE PRESSURE: 1445 kPa).

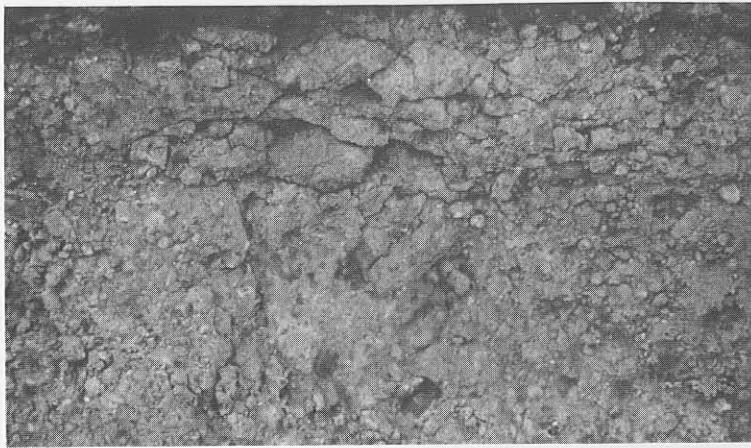
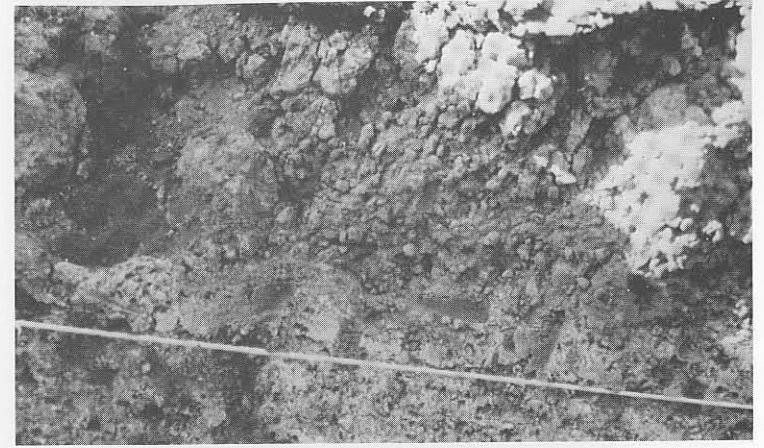
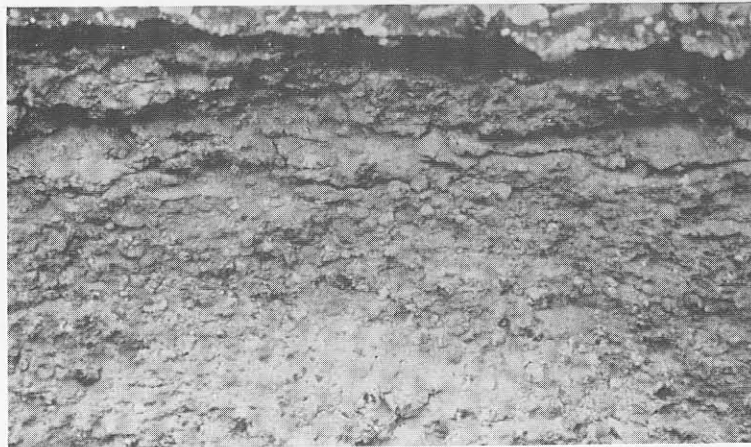
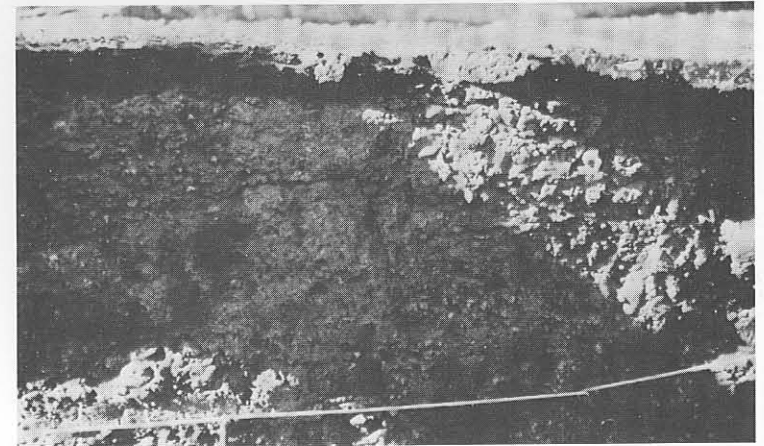
PLATE D.21 RELATIVELY SHALLOW PAVEMENT: ROAD 2212 – EXCESSIVE FATIGUE AND CRUSHING FAILURE AT THE END OF THE TEST (41 803 REPETITIONS) ON HVS TEST SECTION 309A4, MEASURING POINT 5 (TRAFFICKING SINGLE WHEEL LOAD: 150 kN; TYRE PRESSURE: 1445 kPa).

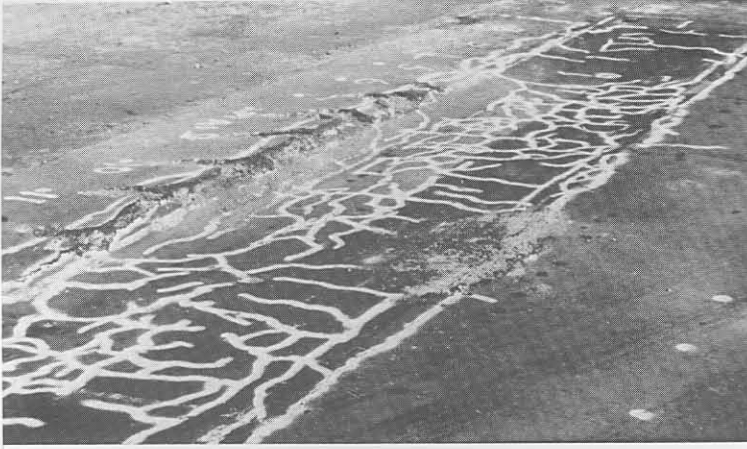
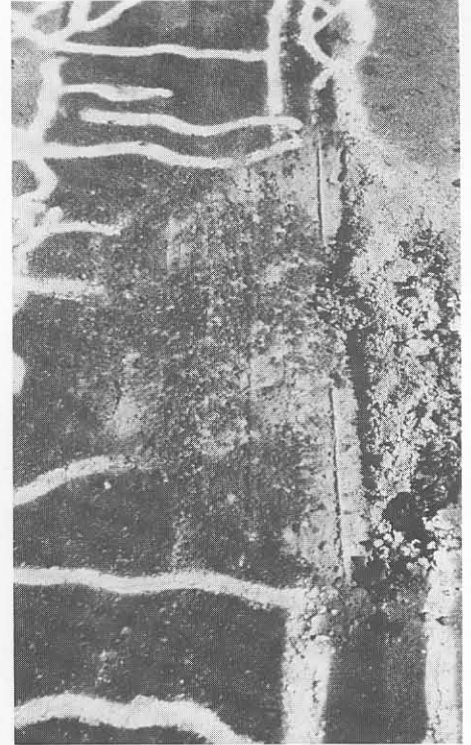
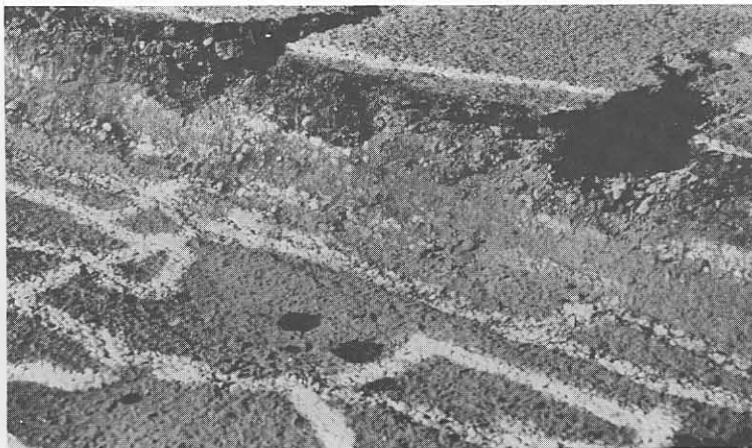
PLATE D.22 RELATIVELY SHALLOW PAVEMENT: ROAD 2212 – CLOSE VIEW OF THE CRUSHING (COMPRESSION) FAILURE OF THE CEMENTED BASE LAYER AT THE END OF THE TEST (41 803 REPETITIONS) ON HVS TEST SECTION 309A4 (TRAFFICKING SINGLE WHEEL LOAD: 150 kN; TYRE PRESSURE: 1445 kPa).
