## Chapter 3.0

### Underground monitoring of roof and support behaviour

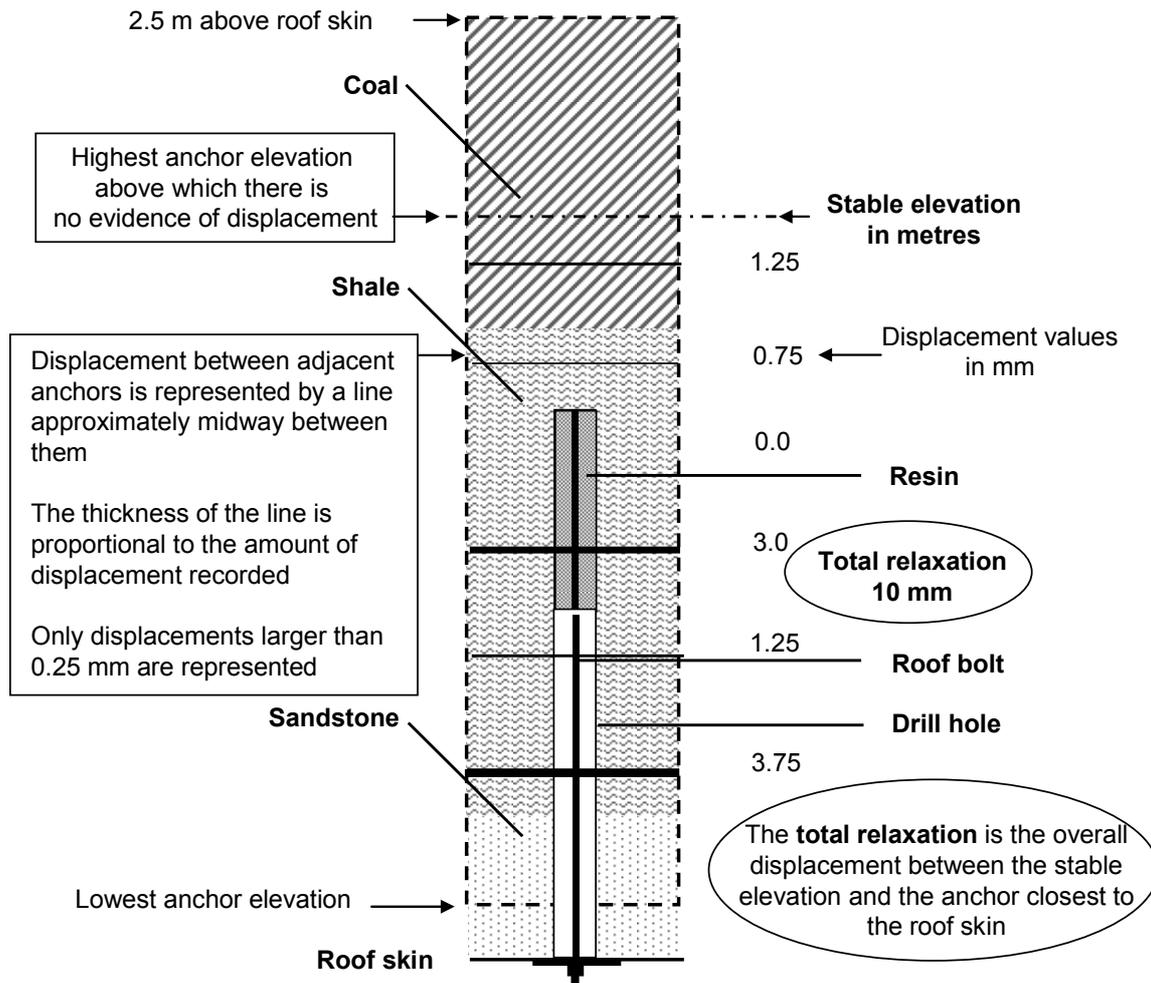
**Figure 3-1** *Graphic representation and explanation of a typical geological profile, support type and final roof strata behaviour*

In Figure 3-1, to assist in explaining this concept, the anchor string showing individual anchor elevations is included. Alongside each displacement line the individual displacement values have been recorded. Where no displacement was observed, a zero value (0.0) is evident, as is the lack of a displacement line. The method used to indicate a negative displacement is also indicated. The anchor string and displacement values are included in Figure 3-1 primarily to assist with the explanation. They are not recorded in the graphic presentations of the individual monitoring site figures, as this information is already present in a slightly different form in the sonic probe graph.

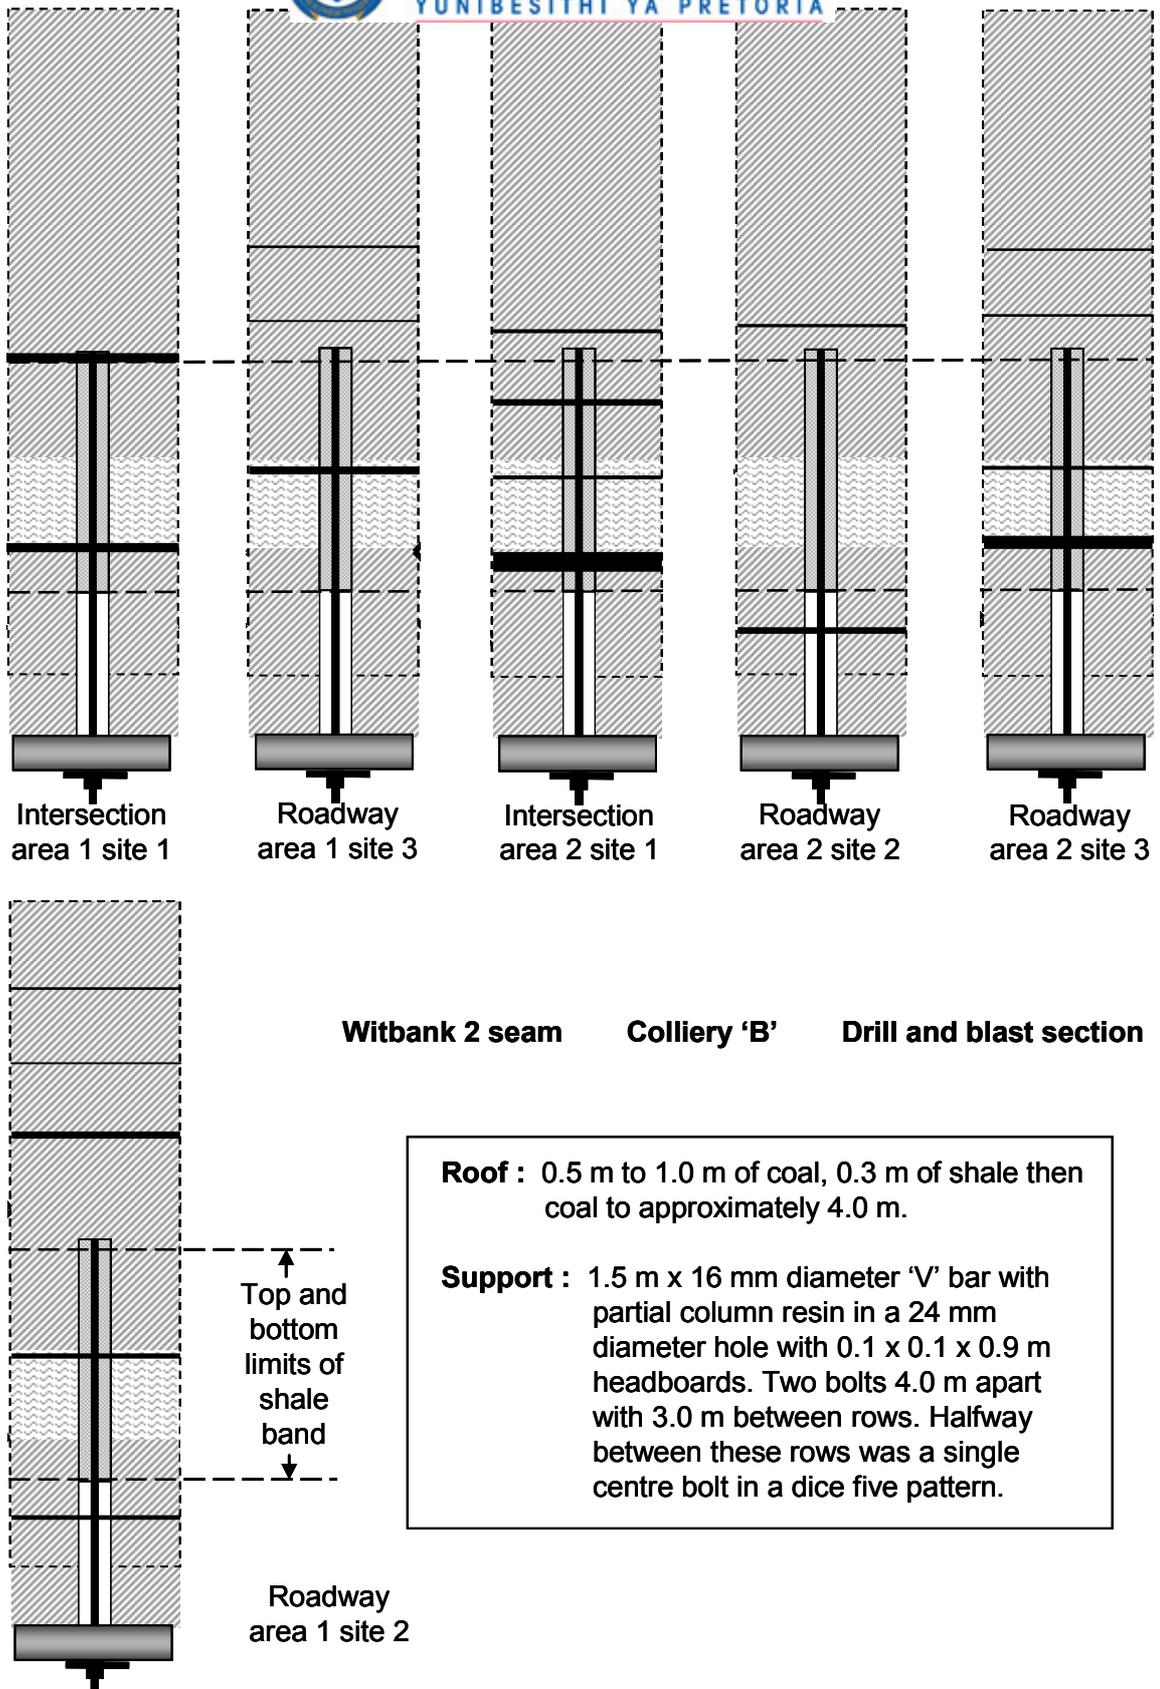
Figure 3-10 Colliery 'B' comparative roof behaviour

The comparative roof performance of all six sites is illustrated in Figure 3-10. From the results, the roadway in area 1 at site 2 appears to exhibit a different behaviour pattern to the other five sites with respect to the strata above the roof bolt horizon up to the 2.5 m elevation. Most of the activity in the roof strata at the other five sites is within the roof bolt horizon. The major positive opening displacements tend to be within the upper and lower limits of the 0.3 m shale band, i.e. between 0.5 and 1.3 m into the roof. This is the region where the bolts were fully resin grouted to consolidate the shale band. Although displacements are indicated in general up to 0.5 m above the bolt horizon, the magnitudes are considerably less than those recorded within the bolt horizon. The upper displacement levels at both intersections are closer to the bolt horizon than some of the roadway sites. The additional 40 per cent increase in the span across the intersection diagonals appears to have had little or no effect on crack propagation between the top of the roof bolts and the 2.5 m elevation.

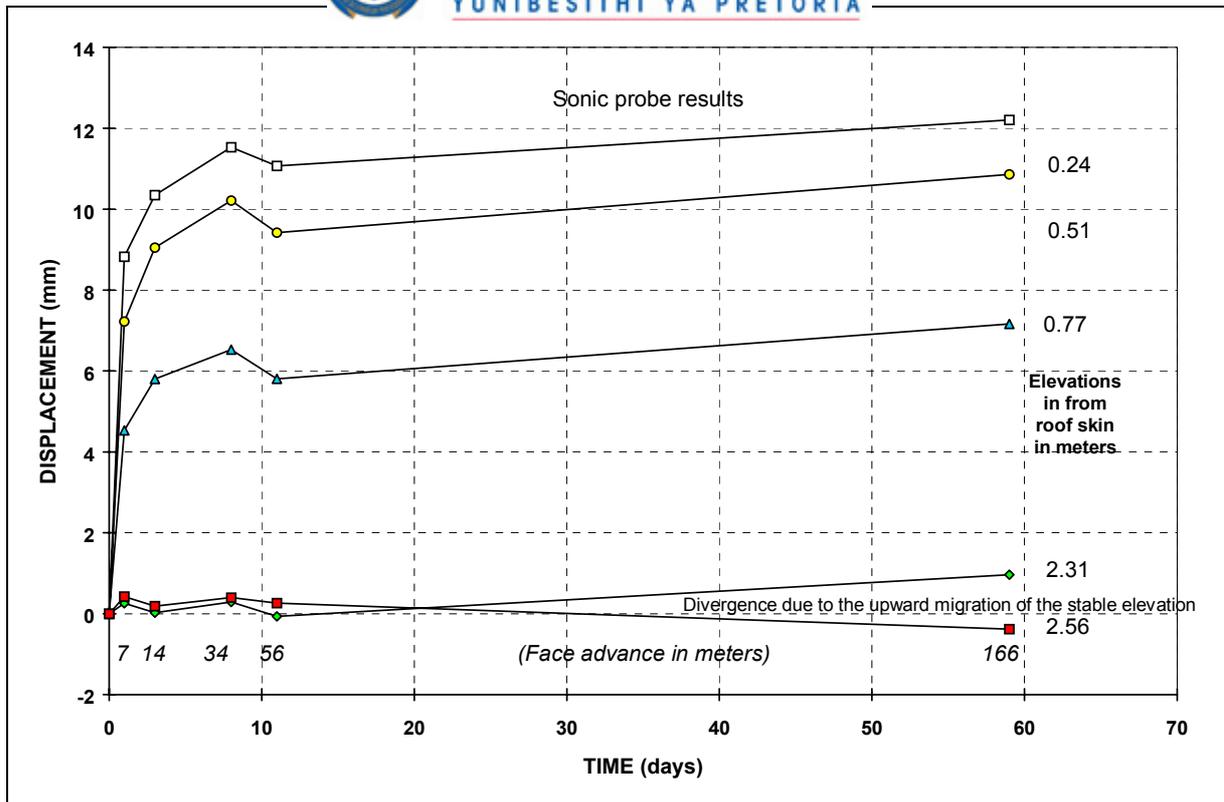
**Figure 3-41 Colliery 'D' area 2 site 2 displacements**

The full displacement with time profile of a variety of elevations up to 2.5 m into the roof at site 2, area 2, Colliery 'D' are presented in Figure 3-41. Between days 11 and 59, the face was advanced from 56 m to 166 m. During this period all the strata between the 0.24 m and 2.31 m elevations in the roof deflected downwards in unison (upwards on the graph). There was no evidence of any relative displacements occurring within the 0.24 m to 2.31 m strata horizon. With time, the roof within this region deflected by about 1.0 mm allowing an additional 2.31 m elevation to become detached and deflect by a similar amount. This upward migration of the stable elevation is evident from the divergence of the 2.31 m and 2.56 m anchors in Figure 3-41.

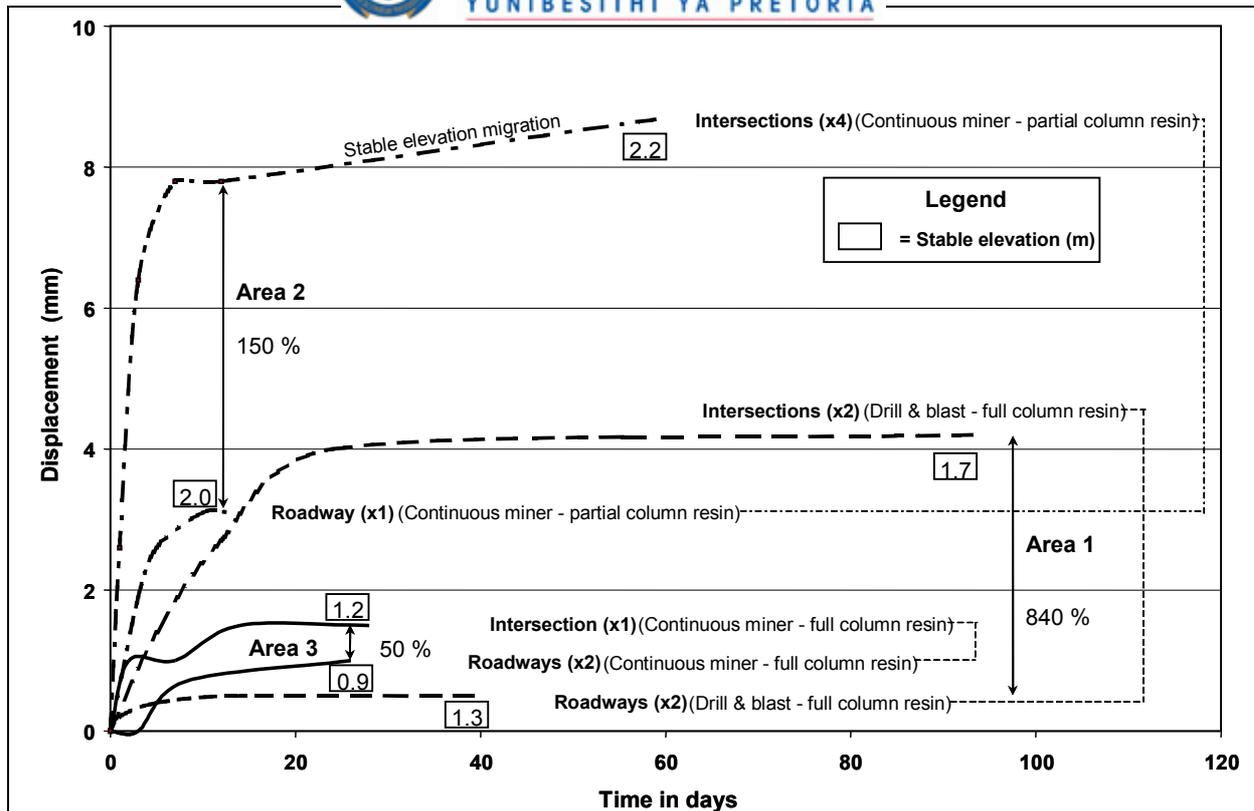
Figure 3-42 Mining method and comparative support performance at Colliery 'D'

Included in Figure 3-42 is the average height of the stable elevation with respect to each curve. The link between the height to which the stable elevation is restricted and the effectiveness of the support in maintaining the integrity of the roof strata within the bolt horizon is apparent in the continuous miner sections. The full column resin support in the drill and blast section however appears to be slightly out of phase with the continuous miner sections. The reasons for this are unclear but could be related to the effects that the pre-existing openings in the roof strata had on the monitoring results.

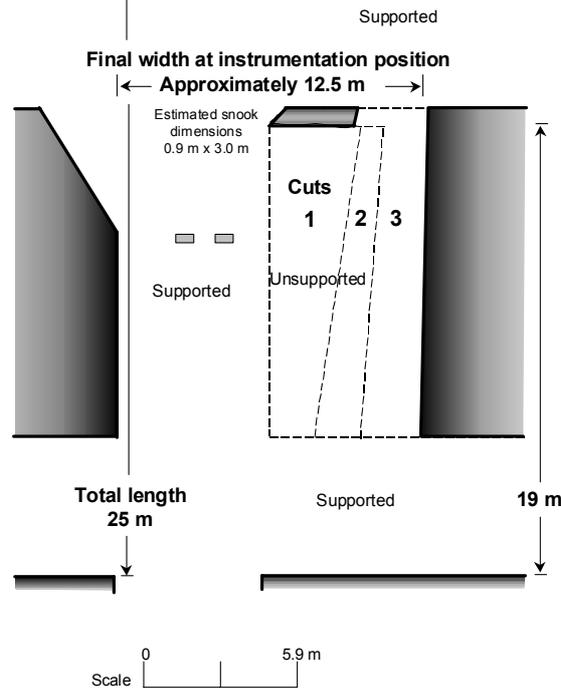
**Figure 3-45 Cutting sequence and final roadway shape**

The roadway was widened in three stages as illustrated in Figure 3-45. Because of the element of risk involved, the first two cuts were stopped slightly short of breaking through into the roadway perpendicular to the one being widened. The intention was to use the behaviour of the slender pillar formed to assist in assessing the overall general stability of the area as widening of the roadway continued. Cut three was planned so as to get the sidewall as close as possible parallel to the centreline of the roadway. Based on the lack of load induced spalling on the

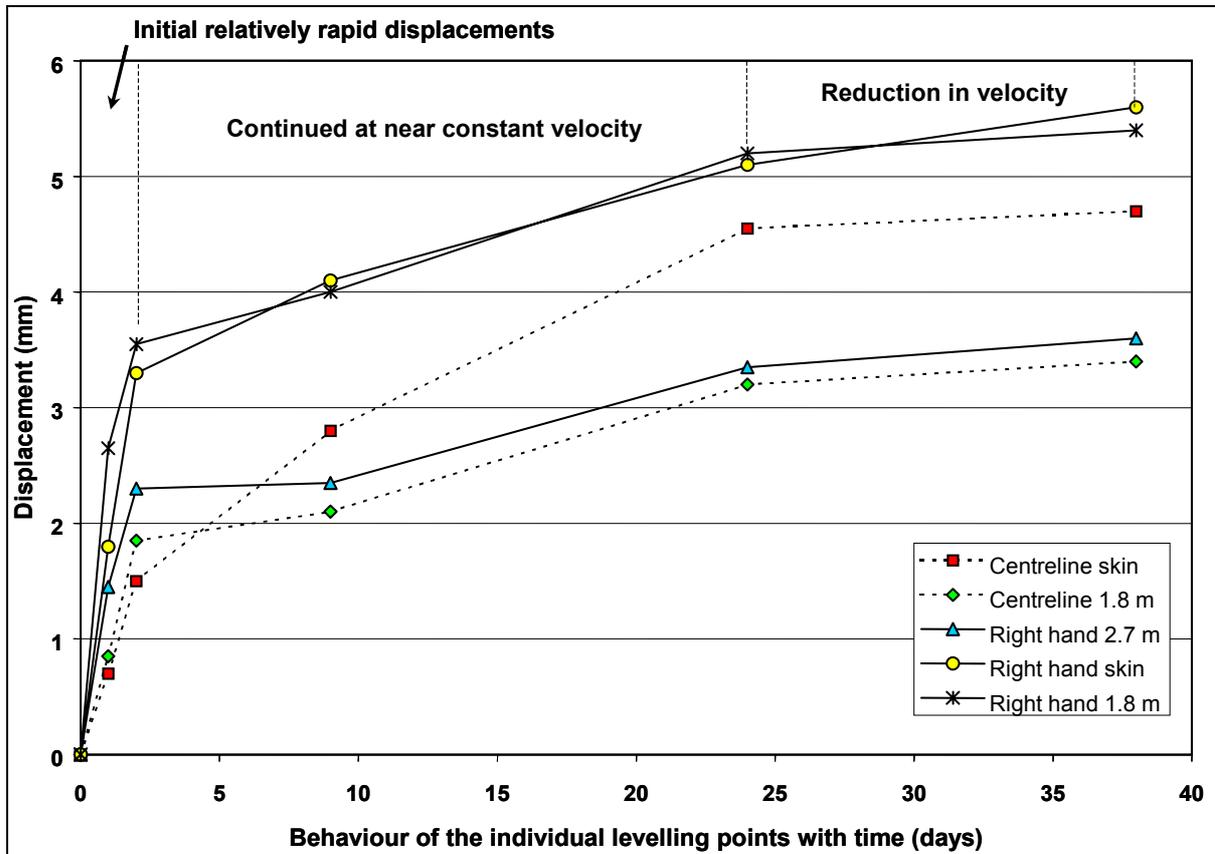
Figure 3-49 Displacement rates as a function of time

Figure 3-49, shows the behaviour of all five points with time. After starting with relatively rapid displacement, as a result of the roadway widening process, up until day two, they continued at a fairly constant rate until day 24. From that point until when the final readings were taken on day 38, the velocity dropped 75 per cent on average.

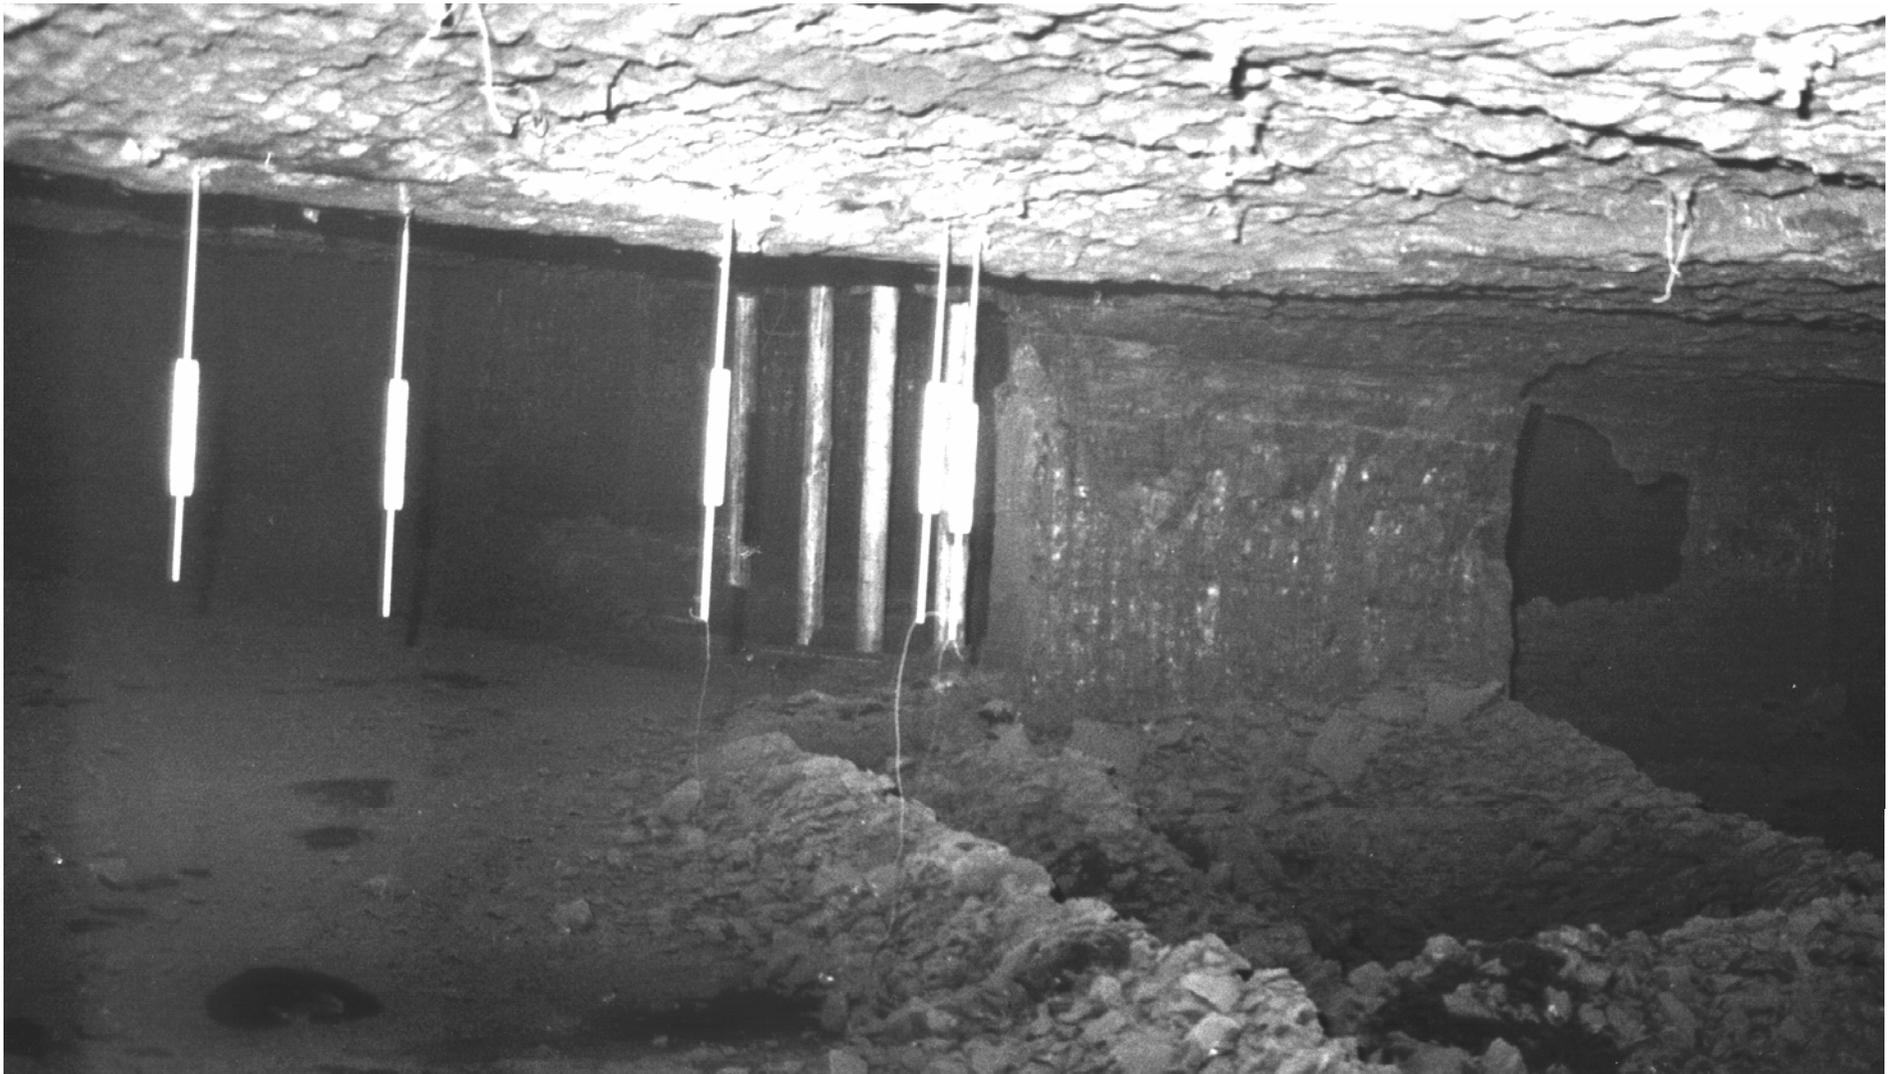
*Figure 3-50 Experiment site taken on day nine*

The last visit was made to the site on day 52 as the area was about to be sealed off. Unfortunately all five permanent staves were missing so it was not possible to get a final set of measurements. The tell-tales were however still in position and there was no evidence of any even minor roof falls in the area. The snook was intact and appeared to have changed very little, if at all since the photograph shown in Figure 3-50 was taken on day nine.
