UNIVERSITEIT VAN PRETORIA  
UNIVERSITY OF PRETORIA  
YUNIBESITHI YA PRETORIA

A P P E N D I X A

PHOTOGRAPHIC RECORD OF HVS TESTS

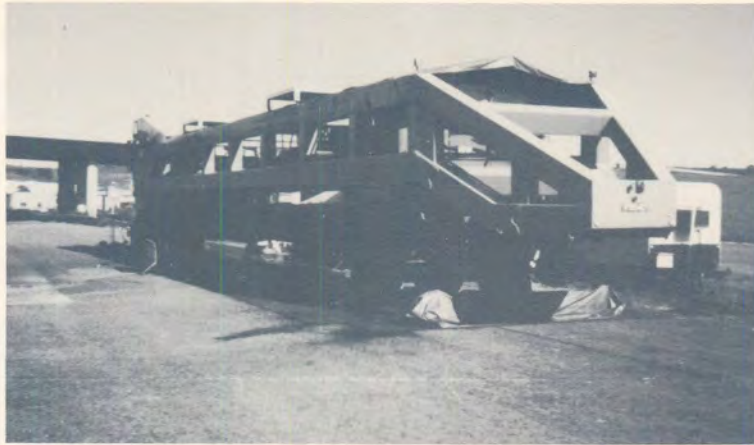
(a) General view of HVS test at Mariannhill, Section 3 (218A3).

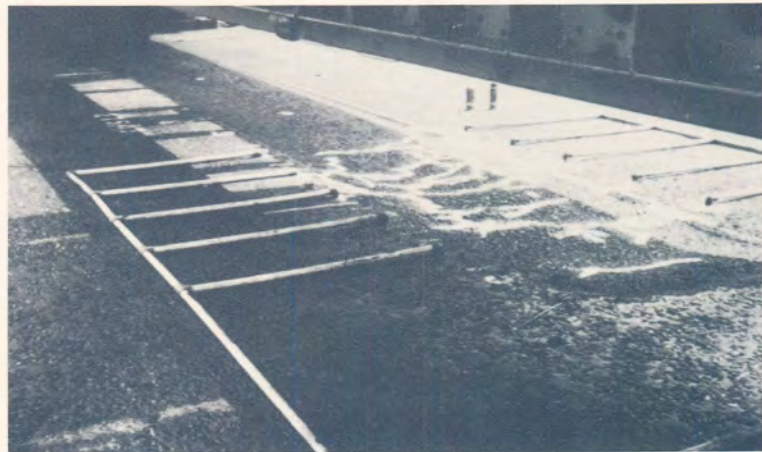
(b) HVS test 1 (215A3): Note the water inlet pipes on the front part of the test section. The white paint indicates the fatigue cracking of the asphalt during the wet test. The uncracked section at the back, is an indication of the surface during dry test conditions. E80s on dry test section:  $21 \times 10^6$ .

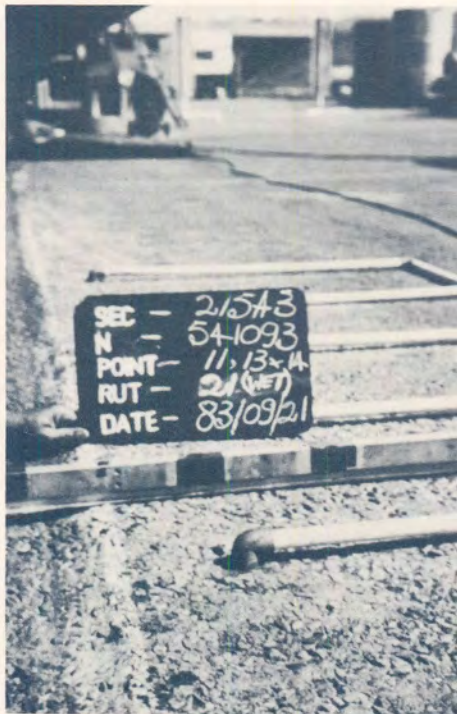
(c) 21 mm of permanent deformation (rut) on wet section. E80s on wet test section:  $0,8 \times 10^6$ .

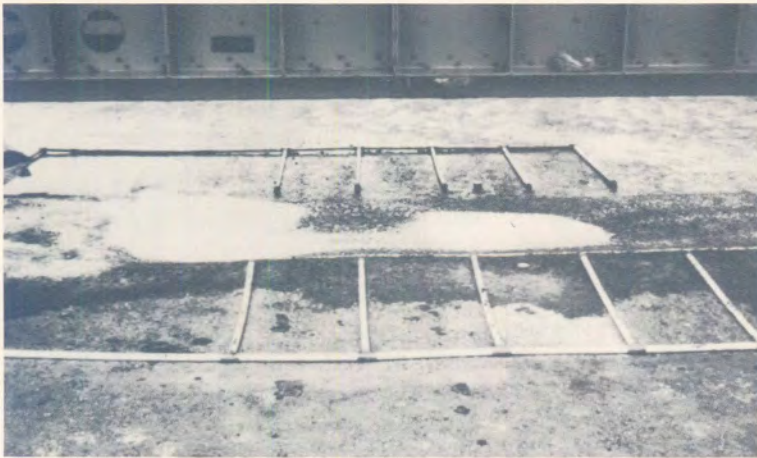
(a) Rutting of Section 1 during wet conditions. (Upper subbase saturated)

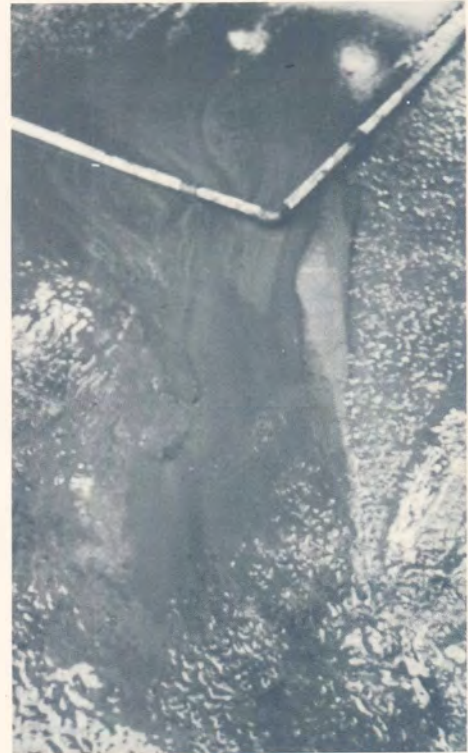
(b) Pumping from upper subbase during the wet test.

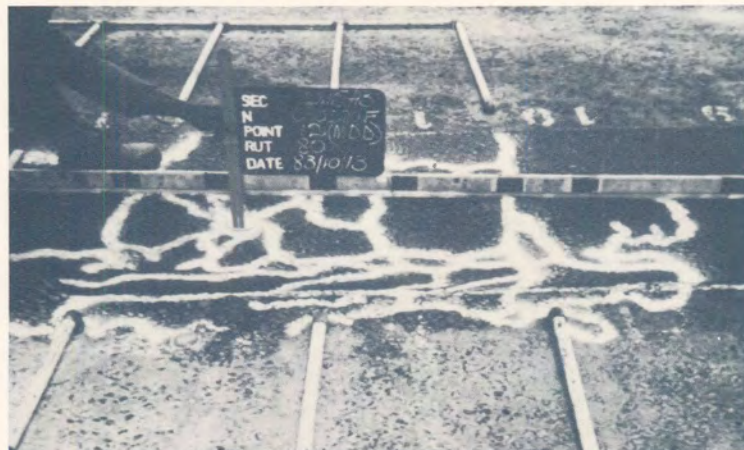
(c) Maximum rut of 80 mm on MDD12. Note the fatigue cracking of the asphalt layer. E80s on wet test section:  $6,8 \times 10^6$

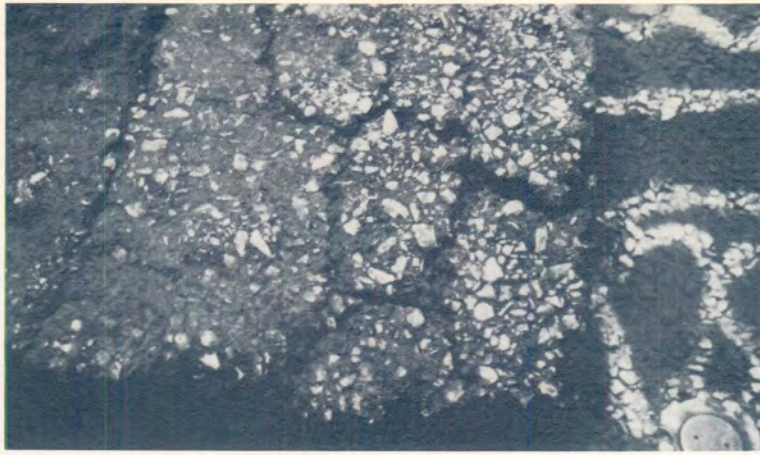
(a) Bottom of asphalt base layer. Note the fatigue cracks and some stripping of asphalt.

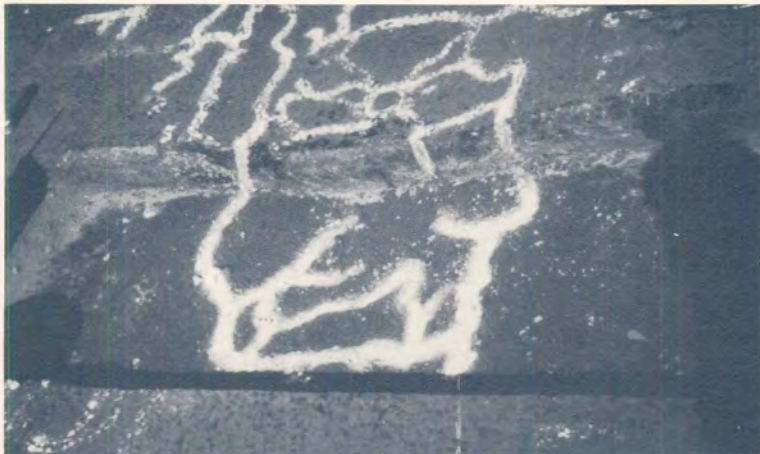
(b) Visible cracks on top of the upper stabilized subbase layer after the removal of the asphalt in (a).

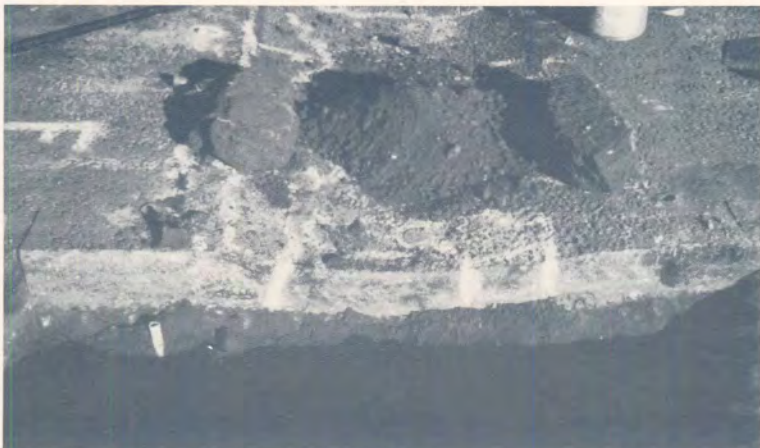
(c) Recovered granulated upper subbase material within the trafficked area. Note blocks of the same material recovered from the untrafficked area.

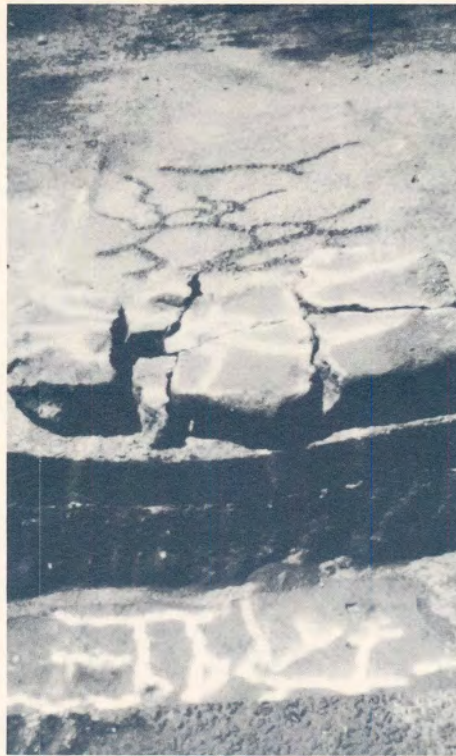
→  
Fatigue cracks on asphalt

←  
Recovered lower stabilized  
subbase layer

(a) Recovered cracked lower stabilized subbase layer within the trafficked area after the test. (Blocks on top of asphalt)

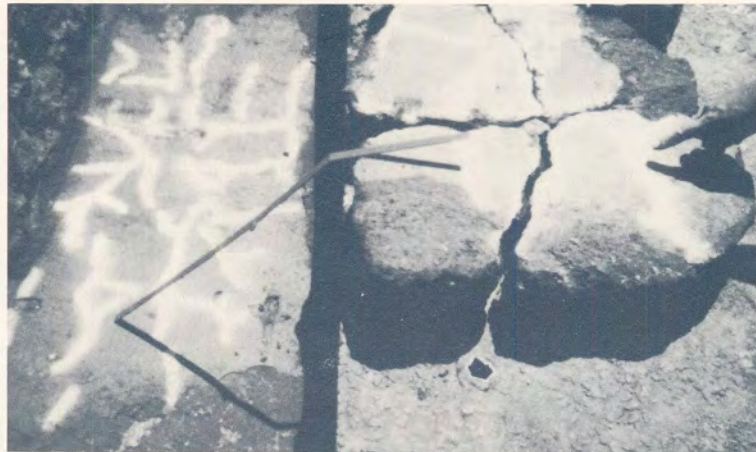
→  
Selected subgrade layer

←  
Recovered lower stabilized  
subbase layer

(b) Printed crack pattern of the bottom of the lower stabilized subbase on the top of the unexcavated selected subgrade layer.

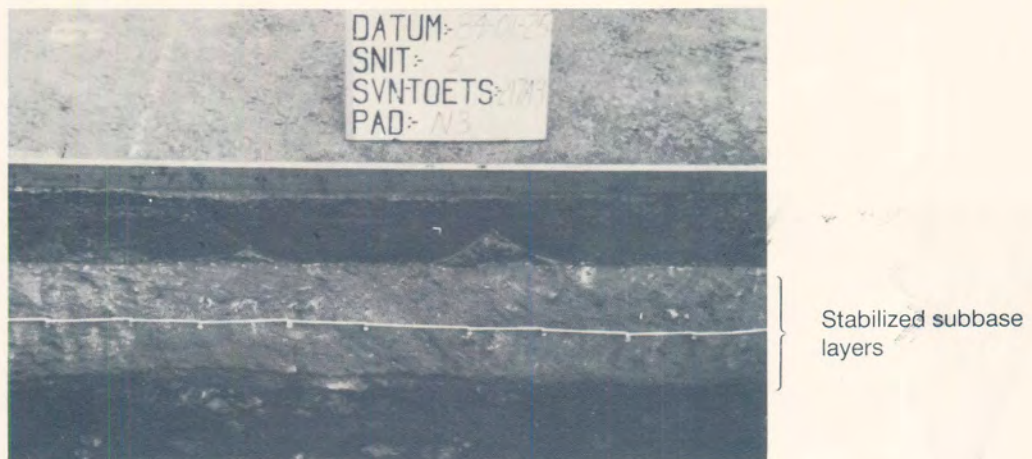
(a) Trench across the test section at the point of maximum rut (20 mm). Note the relatively perfect condition of the stabilized subbase layers, although cracked. ( $32 \times 10^6$  E80s)

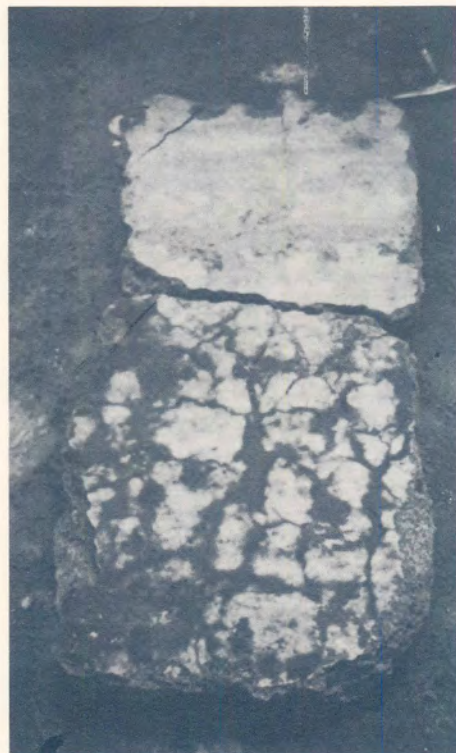
(b) Recovered cracked upper stabilized subbase layer after  $3,6 \times 10^6$  E80s.

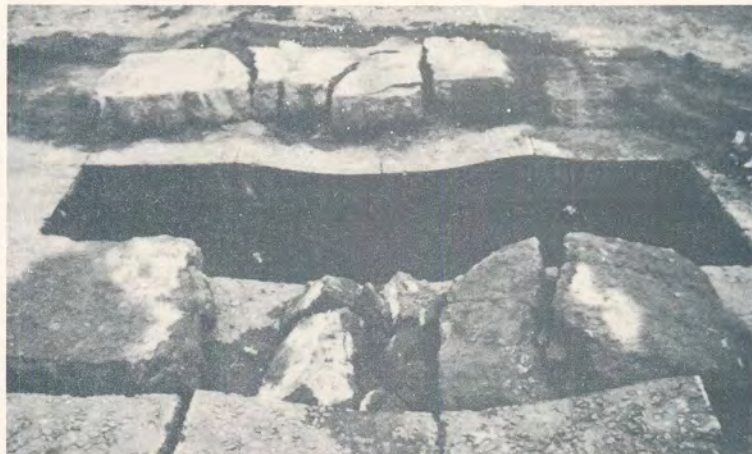
Lower subbase →

Upper subbase →

(b) Note the relatively smaller blocks of recovered upper stabilized subbase material, due to fatigue cracking and fracturing. The lower stabilized subbase experienced only fatigue cracking, hence the bigger blocks of material.

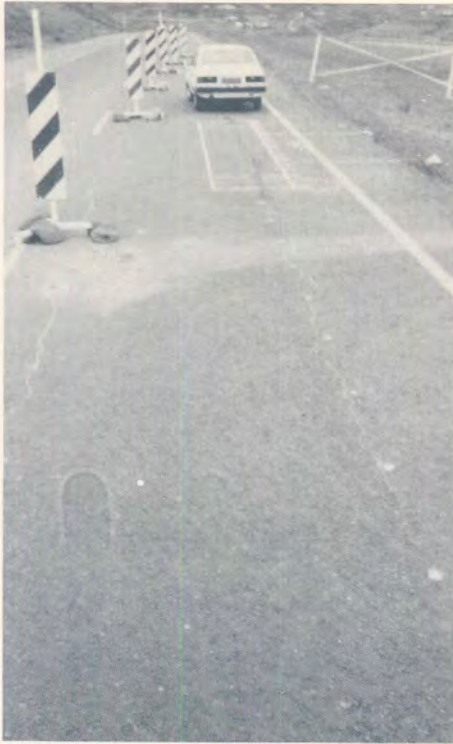
(a) View of HVS site on the fast lane of the south bound carriageway. Note the settlement cracks.

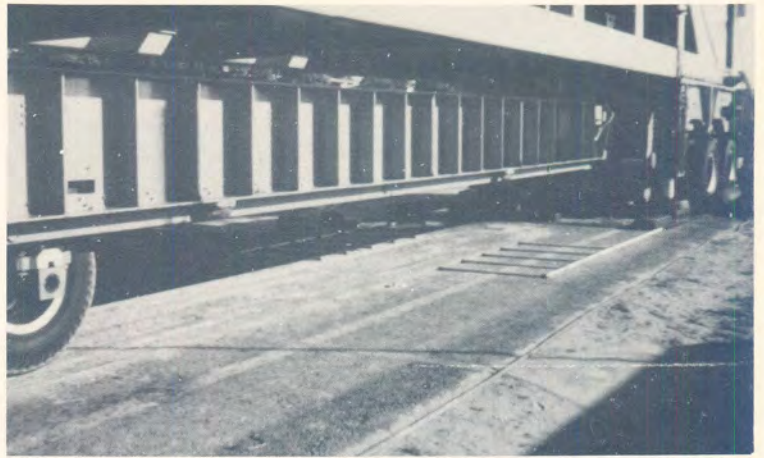
(b) General view of test on SECTION 1. Note the water inlet pipes on the side of the test section.

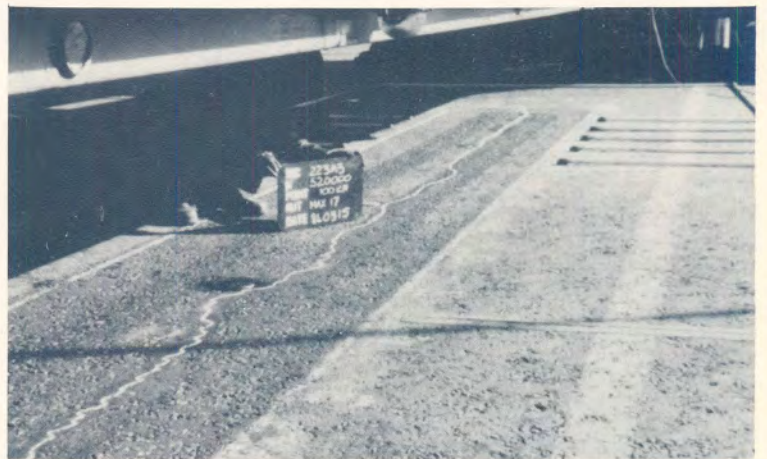
(c) Longitudinal crack on SECTION 1.

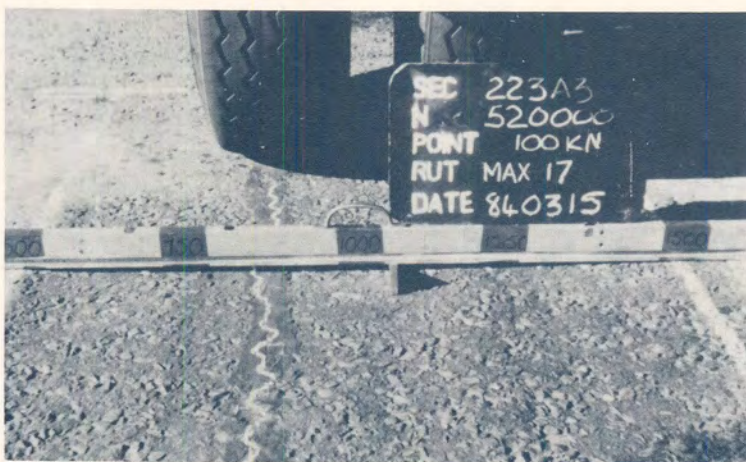
(d) Maximum permanent deformation of 17 mm after 520 000 repetitions of a 100kN dual wheel load (20 ME80s).

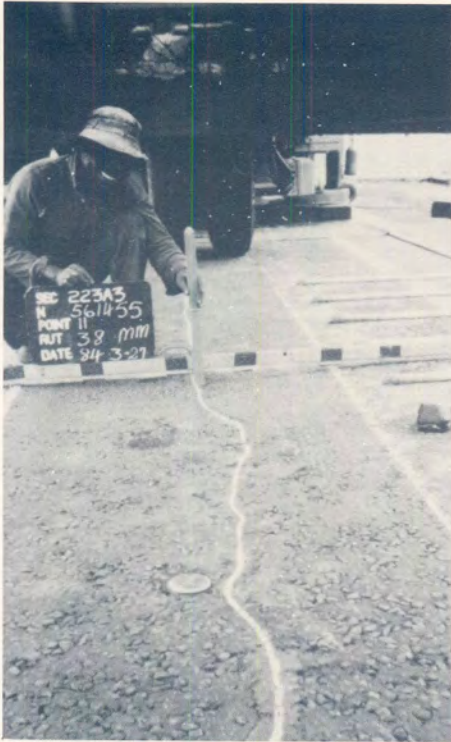
(a) Maximum permanent deformation of 38 mm at the crack after water introduction.

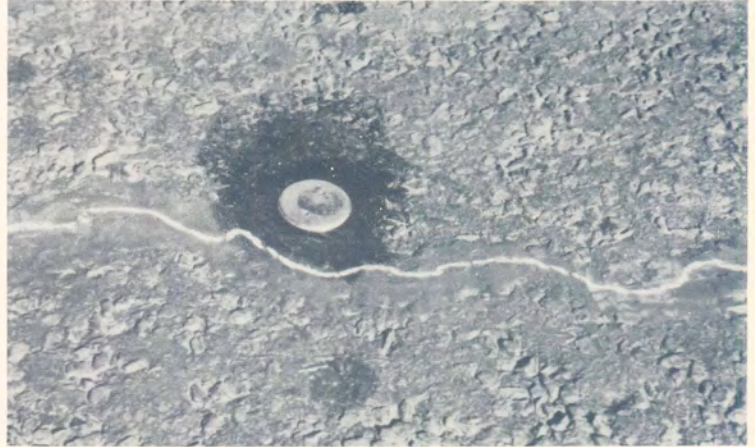
(b) Relative position of MDD8 on SECTION 1.

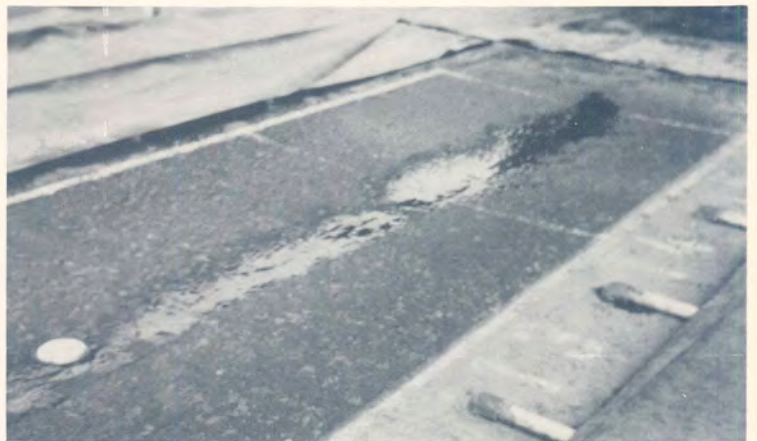
(c) Start of water pumping from the bottom of the crack on SECTION 1.

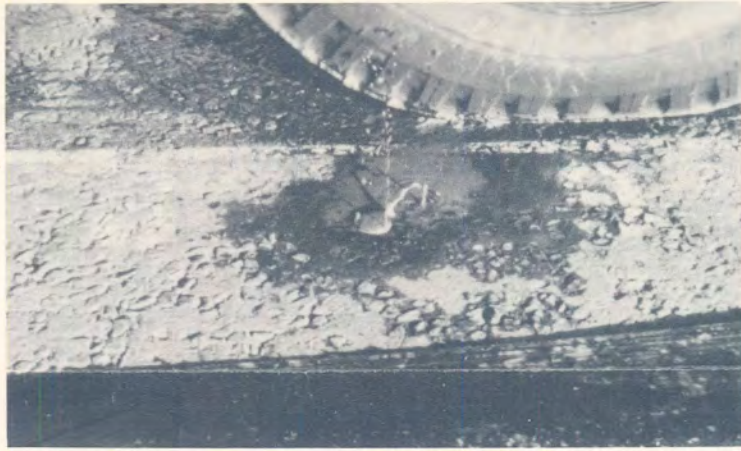
(a) Pore pressure release through nuclear moisture and density measuring hole, next to the HVS test section.

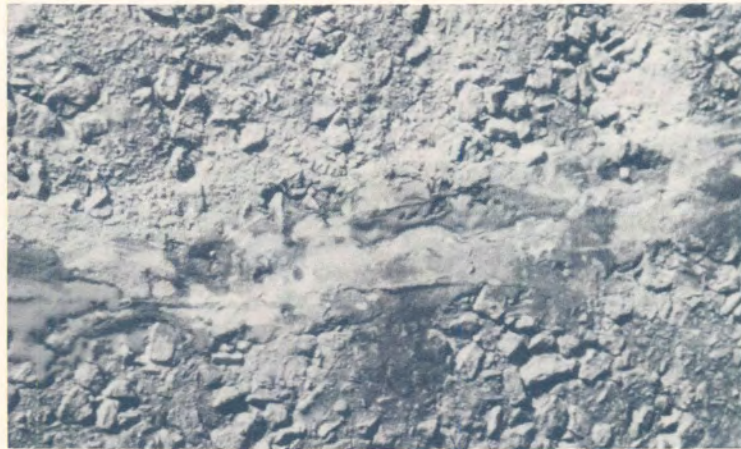
(b) Fines starting to pump through the longitudinal crack.

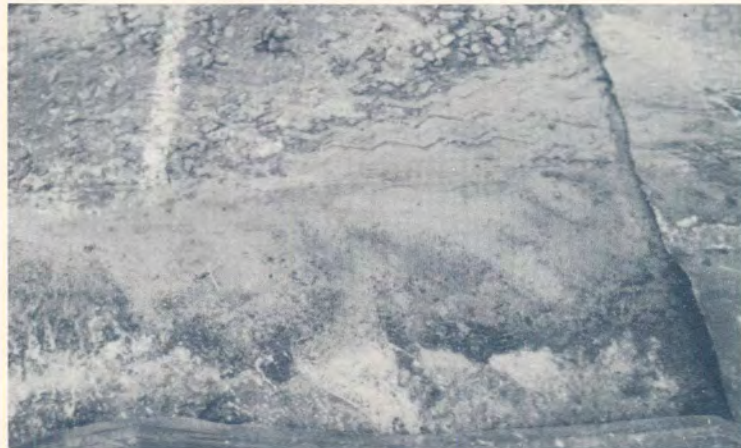
(c) Fines on the side of the test section after the "saturated" test.

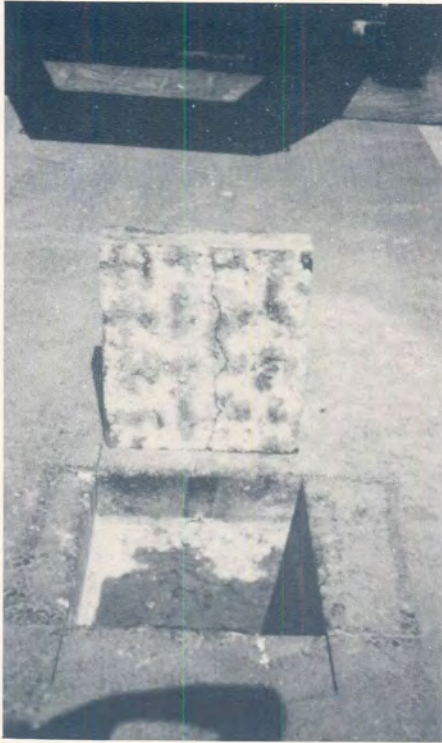
(a) Excavated test pit across the crack indicating that the crack exists in all the layers of the road structure.

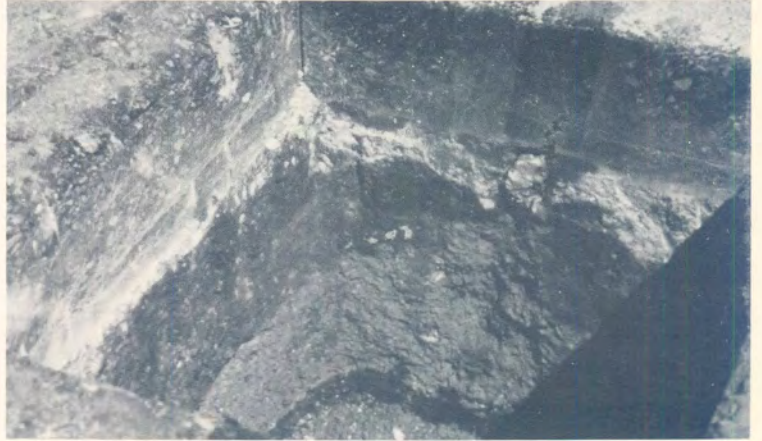
(b) Relative low pH zone at the position of the crack (dark red colour – high pH zone), determined with Phenolphthalein.

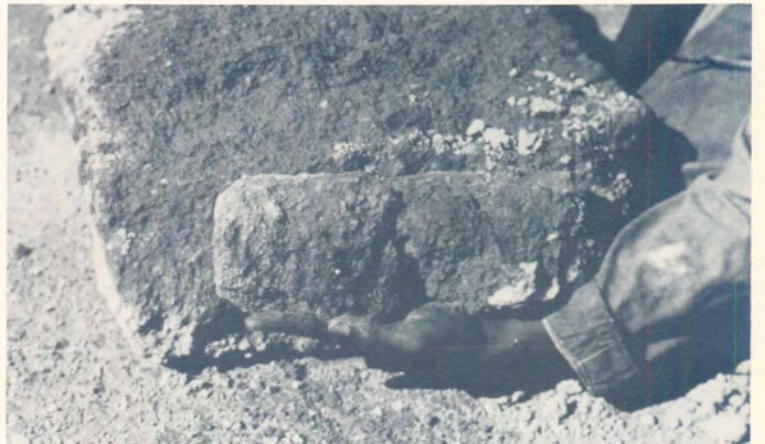
(c) Note the discolouring on the side of the block next to the crack.

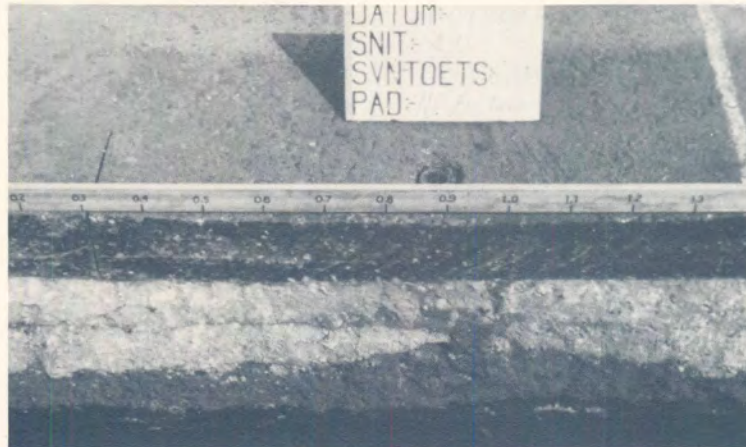
- (a) Face of the test pit, indicating the moisture regime at the position of the crack (point 1,0 on straight-edge). The light brown colour is the well-stabilized weathered Granite subbase layers.

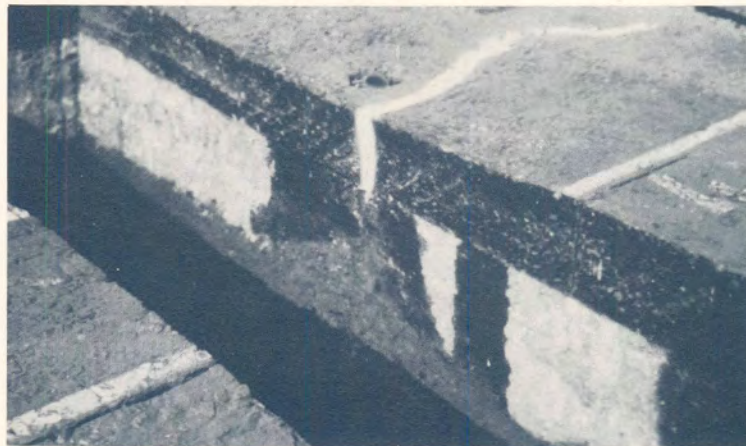
- (b) Relative low pH zone at the position of the crack and the bottom of the lower subbase layer. This zone was carbonated, determined with HCL solution. The dark red area is the relative high pH zone.

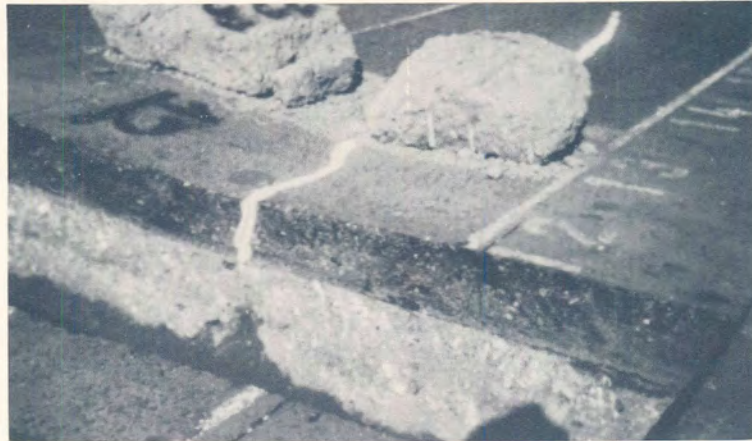
(a) Moisture regime at the crack at measuring point 12 on SECTION 1.

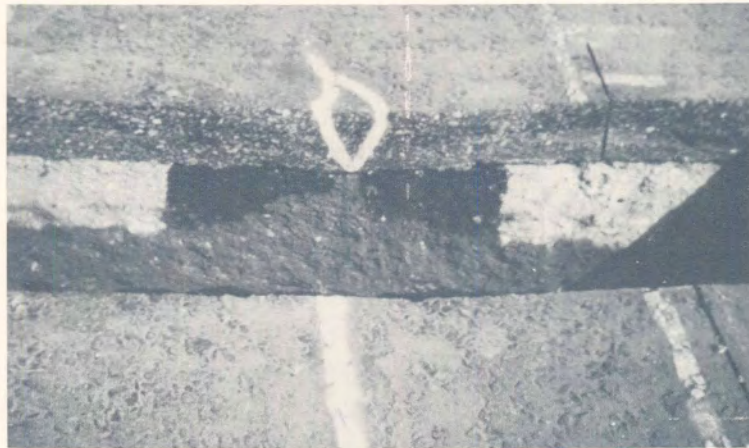
(b) Moisture regime (carbonated) at measuring point 19 on SECTION 2.

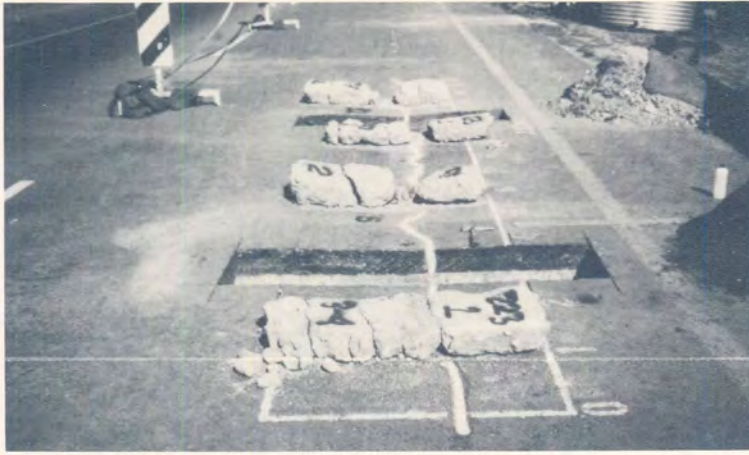
(a) General view of section positions of the two trenches on section 1 and the recovered subbase material.

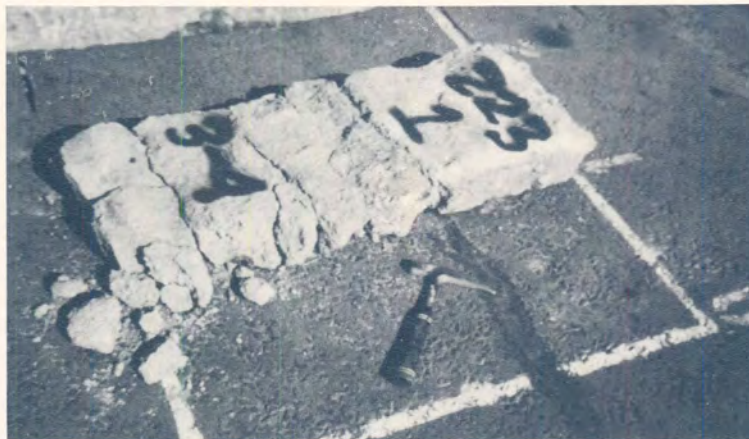
(b) Recovered upper subbase after 20,6 ME80s. (Semi-saturated). Note the position of the longitudinal crack. The other cracks are traffic associated. (Measuring points 3 to 4).

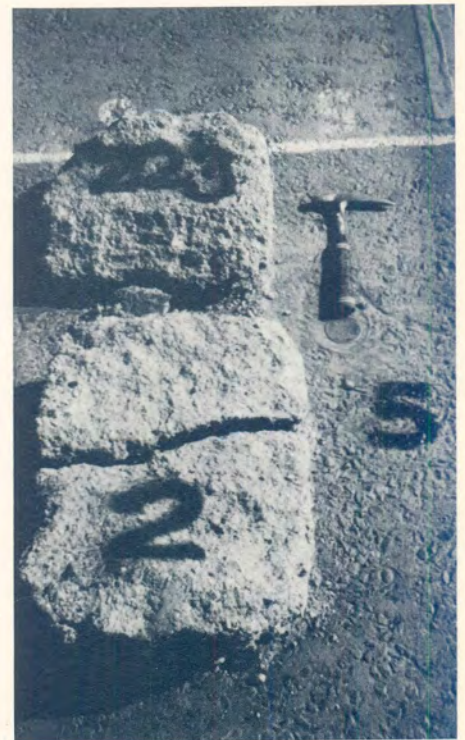
(c) Recovered lower subbase after 20,6 ME80s (Semi-saturated.) The two cracks are non-traffic associated. This layer was partially carbonated. (Measuring points 3 to 4).

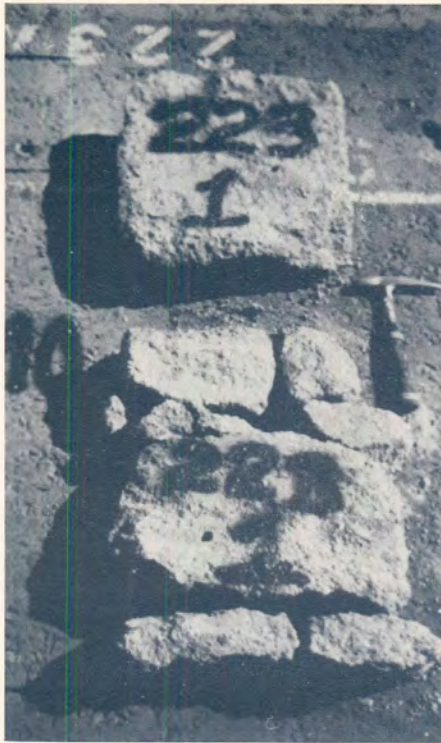
(a) Recovered upper subbase after 20,6 ME80s on SECTION 1 (saturated). Layer cracked and fractured (Measuring points 11 to 12).

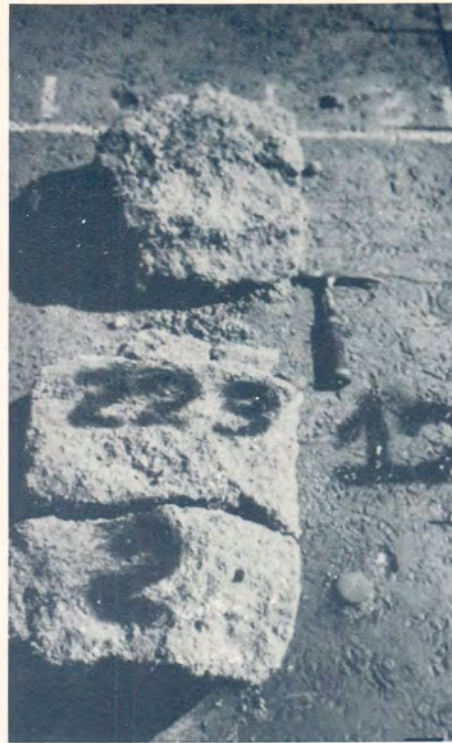
(b) Recovered lower subbase layer after 20,6 ME80s on SECTION 1 (saturated) at measuring points 11 to 12.

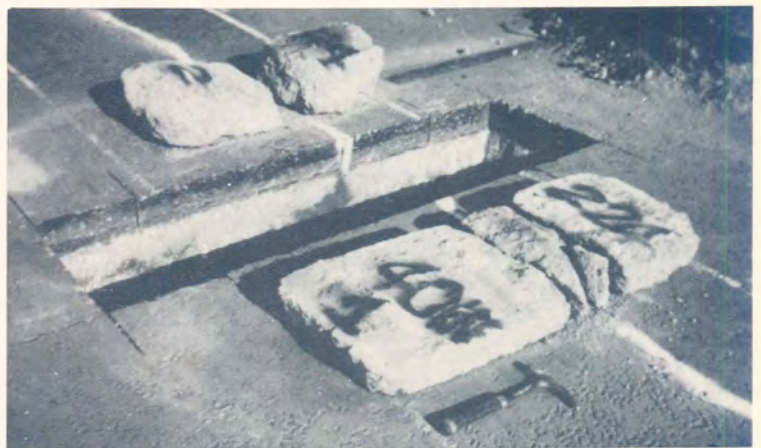
(d) Recovered upper and lower subbase layers from SECTION 2, measuring points 3 to 4, after 280 494 E80s. Note, only non-traffic associated cracks in the blocks.

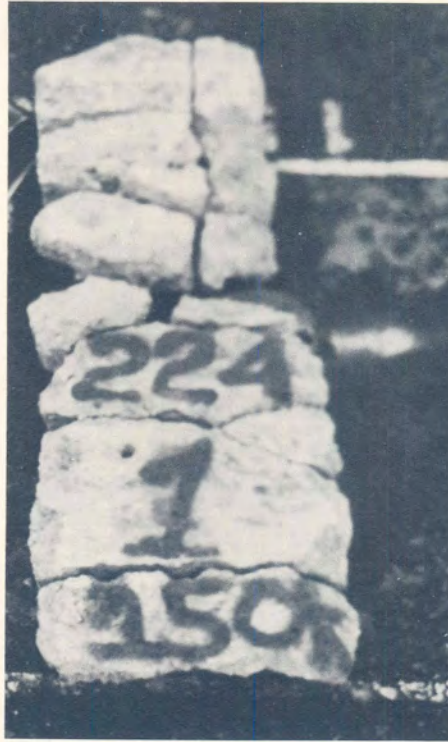
(a) Upper subbase layer cracked and fractured after 17 255 repetitions with 150 kN single wheel load.

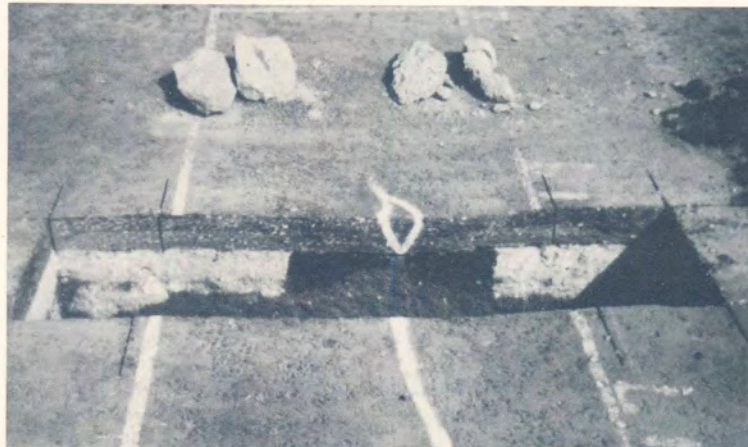
(b) Few blocks recovered from the lower subbase layer. The rest of the layer was soft, granulated and carbonated. Repetitions 17 255 with 150 kN single wheel load.

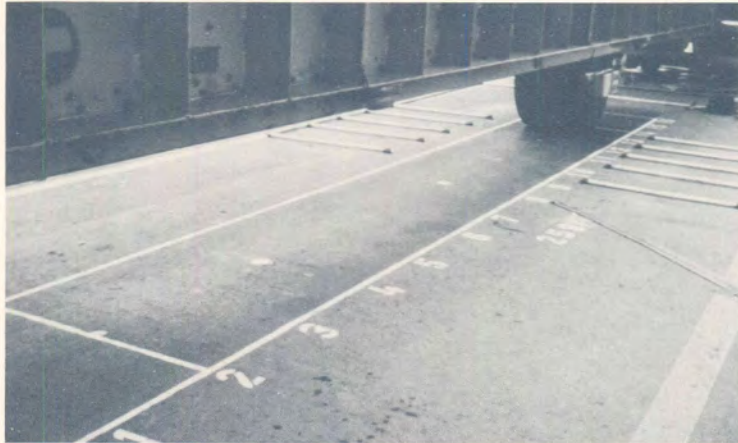
(b) Typical Surface condition of Section 2 in the dry state.

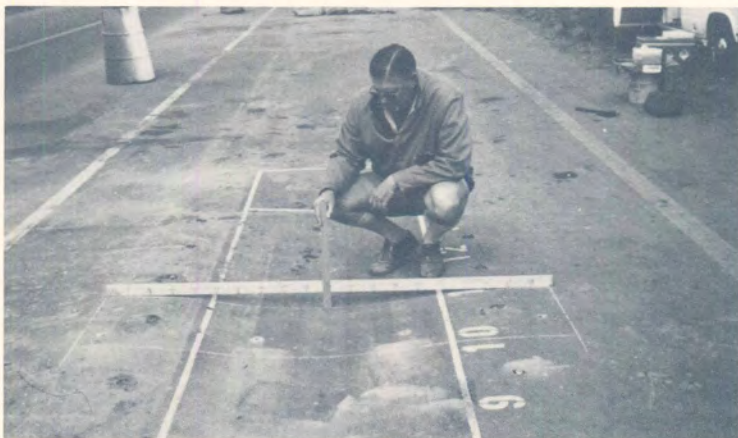
(c) Surface condition of Section 2 after Excess Pore Water Pressure (EPWP) state.

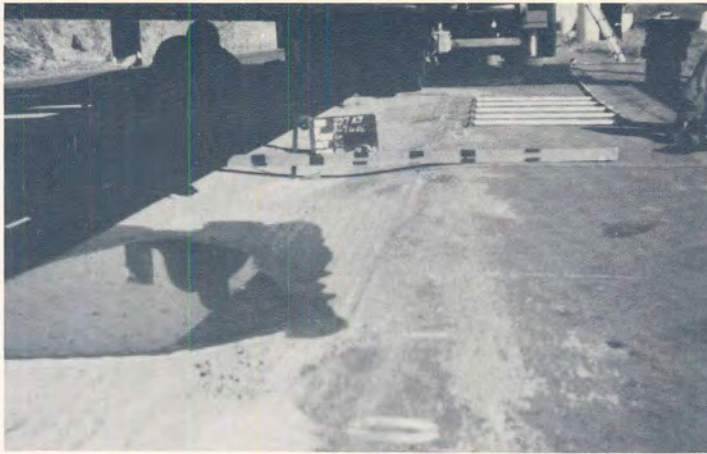
(a) Surface condition of Section 1 after the EPWP state, (62 mm rut after 2067 repetitions at (100kN) Note the white water inlet pipes both sides of the Section.

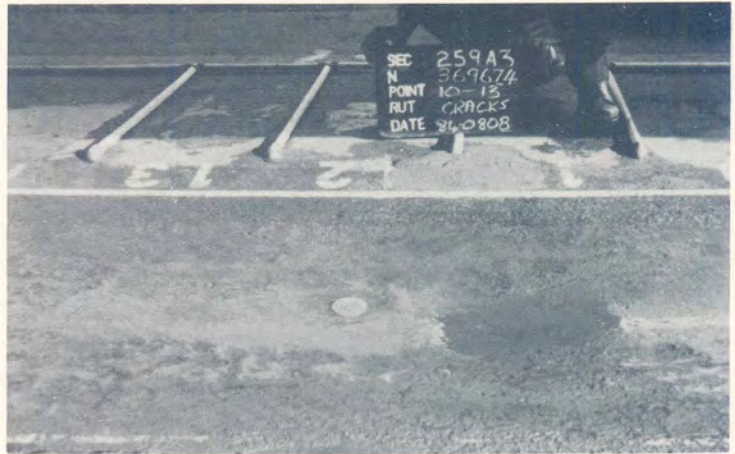
(c) Overhaul view of Section 2 after testing in the EPWP state.

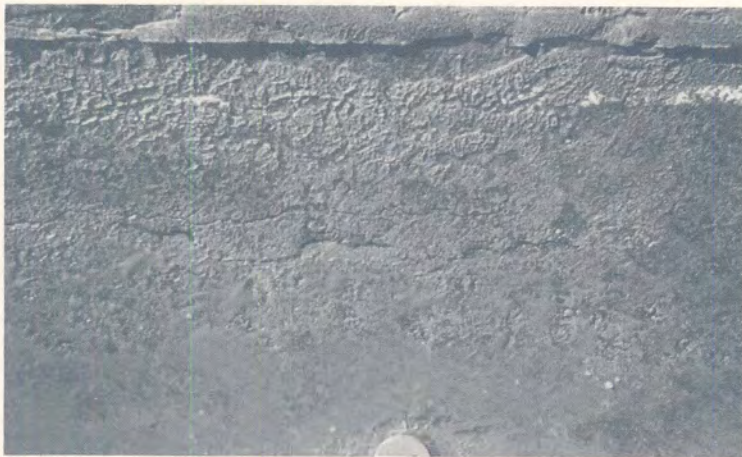
(d) Pumping through longitudinal fatigue crack on Section 2.

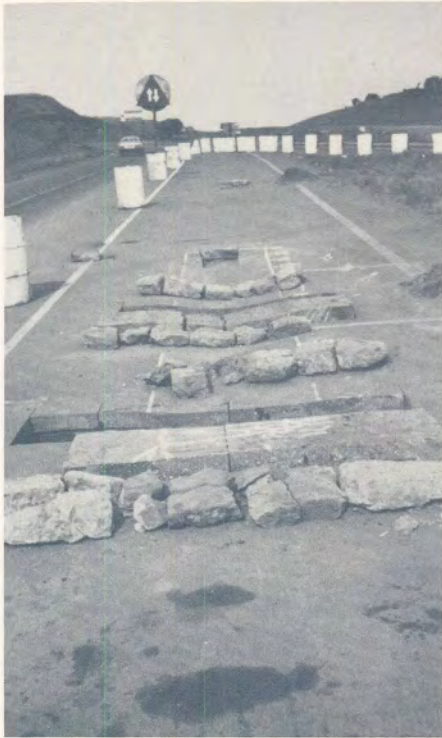
(a) Cross Profiles made across Section 1 after HVS trafficking. NOTE the deformation and recovered stabilized Berea Red subbase material (cracked).

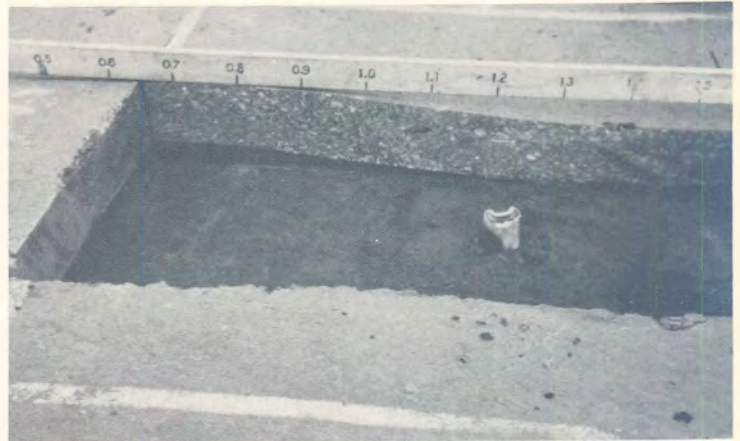
(b) Sideways (horizontal) pumping (erosion) of the lime treated Berea Red upper subbase at the bottom of the heaved asphalt on Section 1.

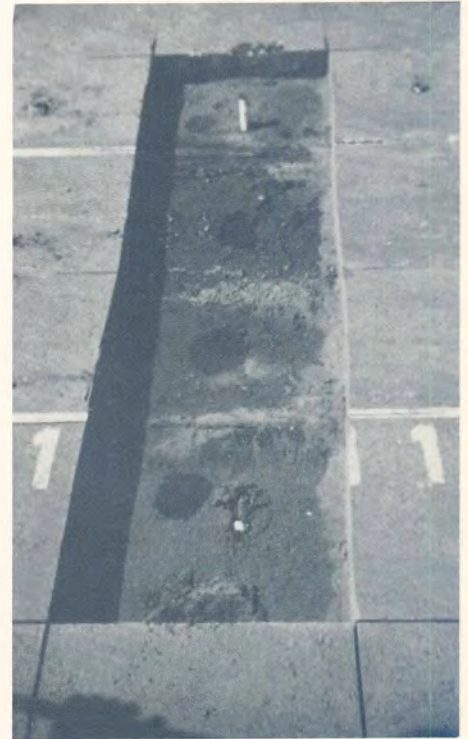
(d) Phenoltalien indication of relative high pH on the top of the upper subbase and the pumped layer.

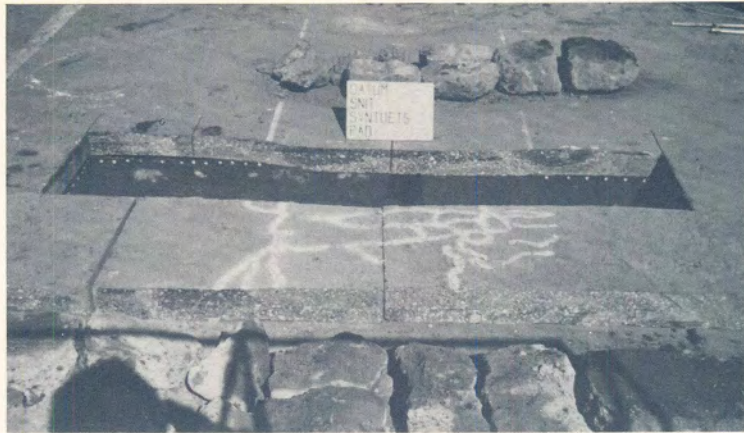
(a) Cross profile across the test Section 1. Note the heaving of the asphalt as a result of the erosion action inside the trafficked area during the EPWP state.

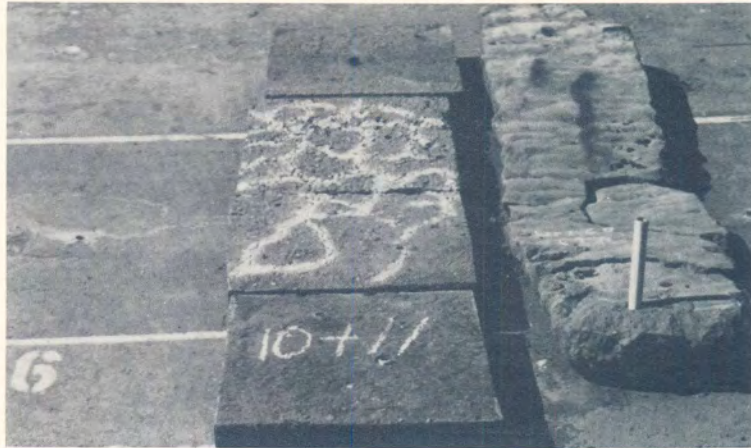
(a) Fatigue cracking at the bottom of the asphalt base layer after the EPWP state on Section 2.

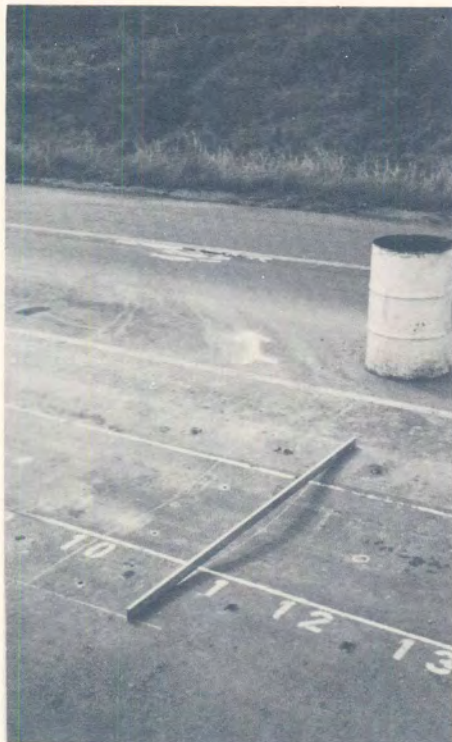
(b) Real road failure next to Section 2 in the normal trafficked lane during the time of HVS testing on Section 2.

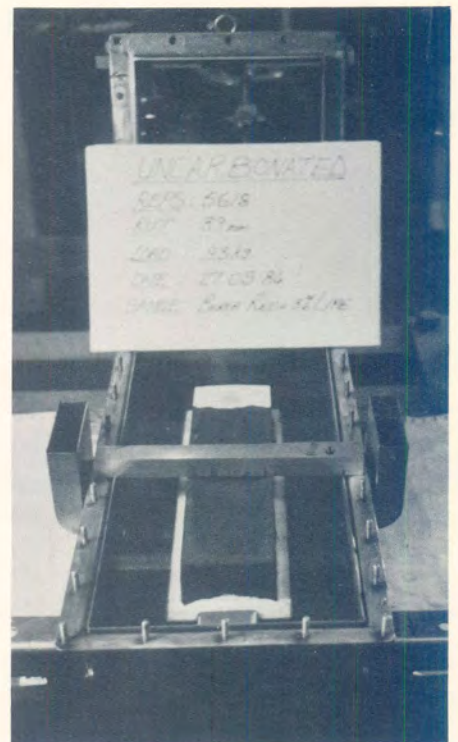
(c) Typical specimen of Berea Red material (recovered at Umgababa), after testing in the new Erosion test at NITRR.

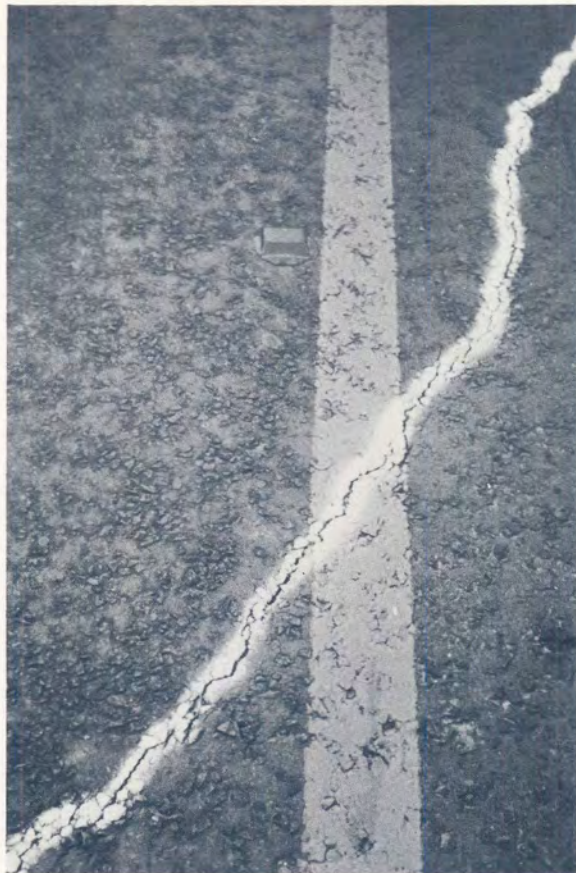
**PLATE 1:** Slope instabilities on National Route N3, at Van Reenens Pass. Note the crack width and the horizontal permanent deformation showed by the yellow line in photograph B.

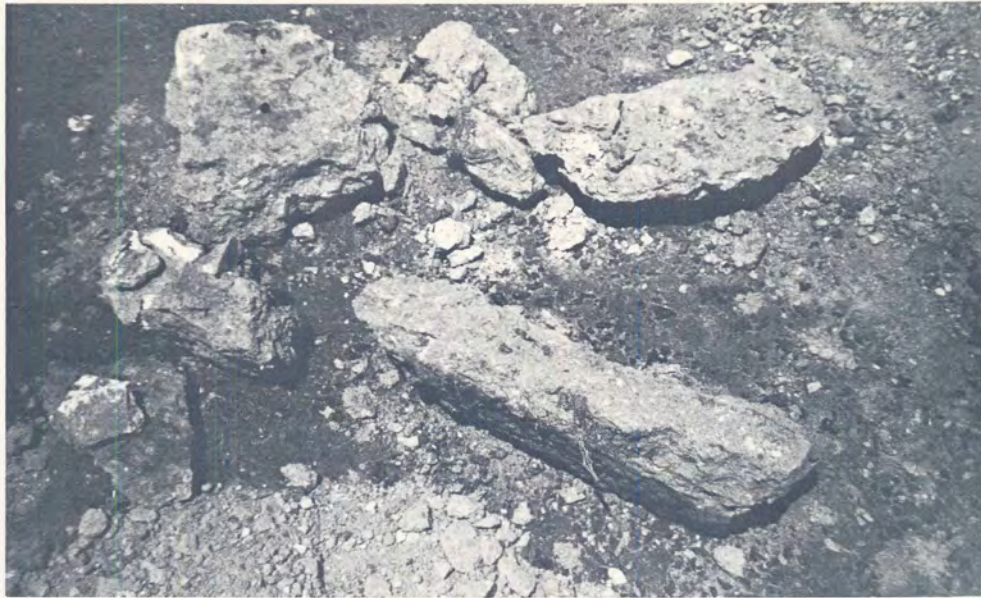
**PLATE 2:** Upper and lower subbase material recovered from the test pit at Section 1 before any HVS trafficking. Note the white spots of badly mixed stabilizing agent in the upper subbase. The lower subbase show better cementing.

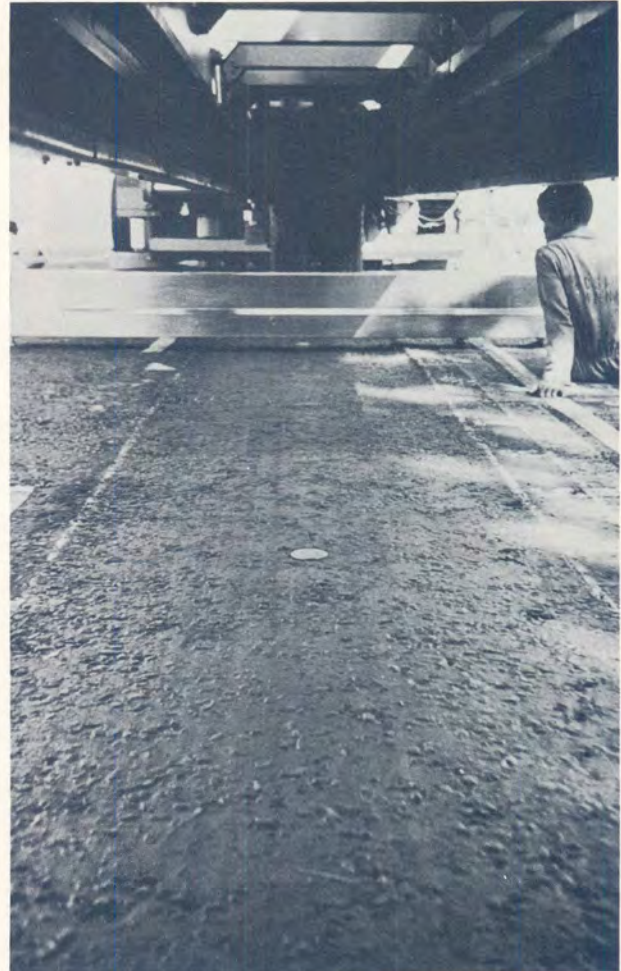
- PLATE 3:**
- A.** Fatigue cracks on the surface of Section 1 after 279 795 actual repetitions of a 70 kN dual wheel load.
  - B.** Closing of cracks at the surface after high temperatures applied to the road surface. Note the permanent deformation on the upper right of the photograph on the test section. The final actual repetitions of a 70 kN dual wheel load was 370 000, and the rut was 20 mm.

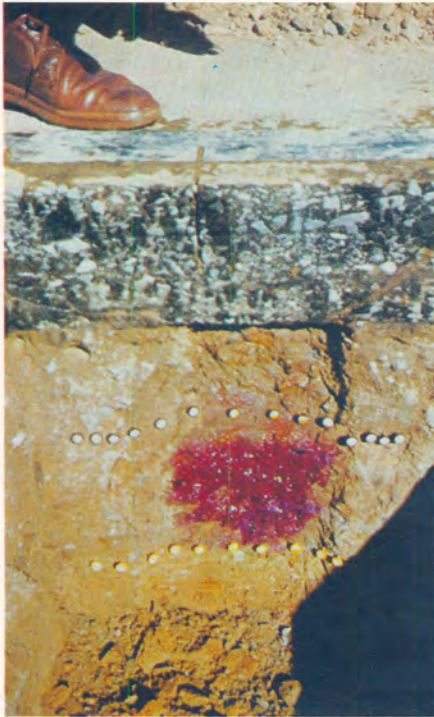
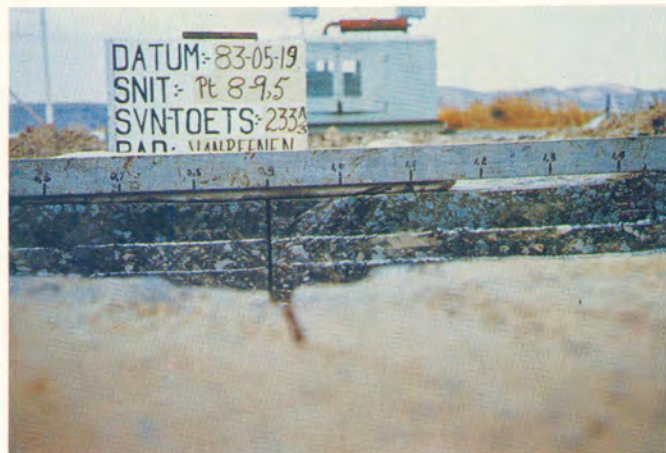
- PLATE 4:**
- A. Chemical phenol-test indicate well stabilized lower subbase, and poor stabilized upper subbase on Section 1.
  - B. Cross section profile on Section 1 after HVS test. Note the irregularities at the layer interfaces, and also the two recycled asphalt layers above the upper subbase.
  - C. Temperature rut at measuring point 8 on HVS Test Section 1. Note that most of the deformation was caused in the wearing course and not in the recycled asphalt base layer.

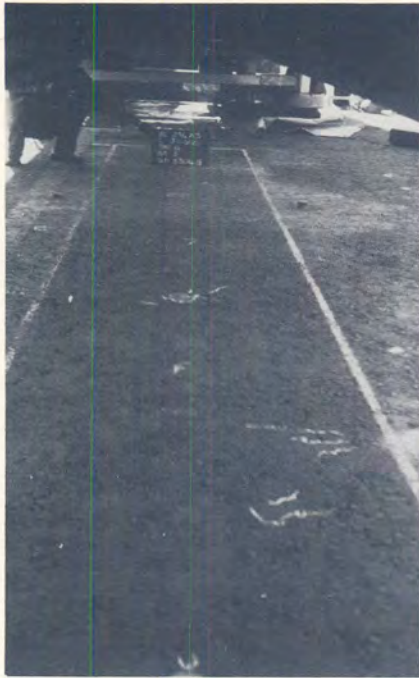
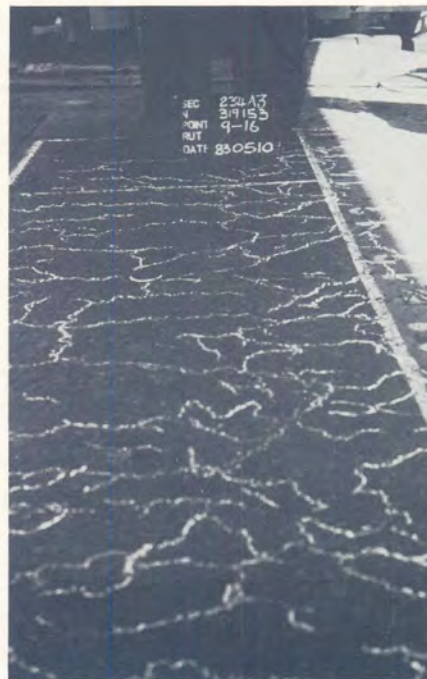
**PLATE 5:** Fatigue crack growth on HVS Test Section 2.

- A. Fine hair cracks after 30 000 repetitions of a 70kN dual wheel load.
- B. Sudden crack appearance on the surface after 100 000 repetitions of a 70 kN, and 201 488 repetitions of a 100 kN dual wheel load on Section 2.
- C. Increased crack growth after 316 153 total repetitions.
- D. Major increase in crack growth from 316 153 to 319 153 total repetitions.
