UNIVERSITEIT VAN PRETORIA  
UNIVERSITY OF PRETORIA  
YUNIBESITHI YA PRETORIA

A P P E N D I X A

PHOTOGRAPHIC RECORD OF HVS TESTS

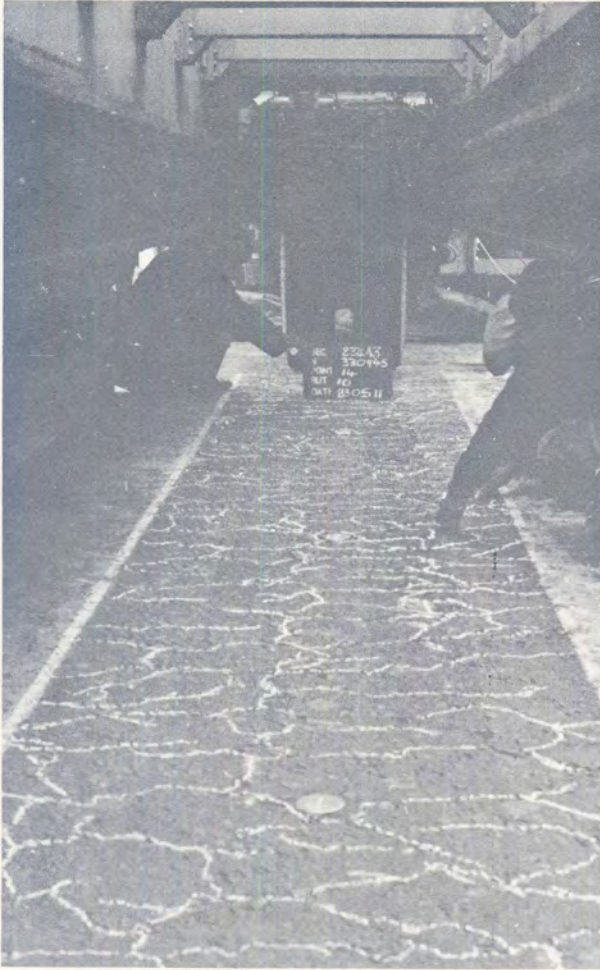
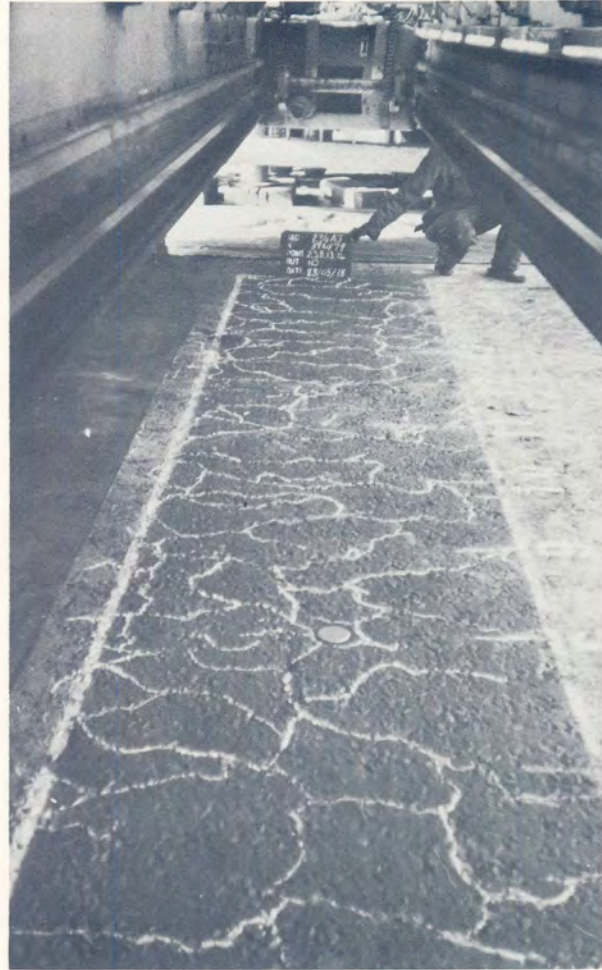
- PLATE 6:**
- A.** Further increase in crack growth after 330 945 total repetitions. Surface water introduced at 330 945.
  - B.** Crack pattern after 396 979 total repetitions. Note zero rut increase from 330 945 to 396 979 total repetitions, under wet surface conditions.

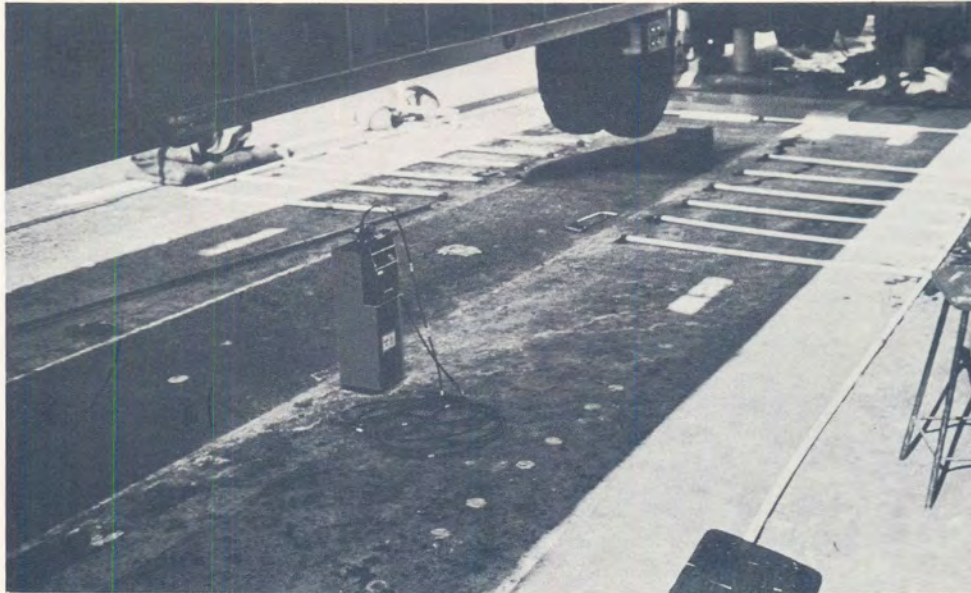
**PLATE 7:** Surface and subsurface water introduced on Section 2 after 396 979 total repetitions.

- A. Water fed-pipes for subsurface water, both sides of the lower end of the test section. Inlet-depth 440 mm.
- B. Pumping of fines from the upper subbase through the cracks on the total test section.

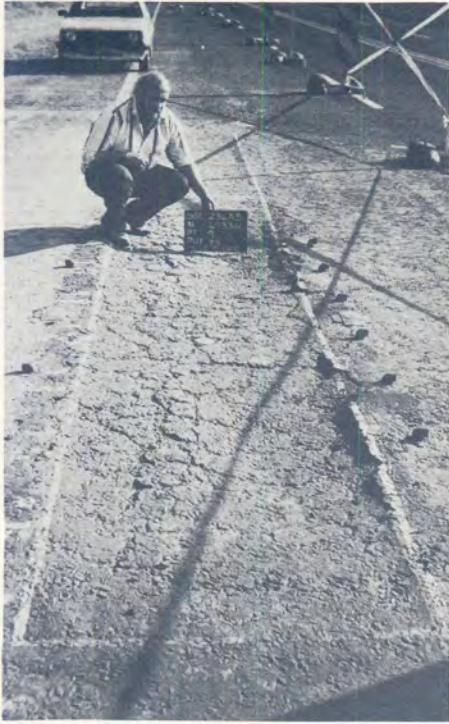
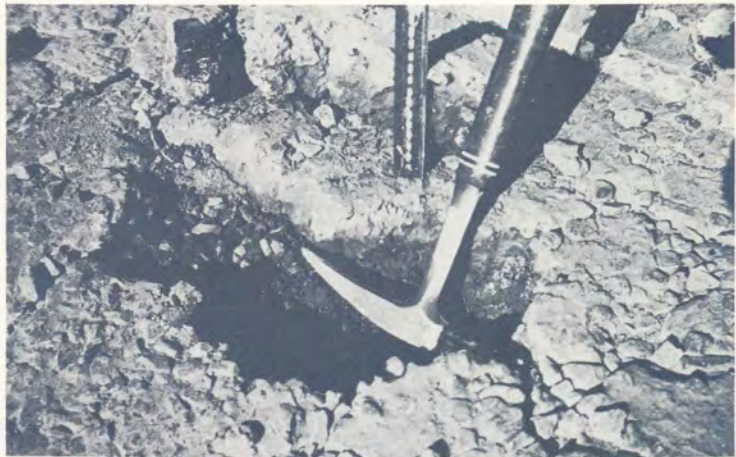
- PLATE 8:**
- A. Final crack pattern and permanent deformation on Test Section 2.
  - B. Longitudinal cracks on edge of Test Section 2 at point 9, where a local rut of 89 mm was formed.
  - C. Stripping and total failure of the upper recycled asphalt base layer, where poor aggregates was used.

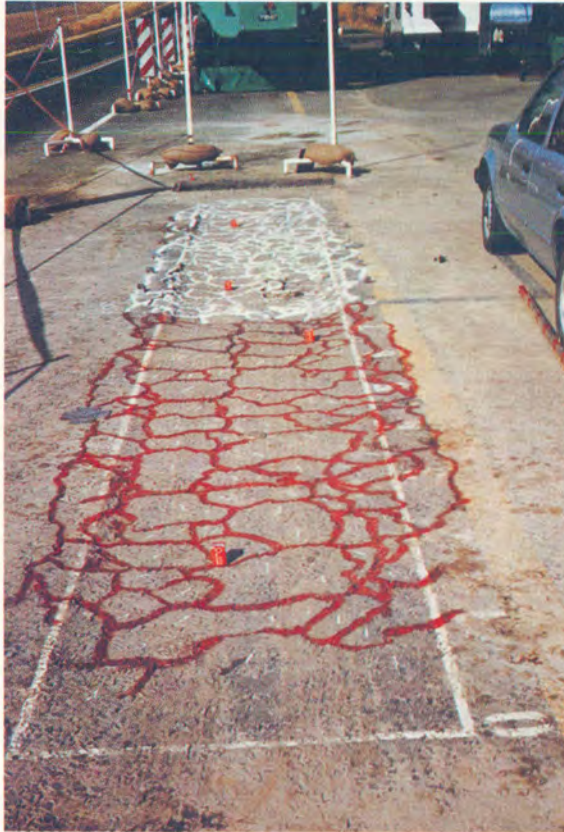
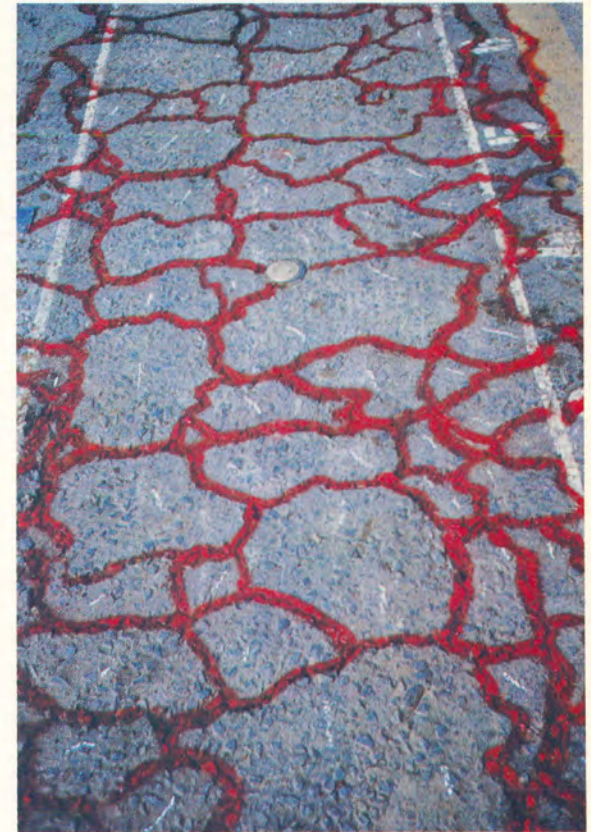
**PLATE 9:** FINAL CRACK PATTERN ON SECTION 2:

- A. Final crack pattern on Section 2. Note the different block sizes of the cracks on the two halves of the test section. Note also the markers on the local rut areas.
- B. Final crack pattern where surface and subsurface water was introduced (big and small blocks). Note the end test pit on the top of the photograph.
- C. Final crack pattern where only surface water was introduced (big blocks).

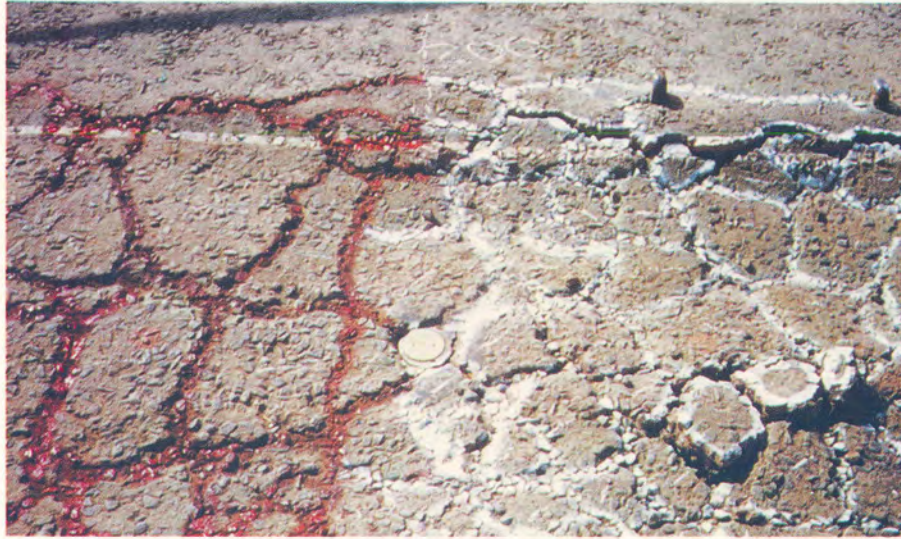
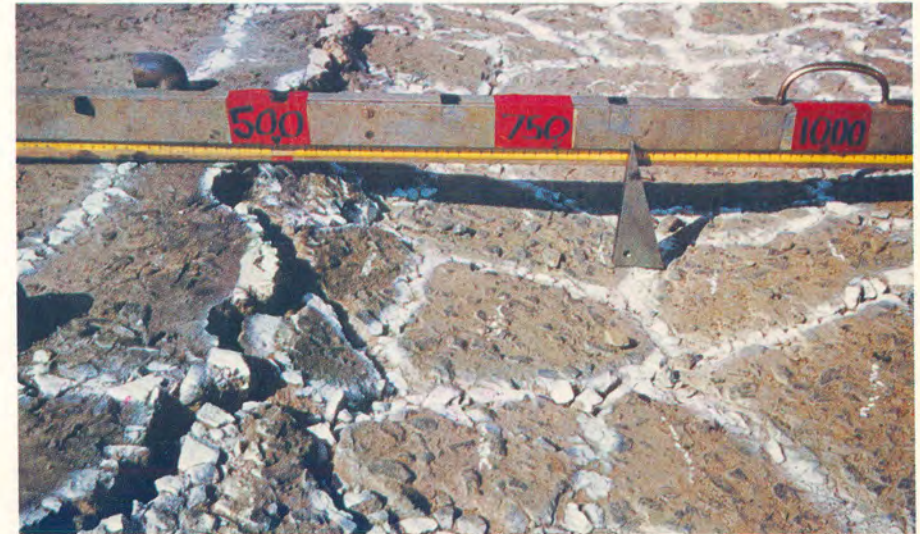
- PLATE 10:**
- A.** Final crack pattern at the MDD at measuring point 8. On the left only surface water, and on the right surface and subsurface water was added.
  - B.** Local rut of 65 mm at measuring point 6 (surface water).
  - C.** Local rut of 89 mm at measuring point 9 (surface and subsurface water). Note the big blocks.

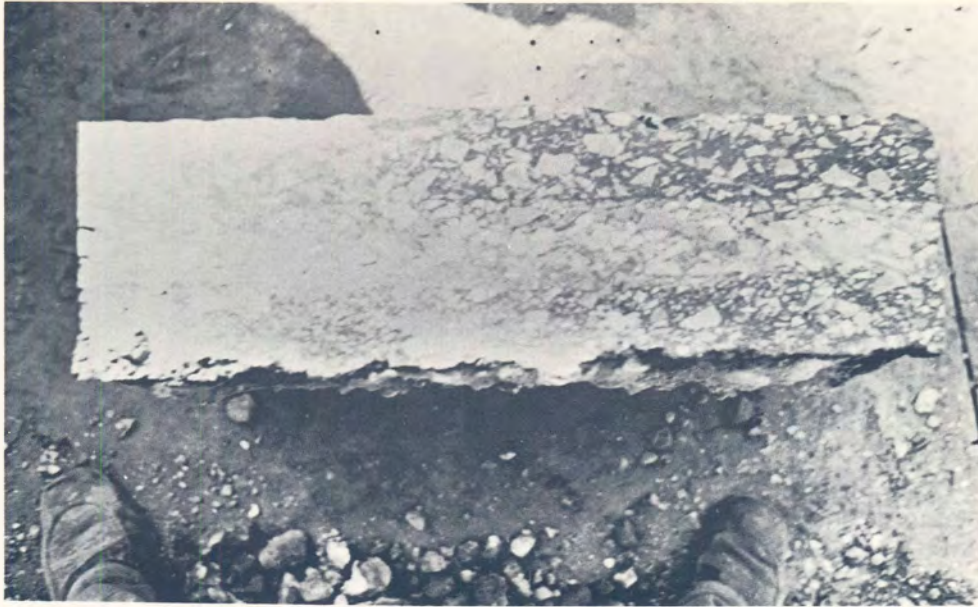
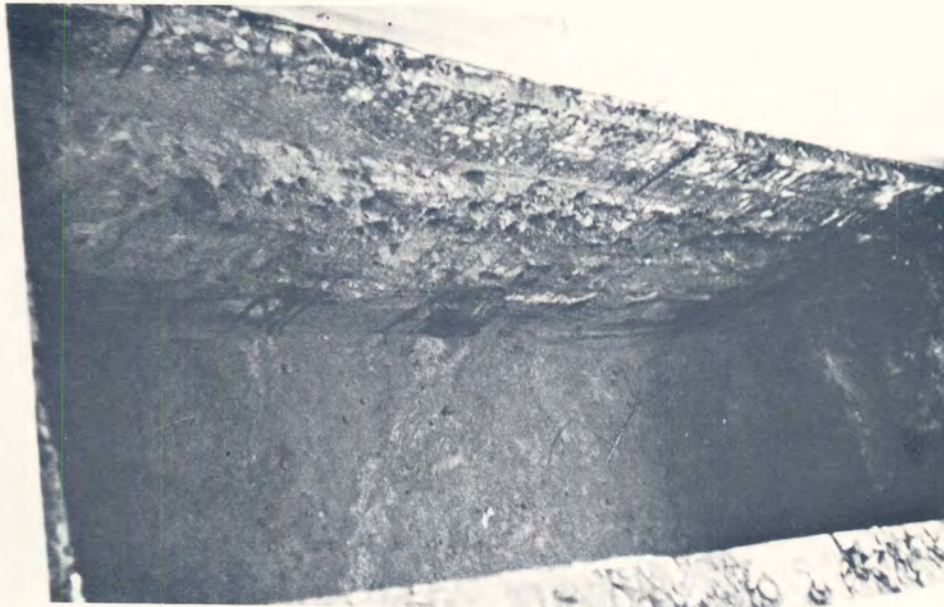
- PLATE 11:**
- A.** Note the three layers in the asphalt. From top to bottom is the 40 mm wearing course and the two 50 mm recycled base layers. Note the middle layer of lighter colour. This is the weak zone in the base layer because of poor aggregates.
  - B.** Fines pumped horizontally into the end test pit. Note the horizontal crack in the weak asphalt layer. Fines was pumped out of this horizontal crack as well as between the upper subbase and base, and between the two subbases.
