CHAPTER 6

FAILURE ANALYSIS OF RETRIEVED ACETABULAR COMPONENTS

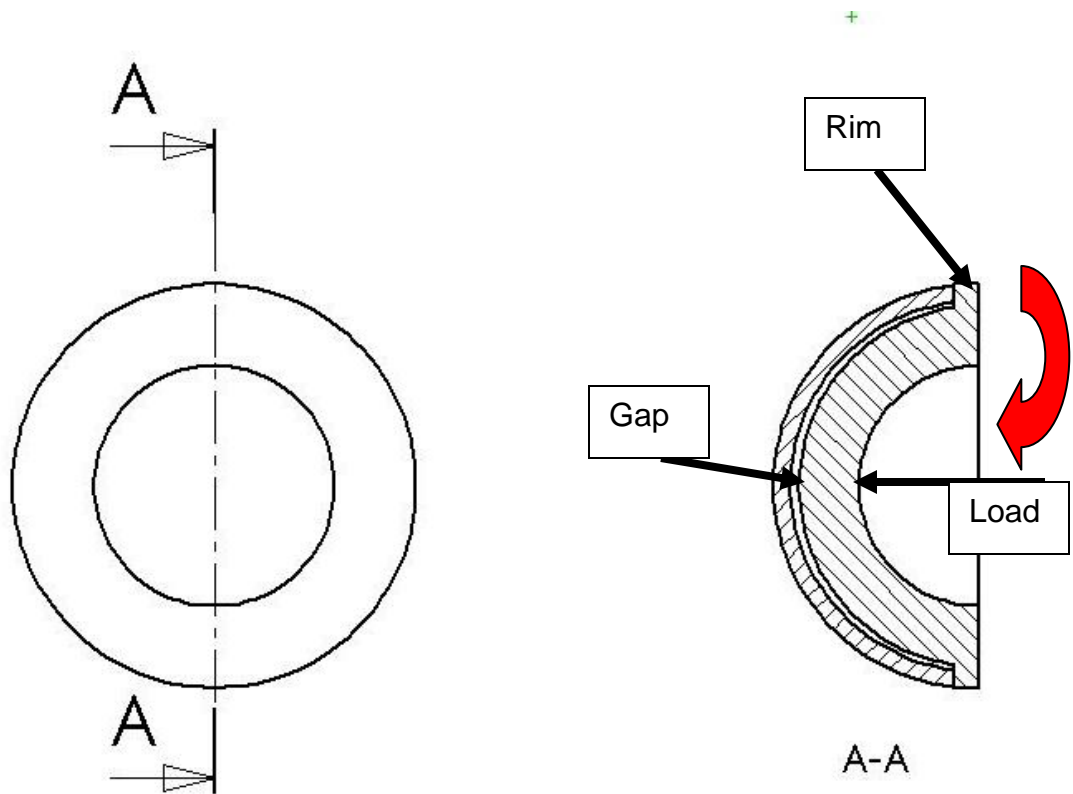
Figure 6.3: Schematic layout of UHMWPE liner not fitting snugly into metal backing

As can be seen from Figure 6.3, there is a small gap between the UHMWPE liner and the metal backing. The load coming into the bearing area will now deform the cup resulting in a bending moment with the corresponding bending stress in the rim of the cup. As the patient is walking, this load will vary according to the load profiles defined in Chapter

2 (Paul, 1976; Bergmann et al., 1993; ISO 14242-1, 2002), resulting in a dynamic load input into the rim of the UHMWPE that can lead to the fatigue failure that is manifested in the form of cracks and the delamination of the rim interface.

From the data presented, it can be accepted that this failure is due to an error either during the design or during the manufacturing process of the metal backing or the UHMWPE liner. As this defect is not a result of the wear mechanism active in-vivo, this defect will not be investigated further.

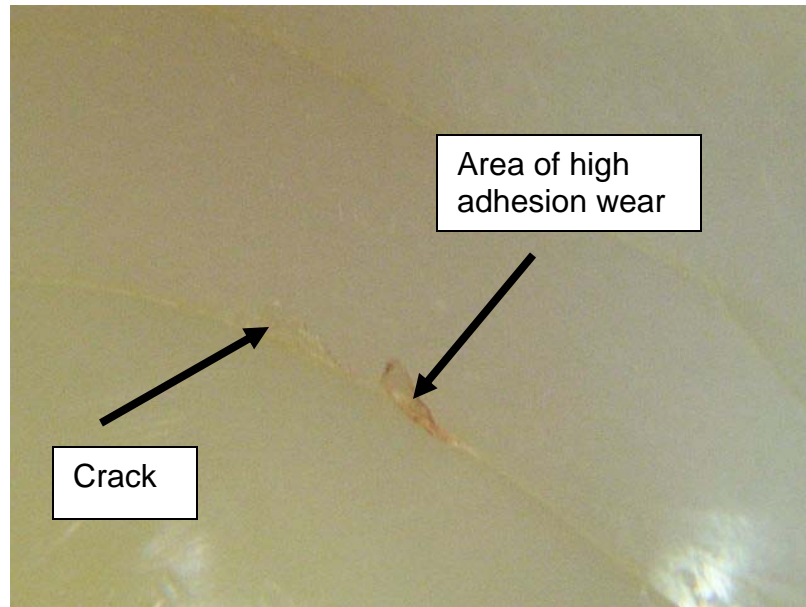
From the data presented in Chapter 5 it is evident that cracks in the bearing area are fairly common as can be seen in Figure 6.5. On closer examination, making use of dye penetrant spray and the use of an electron microscope, the origin of these cracks can be established. The cracks originate in areas where severe adhesion wear has taken place. A

Figure 6.5: Crack on inside of acetabular cup

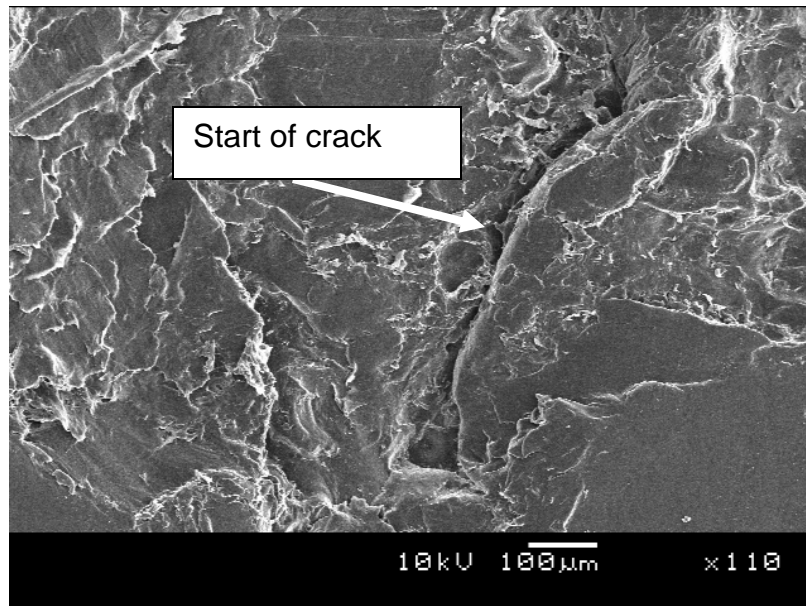
Figure 6.6: Electron microscope analysis of adhesion wear area (magnification x 110)

Under the electron microscope (Figure 6.6), it became clear that as the top layer of the material is being ripped away from the base material by adhering to the femoral head, craters are formed giving

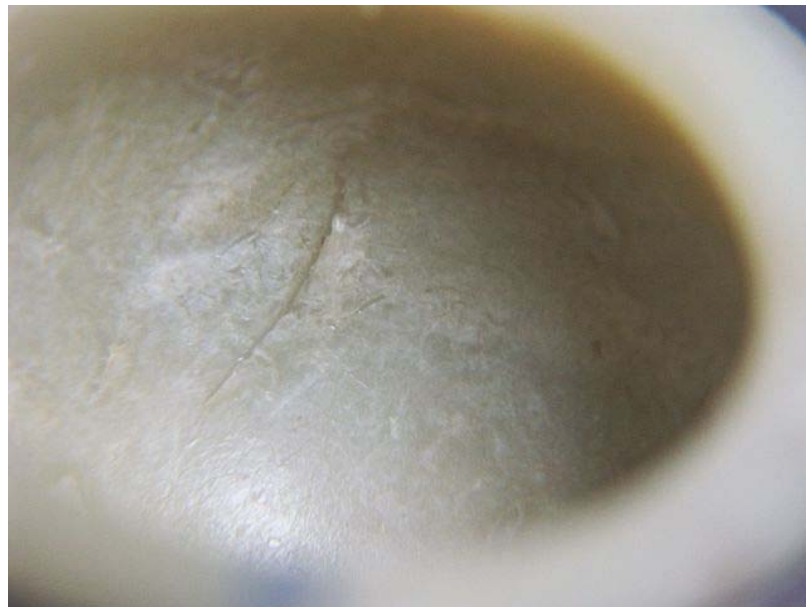
The entering of foreign particles into the bearing is not that uncommon. These particles normally originate from the PMMA cement with which the implant is fixated. An acetabular cup with severe signs of third-body wear is shown in Figure 6.8. In this specific case glass ionomer cement was used for the fixation of the implant. This type of cement is no longer in use and has been replaced with PMMA cement.

Figure 6.8: Acetabular cup with severe scratches on inside

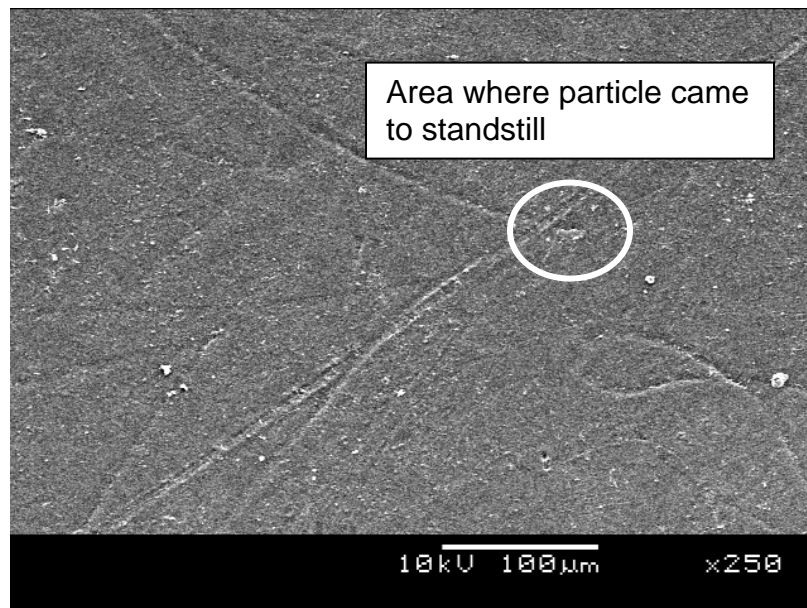
Figure 6.12: Scratch mark on bearing surface (magnification x 250)

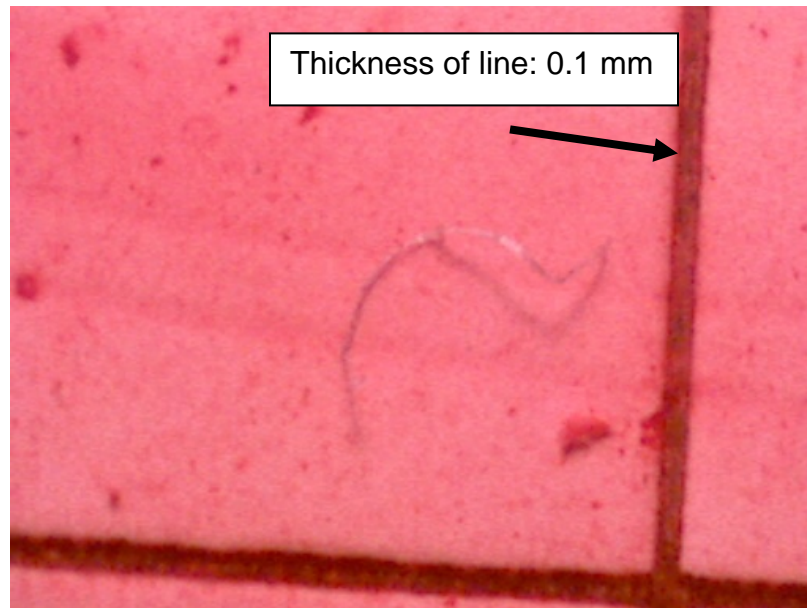
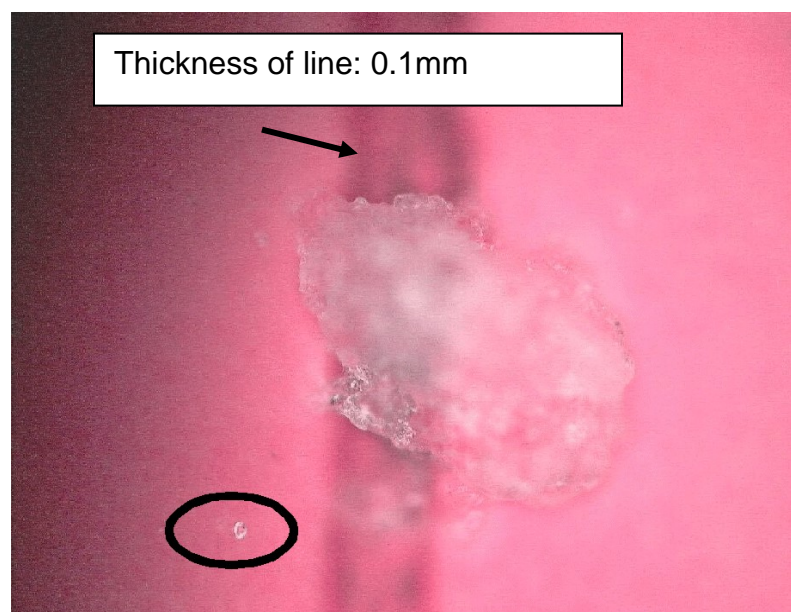
Figure 6.17: Whisker-like debris retrieved from patient (magnification x 20)

Figure 6.18: Debris retrieved from patient (magnification x 40)

The shape and the appearance of these items of debris suggest that both the whiskers and the droplets were formed under excessive heat conditions. From the literature survey, it was clear that for UHMWPE temperatures above 40°C should be avoided, with short time (seconds) peak temperatures of 80°C given by the manufacturers as the absolute maximum (Engineering Material Handbook 1987; Material data sheet, UHMWPE Poli HiSolidur 1999).

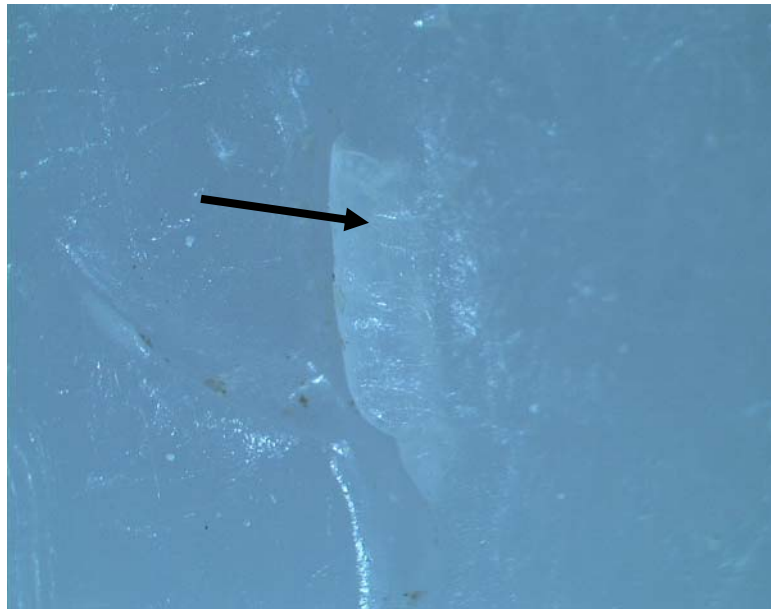
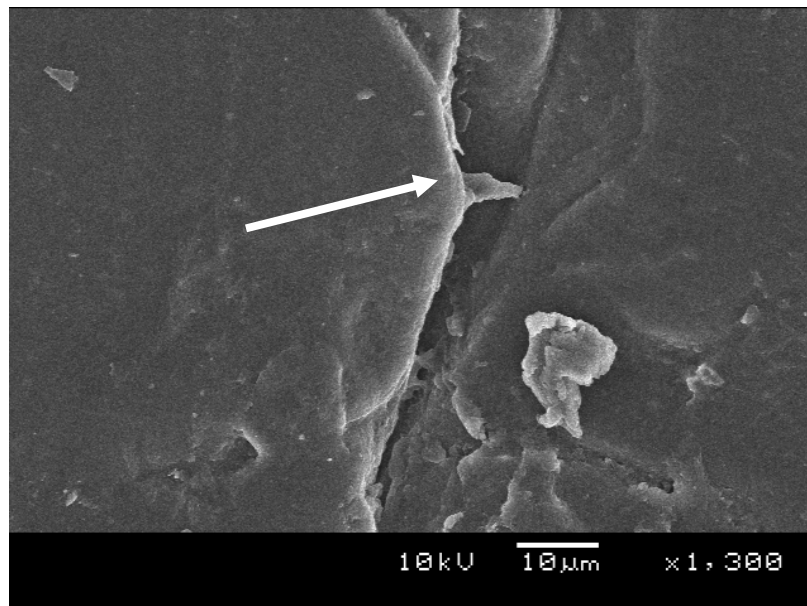
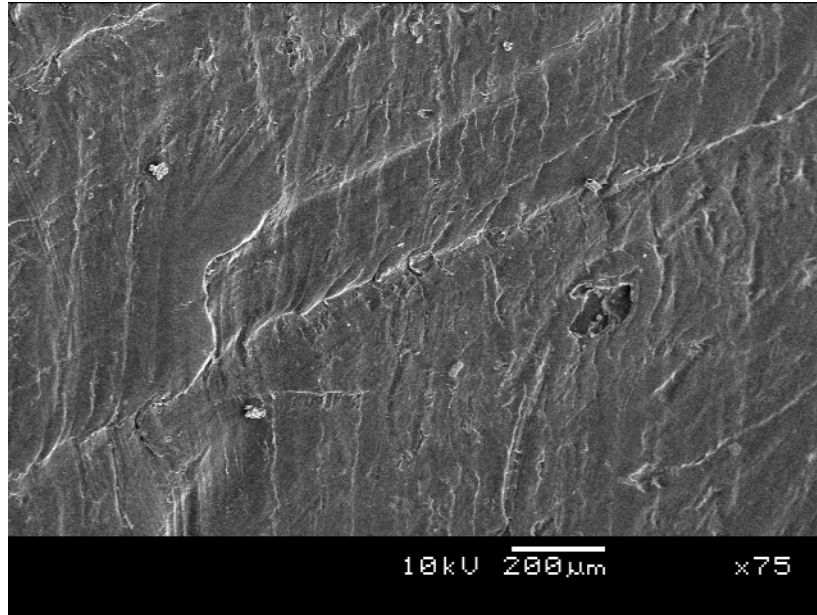
In the observations discussed in Chapter 5, areas of material that had plastically flowed under the prevailing pressure were identified. An acetabular cup with the type of plastic flow mentioned is shown in Figure 6.19. Under higher magnification, making use of the electron microscope, a number of these areas of plastic flow were identified. (See Figures 6.20 and 6.21.)

If the higher creep data at elevated temperatures (Chapter 3) together with the analysis of the brown discolouration is taken into account with the resulting conclusion of localised elevated temperatures, it is clear that the only way this type of plastic flow can occur is that the material at elevated temperatures is squeezed out of the high pressure area to an area of lower pressure.

Figure 6.19: Plastic flow of material visible in cup (magnification x 10)

Figure 6.20: Plastic flow in acetabular cup (magnification x 1 300)

Figure 6.21: Area with plastic flow lines visible (magnification x 75)

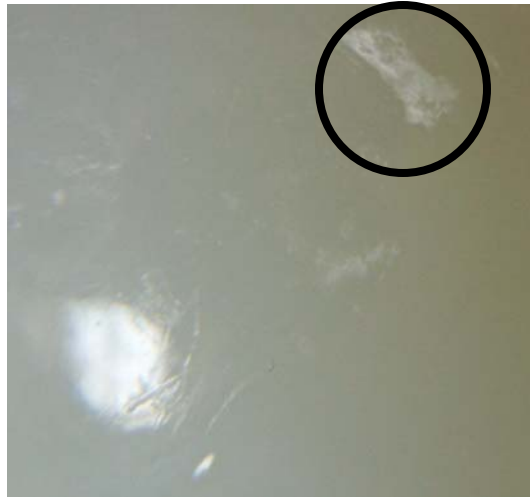
Figure 6.22: Visible adhesion wear in acetabular cup

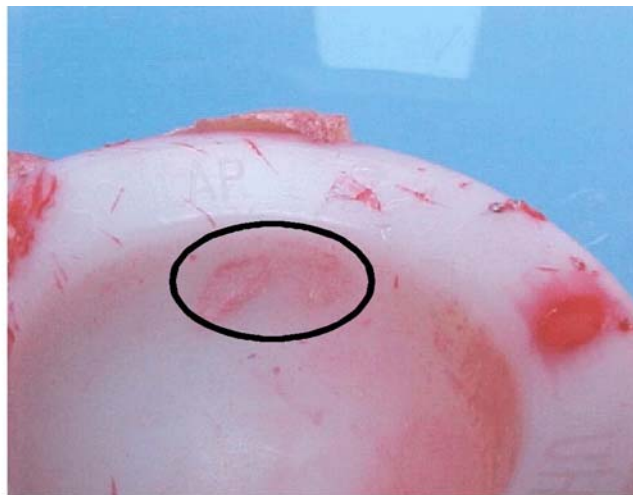
Figure 6.23: Butterfly wear pattern on inside of acetabular cup

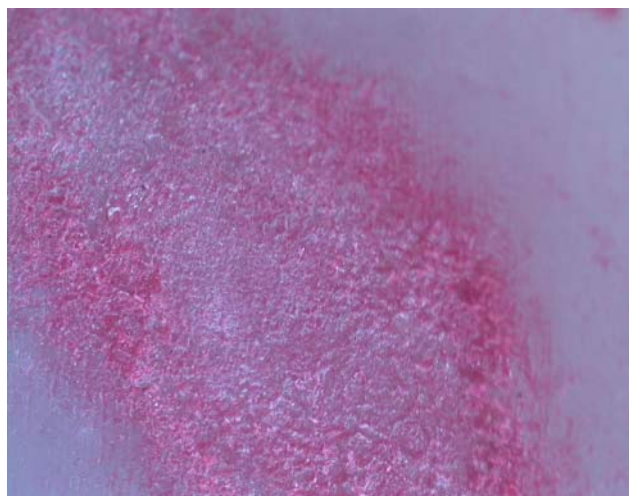
Figure 6.24: Area with adhesion wear (magnification x 40)

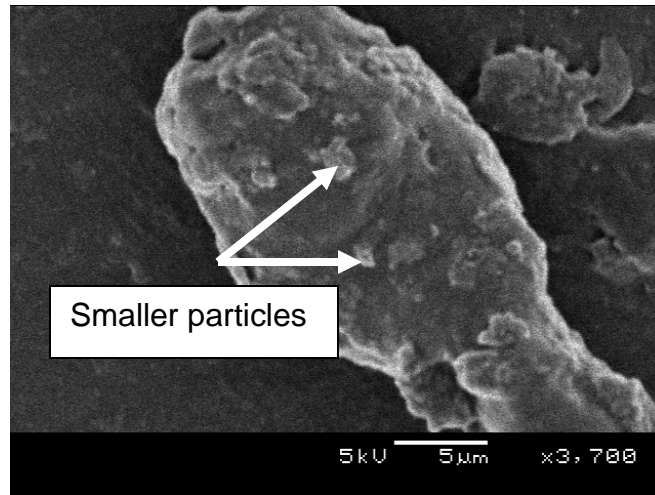
The typical particle that was dislodged from the bearing area is shown in Figure 6.26. This is also the type of particle that can result in the scratches, as shown in Figures 6.15 and 6.16. Examining the particle closely in Figure 6.26 actually reveals a number of smaller particles that were dislodged and is now adhering to the outer part of the bigger particle. The rest of the pictures can be seen in Annexure E. It must be noted that although the particle shown in Figure 6.26 was worked out of the high-pressure high-temperature area of the bearing, it was again attached to the base material when the pressure and temperature dropped sufficiently.

Figure 6.26: Wear particle with smaller particles attached to it
(magnification x 3 700)

The mechanism for the formation of this type of particle can therefore be described as a snowball effect where the smaller particles, which were sufficiently softened by the prevailing head and pressure, adhere to the bigger particle as this was rolling or skidding along on the inside of the acetabular bearing.

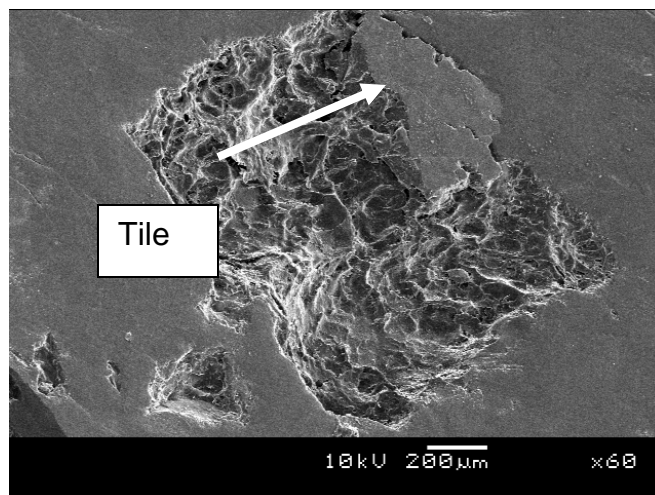
A second type of adhesion wear was identified where the surface layer of the acetabular bearing is ripped off in what looks like tile-shaped wear debris, as shown in Figure 6.27.

Figure 6.27: Area with adhesion wear (magnification x 60)

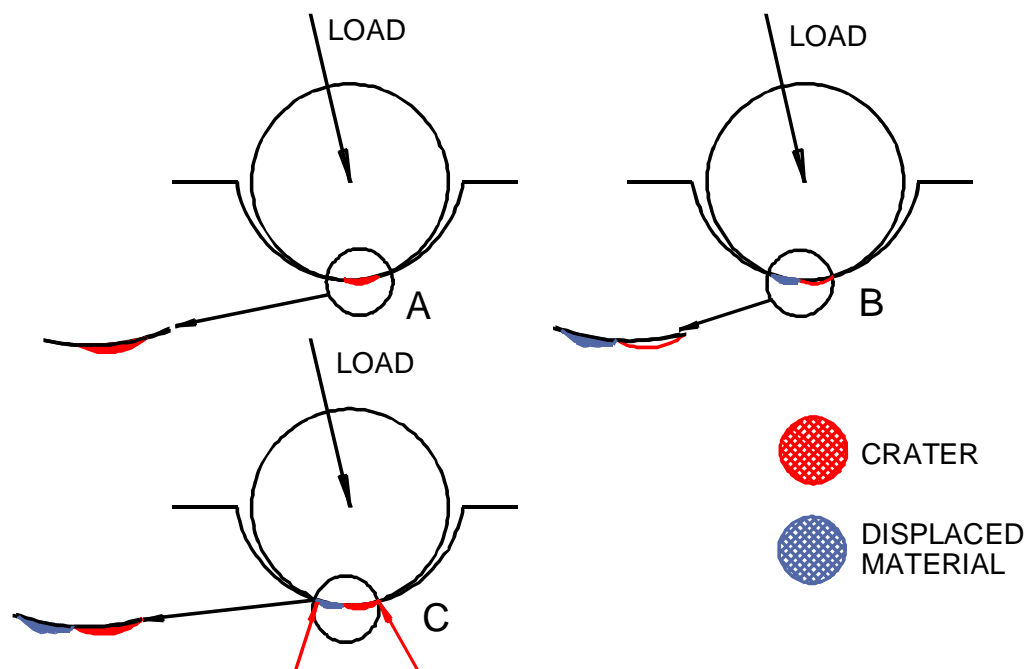
surface temperature at the point of highest loading increases accordingly. As the temperature goes up, adhesion between the femoral ball and the socket increases with a resultant higher heat input in the high-stress area. (See Figure 6.29(A).) A point is reached where the material has softened sufficiently and the adhesion has increased to the point where the bearing material is dragged along by the ball, in a similar manner to a wear particle being dragged along by a shaft in a rotating plain bearing couple. This leaves behind a crater, with the displaced material trapped between the cooler edges of the crater and the femoral head. Loading will flatten the material removed (see Figure 6.29 (B)) into a wafer with irregular edges as shown by the retrieved particles in Figures 6.26 and 6.28. If, on the other hand, a scratch exists under the wafer, there will be a tendency to extrude material along the scratch as a fibre or whisker as shown in Figure 6.17. It should be noted that the pressure in the wafer of removed material will be very high as the wafer will, in effect, be forced between the ball and the cup, effectively raising the ball relative to the cup with the load being mainly supported by the wafer. (Note that the flattened wafer can be forced into the bearing surface.) The particles will with time migrate through the bearing to the surrounding tissue.

A further aspect to consider is that after a crater has been formed, the edges of the crater will be bearing the highest load, as shown in Figure 6.29(C). The process described above will be repeated during the dynamic loading, with the result that the crater will grow in size and in depth, as is commonly observed in retrieved acetabular cups.

Figure 6.29: Steps in wear debris formation in acetabular cup
