**FAILURE ANALYSIS OF ULTRA-HIGH MOLECULAR WEIGHT
POLYETHYLENE ACETABULAR CUPS**

NICOLAAS DANIEL LOMBARD BURGER

DOCTOR PHILOSOPHIAE (PhD)

DECEMBER 2005

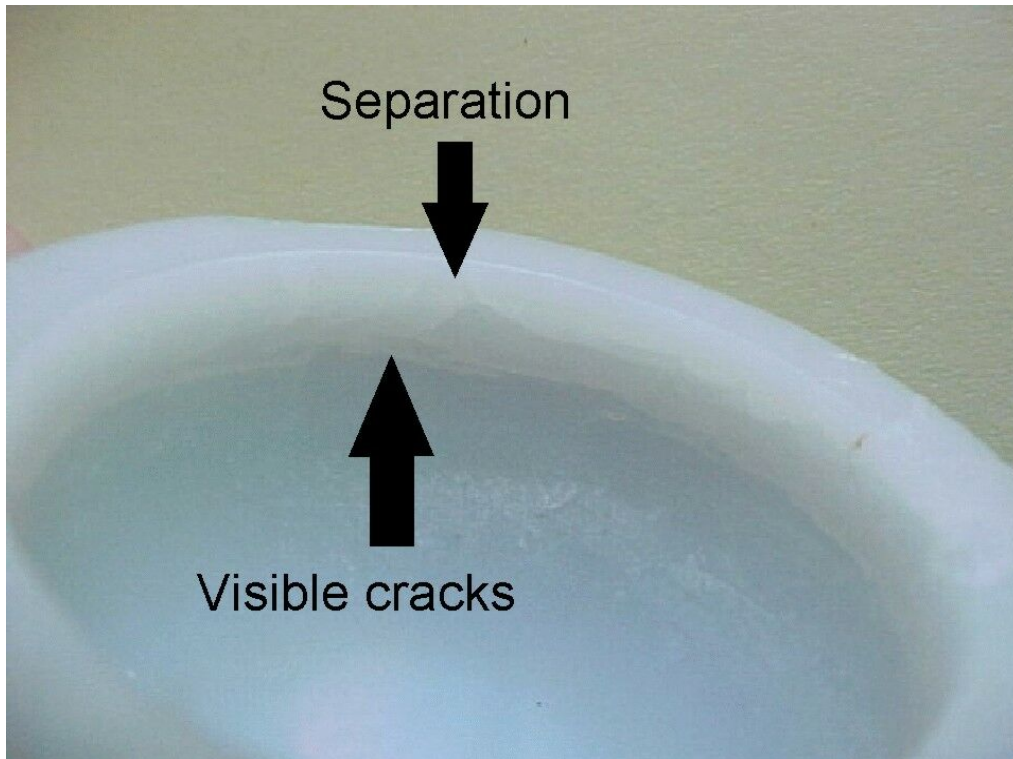
Fracturing of metal backed liners can conceivably also occur as follows: If the polyethylene liner is not machine-pressed into the metal backing, but only clipped into position, the possible lack of conformity between the cup and metal backing can cause higher stresses on the rim of the cup. The resulting alternating stress can cause fatigue cracks (Figure 4.3a) and separation within the material on the rim (Figure 4.3b).

Figure 4.3a: Metal backed acetabular cup with cracks on rim

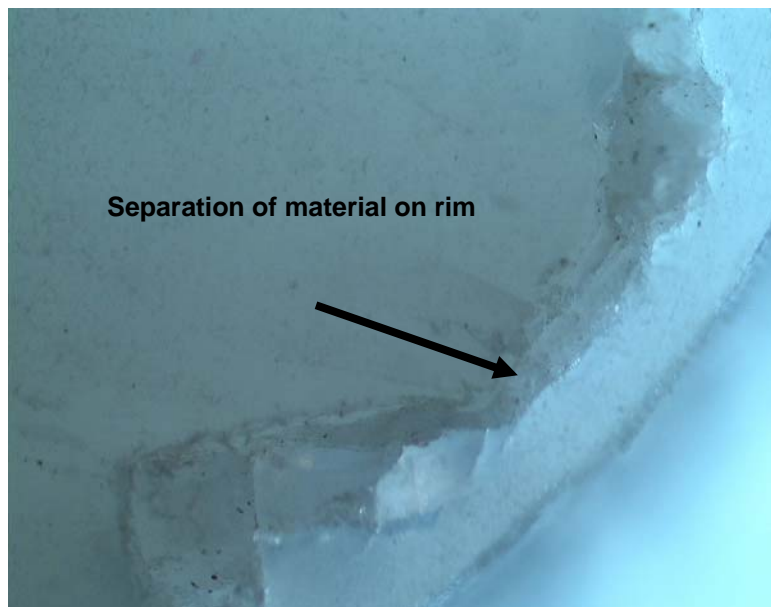
Figure 4.3b: Separation within material

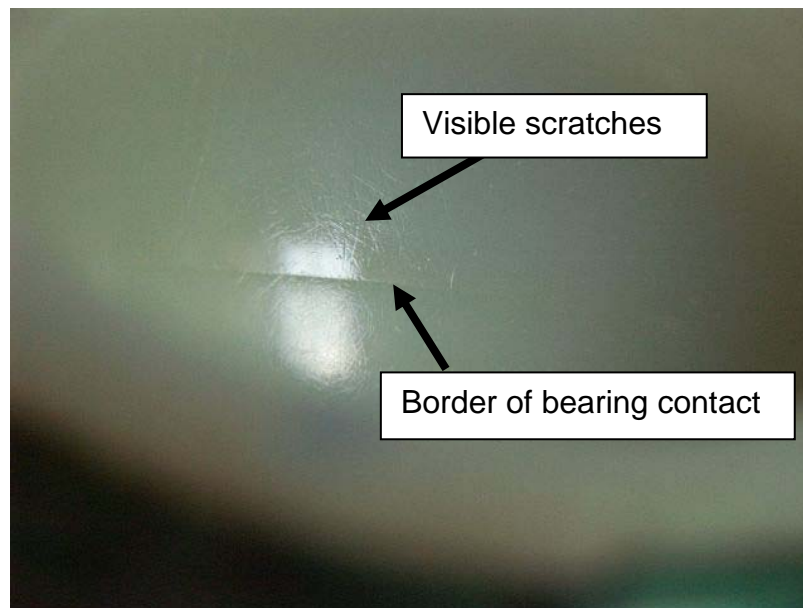
During examination of the retrieved cups, scratches were found in some of them. Although scratches on a micro scale have been reported in the literature (see Chapter 2), scratches visible with the naked eye are also present. These large scratches will be synonymous with third-body wear, independent of what caused the wear particles or the type of particles. The appearance of these scratches is not limited to the final wear area, but can also be created during the initial stages shortly after implantation. An example of a cup with this defect is shown in Figure 4.7.

Figure 4.7: Scratches visible on inside of cup

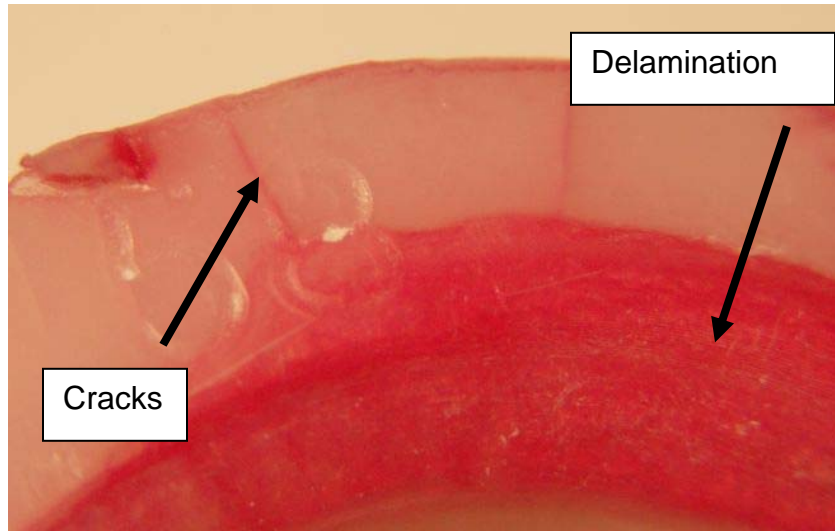
Figure 6.1: Metal back acetabular cup with cracks and delamination on rim of cup

This failure of cracks and accompanying delamination on the rim of the cup were only seen in metal back cups and also only in the metal back cups from one specific manufacturer. On closer inspection, it was noted that the UHMWPE liner does not fit snugly into the metal backing allowing the resultant forces in the hip joint to be transmitted into the pelvis via the rim of the UHMWPE liner only. This principle is schematically shown in Figure 6.3.

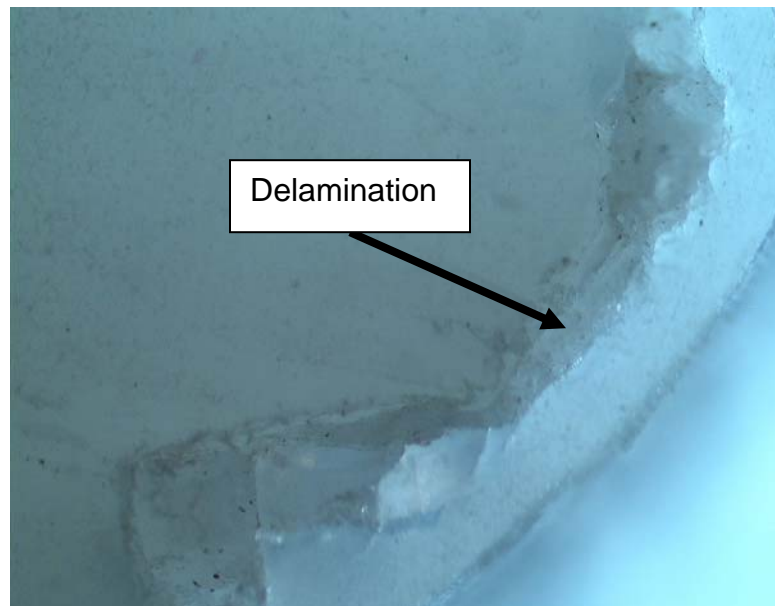
the area where the rim meets up with the body of the cup was also visible. This delamination varied from small localised areas to a single retrieved cup where this delamination was on the complete circumference of the cup. A cross section of a cup with this delamination visible is shown in Figure 6.2

Figure 6.2: Cross section of acetabular cup showing delamination on the rim of the cup (magnification x 20)

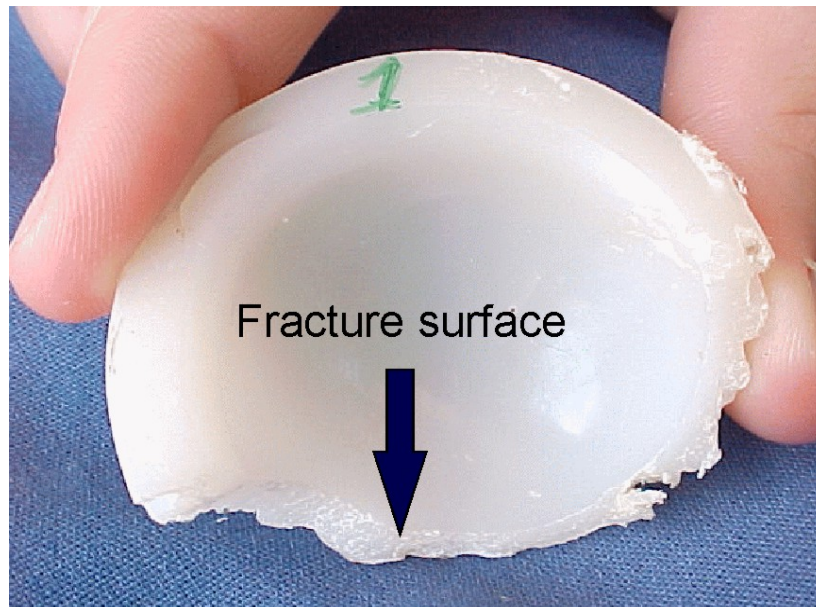
Cracks inside the bearing area can lead to the catastrophic failure of an acetabular component as can be seen in Figure 6.4.

Figure 6.4: Acetabular component after catastrophic failure

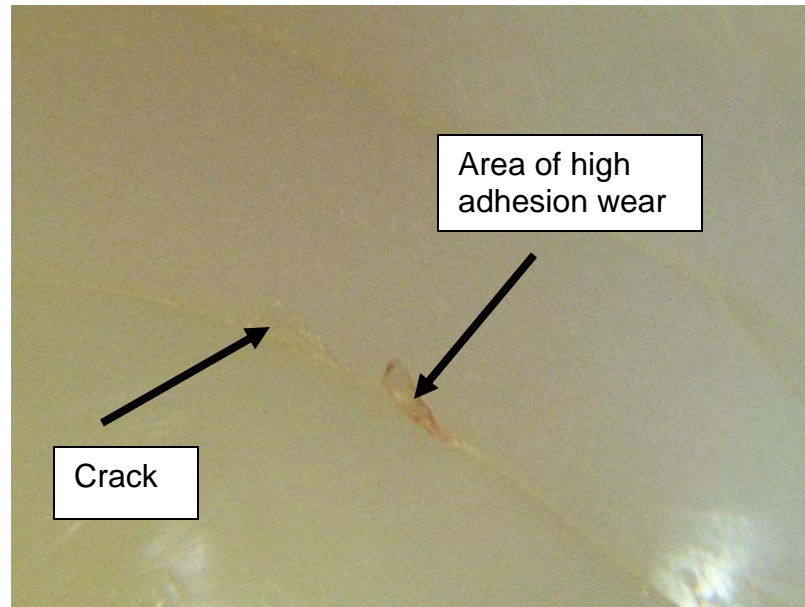
Figure 6.5: Crack on inside of acetabular cup

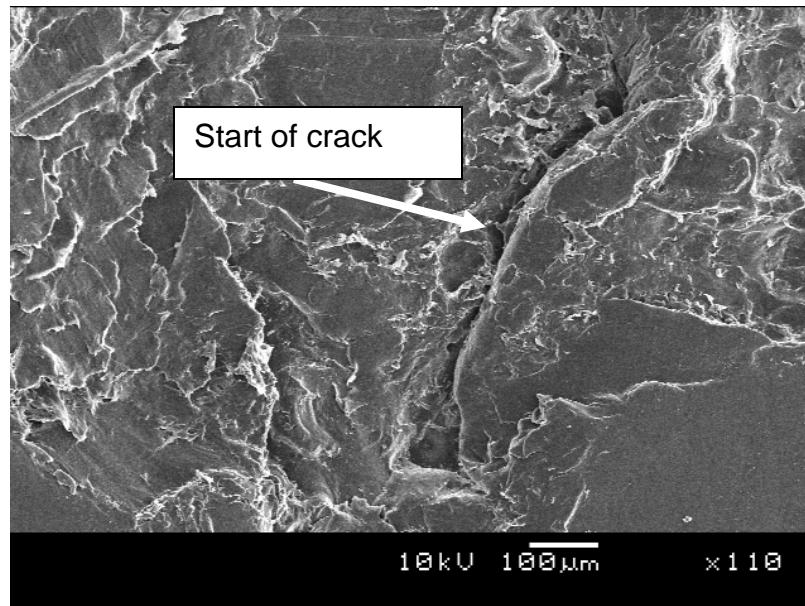
crack starting from an area of adhesion wear can be seen in the electron microscope picture as presented in Figure 6.6.

Figure 6.6: Electron microscope analysis of adhesion wear area (magnification x 110)

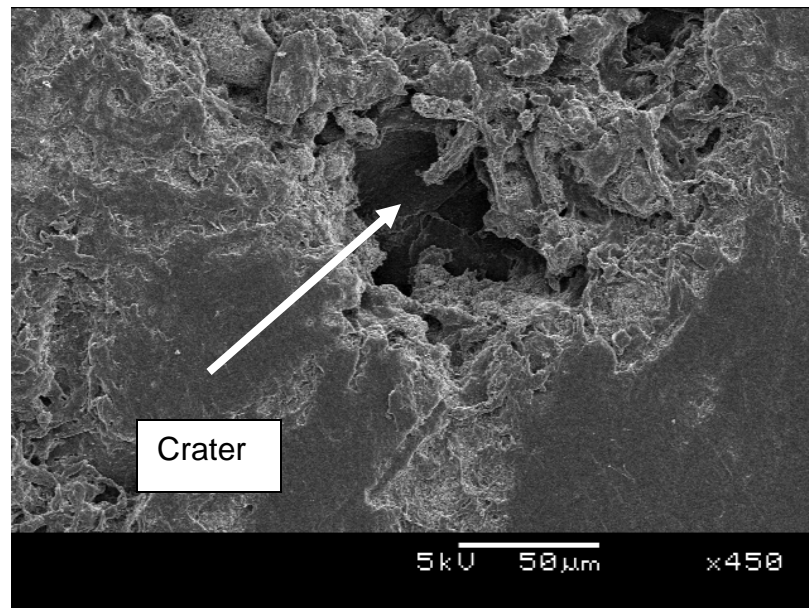
rise to areas with high stress concentrations. A crater under the surface after the removal of the top layer of material can be seen in Figure 6.7. Under the dynamic loading conditions, these stress raisers will lead to the formation of long cracks, which can lead to catastrophic failures of the acetabular component.

Figure 6.7: Crater under the surface after adhesion wear (magnification x 450)

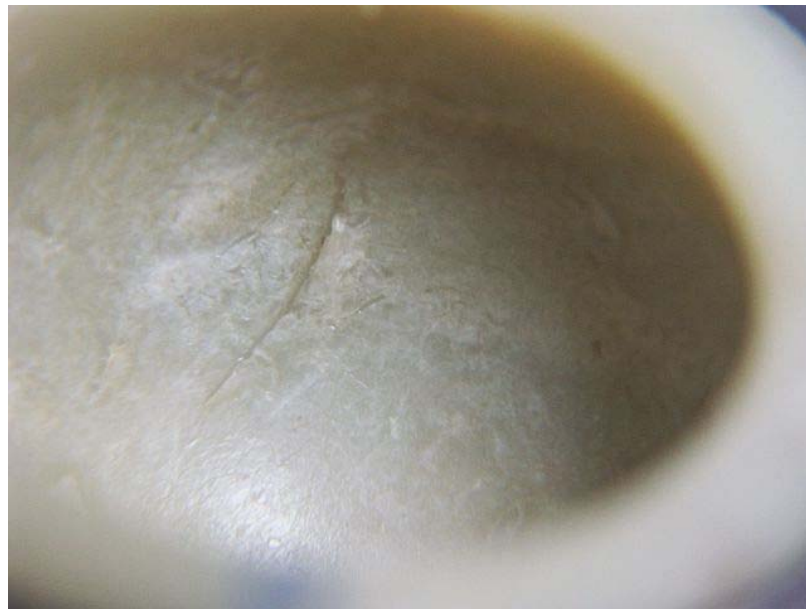
The entering of foreign particles into the bearing is not that uncommon. These particles normally originate from the PMMA cement with which the implant is fixated. An acetabular cup with severe signs of third-body wear is shown in Figure 6.8. In this specific case glass ionomer cement was used for the fixation of the implant. This type of cement is no longer in use and has been replaced with PMMA cement.

Figure 6.8: Acetabular cup with severe scratches on inside

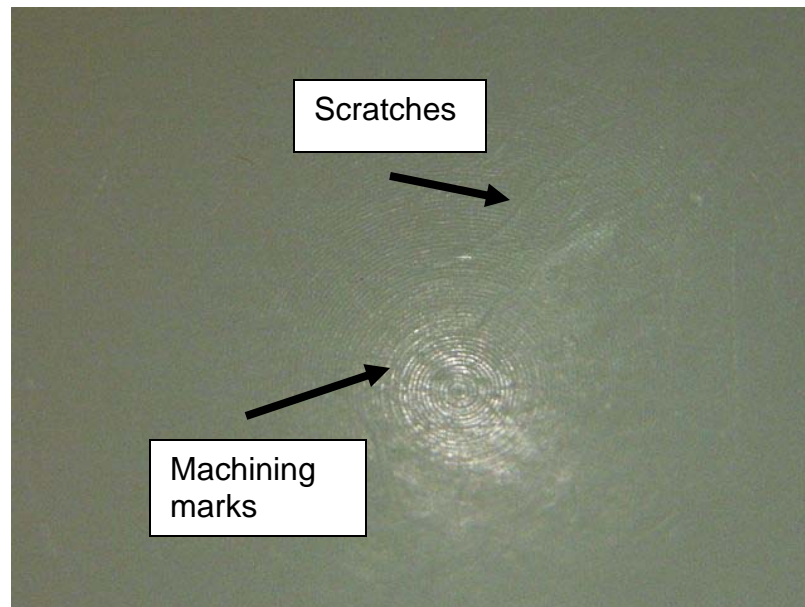
In all the acetabular components retrieved, scratches as a result of the normal wear products floating around in the bearing area can be seen. The majority of these scratches are too small to see visually and it can only be seen under a magnifying glass. Throughout the literature reference is made to multidirectional fine scratches (Jasty et al., 1997; Schmalzried et al., 1999; Haraguchi et al., 2001), which are not easily visible to the naked eye. An acetabular cup with multidirectional fine scratches under a magnification of 20X can be seen in Figure 6.9. (Note that the machining marks are also visible in the Figure.)

Figure 6.9: Acetabular cup with multidirectional fine scratches and with machining marks still visible (magnification x 20)

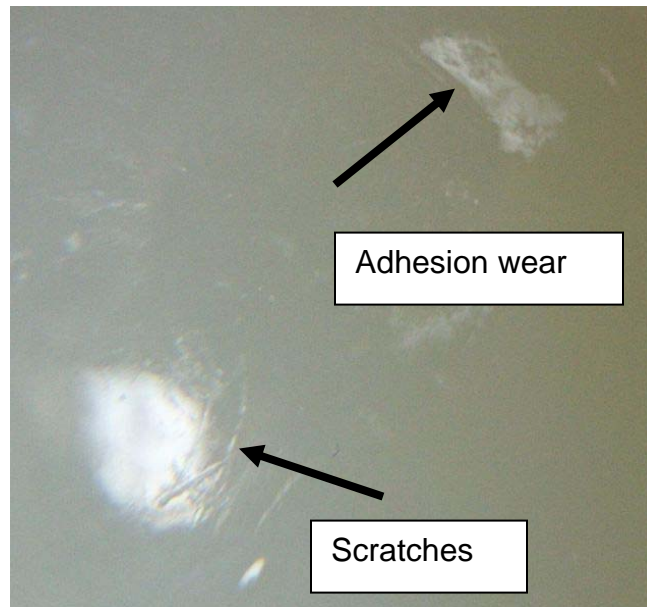
Scratches visible to the naked eye are also seen in some of the retrieved acetabular cups. When inspecting the acetabular components with a magnifying glass, treating it with dye penetrant spray and investigating under an electron microscope, the size and magnitude of these scratches become evident. The first impression is that this type of scratch must be the result of a third-body particle floating around in the bearing area. An acetabular cup with this type of scratch is shown in Figure 6.10.

Figure 6.10: Bearing area with signs of large scratches and area with adhesion wear

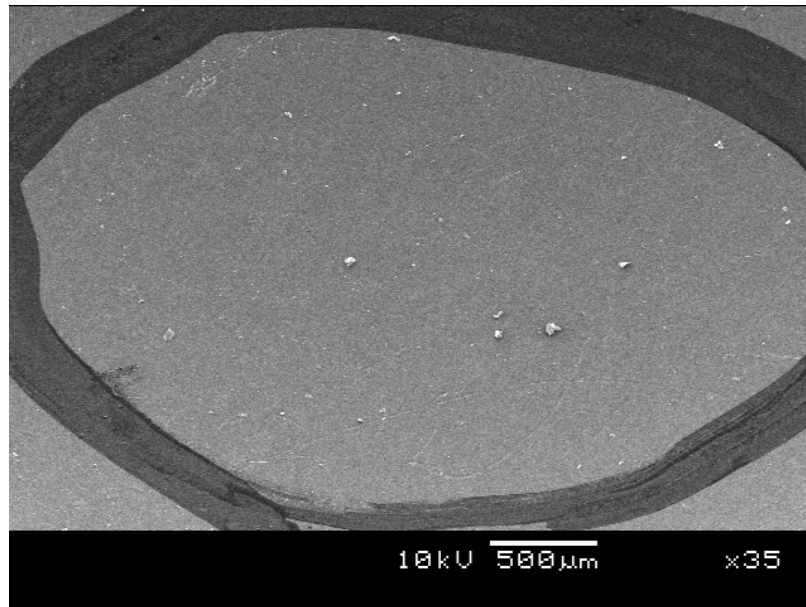
Figure 6.11: Scratches on bearing surface with white particles visible (magnification x 35)

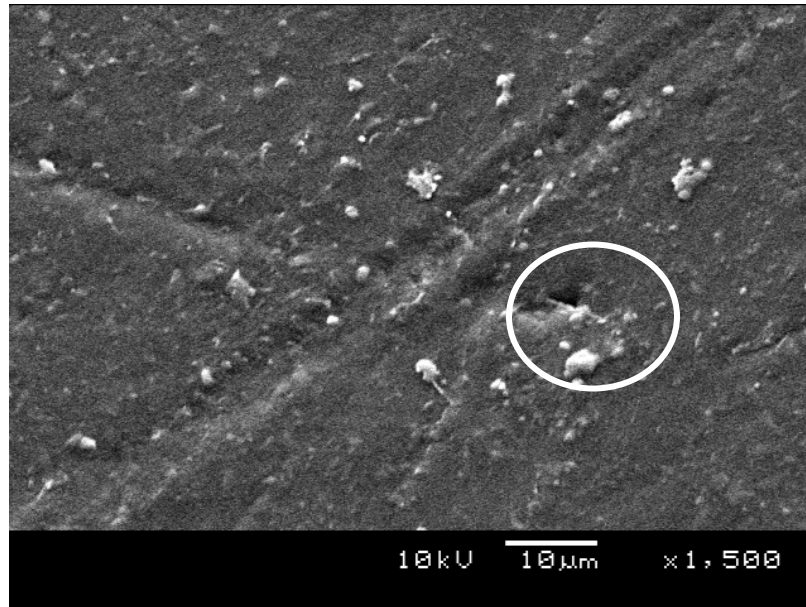
Figure 6.13: Final position of particle causing damage to bearing surface (magnification x 1 500)

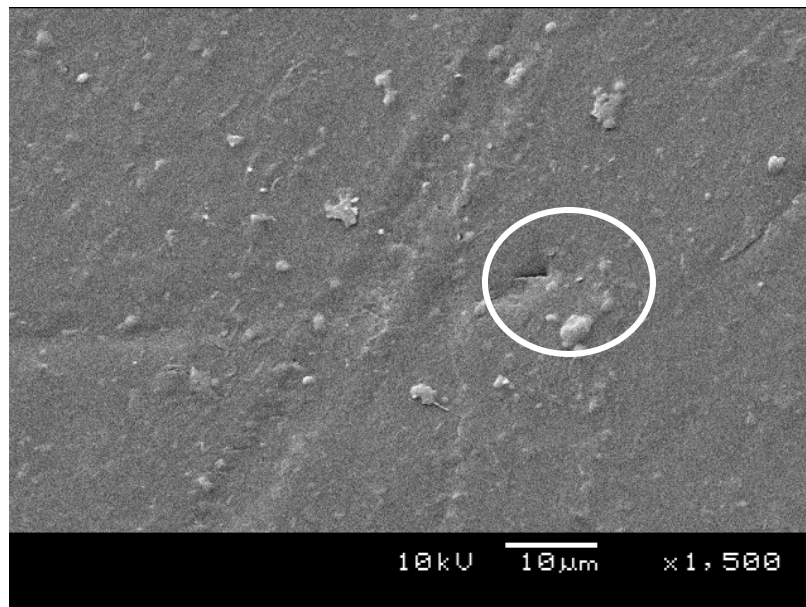
Figure 6.14: Electron microscope back scatter analysis of scratch (magnification x 1 500)

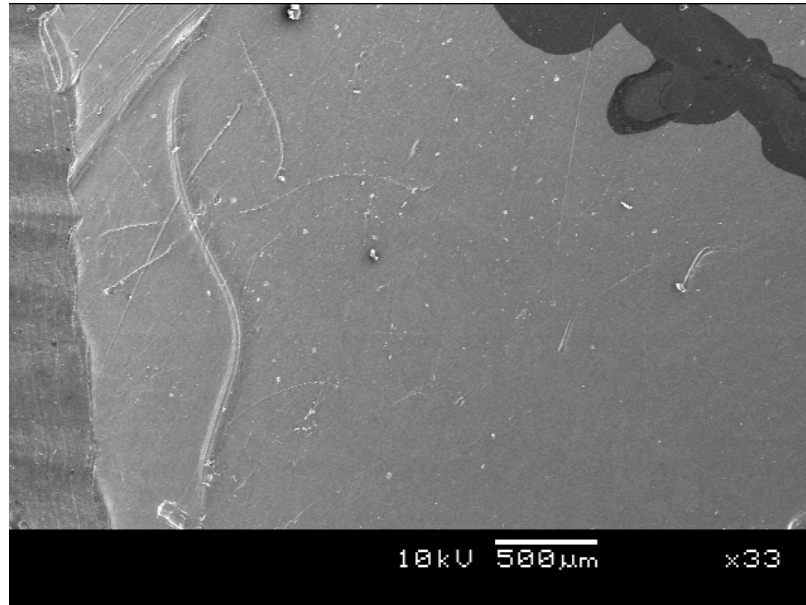
Figure 6.15: Scratch on bearing surface (magnification x 33)

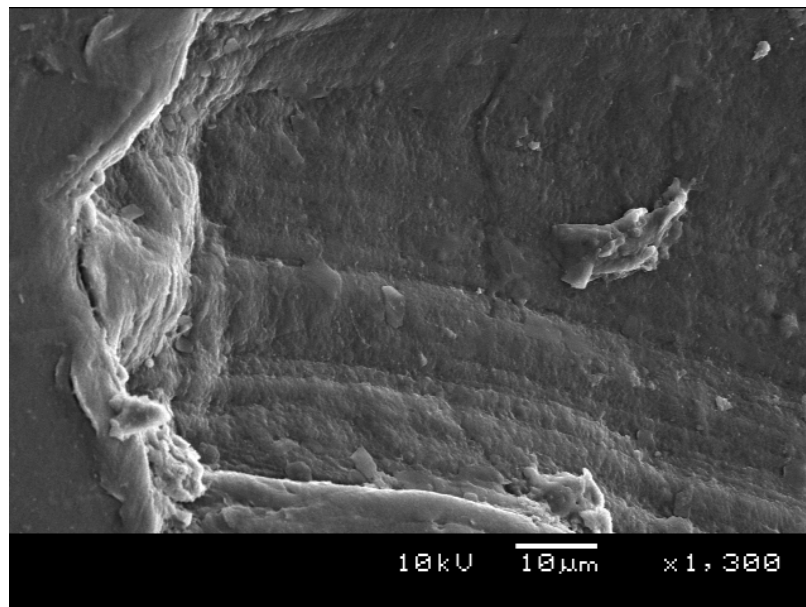
Figure 6.16: End of scratch on bearing surface (magnification x 1 300)

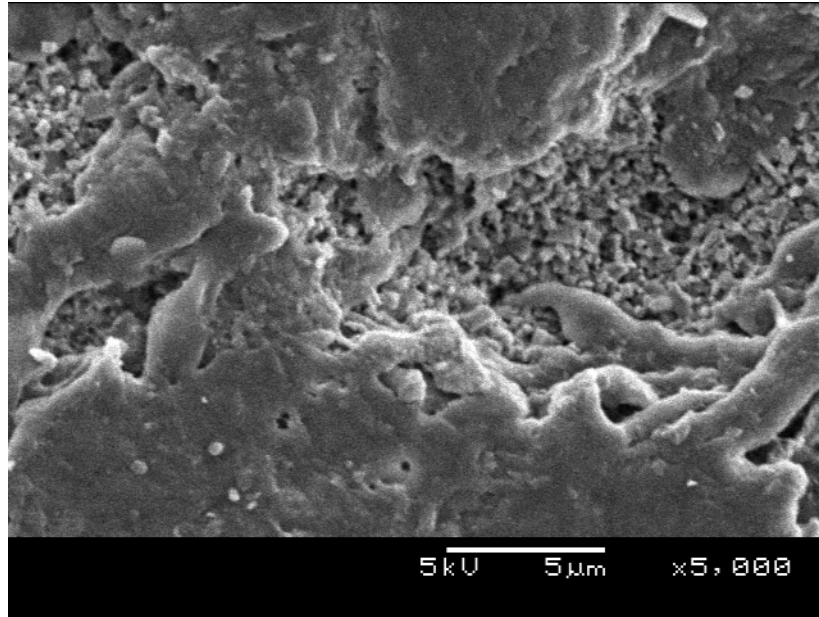
Figure 6.25: Area with adhesion wear exposing the base material of the acetabular cup (magnification x 5 000)

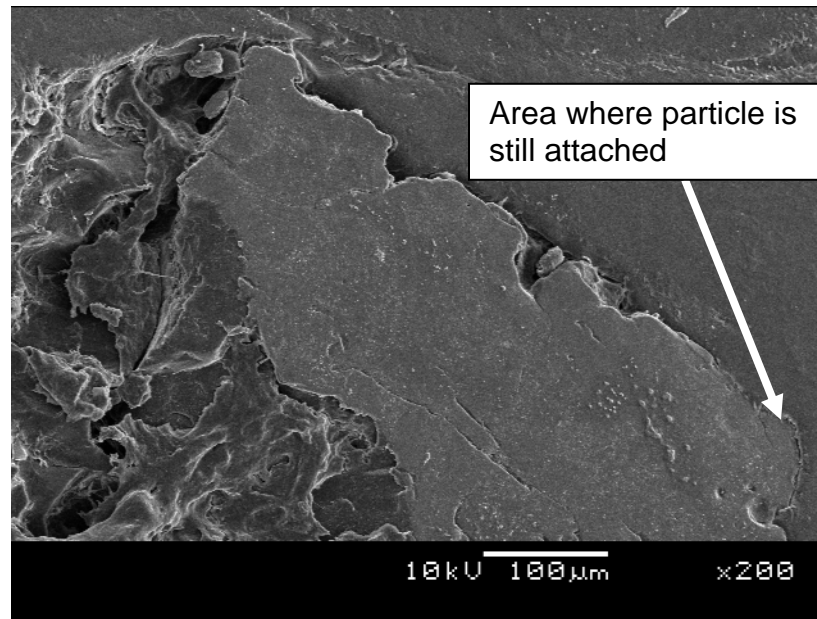
Figure 6.28: Adhesion particle about to be broken out (magnification x 200)

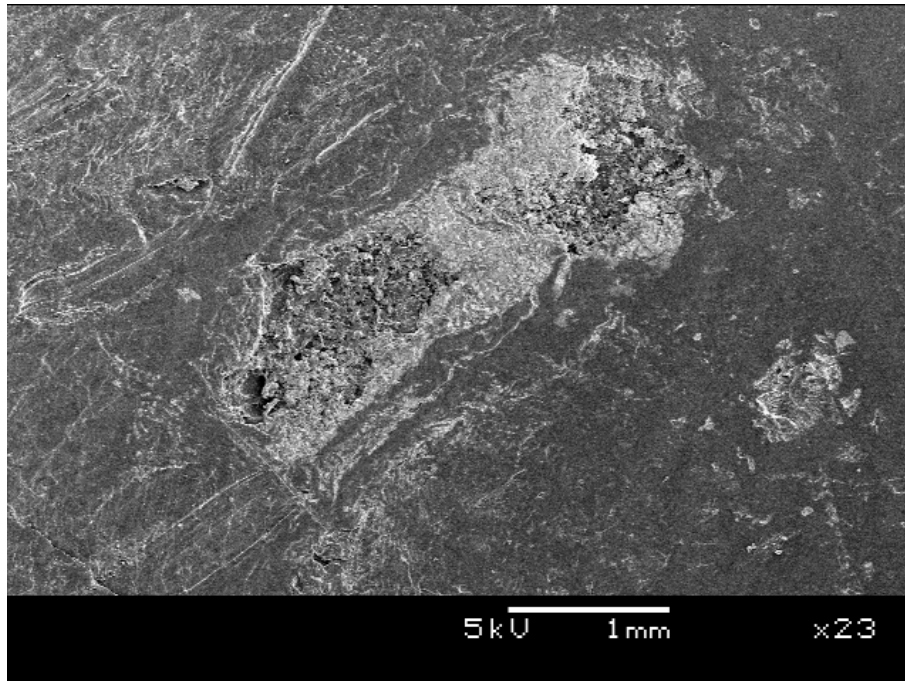
Figure 8.11: Adhesion wear on bearing surface of retrieved acetabular cup

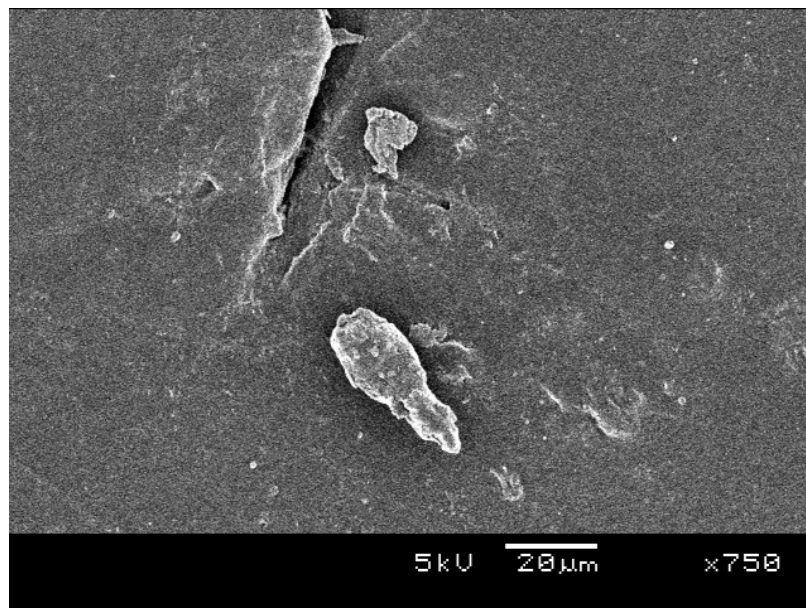
Figure 8.12: Wear particle still attached to UHMWPE acetabular cup
