Metals from K2 and Mapungubwe: A technological study of early second millennium material culture, with an emphasis on conservation

A thesis submitted in partial fulfilment of the requirements for
the degree

DPhil Archaeology

February 2013

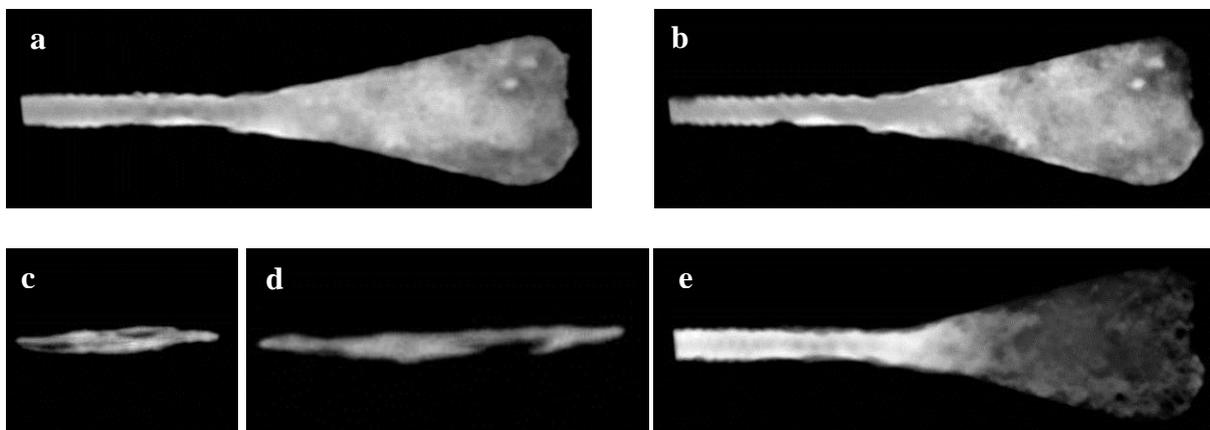
However, the wire twisted around the shaft is seen with greater clarity in the neutron images (Fig.3.8a, b). The fact that the wire feature stands out more clearly in the neutron images, suggest that the original iron has become almost completely corroded. Based on the neutron tomography axial slices, approximately 59% of the object consists of corrosion products, which are mostly concentrated in the blade. A Summary of the neutron tomography result of the object was given in Appendix D. Table: 3.1.

Figure 3.8. a) Neutron 2D image of SII. b) Sagittal tomogram slice near the mid plane showing detachment of corroded metal in the blade as dark areas. c, d) Neutron tomogram axial slices illustrating lamination and flaking in the blade. e) X-ray 2D image showing the metal core in the same zone as in the neutron sagittal slice.

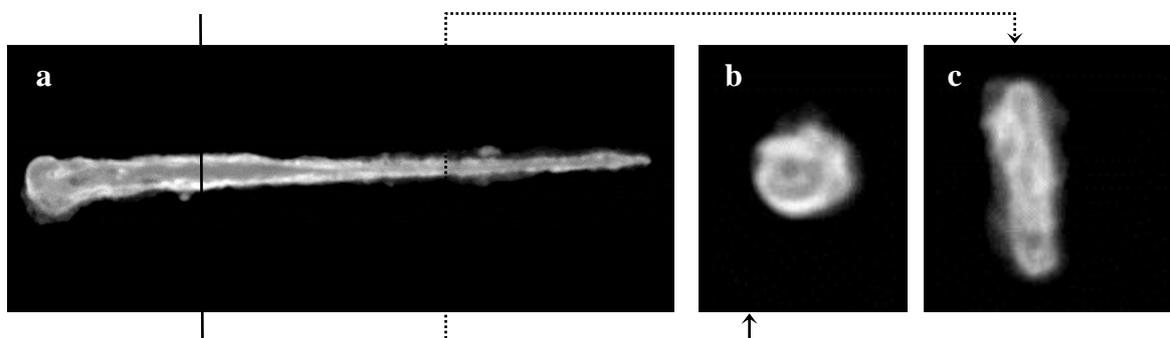
Neutron tomography of the object shows that it is not robust. The metal core is severely corroded and in some parts it has completely vanished. The original surface is uneven and extremely pitted. Low density corrosion products cover the entire surface area. The shaft has a loop in the top which was filled by corrosion products and seems such as a sphere now (Fig.3.9). A summary of the neutron tomography result of the object was given in Appendix D. Table: 3.1.

Figure 3.9. Neutron tomograms of SI3. a) Axial slice of the shaft. The penetration of corrosion into the metal core in this part has weakened the shaft. b) Axial slice of the blade. The remnant of original surface is uneven. c) Frontal slice. The sweat scraper has a looped shaft which is not clear among the corrosion.

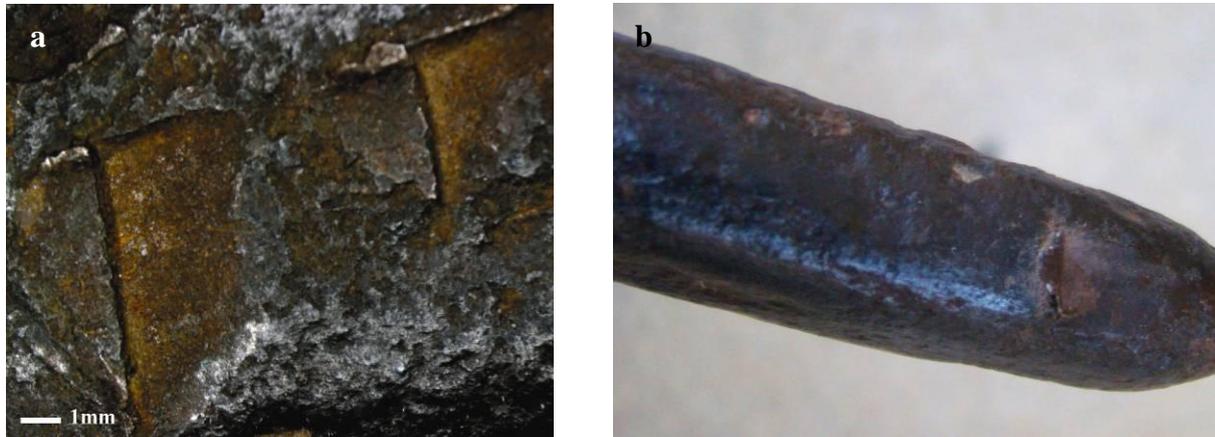
flaked on one side of the shaft. This flaking indicates that the hoe shaft was probably fixed to the hard surface of an anvil during hammering of the blade tip. The force of hammering resulted in sudden slipping of the hoe from the anvil. Scrubbing of the hoe handle and the hard anvil edge peeled the metal surface (Fig.3.16b). Compared to the other ones the shaft of this hoe has no sharp edges.

Figure 3.16. a) The broad scratch marks on the shaft of hoe (MI2). b) Foliation the metal caused by scrubbing with another hard surface probably a metal anvil.

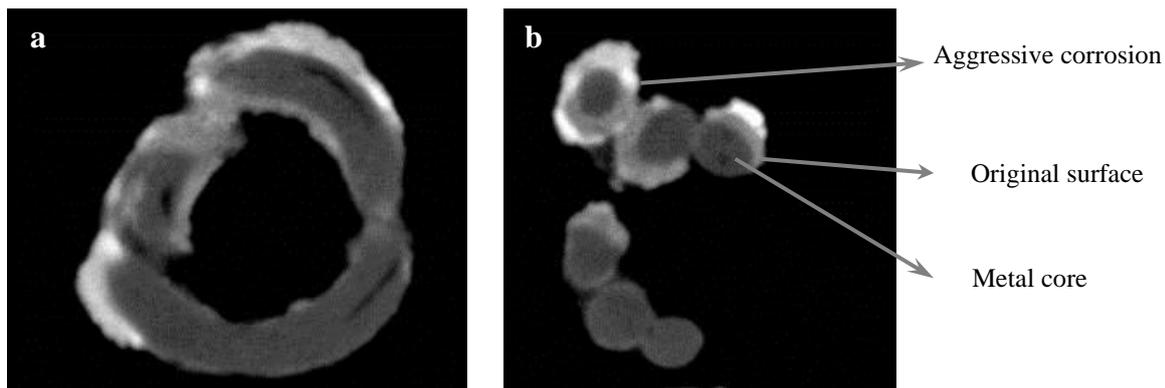
Figure 4.5. Neutron tomograms of MC1. a) Frontal slice b) sagittal slice shows how aggressive corrosion disturbed the original surface.

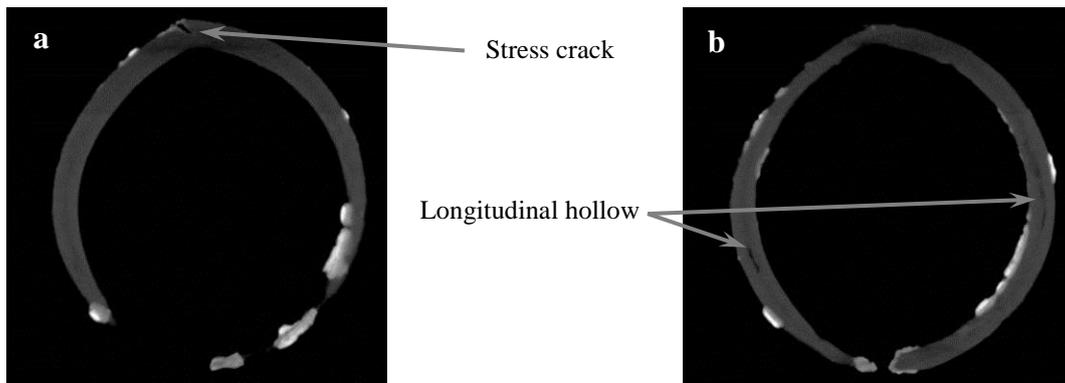
Figure 4.6. Neutron tomograms of MC2. a) Frontal slice. Deformation of the bangle almost in the middle resulted in a crack in this zone. b) Frontal slice. Two longitudinal hollows are observable along and within the wire. The original surface is seen within the corrosion products in some places.

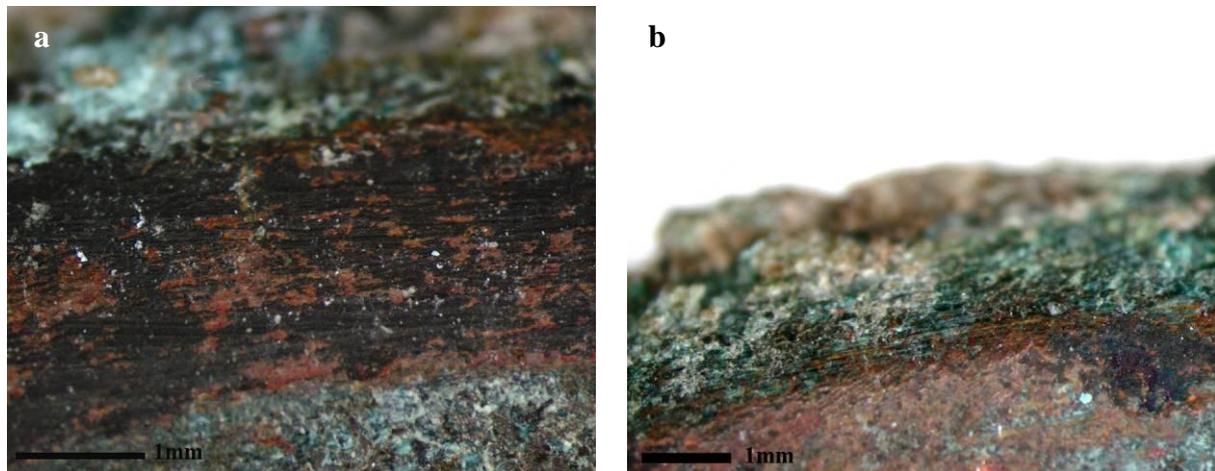
Figure 4.9. a) Unparallel abrasion lines on the surface of copper bangle (MC12) which covered partly with red and black corrosion products. b) Continuity of abrasion lines under green corrosion layer.

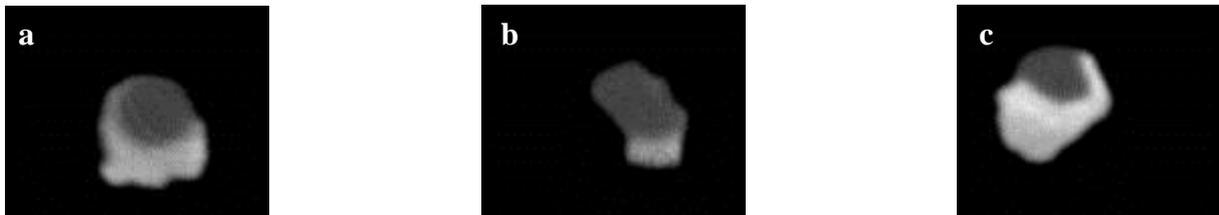
Figure 4.11. Neutron tomogram axial slices of KC2 a. b) Round and rectangular cross section of the rod in opposite side. c) Penetration of corrosion products in metal core almost to the middle of rod.

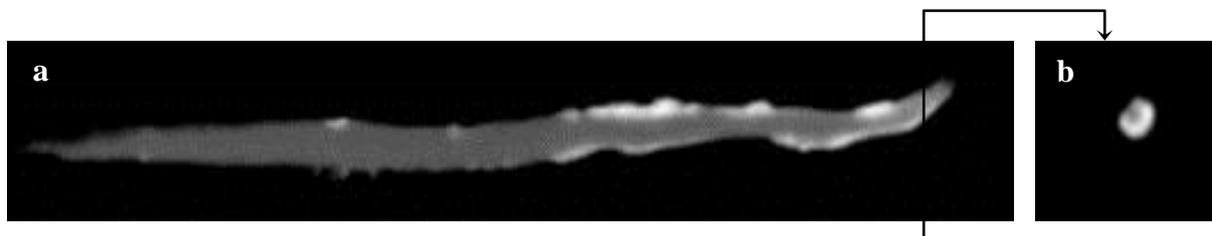
Figure 4.12. Neutron tomogram of MC4. a) Frontal slice. This slice shows half part of the object toward its narrow point. b) Axial slice. The low thickness of the remnant metal core in narrow end of the peg is observable.

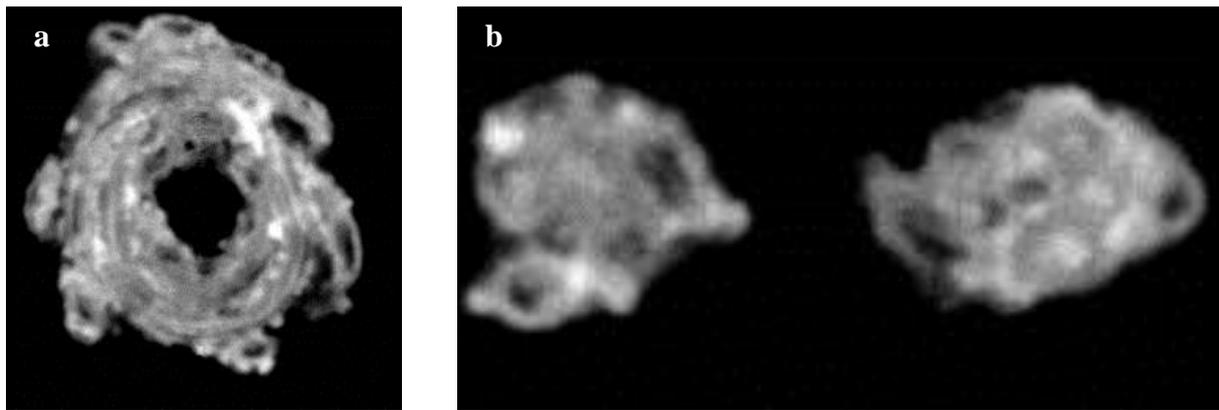
Figure 4.19. Neutron tomograms of SC1. a) A sagittal slice revealing the presence of hollows among the wires, corrosion products as bright white areas and original winding path in dark gray. b) Frontal slice revealing the cross section of the ring and the presence of a core region inside the wire that remains intact only inside some strip wires.

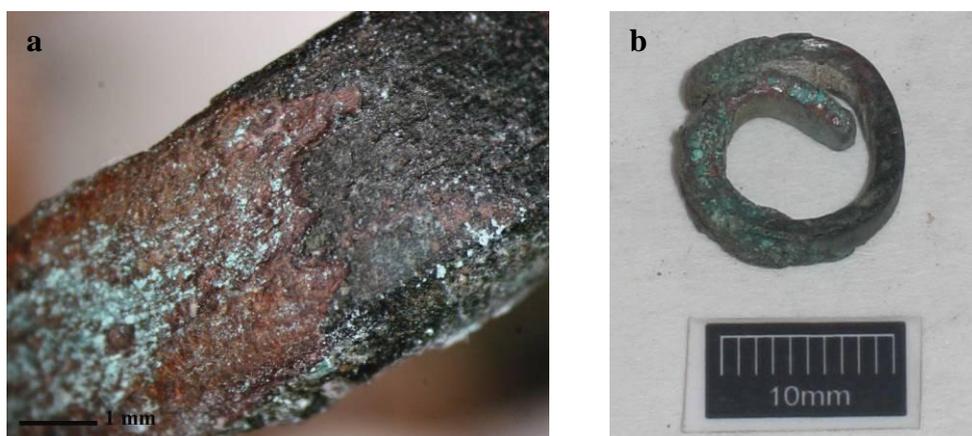
Figure 4.20. Small copper ring (SC2). a) Sever mechanical cleaning resulted in removing the cuprite layer from some parts of the surface. The jagged form of cuprite layer in edge shows it was produced as the result of surface abrasion by a hard material. b) Copper ring (SC2) before treatment.

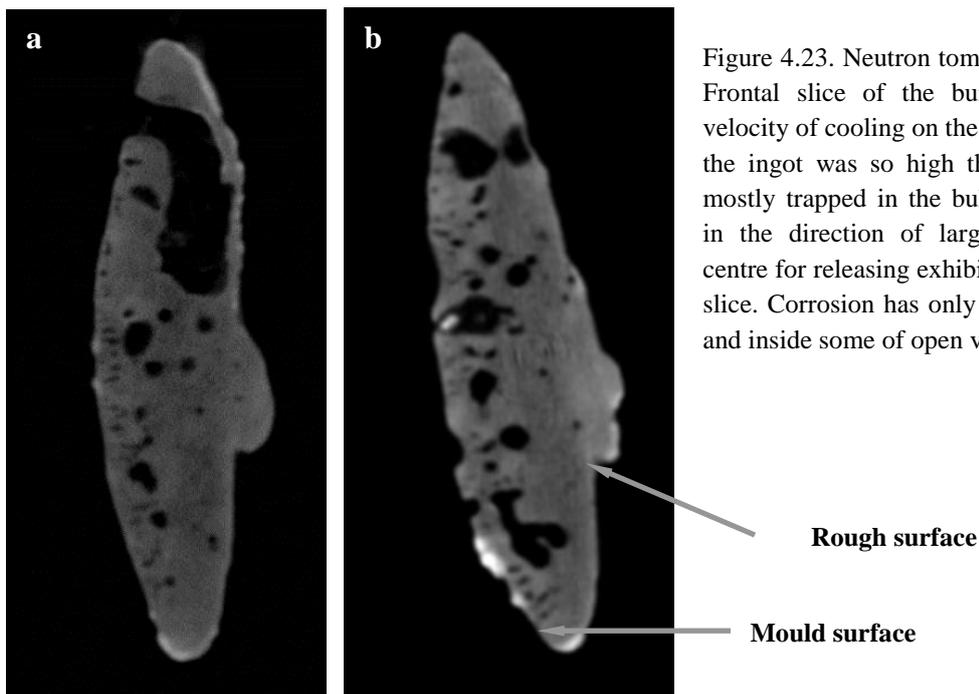
Figure 4.23. Neutron tomography of MC9. a) Frontal slice of the bun ingot shows the velocity of cooling on the surface and sides of the ingot was so high that the gas bubbles mostly trapped in the bulk of ingot. Change in the direction of large void toward the centre for releasing exhibits this fact. b) Axial slice. Corrosion has only seen on the surface and inside some of open voids.

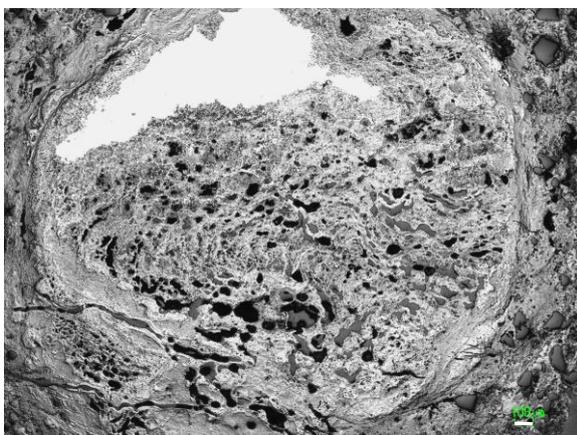
Figure 5. Overall micrograph of the rod (MI6) showing small metal remainder within corrosion products which have kept the physical shape of the metal. (Scale: 100μm)

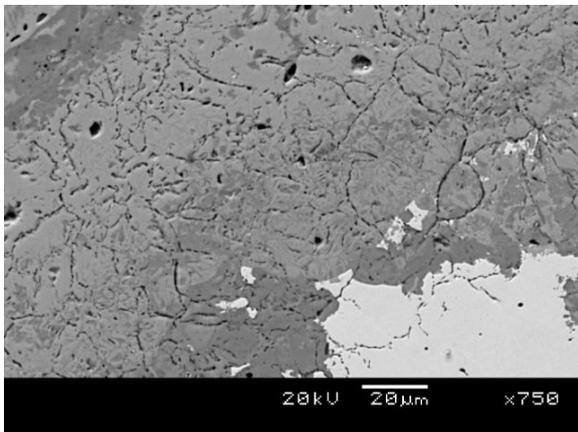
Figure 9. Polished transverse section of (MI6) shows fine cracks within the metal matrix and its fossilized structure within corrosion products. (SEM-BSE)

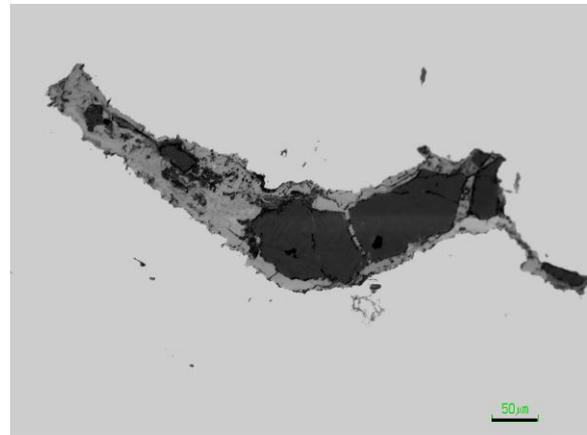
Figure 28. Micrograph of slag and oxide inclusion within metal phase in (MI2 shaft) with transverse fracture in glassy phase. (Scale: 50μm)

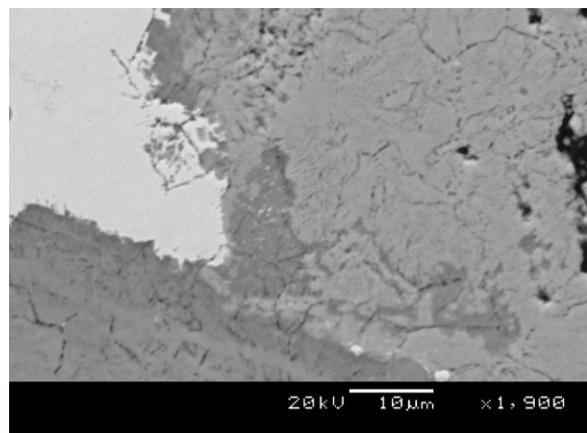
Figure 54. Stress corrosion resulted in formation of fine cracks in metal phase in block twisting wire (MI8). (SEM-BSE)

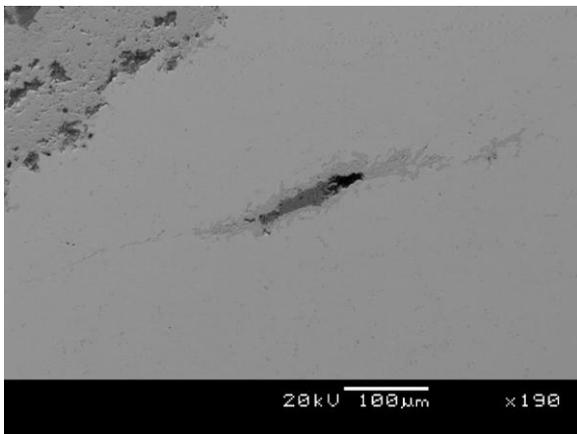
Figure 69. penetration of corrosion within fissure present in metal phase in MC12. (SEM- BSE).

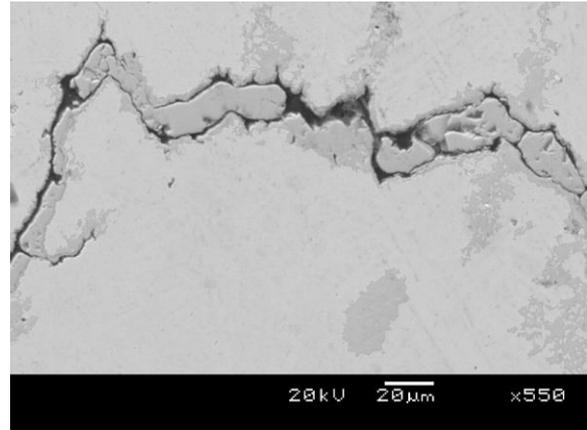
Figure 80. Transverse section of MC8 in shank shows central open wide crack within metal phase along with patches of corrosion in its vicinity. (SEM-BSE)
