Mining through areas affected by abnormal stress conditions at Syferfontein Colliery

by C. Legote*

Paper written as project work carried out in partial fulfilment for BEng (Mining Engineering) degree

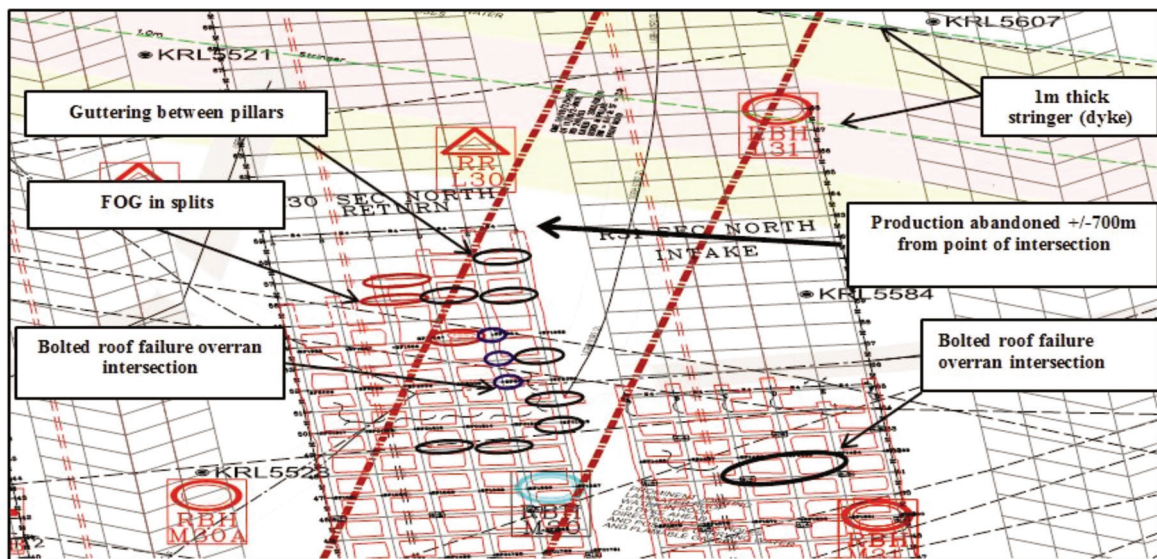
- to less than 5 m)
- ▶ Large volumes of strata water entered the working face, even with the drilled drainage holes
- ▶ Observed roof failures were time-dependent, occurring during production and up to four weeks post-production, driving the need to re-support back areas with wire mesh plus additional roofbolts. This had an adverse impact on planned rates of productivity
- ▶ Production was first halted in this panel due to the resulting reduction in productivity
- ▶ The section moved to the adjacent R30 North Return panel (Figure 3). Similar conditions were anticipated and the increased support strategy was implemented from the onset. Similar failure conditions as in the adjacent panel persisted, but were more serious. These included bolted roof failures that overran intersections, falls of

ground within splits, and increased guttering between bolts

- ▶ As indicated in Figure 3, the nature of the failure conditions drove the section to minimize the number of mining roads from seven to three. This became unproductive and posed further strata and ventilation challenges
- ▶ Production in this panel advanced only 250 m from the adjacent panel before it was abandoned due to low productivity and safety concerns.

Figure 3 – Map indicating conditions in the section 3 panels leading to abandonment of production

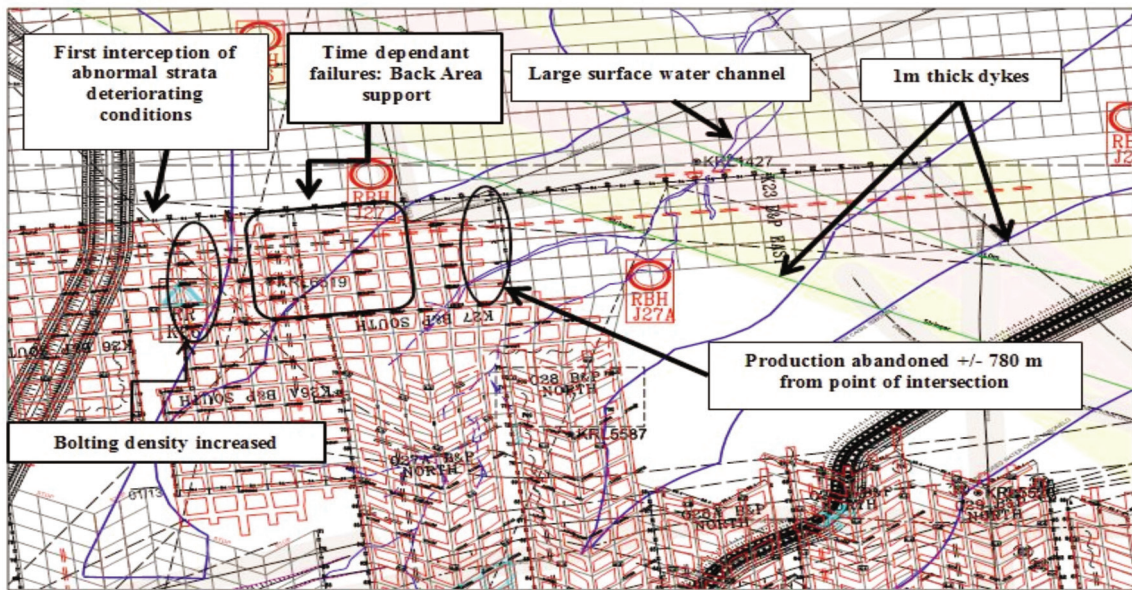
- ▶ Exactly the same failure conditions as in section 3 were observed in section 6. Section 6, however, was mining in an eastern direction more than 1 km from section 3. Adverse conditions became apparent in the K22 B&P

East panel, before the section relocated to the adjacent K23 B&P East panel.

- Water-driven falls of ground resulting from bursts of intruding water occurred before drainage holes could be drilled. Occurrence was close to the face and before roof support could be installed
- Mining span was also reduced to counteract the falls of ground without increasing the pillar centres.
- Similar to section 3, it was found that the failures in all panels followed a NE-SW direction and were aggravated by reactivated joint planes
- Production was eventually abandoned citing similar reasons as for section 3.

- Dyke structures have a propensity to concentrate stresses around them (Khumalo, 2012). Both sections were approaching a 1 m thick dolerite dyke, but its influence on the stress conditions was overlooked as both section halted production approximately 250 m away from this dyke (Figure 4). The magnitude of concentrated stress is not necessarily related to the size of the feature but rather to the nature and source energy at deposition, as alluded to by Muaka (2013). This was evident with similar cases around the mine, yielding different conditions

Figure 4 – Map of section 6 highlighting conditions in the panels
