03

SITE AND CONTEXT

3.5 CURRENT BUILDING CONDITION

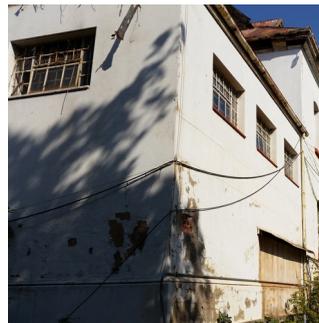
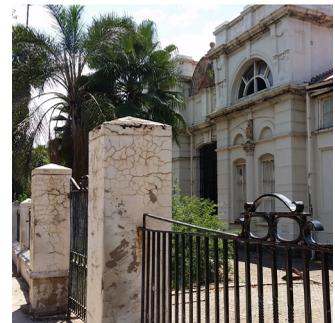
Walls and Paint

The building has originally been finished with a lime plaster. The plaster is giving way and is peeling off in various places. Hairline cracks, are also visible in the plaster, due to the lack of maintenance and water seeping into the walls. The bricks, used for the construction of the building, are very soft and porous, and easily erodes when coming in contact with water.

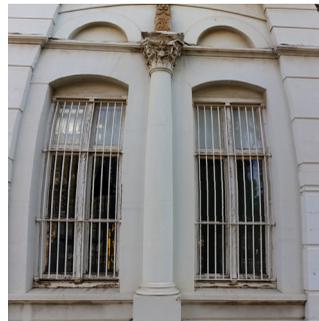
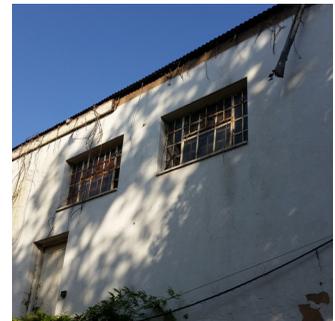
Windows

The clerestorey windows on the southern side as well as the western side has been painted, and so no light can penetrate through. This makes the southern wing and the western wing very dark inside.

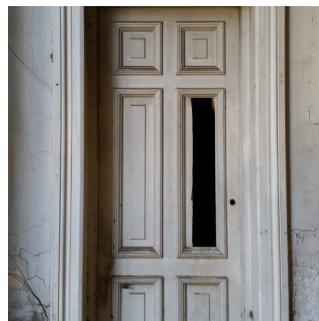
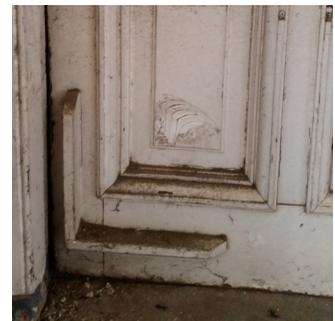
Some doors have been vandalised and have broken panels. There are also traces of repair work carried out on doors, in an attempt to close holes in the timber. Doors to the foyer space, have been nailed into a semi-closed position.

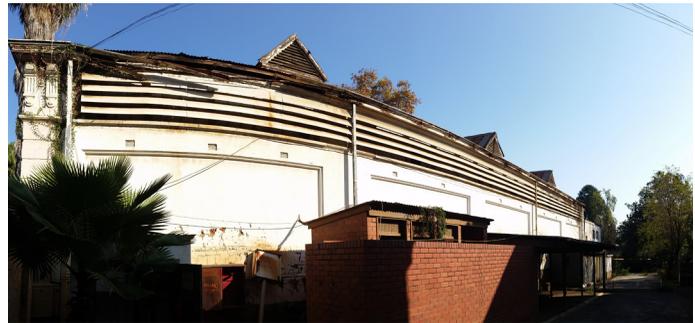
Roof

Gutters and downpipes are rusted and weathered, and at some places missing.

The roof panels are very old, and at places rusted through, causing water to seep into the building.

The roof structure is very old, and although an investigation of the trusses could not be made, it is advised that the trusses be inspected for structural integrity and replaced or strengthened where needed.

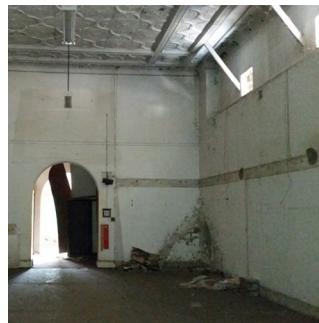
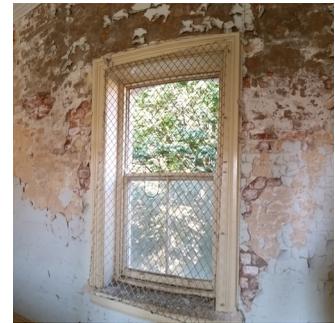
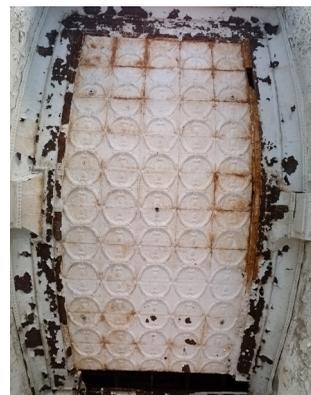
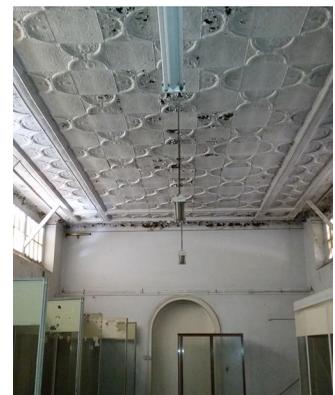
At some places the paint is peeling off, and where roof panels have sustained major damage, water has in turn also caused major damage to the plaster. This is mostly evident on the first floor of the northern wing.

The original pressed steel ceiling panels are rusted in places and the paint is also peeling in some areas.

Interior walls have also been finished with a lime plaster. In order to prevent paint, that was later added, to seep into the walls, a pitted plaster was added to the interior walls (Niebuhr 2007:157). It is still best advised to use a lime based paint on all walls.

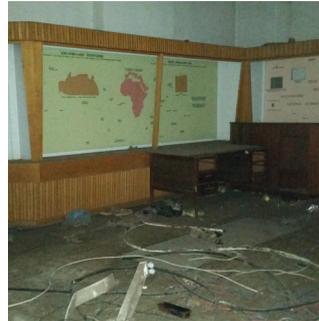
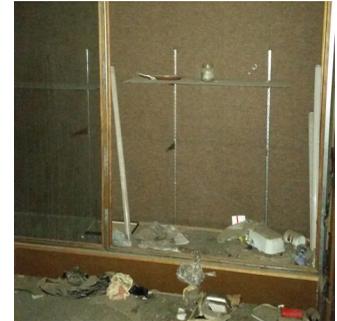
Various partitions (for exhibition show cases), have been added to the interior at later stages, but have, with the building being vacated, been damaged and half-removed. Partitions have been added to define different office spaces in the northern wing of the building, but have been vandalized and are in a poor condition.

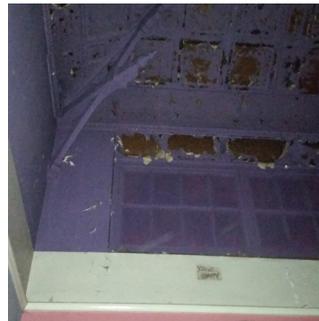
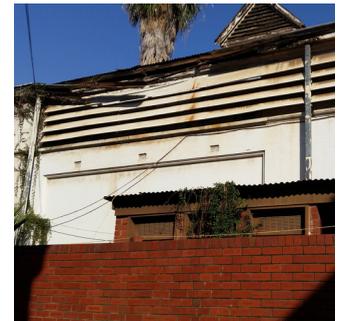
Clerestory windows in the exhibition halls of the southern wing, have been painted black, presumably in order to have better control over light. This has a very negative impact on the interior space, due to the lack of both natural and proper/ focused artificial light in the space. External, horizontal asbestos louvres have also been added by one of the previous zoo directors (Niebuhr 2007:163). It is presumed that these louvres have been installed to prevent any direct (specifically eastern and western) sunlight from entering the spaces, but they block most of the natural light from entering the spaces, and have a negative effect on the spaces.

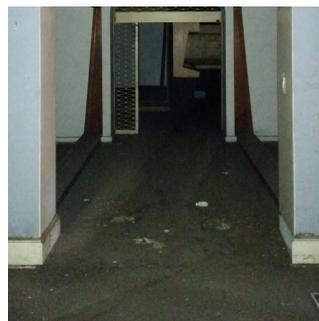
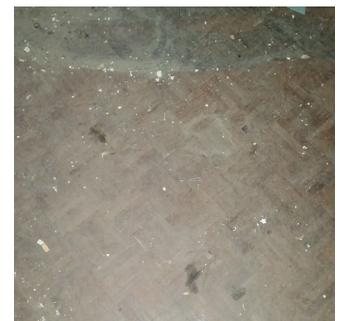
The imported black and white checkered marble floor in the entrance foyer, is in a good condition. The original 110mm Oregon Pine timber floors have, sustained minor dents and breakages to planks. The floors were been covered with battleship lino floor covering in the western wing and with "Hunt Leuchars & Hepburn" parquet flooring in the eastern wing in the late 1960s.

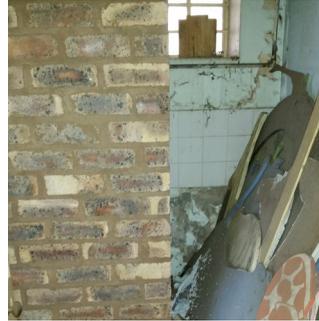
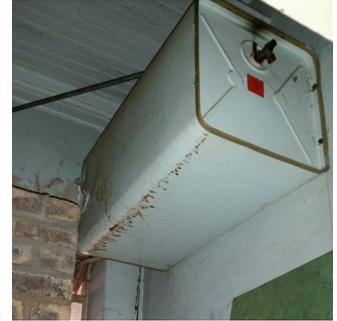
Additions

The addition of a toilet, shower and wash hand basin, to the administrative wing of the building, has been done poorly without a conscious response to the building fabric in a respectful manner.

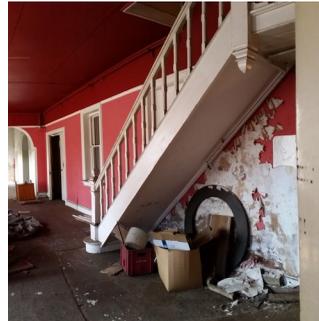
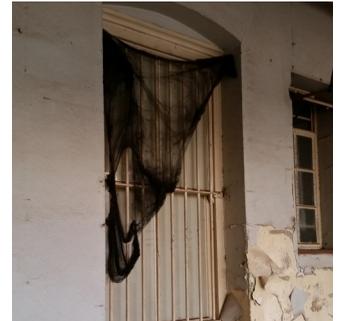
The staircase to the first floor, of the administrative wing, has been built according to the original plan, but goes past a window right up against the wall, and is a poor execution of a staircase in the space with relation to the façade. This window has consequently been boarded up.

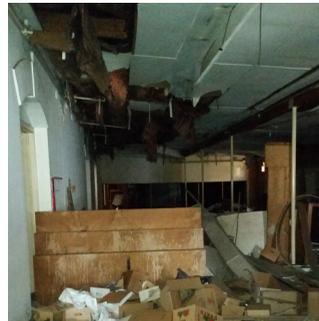
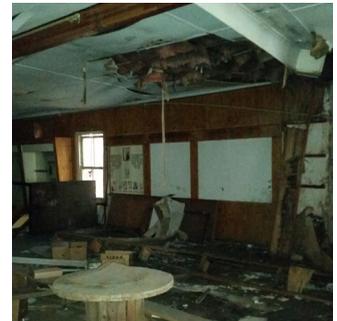
A large part of the roof, of the added building section in the courtyard, has collapsed due to water. This space is in a very poor condition and is badly vandalised.

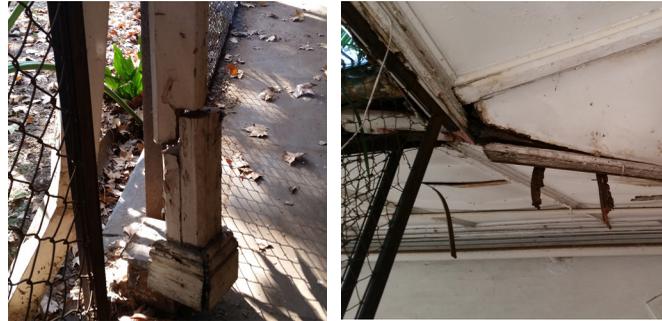
Roof

The veranda roof has due to a lack of maintenance, corroded severely. Various roof panels are rusted through, which has damaged ceiling panels. Some of the timber beams are rotten and not structurally sound any more. The timber columns are also rotten at places, and some are even missing in total.

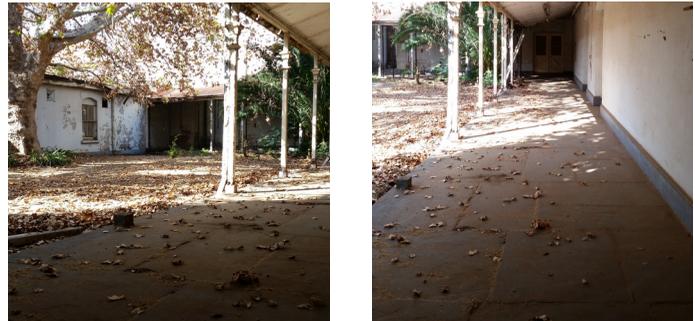
Floor

Local Blue slate slabs (presumably from the Erasmuskloof quarry), have cracked at some places. Half of the veranda has been covered with a building addition in the courtyard, and the floor has been covered over with a new floor covering.

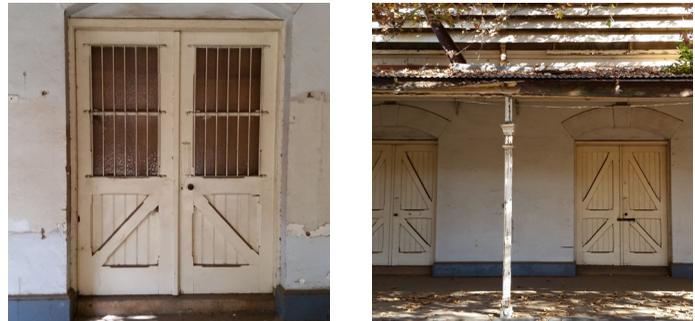
Doors

The roof has ensured that most of the doors opening out onto the veranda have been preserved fairly well. The only need for maintenance is missing ironmongery and paint.

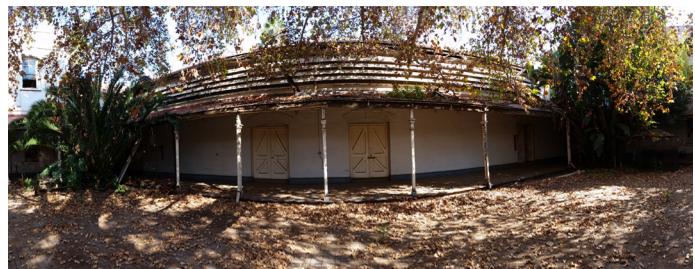
Garden

The oak tree in the center of the courtyard, has presumably been planted after completion of the building work. The roots of the tree have not been cut back in recent years, and is causing some disruptions with the foundations and with water and drainage pipes.

The garden in general, has been neglected and most of the plants have died. The garden, as

designed on the original plan, does not seem to exist anymore.

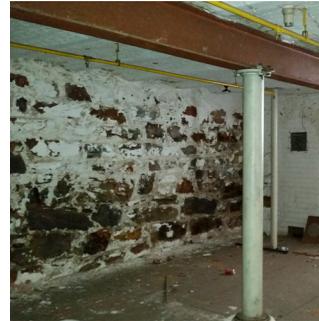
3.5.4 Basement

The granite foundation walls of the basement have been painted and the paint is peeling due to dampness on the walls.

Later additions are also evident in the way arches and openings have been closed, in order to create separate spaces within the basement.

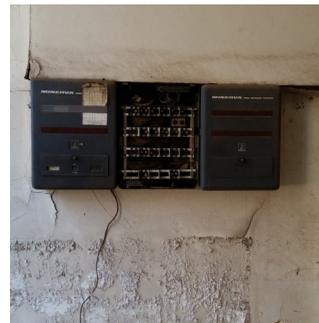
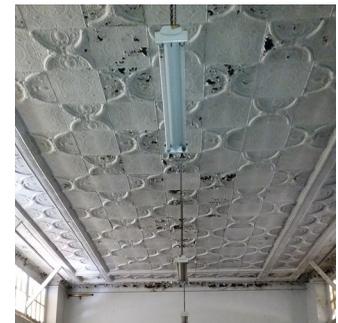
Electricity

There are very few indications of electricity being part of the original building design. According to a previous study and analysis of the building, as part of her Masters dissertation, I Niebuhr (2007:163) had found an old chandelier hanging from the ceiling in the entrance foyer of the building. The chandelier is not present in the building any longer. An old breaker switch is however, still present in the foyer, which is indicative that some sort of old electrical installation had been part of the building from an early stage. Other electrical installations only include fluorescent lighting in some areas as well as an electrical geyser, which are evidently later additions. The electrical supply and wiring of the building is very old, and might not be in safe working order.

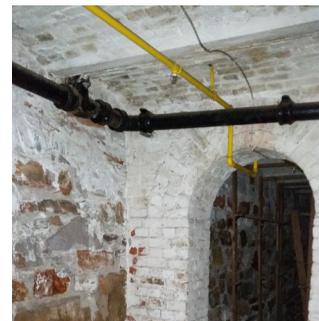
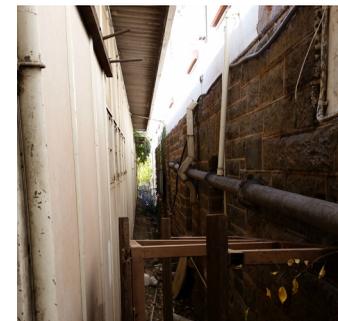
Sewerage

There exists no evidence of water or sanitation being part of the original building. A toilet, wash hand basin and a shower, have been added to the northern wing of the building. A wash hand basin has also been added to the western tower of the building. A 100mm galvanized steel pipe is visible in the eastern tower, and it is assumed that the pipe was used to relay water from the central foyer's roof. A 100mm LCC (London Country Council) cast iron vent pipe (Niebuhr, 2007:164) is also present in the northern tower. This pipe, is also taken right past the windows of the basement, in order to connect to the sewerage connection at Boom Street.
