Investigating the different support methods for various geological structures encountered in hard rock mining within the Eastern Limb of the Bushveld Igneous Complex, South Africa.

Master of Science (Engineering Geology)

University of Pretoria

June 2018

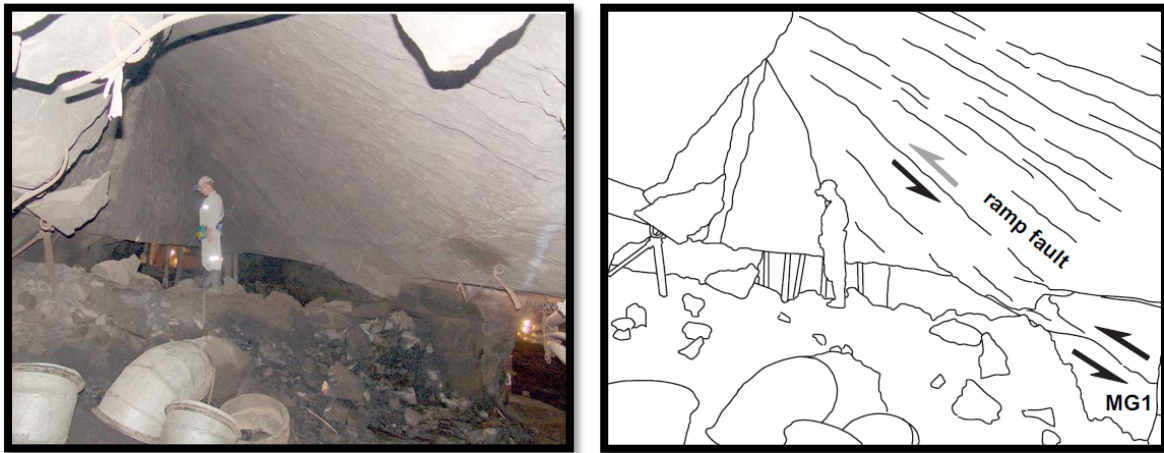
Fallout of large wedges along the weak side of the low angle faults(thrust faults) pose a risk to mining practises, fallout along these feature are a major concern within the Bushveld Igneous Complex (Perrit and Roberts, 2007).

Figure 15 – Failure of “dome” thrust fault feature within underground workings (edited from (Perrit and Roberts, 2007 and Internal presentation-Glencore Alloys).

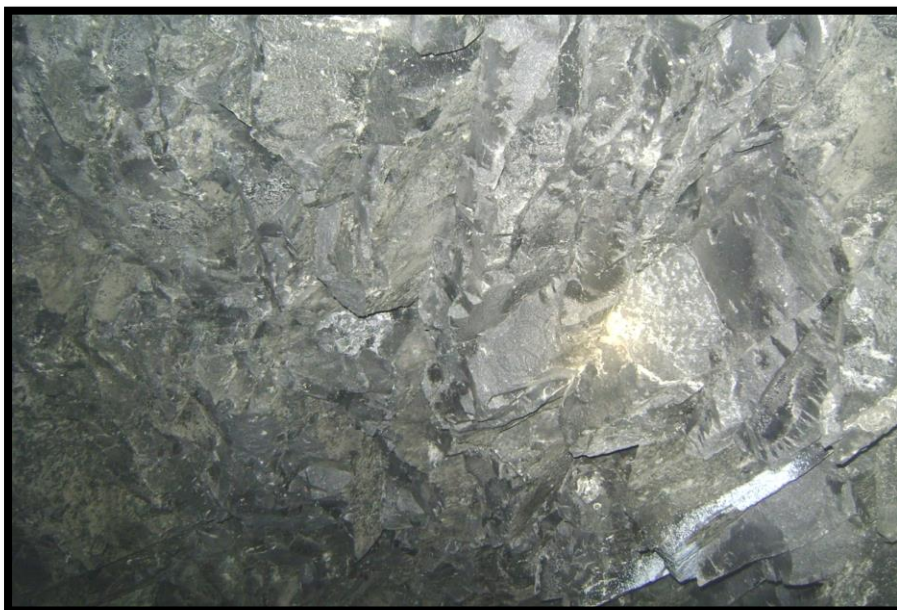
Figure 22 – Exposed dolerite dyke feature within investigation are – Note the blocky hanging wall conditions (W. du Preez, 2016).

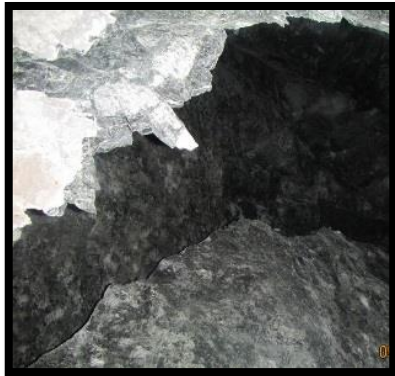
The underground panel in which hanging wall failure occurred was due to a wedge shaped rock that dislodged along the contact plane of a dolerite dyke feature that runs oblique to the mining direction. Failure occurred as a result of water seepage along this particular area of the dyke. The fall-out included part of the dolerite dyke and part host pyroxenite rock.

Figure 33: Photo indicating the extent of the dislodged rock and water within hanging wall rocks- Note the serpentinite coating along exposed planes.

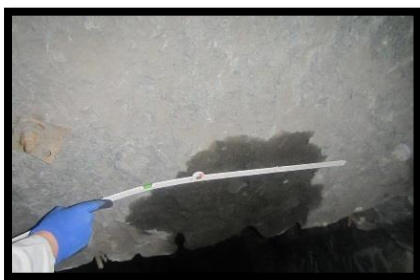
Water seepage has made its way from the water table down into the rock mass using the dolerite dyke and adjacent area of weakness as a travelling way due to heavy summer rains. Water was dripping from the hanging wall into the excavated mining panel. On the original visit no water was present within the hanging wall, recommendations on how to support the dolerite dyke area were issued and mining commenced. The wedge feature was still within unmined ground, mining progressed into this ground after the visit was conducted. Heavy rains occurred after the original visits and water seepage occurred deteriorating the conditions of the rocks and the planes between the dyke and associated area of influence to such an extent that failure occurred.

Figure 34: Photo indicating the extent of the dislodged rock and water within hanging wall rocks- Note the serpentinite coating along exposed planes.

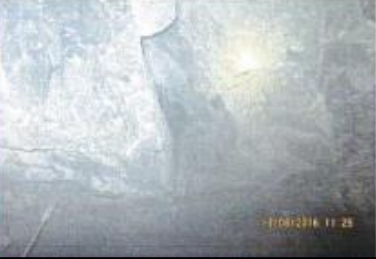
<p>Wedges and partings due to Joint nature . All bolts protruding 30cm + must be replaced.</p>

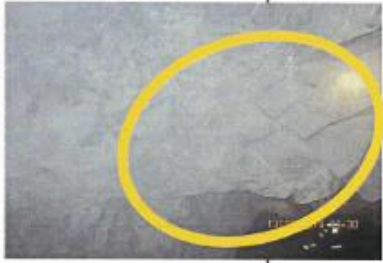
<p>Overhang and loose wedges along Up Dip Sidewall. Blast down loose wedges and overhang. Replace all damaged support.</p>
