Fracture Analysis of Compressor Impellers in Olefin Units: Numerical and Metallurgical Approach

This paper presents a failure analysis conducted in 7175 aluminum alloy compressor impellers used in olefin units which operate at 34500 rpm to compress gas in the process. Some characterizations such as chemical composition, microstructure, and hardness tests were conducted to obtain a detailed evaluation of the base alloy. Furthermore, a finite element method and a 3D point cloud data technique have used to determine critical stress points on the surface of impellers. The finite element result showed the root of blades has significant stress concentration. Moreover, the formed cyclic tension has led to a fatigue phenomenon in the root of the blade, so near this location, the local strain accumulation was visible in 3D points cloud data. The fractography results showed that the mode of crack progression and the fractured surface would change by changing the stress mode. In addition, CFD modeling for investigating the effect of flow hydrodynamics on the HP and LP compressor blades is analyzed. The results revealed that the maximum pressure of gas stream for the rotor speed of 34500 had

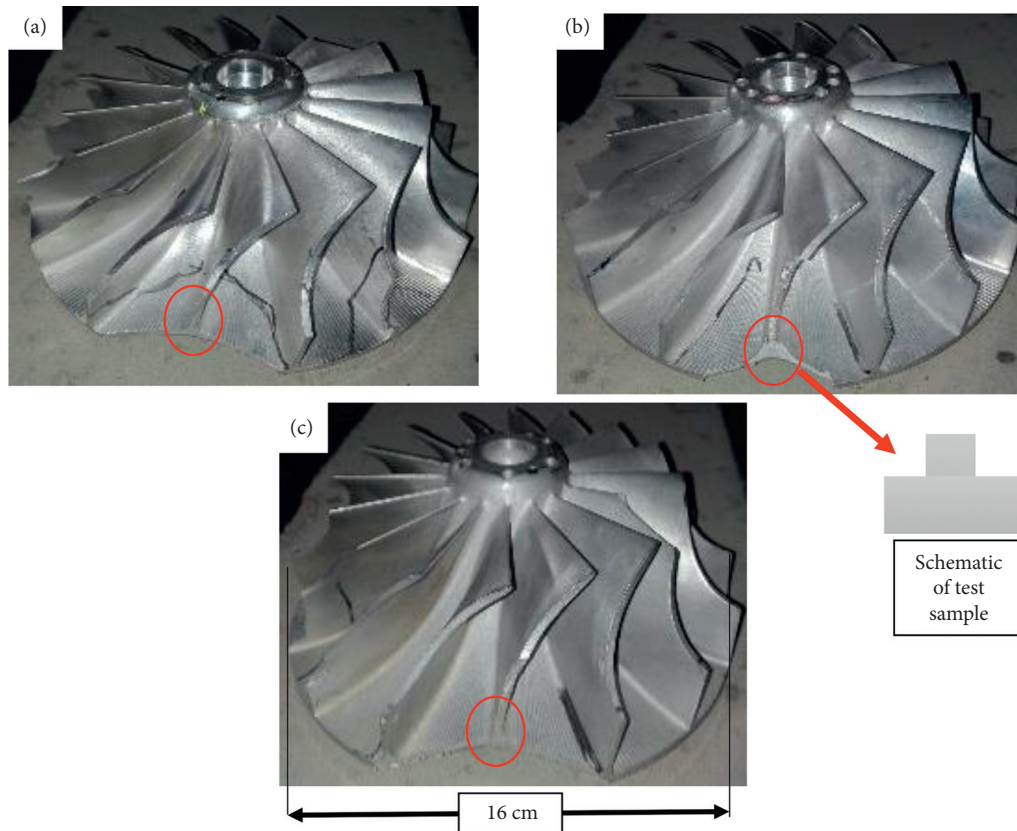
FIGURE 1: Three fractured impellers and schematic of test sample for (a) sample 1 (b) sample 2 (c) sample 3.

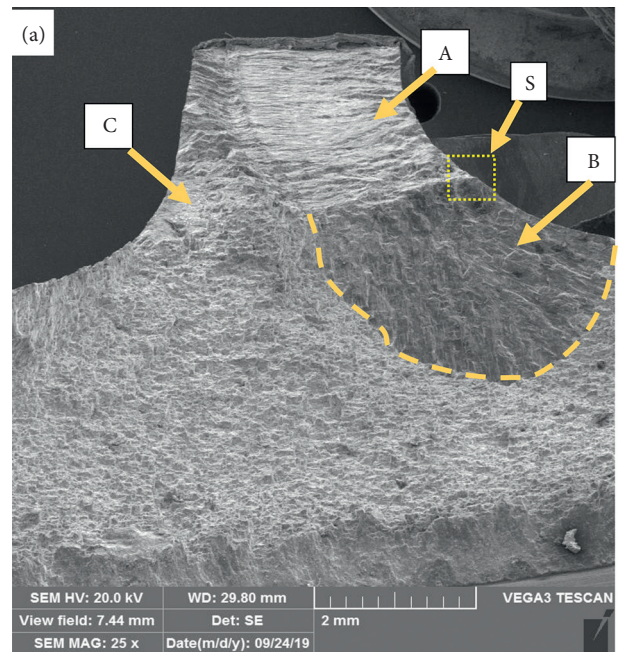
3.1. Fractography. In Figure 1 schematic of the test sample is shown. In continue, its macrostructure can be seen for sample 3 in Figure 4. This fatigue fracture surface illustrates different regions that include: S (Stage I) A and B (stage II), and C (ductile fracture). The red arrows indicate crack directions. The crack initiated in S and branched to A and B regions. The plastic accumulation method [16] is dominant in the B region, and this area has undergone shear deformation. In contrast, the dislocation blockage mechanism is predominant for region A and a different fracture surface is created than in region B. Therefore, region A shows the mussel-like surface or so-called fatigue-induced beach

marks and region B illustrates shear dimples. The region C indicates final fatigue fracture with brittle fracture surface. Fatigue crack in zones A and B have reached its critical size. Finally, the C region has formed abruptly and rapidly in the last step and completed the fatigue failure.

FIGURE 4: Macrostructure of fracture surface for sample 3.

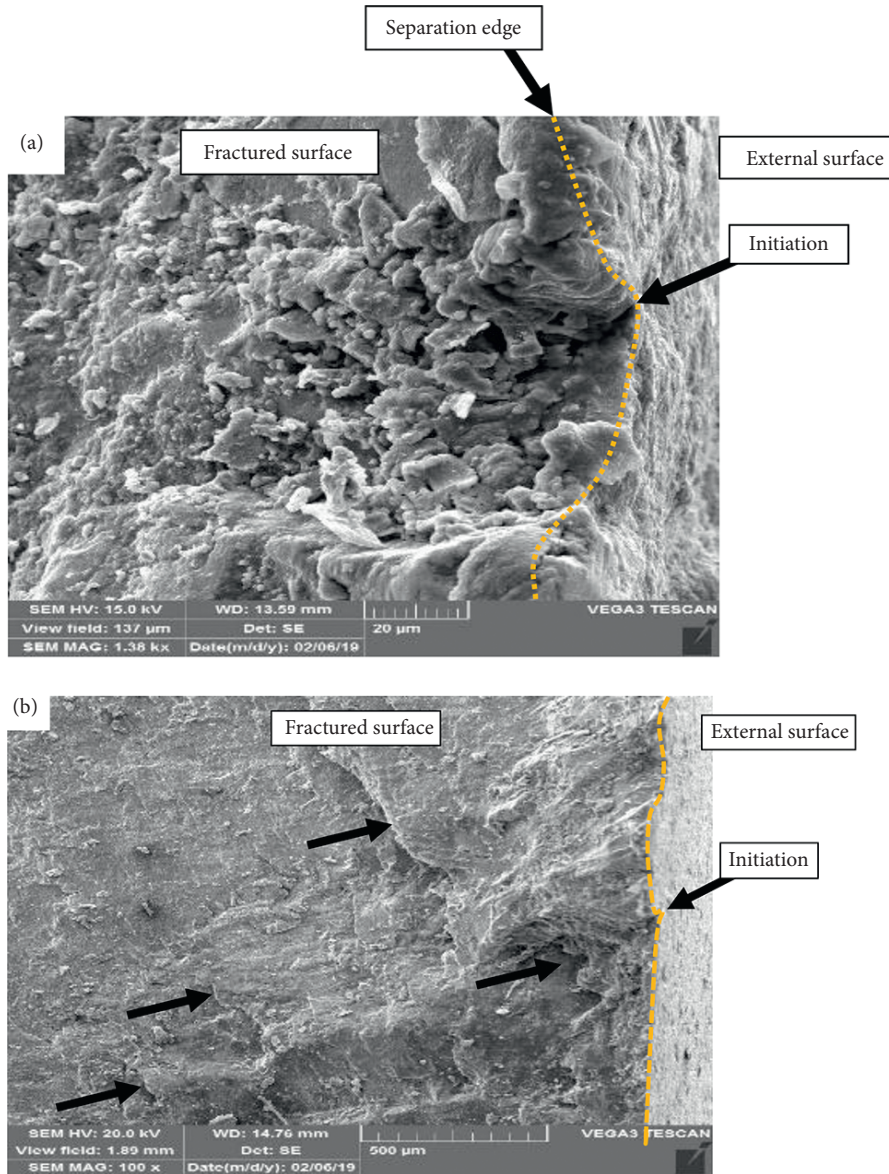
In all specimens, fatigue crack initiated at the surface and propagated with different paths. Figure 5 illustrates high magnification of the initiation crack site (S region in Figure 4) for samples 1 and 3. In addition, it can be seen different cracks in this subsurface area.

FIGURE 5: SEM fractured surface of S region in Figure 4 (a) sample 1 (b) sample 3.

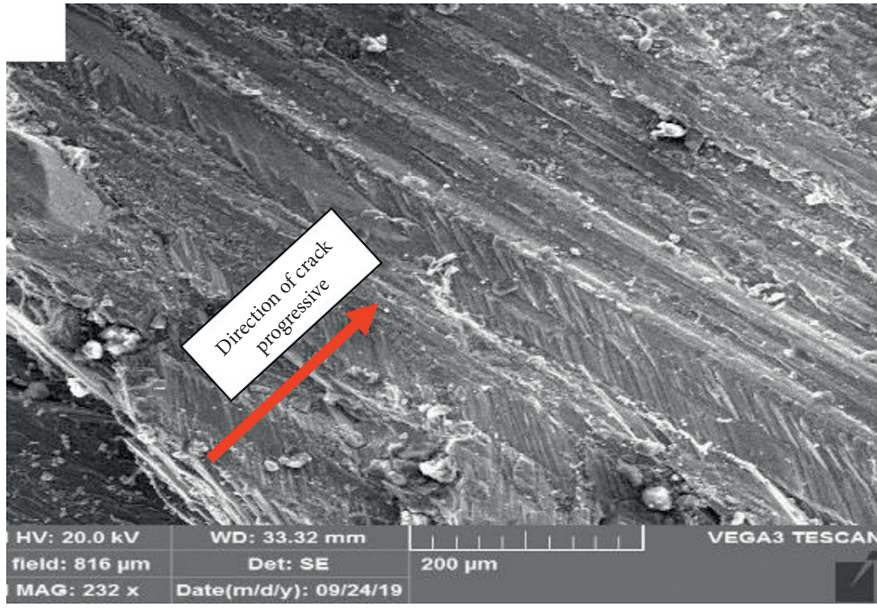
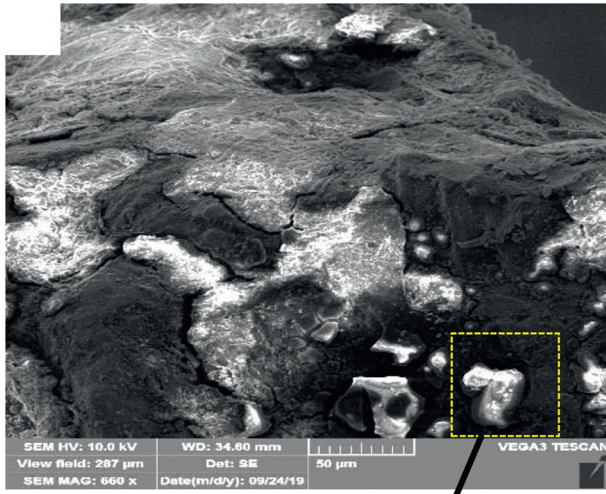
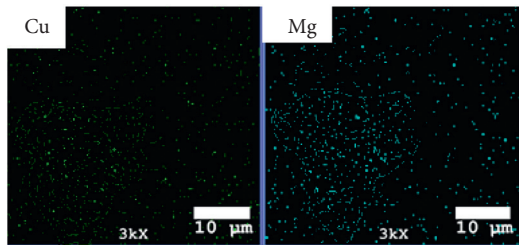
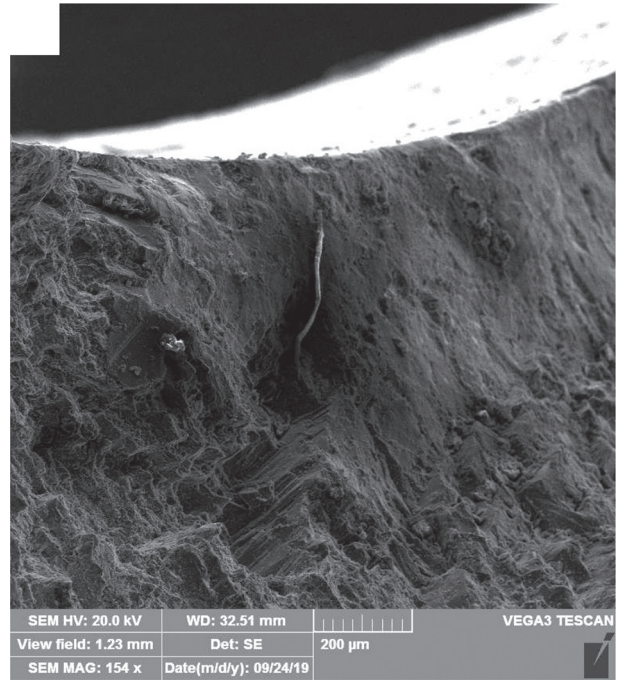
Figure 6(a) shows the high magnification of Zone A with beach marks. In zone A, the direction of crack propagation has been perpendicular to the direction of load and beach line marks. This pattern is quite common for fatigue failures. In this zone, the crack tip undergoes plastic deformation and progresses slowly. In general, the cracks propagate in the perpendicular direction of the highest tensile stress [17]. A comparison of Figures 6(a) and 6(b) indicate that the crack progressive was different in the two regions (A&B). In fact, the crack direction has angularity with applied tension mode in the B region. For this reason, deformed dimples are noticeable in region B. In addition, the EDS results confirm the presence of coarse Al_2MgCu precipitations in this area.

Given the geometry of blades and hub connection, it seems that the critical crack length was about 2 mm. This area is shown in Figure 6(a) by a yellow dashed line.

FIGURE 6: SEM image of fractured surface of sample 3 (according Figure 4) (a) zone A (b) zone B and (c) zone C.

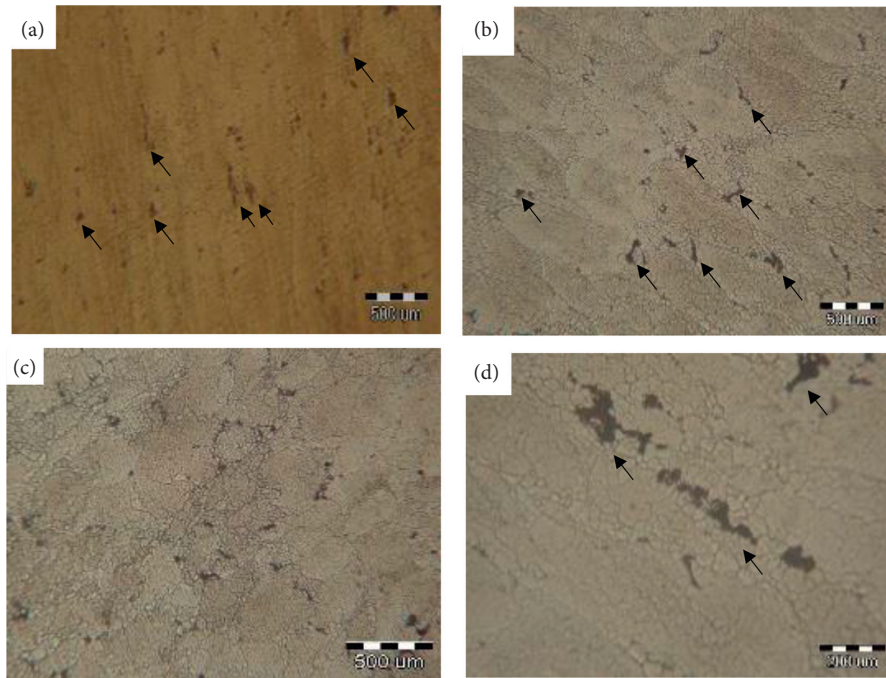
3.2. Metallurgical Characterization. Figure 7 shows OM images of all specimens. Sample 2 has more recrystallization microstructure than others, but the average size of the precipitations of sample 2 is higher than both samples 1 and 3. Also, it can be seen that all microstructures have been overaged. The more magnification of microstructure of sample 2 is illustrated in Figure 7(d). This phenomenon is confirmed clearly by the presence of precipitations in the grain boundaries. Arrows in Figure 7 indicate some of them. It was mentioned that this alloy is susceptible to overaging [18].

FIGURE 7: OM images of microstructure of (a) sample 1 (b) sample 2 (c) sample 3 (d) higher magnification of sample 2.

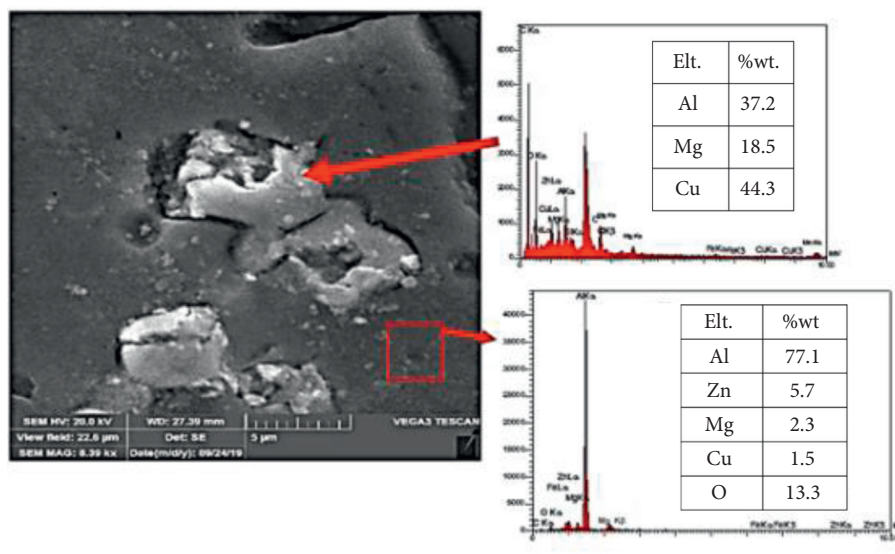
The EDS results of the grain boundary precipitation have been illustrated in Figure 8. It can be seen that Al_2MgCu (S phase) precipitation has formed in the grain boundary. This phase has a centered-orthorhombic crystal structure [19]. Also, this precipitation on a large scale can be the site of crack initiation under loading. This phenomenon is displayed in Figure 9 for one precipitation in sample 3. In other words, the clear discontinuities (yellow arrows) are visible between precipitation and Al alloy matrix. It should be noted that this image was created without the etching process. Comparison of the different samples showed two points: the number of precipitations varies for different specimens and severe precipitations discontinuity with the Al matrix in sample 3. Although low deposition of this precipitate can improve the mechanical and corrosion properties [20], increasing the amount of this precipitate has the opposite effect on the mechanical properties. The existence of the latter precipitations is one of the significant weaknesses of this Al alloy microstructure. Moreover, Al grain boundaries may have been embrittled by large S phase precipitation. It

low coherency between precipitations and Al matrix (Figures 8 and 9).

FIGURE 8: SEM& EDS results of grain boundary precipitation (sample 1).

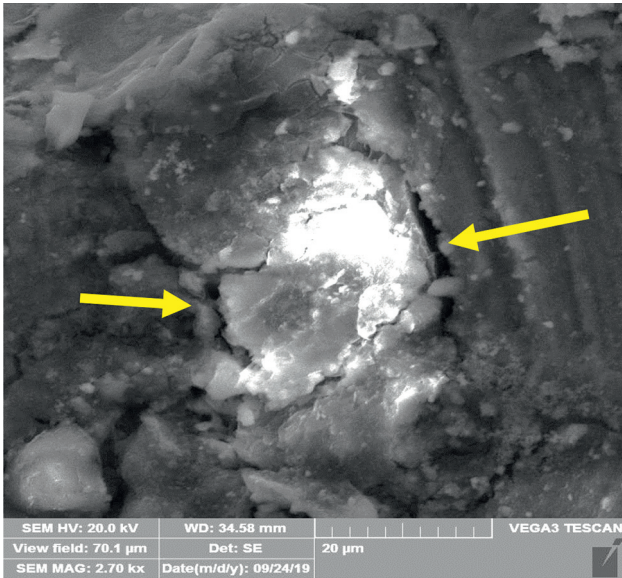
can be seen large cracks between precipitation and Al matrix in Figure 9. The main reason of this phenomenon is related to the incoherency of precipitation. According to Chen et al.

[21], the coherency degree of the precipitates with the 7055 Al alloy is the main factor in the fatigue crack progressive. In the present work, the crack growth rate was very high due to

FIGURE 9: SEM image of grain boundary precipitation and cracks (sample3).

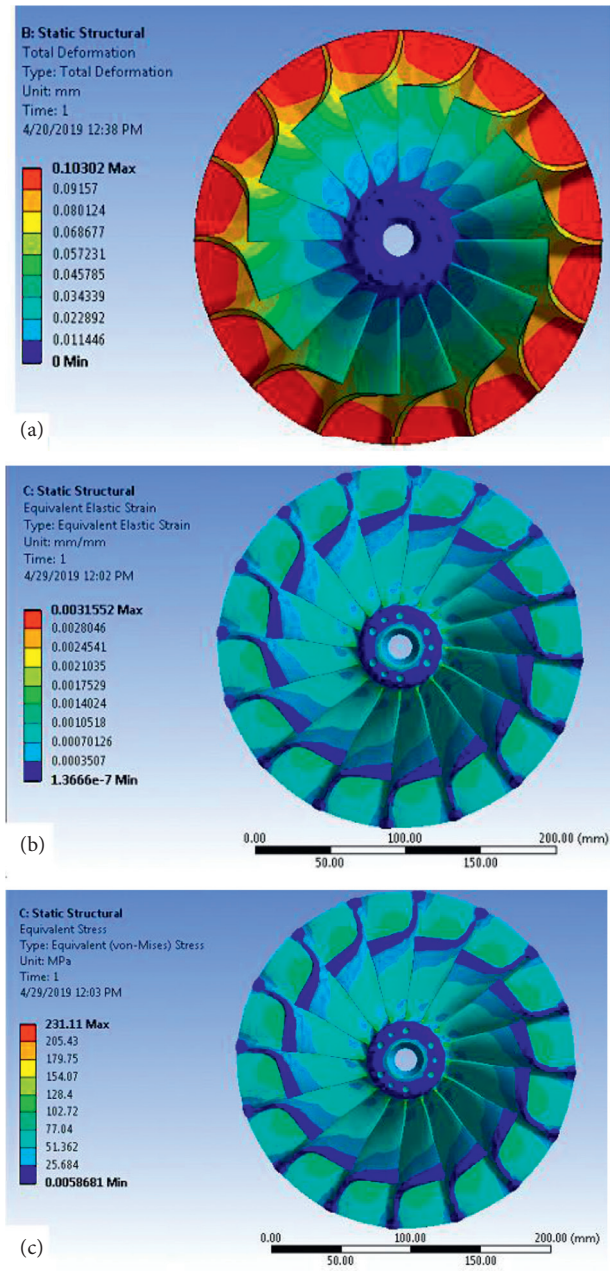
The surface load is caused by gas fluid pressure. Figure 15 illustrates the contour of the total deformation of the impeller at 0.1 bar pressure difference in 34500 rpm. The value of pressure difference was extracted from process conditions. Since the fluid analysis results show that the pressure difference between the two sides of the blade is less than 1 bar, there is no need to transfer the pressure distribution to the structural analysis. Instead, the pressure is applied uniformly to the lower surface of the blade.

Figure 15(a) illustrates that the maximum deformation is about 0.1 mm. The extracted contour of elastic strain and von-Mises stress for mentioned conditions are shown in Figures 15(b) and 15(c), respectively. The extracted contours illustrate the maximum stress has accrued in the root of the blades of the impeller. This is due to the interference of the torque due to the centrifugal force and the fluid pressure, which is maximized at this point. Moreover, Von-Mises stress has a maximum value of 231 MPa in the root of the blades of the impeller. This phenomenon is evident in Figure 16.

FIGURE 15: The extracted contour of (a) total deformation (b) elastic strain (c) Von-Mises stress for pressure difference 0.1 bar in 34500 rpm.

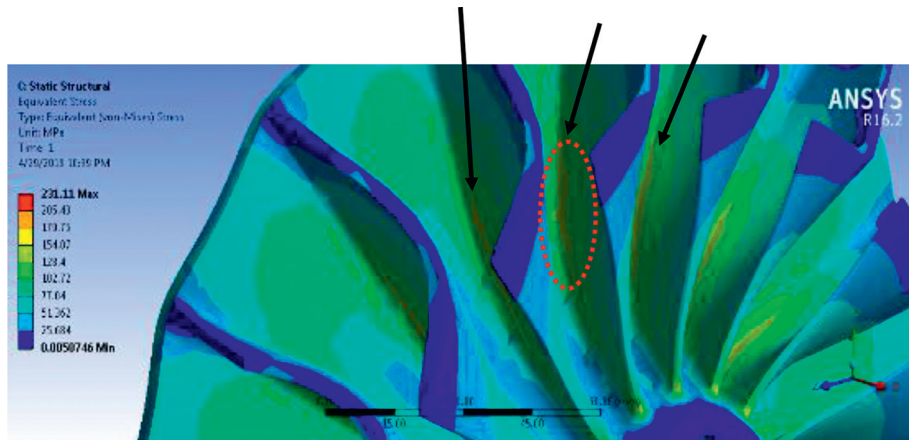
FIGURE 16: High magnification of The contour of Von-Mises for 0.1 pressure difference in 34500 rpm.

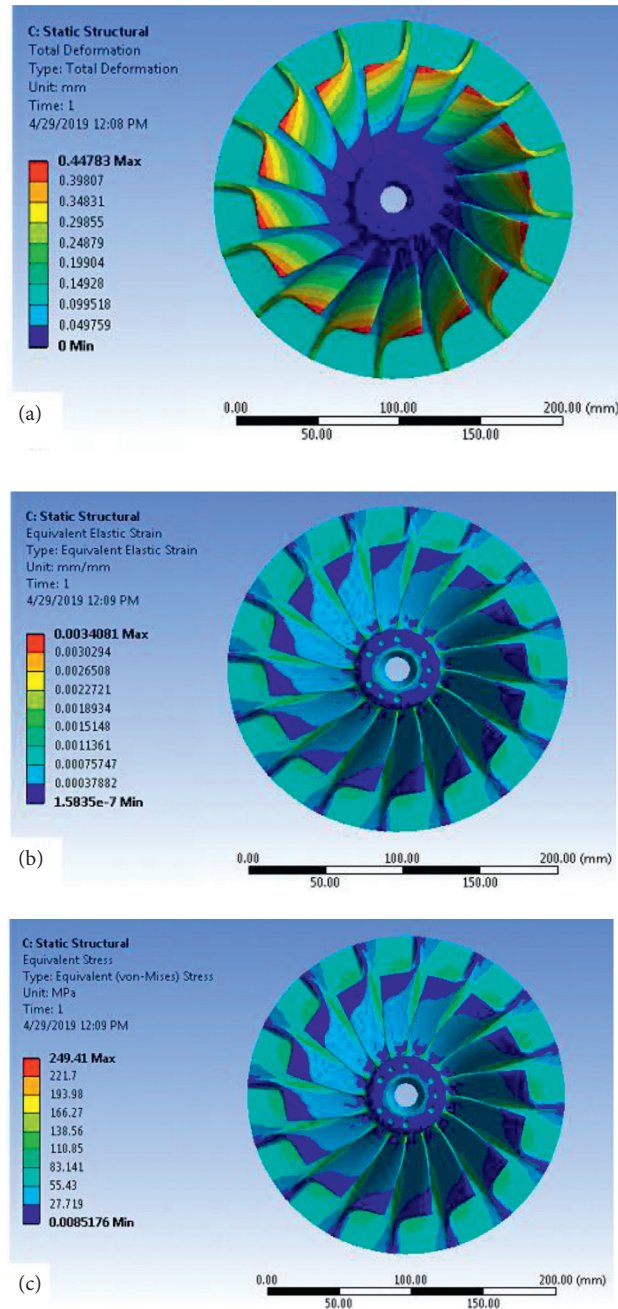
In the following, to estimate the effect of the maximum fluid pressure and make the more critical situation with respect to the actual situation, the pressure difference was increased to 0.5 bar, and the calculations were repeated. The results of the latter state have illustrated in Figure 17. In this state, the maximum total deformation was 0.45 mm on the tip of the blades. It seems the fluid pressure has predominated to centrifugal load in this location. However, the root of the blades has maximum stress of 249 MPa in Figure 18. Therefore, due to the high proportion of centrifugal loads, the maximum stress does not increase as the pressure difference increases in the root of blades. The compared results between pressure differences of 0.1 and 0.5 are shown in Table 8. In summation, based on Figures 15 and 17 the location of maximum stress occurs at the root of the compressor blade. For example, for pressure difference 0.5, in Figure 17, the value of Von-Mises stress in the root is in the interval 166–250 MPa, while this value for other parts are below 110 MPa, this difference is considerable. Based on this analysis the probability of failure in the blade’s root is much higher than in the other parts.

FIGURE 17: The contour of (a) total deformation (b) Elastic strain (c) Von-Mises stress for pressure difference of 0.5 bar in 34500 rpm.

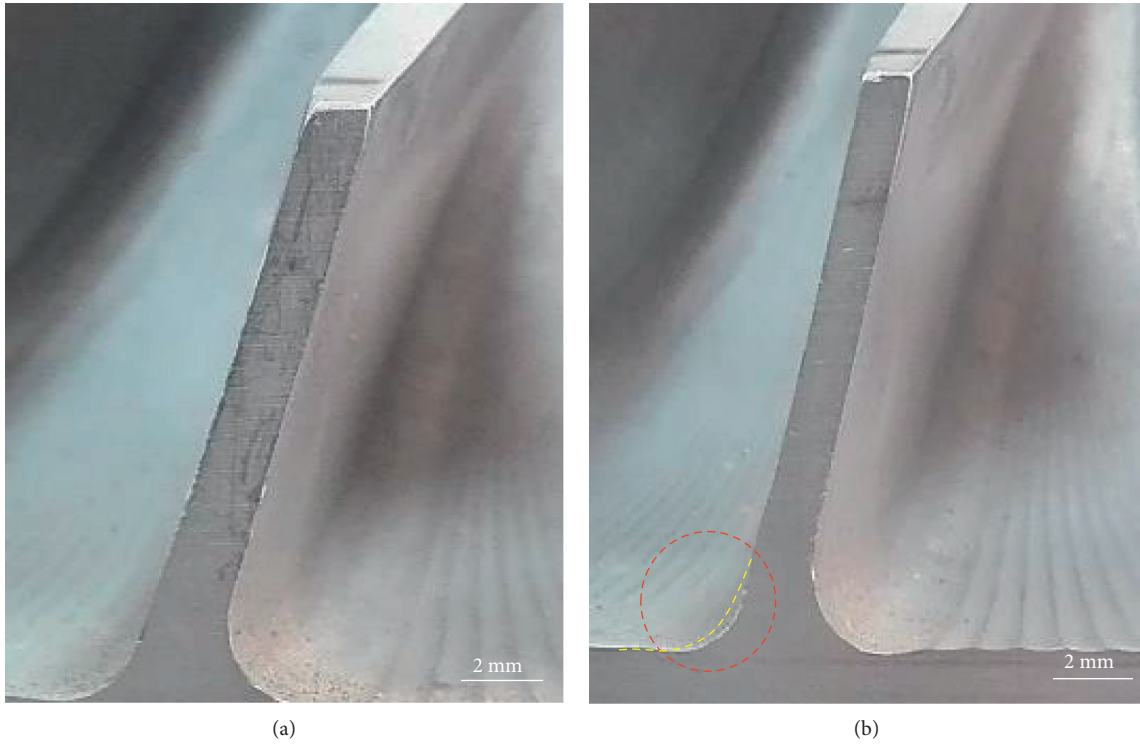
3.4. 3D Points Cloud Technique. Figure 19 shows traditional camera photos of samples before and after service. Since the original sample was the basis for preservice parts verification, it has been avoided to reproduce the preservice photos of samples 2 and 3 in Figure 19. It can be seen that all specimens undergo local deformation near the blade to hub junction. This site is near the fractured surface on the

ruptured blade. It can be concluded that discontinuities accumulated at this position. This means that deformation bands are formed by applying a large external load at the concentration stress sites due to asymmetric slippage of the crystal planes. With the formation of deformation bands, crystalline defects such as voids move in the same direction to accumulate at the point of crack initiation. Therefore,

FIGURE 19: Camera image of sample 3 (a) before service (b) after service.

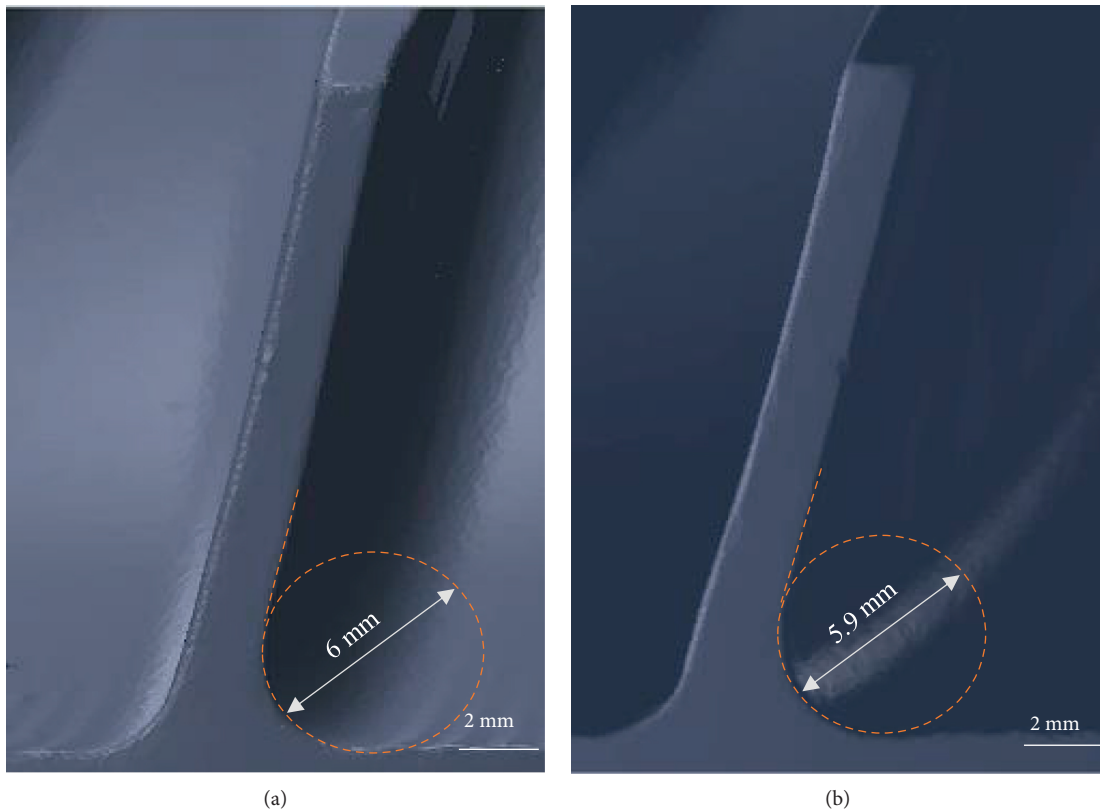
The 3D points cloud technique was used for exact investigation of deformation of all sections of compressor impellers after service. Figure 20 illustrates 3D images of sample 3 before and after service with high magnification. The 3D image of sample 3 is analyzed before and after service for better comparison. It can be seen that deformation is the highest near the junction of the blade and hub of the impeller. So that the radius of the connection of the blade to the hub has changed from 6 mm to 5.9 mm for sample 3. This change was lower for samples 1 and 2. As the radius becomes

smaller, the stress concentration at this point will increase. Therefore, this technique can well show small geometric changes, especially for critical points of the impeller. According to the cyclic load system and fatigue condition for impeller blades, accumulation of elastic strain lead to local plastic deformation in this site. Due to the presence of coarse precipitations in the grain boundaries of crystalline structure, elastic strains have accumulated around them. Recently, Malitckii et al. [27] reported the strain accumulation during microstructurally small fatigue cracks by the digital image correlation technique. Therefore, given the over-aged microstructure (coarse precipitations), sufficient conditions have been provided for a new impeller fracture surrounding the blade-to-hub connection area.

FIGURES 20: 3D points cloud of sample 3 (a) before service (b) after service.
