Site J

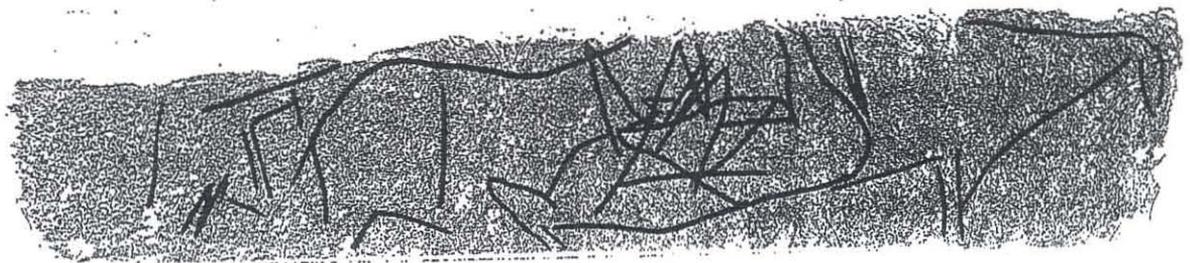
(Figure J1: The Eland)

The eland is naturalistic in style and incised making use of a fine line technique (Figure J1). The head, horns, neck and forequarters are well proportioned, but the hindquarters are distorted. The characteristic coloration line running from the nuchal hump to the lower limb is vague but present. The antelope is engraved lowering its head. The shank and pes are enlarged and the caudal appendage extends to the heel of the back leg, which is correct. Both legs come to an abrupt end. There are two more eland engraved upside down on the naturalistic eland. They to are naturalistic in style. The eland on the right has a head and back leg, and the nuchal hump is present. The eland on the left has an oval shaped head and front legs, the back leg and caudal appendage was omitted. The neck and forequarters of both eland are triangular in shape (Figure J1 defined).

The texture of the rock surface is medium grained, with a few small erosion marks found all over the engraved surface. The condition of the engraving is satisfactory, but must be monitored . The engraving is located in the centre of the site and faces south.

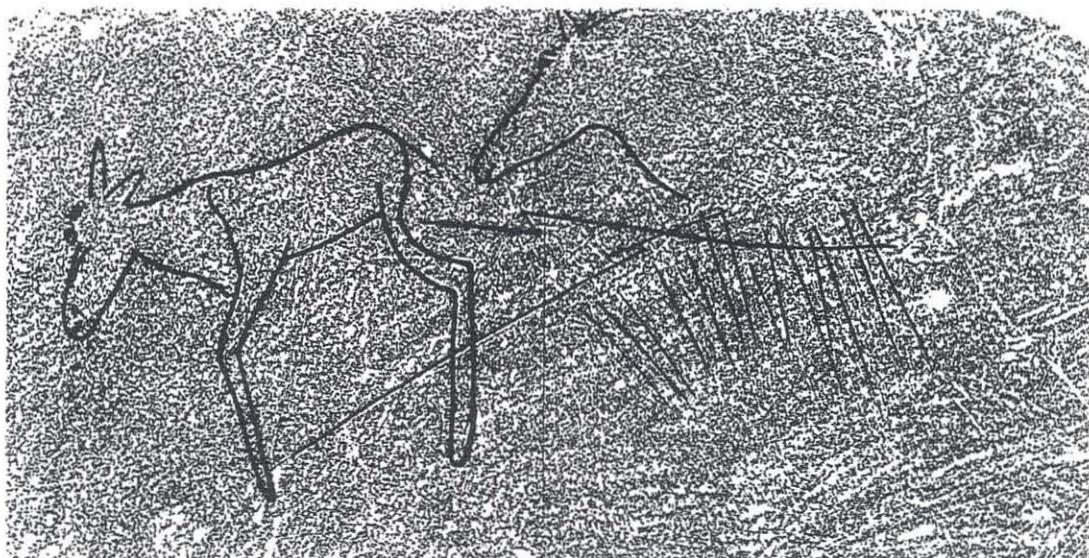
Figure J2 - Eland and baby (*Tragelaphus oryx*)

The engraving is naturalistic in style and a broad line incision technique was used (Figure J2). The engraved surface consists of an eland mother and her calf. The calf is very detailed and natural. The head includes detail of both pinna, orbital sockets, nose and mouth, even coloration marks and the characteristic pronounced forehead are visible. The forequarters, including the nuchal hump and characteristic coloration line running from the hump to the lower limb are included. The thoracic area is highlighted. The lower limb, carpus and manus of the front leg were engraved, however the hoof was omitted. The shank, heel and pes of the back leg were included, but once again the hoof was omitted. The hindquarters and caudal appendage are also present, the caudal appendage is just a short straight line. The mother is portrayed as watching her calf from behind the grass. The mother is not as detailed as the calf with only her head and neck exposed. The head includes a mouth, pinna and a crude representation of horns, all based on a neck. Below the head engraving of the eland there are numerous diagonal scratching's representing the long grass. There are numerous other multiple and single lined scratching's found all over the engraved surface, that are not part of the original engraved work, but superimposed on it and don't amount to anything (Figure J2 defined).

The surface of the rock engraved upon is medium in texture, with numerous small erosion marks found all over the surface and some cattle marks on the top right hand corner, that don't interfere with the engraving itself. The condition of the engraving is good, but needs to be monitored. Its only threat at present is further weathering due to the elements. It is located towards the base of the hill towards the guesthouses and faces north- east.

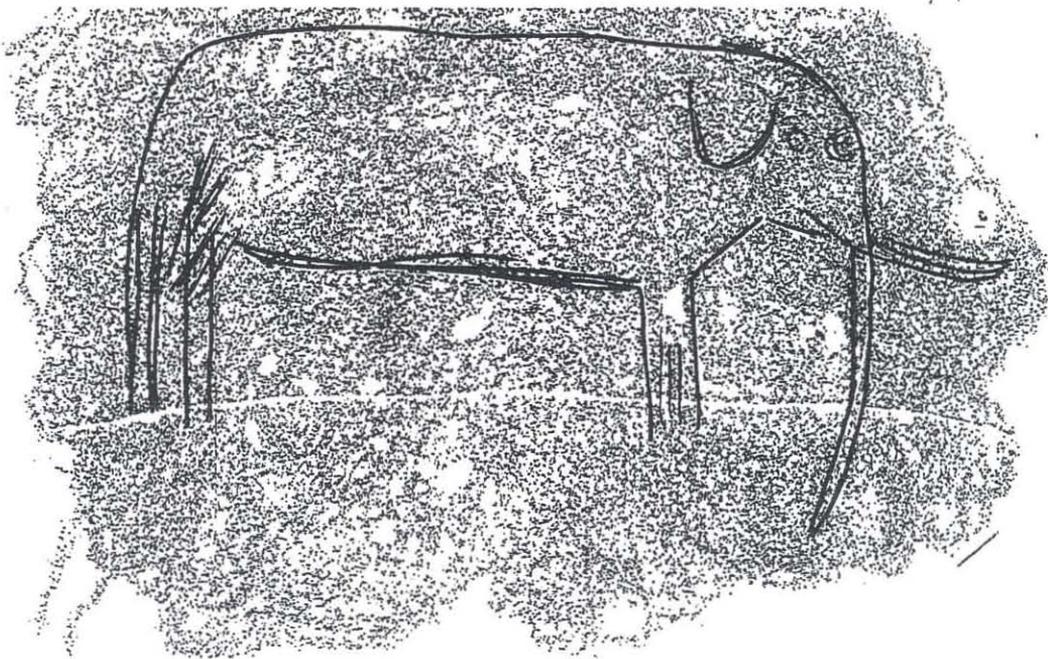
(Figure J3: The Elephant)

The engraving is stylised, simplistic and is incised using a multiple fine line technique (Figure J3). The engraving is not well proportioned, with the ear being too small and the eye of the elephant being too big. The head is detailed and includes an ear, eye, teeth and trunk. All four legs are present, but no tail can be identified. The body of the elephant is portrayed as being oval in shape and the legs are simple straight parallel lines (Figure J3 defined).

The texture of the rock surface is rough, with numerous small erosion marks found all over the engraved surface. The condition of the engraving is good. There is a lightning crack running all the way through the rock along the base of the engraving, which has split the rock in two, but it has in no way hurt the engraving. The engraving is located in the middle of the hill and faces west.

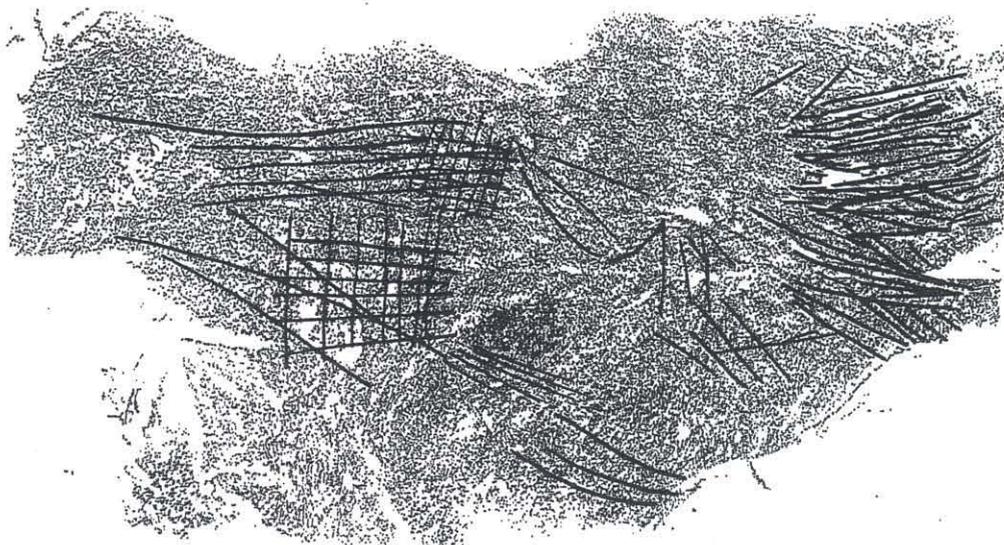
(Figure J4: Pattern work)

The engraved work is stylised and a fine line incision technique was used (Figure J4). According to Prof. J.D. Lewis-Williams work on entoptic phenomenon, entoptics are diagonal parallel lines, dots, grids, squiggles, zigzags, parallel curves and star shapes, all of these have been found in the Magaliesberg, except the parallel curves and squiggles. Entoptic phenomenon's are observed by people due to hallucination, brought on by drugs and trances, they are common to shamanistic societies, like the Bushmen. The pattern work found on this engraving could be entoptic. There are long horizontal parallel lines, overlapping a grid, next to some relaxed zigzags. On the far right there are several deep engraved lines, from tool sharpening. Below all of this there are further very fine multiple scratching (Figure J4 defined).

The texture of the rock surface is medium in grain, with extensive erosion marks on the left-hand side of the engraving and smaller erosion marks on the rest of the rock surface. The condition of the engraving is poor and needs to be monitored, but due to the content of the engraving costly removal is not recommended.

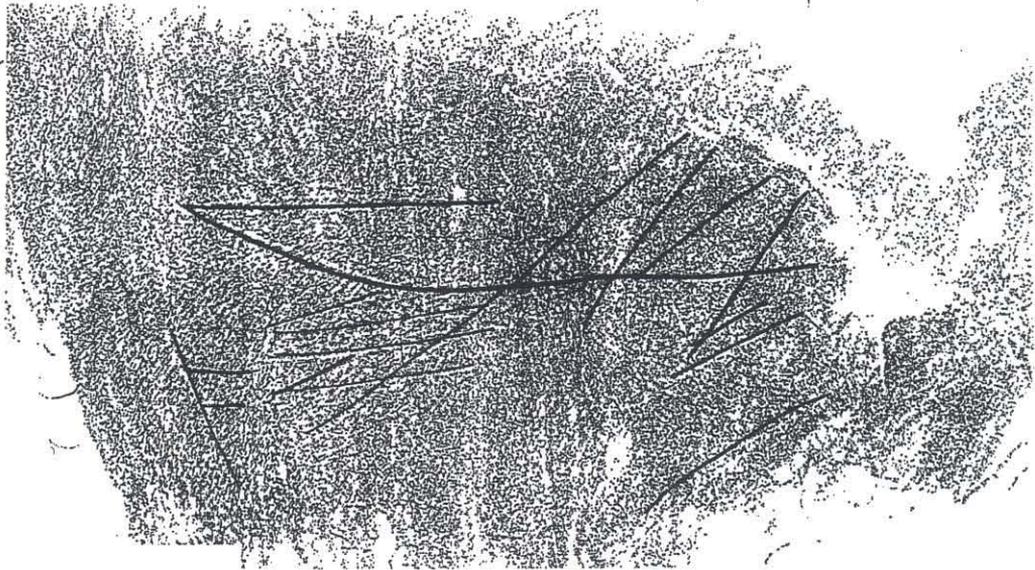
(Figure J5: Pattern work)

The pattern work was incised making use of a fine line technique (Figure J5). There is no structure to the work, which consists of parallel lines and converging lines, which run in all directions and are different sizes (Figure J5 defined).

The texture of the rock surface is fine grained, making rubbing difficult. There are a number of small erosion marks on the engraved surface. The condition of the engraving is satisfactory.

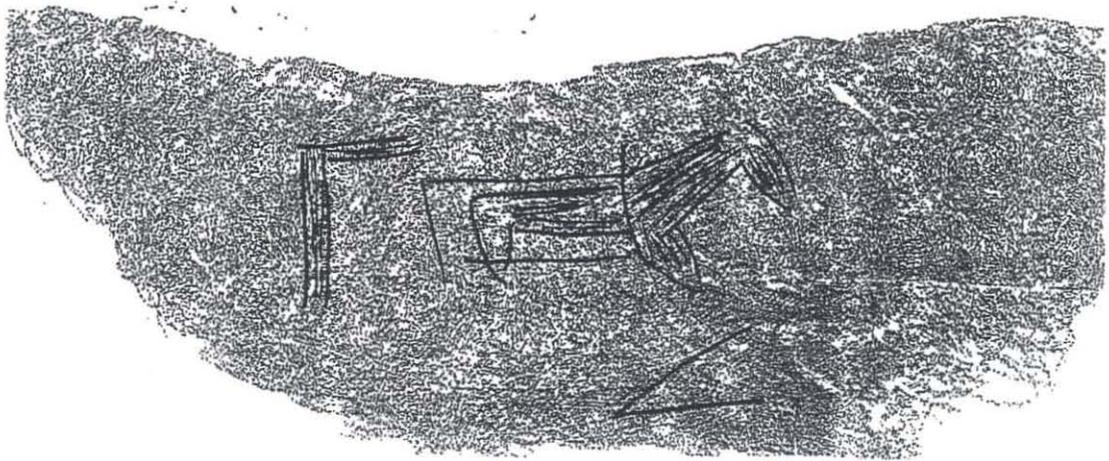
(Figure J6: Stylised antelope and Pattern work)

The engraved work depicted on the rock was incised making use of a fine line technique (Figure J6). At the top and centre of the engraved surface there is a stylised multiple incision of a buck. The body and legs of the buck are rectangular and the head and neck are triangular in shape. The buck is superimposed on linear work, which includes parallel, converging and curved lines in various directions (Figure J6 defined). The style of engraving suggests that the artist be of Sotho-Tswana origin.

The surface of the rock has a fine-grained texture, with numerous small erosion marks. The condition of the engraving is satisfactory, with its only threat being further weathering due to the elements. The engraving is located towards the centre of the hill and faces east.

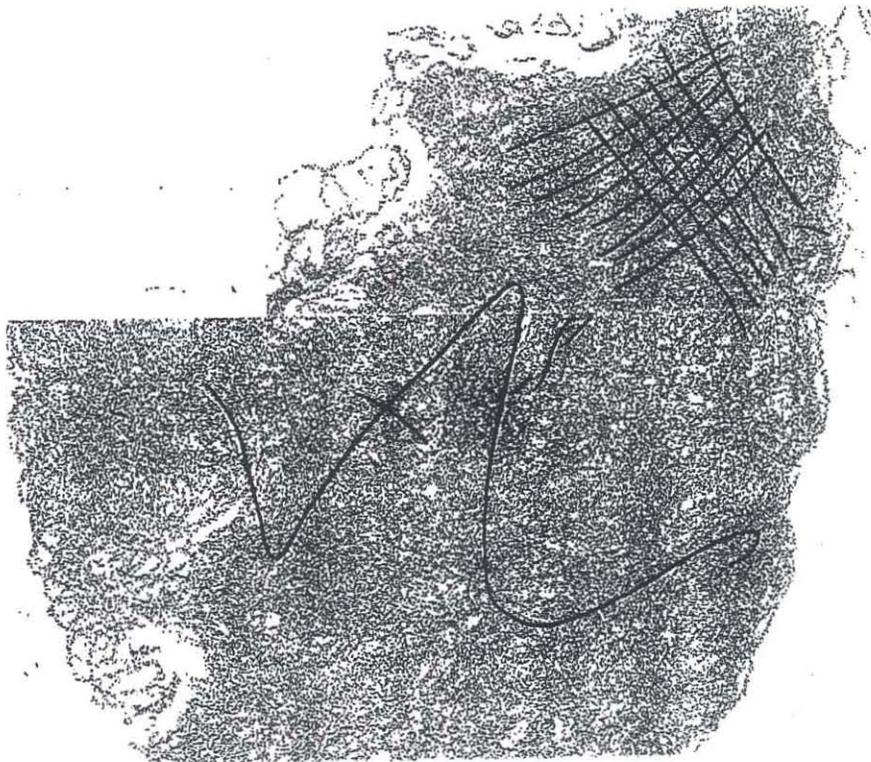
(Figure J7: Pattern work)

The pattern work is incised making use of a fine line technique (Figure J7). The pattern work is entoptic in nature with curved lines above and a grid pattern above. The grid pattern work is made of converging lines (Figure J7 defined).

The texture of the rock surface is fined grained, with numerous small erosion marks on the engraved surface and large erosion marks on the periphery. The condition of the engraving is good, but should be monitored.

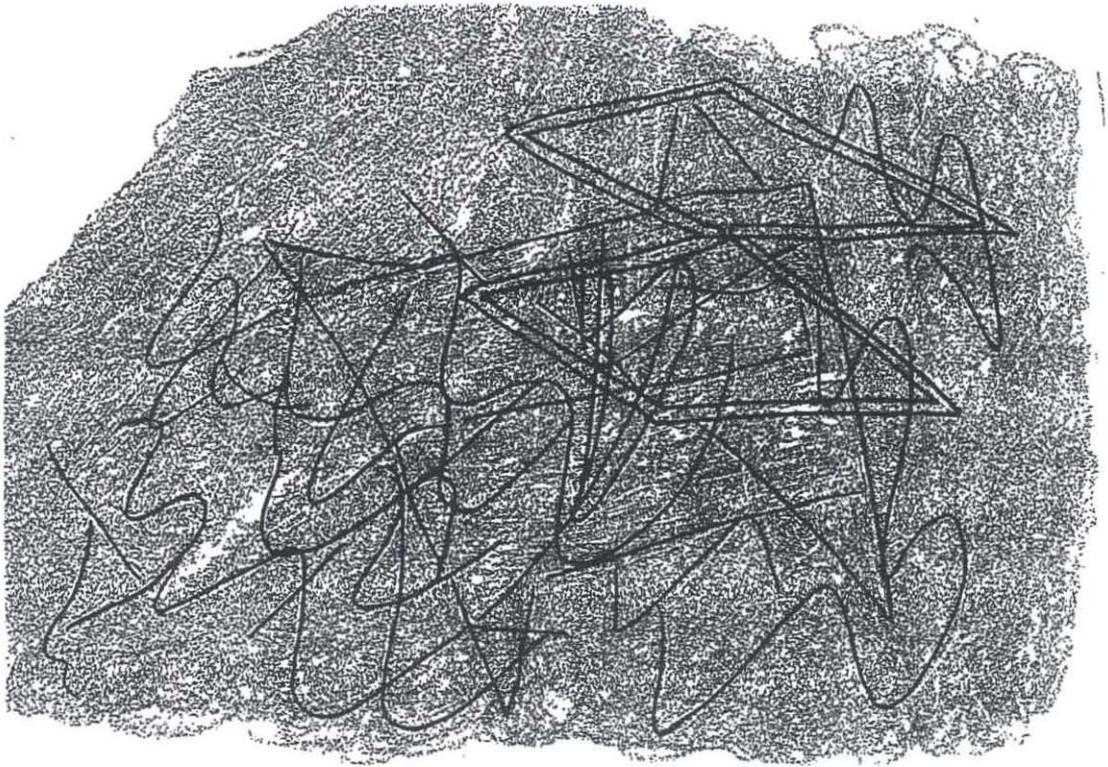
(Figure J8: Pattern work)

The pattern work is structured and purposeful and the technique used is fine lined (Figure J8). There is a large rubbed quadrangle, consisting of multiple fine line incisions, with four rubbed triangles on the top and bottom of the quadrangle. Superimposed on top of this, is pattern work representing mirror imagery. Multiple curved lines were engraved representative of water, with two "M" shapes forming the reflection. The "M" shapes are comprised of parallel lines, with the legs of the two shapes touching. This is proof that the Bushmen understood complex concepts (Figure J8 defined).

The texture of the rock surface engraved upon is medium grained. There are numerous small erosion marks on the engraved surface as well as one or two cattle marks. The condition of the engraving is good, with its only threat being further weathering due to the elements. The engraving is located towards the top of the hill and faces southwest.

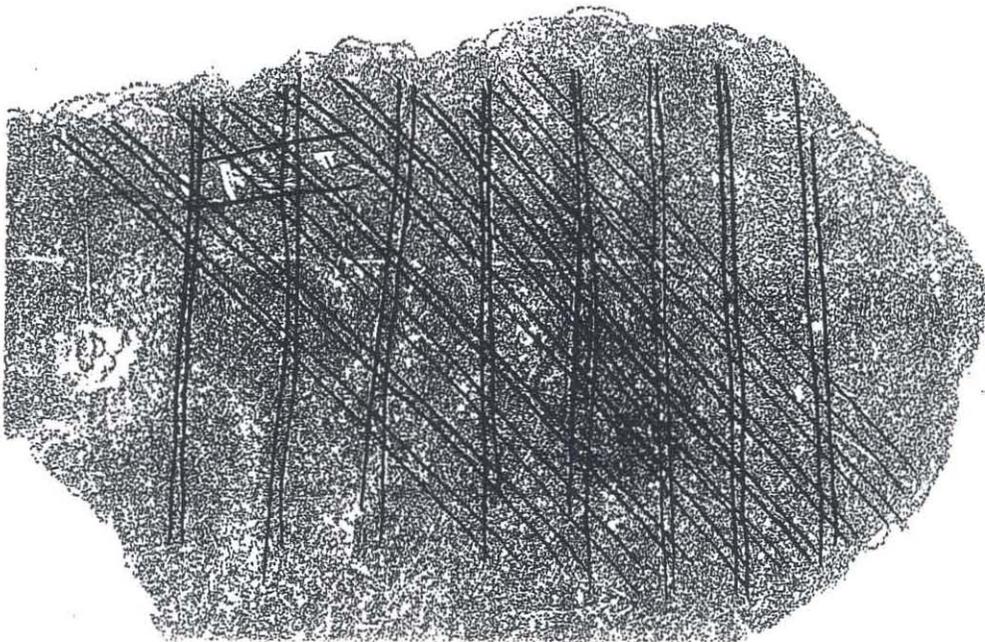
(Figure J9: Pattern work)

The pattern work is structured and a fine line incision technique was used (Figure J9). The pattern work consists of eight equally spaced parallel lines and thirteen equally spaced diagonal parallel lines. The vertical parallel lines are superimposed on the diagonal parallel lines, but were engraved at the same time (Figure J9 defined).

The texture of the rock surface engraved upon is medium grained. There are numerous small erosion marks present all over the engraved surface with a large erosion mark on the right hand side of the engraved surface, this however doesn't interfere with the engraved work. The condition of the engraving is good, with its only threat being further weathering due to the elements. The engraving is positioned towards the top of the hill and faces east.

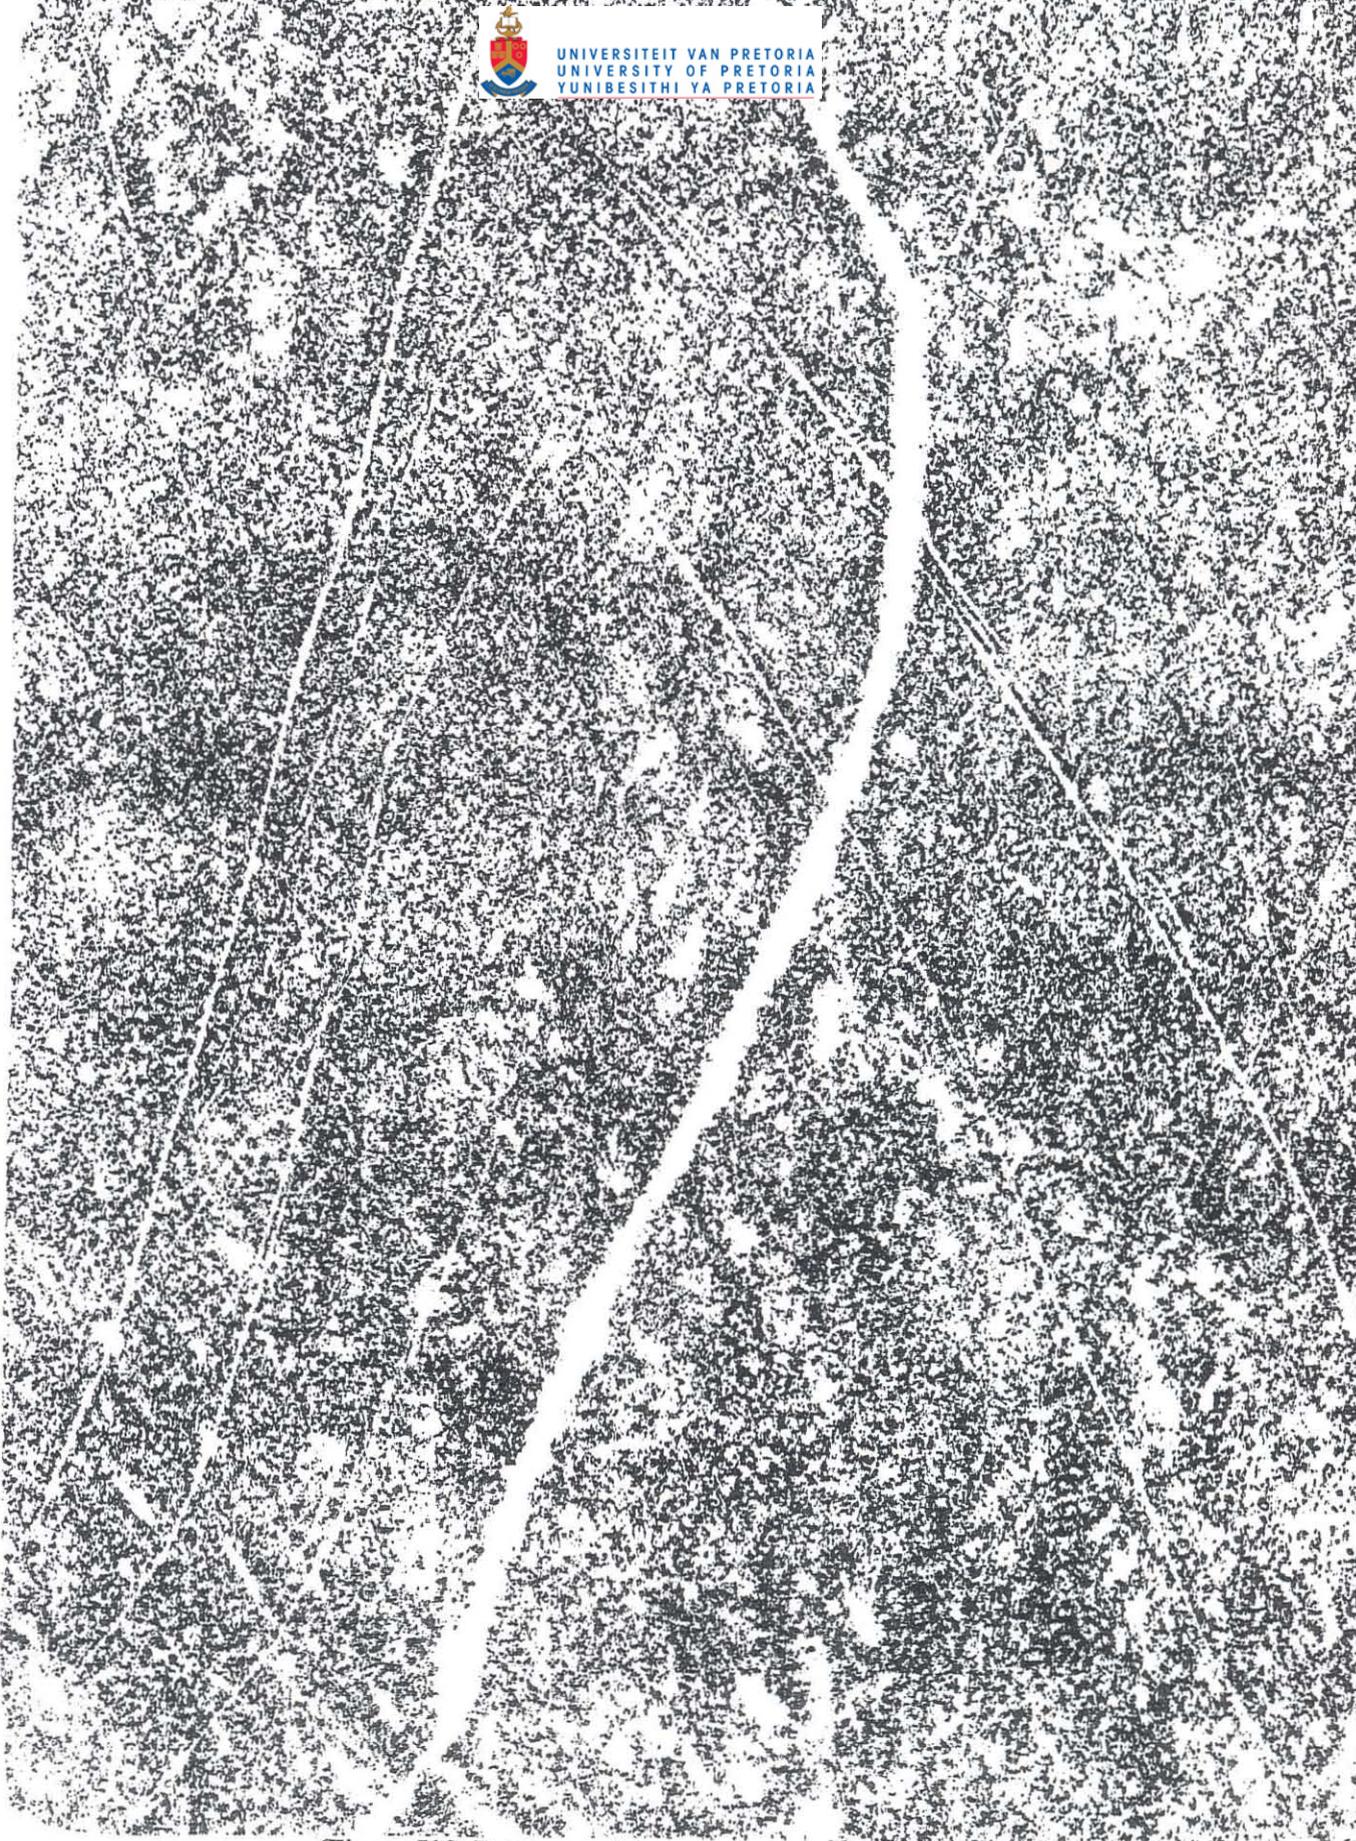
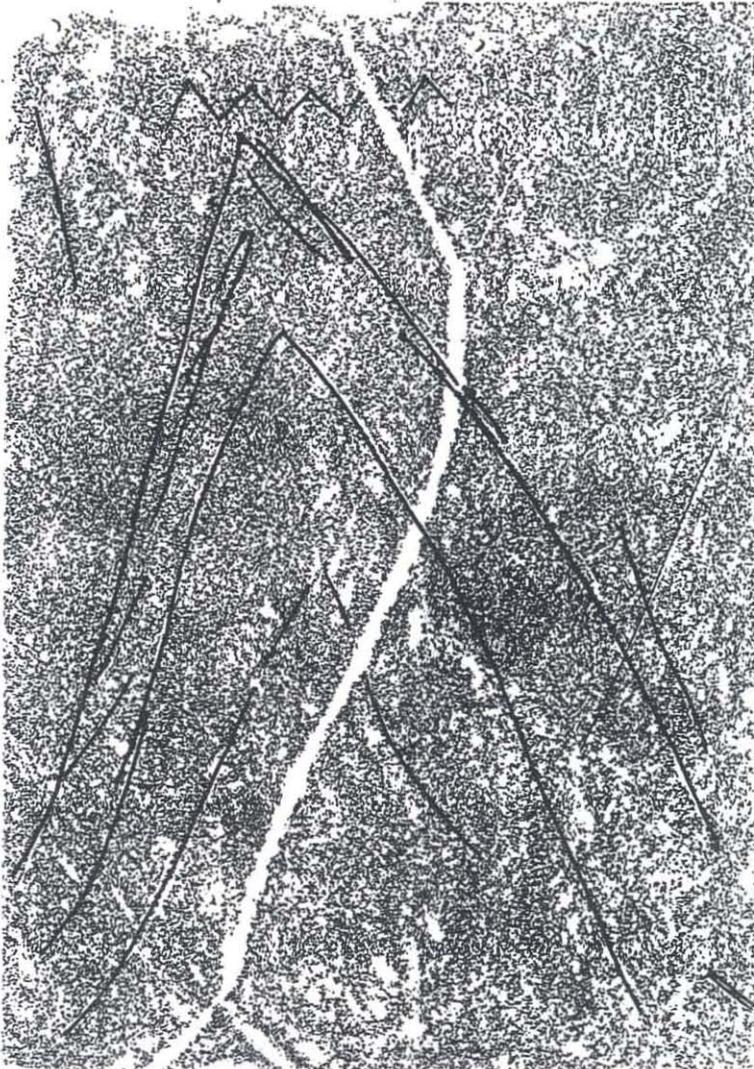
(Figure J10: Pattern work)

The pattern work is structured and incised making use of a fine line technique (Figure J10). The pattern work consists of three, parallel; upside down "V" shapes. At the tip of the largest "V" and superimposed on the "V" shape there is a single zigzag line that is very faint (Figure J10 defined).

The texture of the rock surface engraved upon is medium grained, with numerous small erosion marks all over the engraved surface. Running down the middle of the engraving is a crack, which was caused by lightning. Considering everything the condition of the engraving is good. The engraving is located towards the top of the hill and faces northeast.

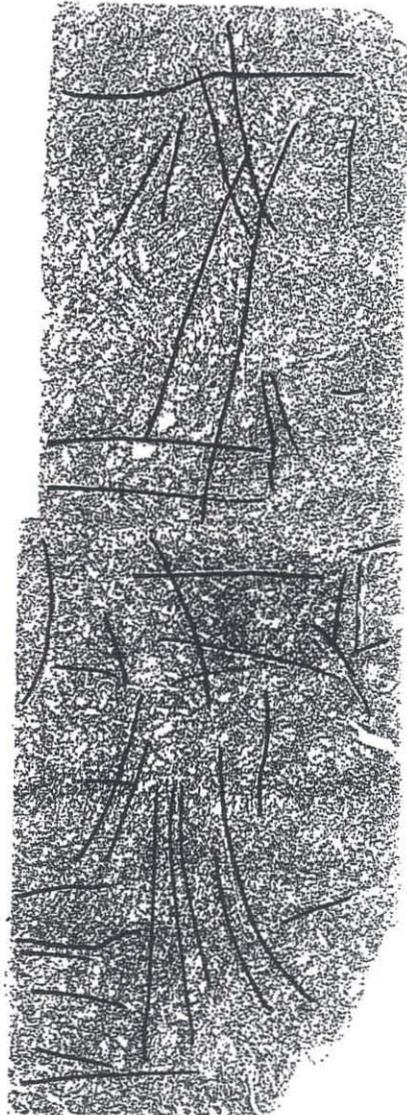
(Figure J11: Pattern work)

The engraved work is incised making use of a fine line technique (Figure J11). The engraving comprises of two covering lines, with punched markings inside, there are other punch marks found elsewhere on the rock surface. Superimposed on this pattern work are various curved lines, possible entoptic phenomenon (Figure J11 defined).

The texture of the rock surface is fine to medium grained, with numerous small erosion marks found all over the rock surface. The condition of the engraving is satisfactory, with its only threat being further weathering. The engraving is located midway up the hill, behind the guest house and faces north.
