## CHAPTER 3: MATERIAL AND METHODS

### 3.1.2 General literature, maps and other data.

#### 3.1.2.1 Kromme River:

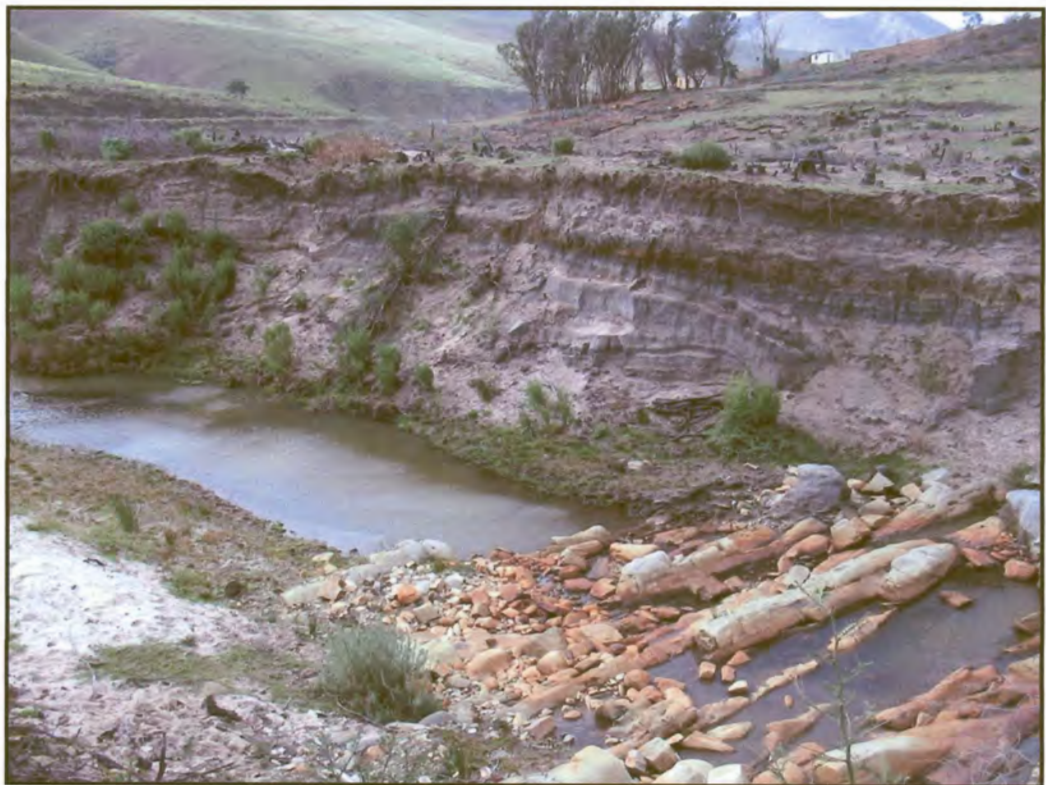
In 1998, at least eight major headcuts in the Kromme River were identified, and since then, seven have been repaired with gabion structures. Other problems like channel bank erosion expose the bedrock (Figure 7) (Haigh *et al.*, 2002).

**Figure 7: Extensive channel bank erosion exposing bedrock. Horizons of dark organic, sometimes peat-like material, alternating with lighter coloured sands (relatively poor in organic material) reveal the episodic nature of the sediment supply from the tributary catchments.**

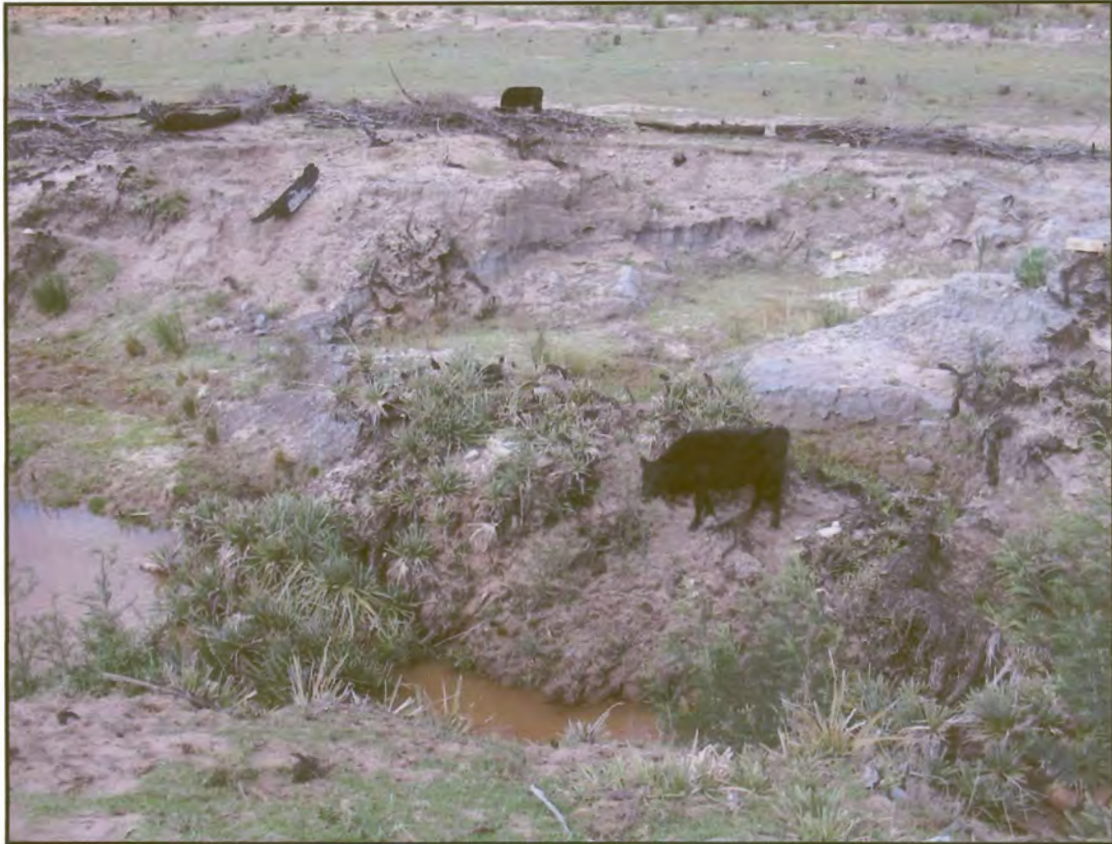
**Figure 8: The area around the structure must be fenced off to prevent over-grazing and trampling by cattle.**

1. Follow-up monitoring and maintenance visits by the Design Engineer and Implementing Agent to monitor the stability of the structures.
2. Rehabilitation monitoring by Senior Project Manager with assistance from a Technical Advisor.
3. Monitor the revegetation and riverbank stability through long-term fixed point photography.
4. Control of invasive plant species.
5. Fencing-off the structure to exclude animals (Figure 8).
6. Monitor the headward movement of the headcut at Kompanjesdrif.

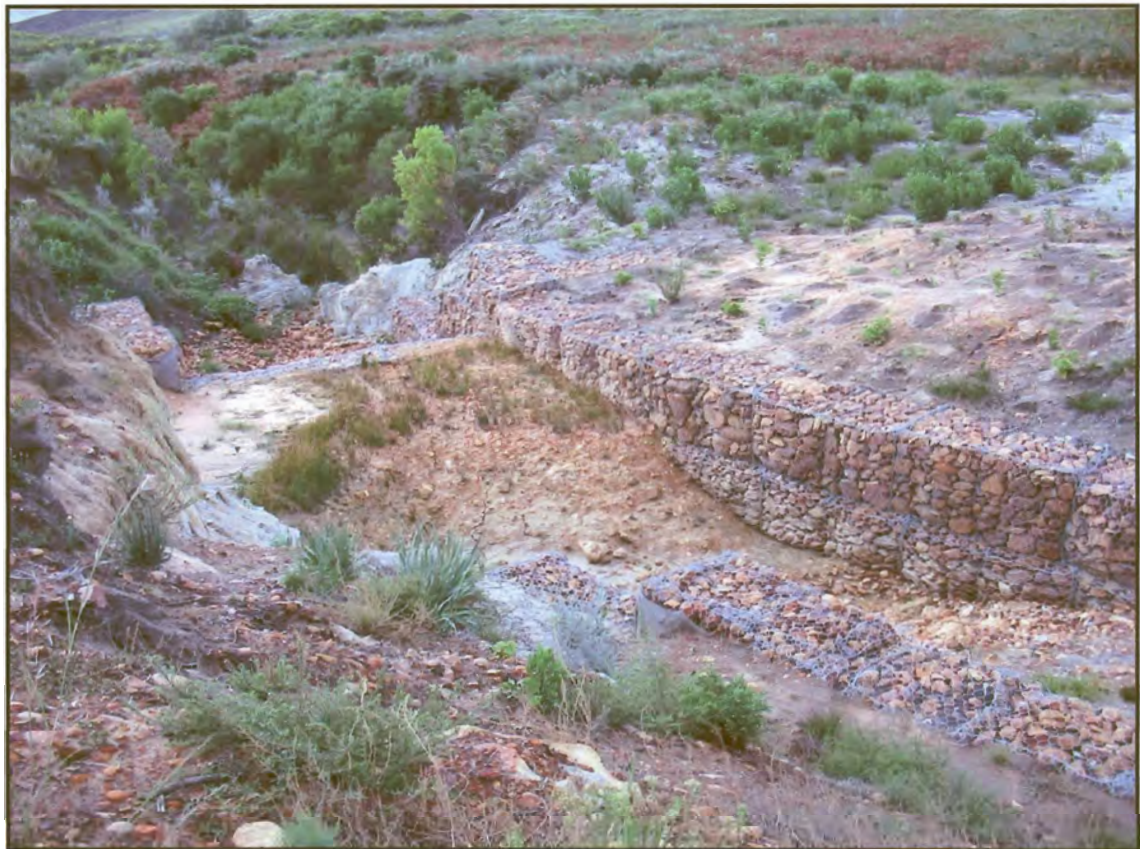
**Figure 11: Close-up photo of the headcut rehabilitation structure at a tributary of the Kromme River. This rehabilitation structure will not form part of the Wilge River Wetland study but indicates rehabilitation measures in the catchment.**

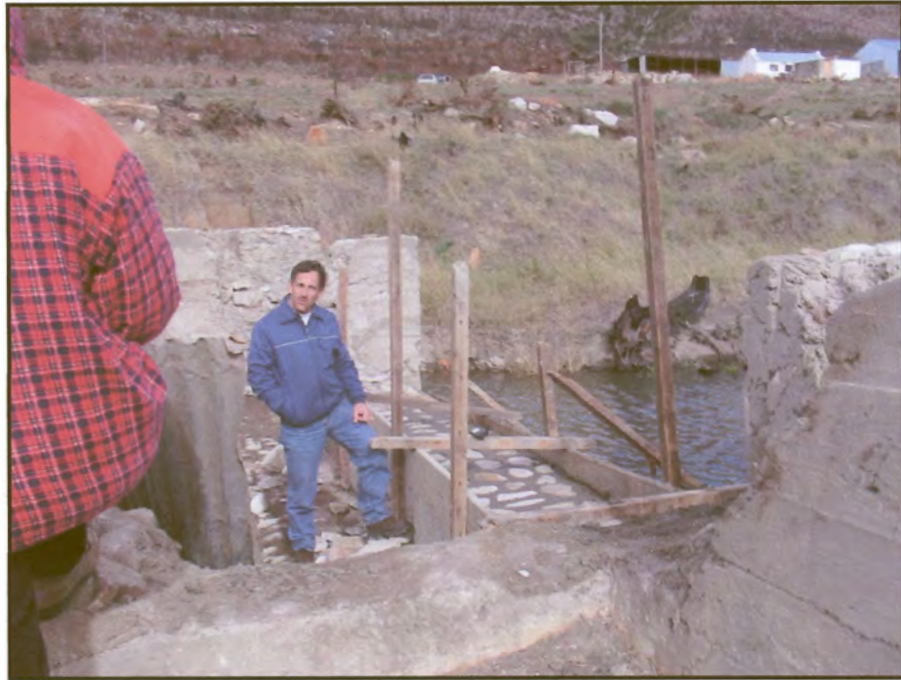
**Figure 12: Rehabilitation structure 1: Concrete Weir being constructed.**

<b>2</b> 24° 00' 19" 33° 51' 48"	Headcut 2.5 m deep and 9.5 m wide eroded river channel within riverbed.	2.5 m high concrete gravity structure (Figure 12) 3m wide at bottom and 9.5 m overflow width build on rock foundation across a narrow section of the river below a headcut.	<ul style="list-style-type: none"> <li>Structures must act as silt traps.</li> <li>Rehabilitation of indigenous vegetation. must protect the soil.</li> <li>Lift water table.</li> <li>Dissipate the energy of floods.</li> <li>To prevent further erosion of the wetland.</li> </ul>
<b>3</b> 24° 00' 08" 33° 51' 51"	Headcut 5.5 m deep and 17.5 m wide eroded channel within riverbed.	5.5 m high concrete gravity structure (Figure 13) 6 m wide at bottom and 17.5 m overflow width build on rock foundation.	<ul style="list-style-type: none"> <li>Structures must act as silt traps.</li> <li>Rehabilitation of indigenous vegetation. must protect the soil.</li> <li>Lift water table.</li> <li>Dissipate the energy of floods.</li> <li>To prevent further erosion of the wetland.</li> </ul>

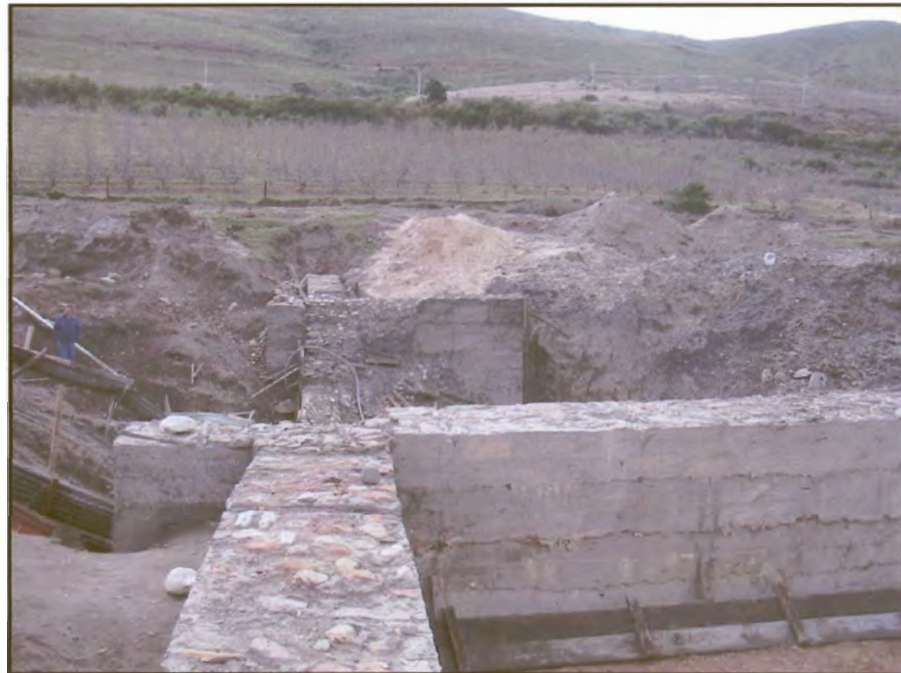
**Figure 13: Rehabilitation structure 2: Concrete Weir being constructed.**

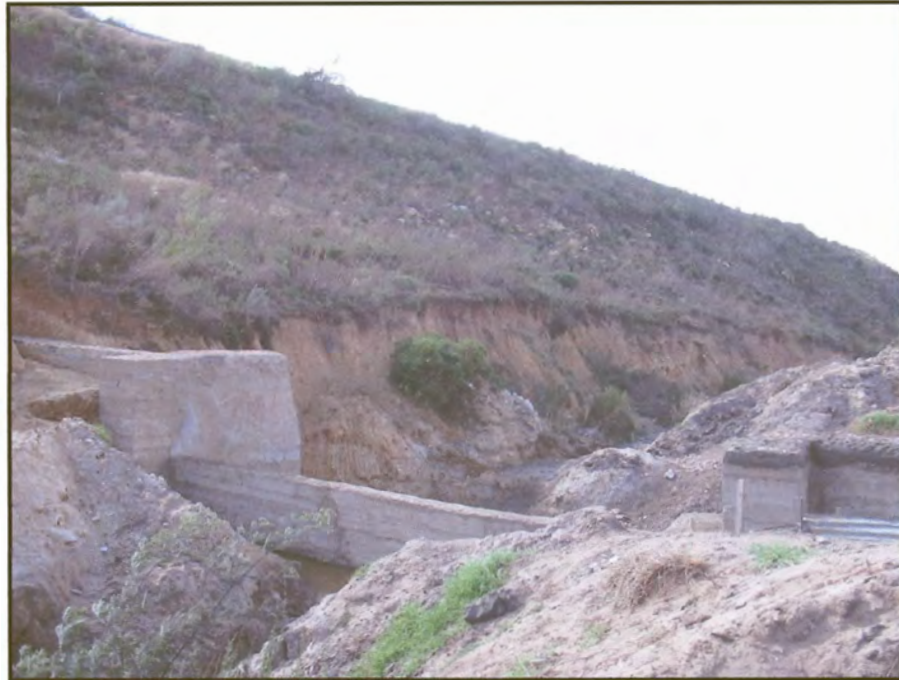
**Figure 14: Rehabilitation structure 3: Concrete Weir being constructed.**

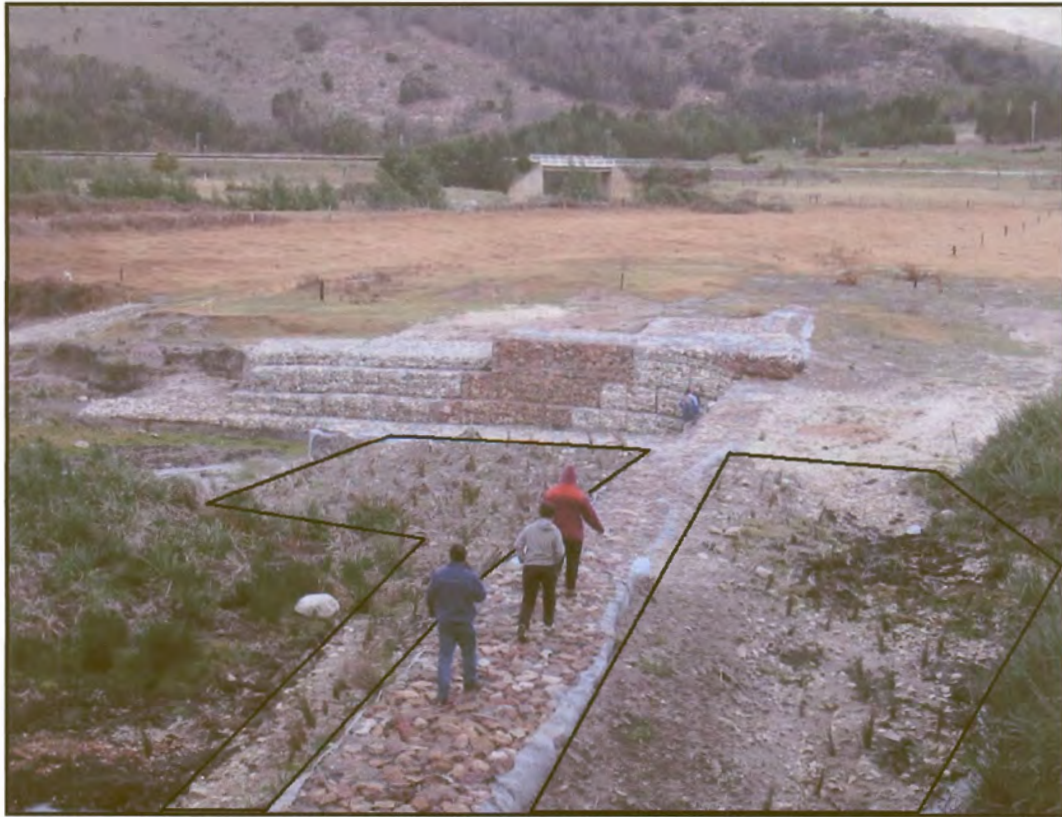
**Figure 16: Rehabilitation structure 5: Gabion weir at Hudsonvale. Note the revegetation on the sides.**

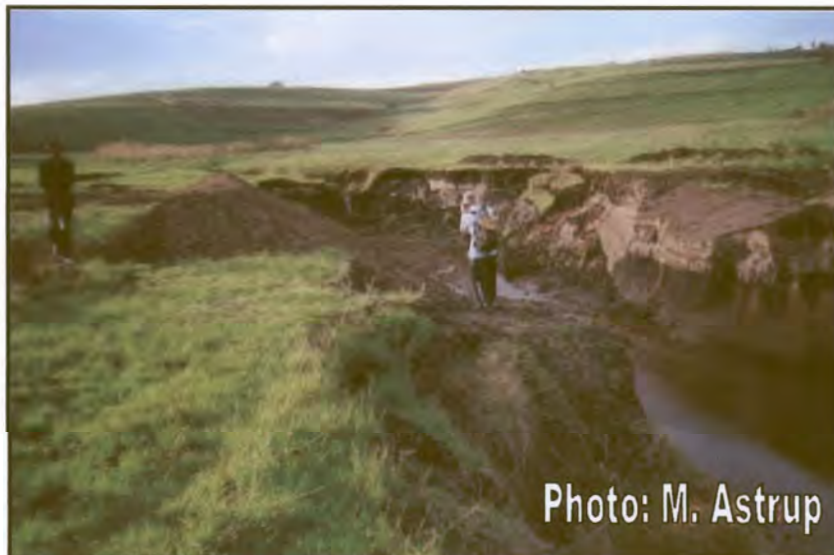
After 6 weeks of structure work at each site, 600 mm of rain fell in the catchment between 16 – 22 July 2002. This heavy downpour event was totally out of season. The Mbongolwane wetland falls in a summer rainfall region, the maximum rainfall months are: December, January and February (Figure b in Appendix 2) (ARC-ISCW, 2002).

Astrup (2002) commented that all the preparatory work at both the sites was totally destroyed (Figure 24). Flood waters gushed through the sites and caused serious erosion on the chute preparation (Figure 25, 26, 27, 28, 29 and 30). Astrup (2002) explained further that it was impossible to start again with chute preparation due to water flow and the loss of precious work time. The risk of spring rains would threaten chute preparation work started at this stage. Large volumes of water flowed through the Amatigulu site right up until August. A decision was taken to re-plan a structure for the winter of 2003 (M. Astrup, *pers. comm.*).

**Figure 24: Amatigulu site. View of the damaged geocell chute after July 2002 floods. Note the lush green grass after the rains.**

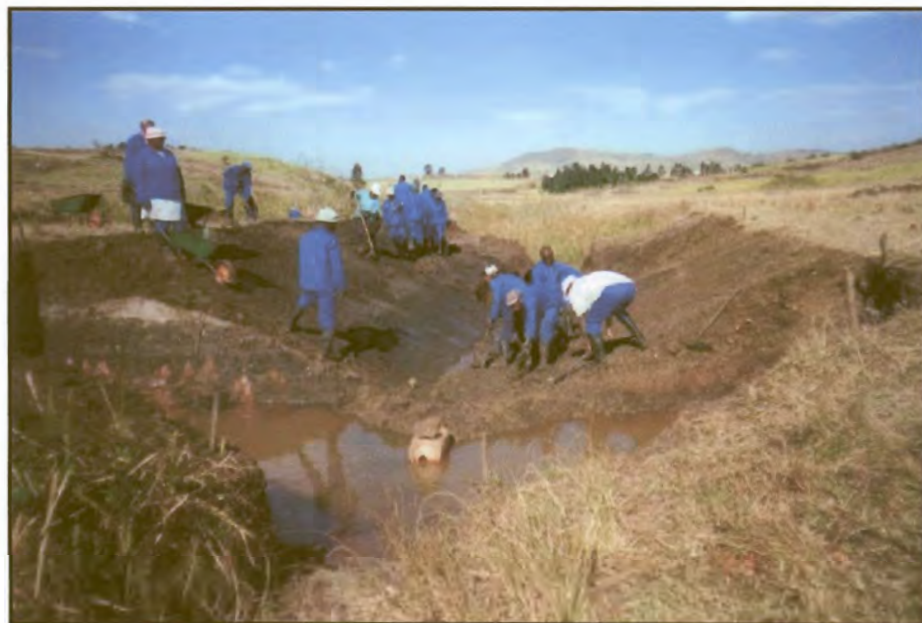
**Figure 26: After flooding. Photo taken downstream after July 2002 at the Amatigulu site. Geocell chute preparation at 1:5 gradient (Photo: M. Astrup).**

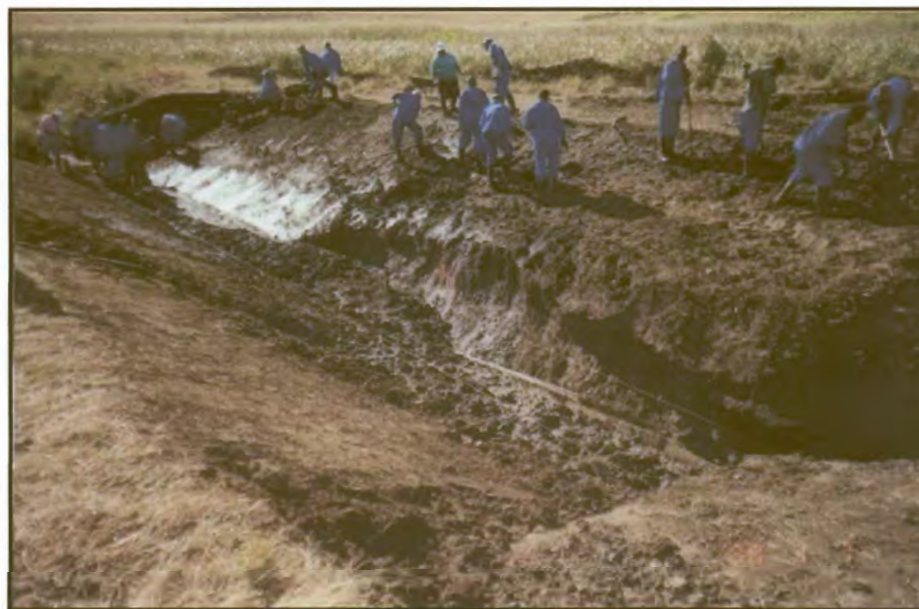
**Figure 28: After flooding. Photo taken upstream after July 2002 at the Amatigulu site. Geocell chute preparation at 1:5 gradient (Photo: M. Astrup).**

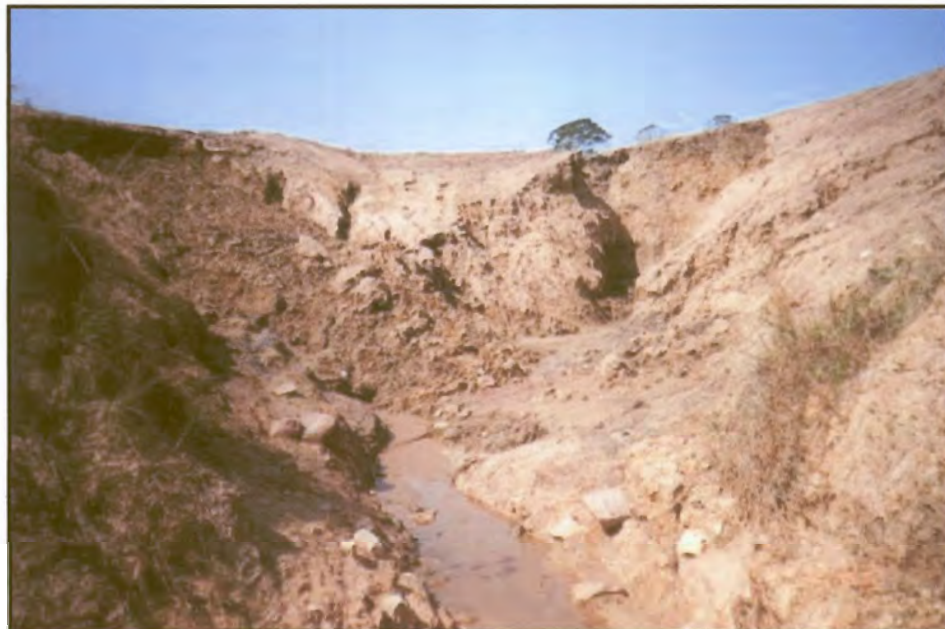
**Figure 30: Uvova site damage to chute preparation after July 2002 floods (Photo: M. Astrup).**

A 25 - m long sand bag groyne (Figure 31 a) to divert the stream flow away from the headcut site of the donga, together with an earthen embankment with a small buttress weir 300 mm high and 45 m long (Figure 31 b) across the stream so as to evenly spread water flow. In addition, a 500 mm high earthen embankment (storm drain) (Figure 31 c) was constructed directly above the headcut site so as to ensure water does not enter at this point. Reparation work on the Uvova site was done during September and October 2002 (Figure 31 d).

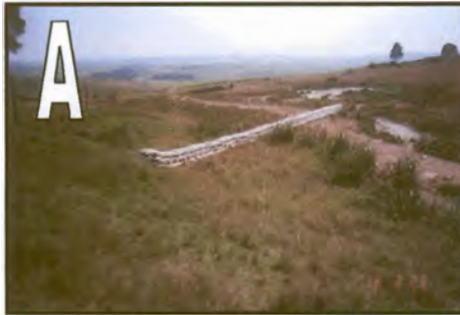
**A**  
Sandbag groyne to divert stream to right-hand course away from headcut. This is a temporary structure while stream formalizes channel to the right.

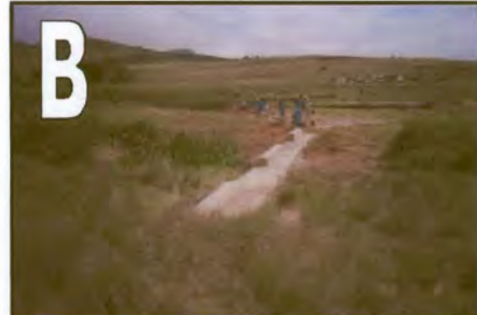
**B**  
Buttress weir under construction. 50mm PVC piping will carry base flow into headcut site.

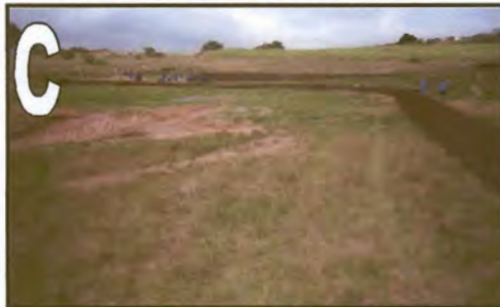
**C**  
Earthen embankment (500 mm) high storm drain to keep floodwater away from headcut on left. Large earthen embankment and buttress weir visible on top left of photo.

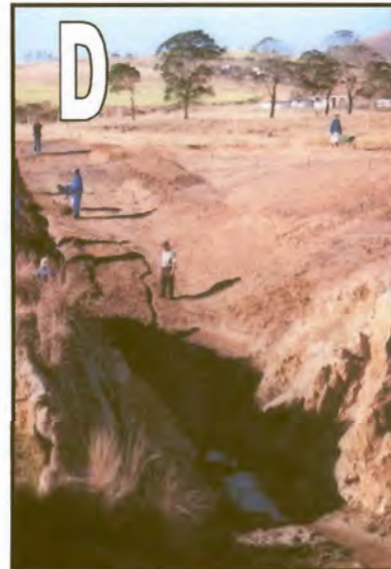
**D**  
Preparation for geocell chute work.

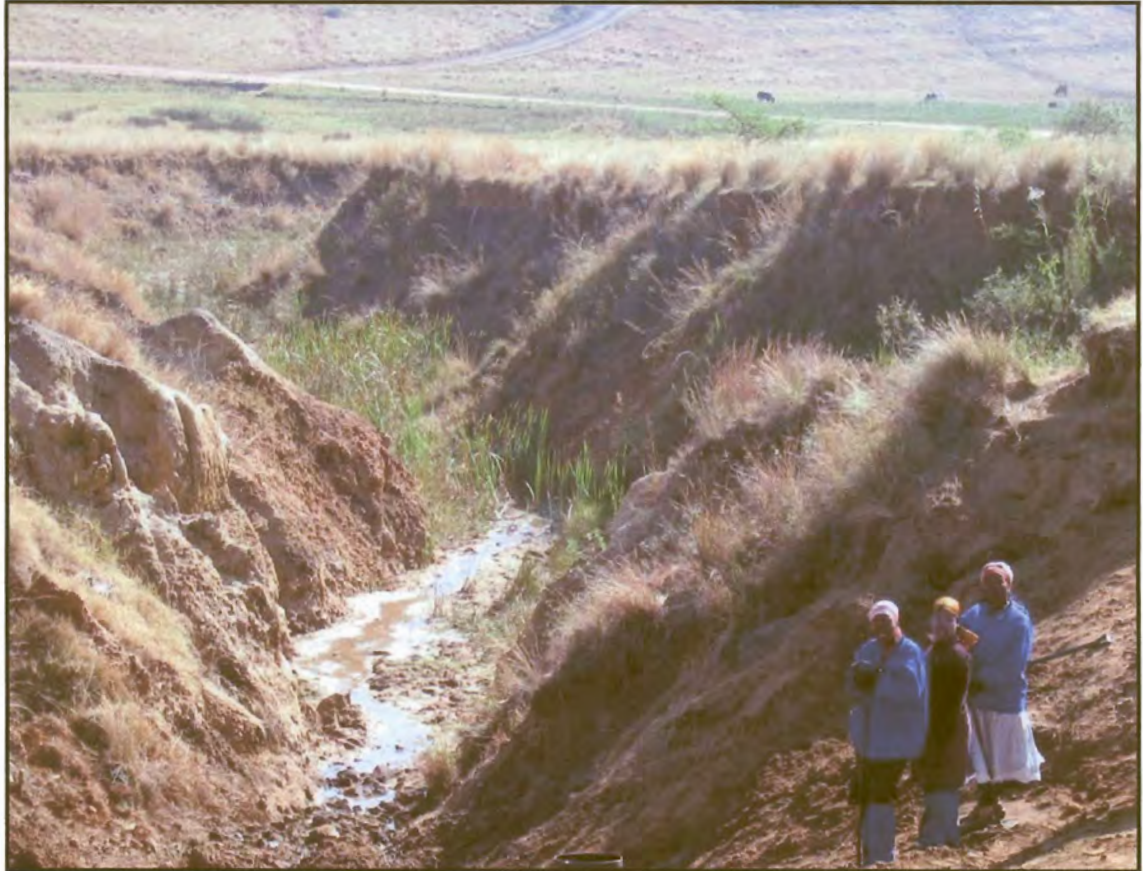
**Figure 32: An eroding headcut situated on the Uvova stream. The stream enters the Mbongolwane wetland. Photo taken on 4 July 2002.**

A concrete chute is planned for where the stream flow enters the drainage line (Figure 32). The position will be about 400 m below the headcut.
