Effect of Solution Aggressiveness on the Crack Growth Resistance and Cracking Mechanism of AA2024-T3

Christina Margarita Charalampidou¹, Christiaan C.E. Pretorius²; Roelf J. Mostert^{2,*}; Nikolaos D. Alexopoulos^{1,*}

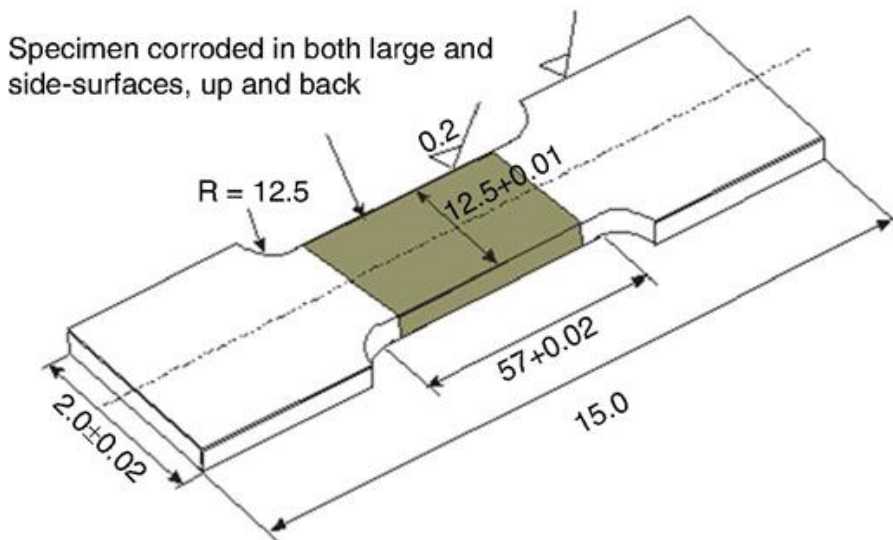
Figure 1. Schematic representation of shielded tensile specimens according to ASTM E8 specification.

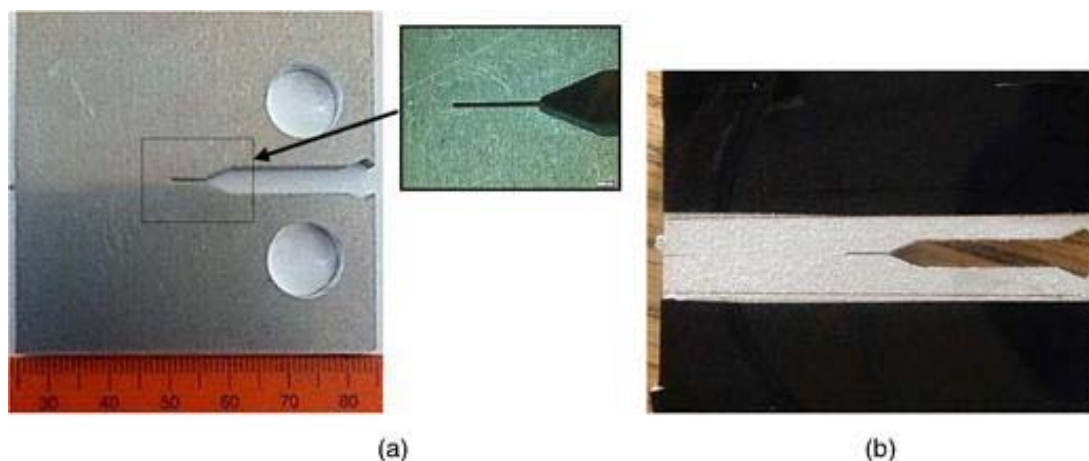
Figure 2. (a) Photograph of the C(T) specimens' geometry and notch detail according to ASTM E561 specification and (b) photograph of the shielded specimen.

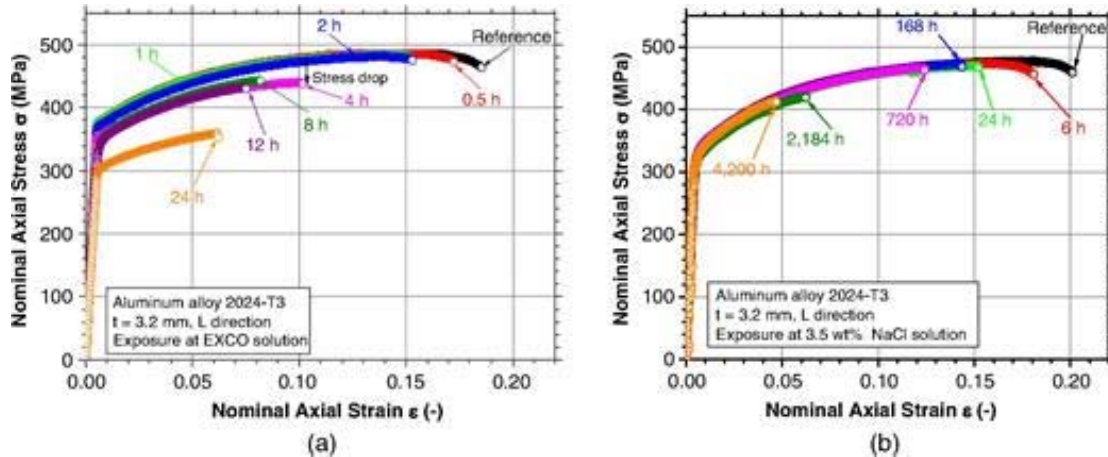
Figure 3. Typical tensile nominal stress-strain curves of AA2024-T3 after corrosion exposure to (a) EXCO solution and (b) 3.5 wt% NaCl solution.

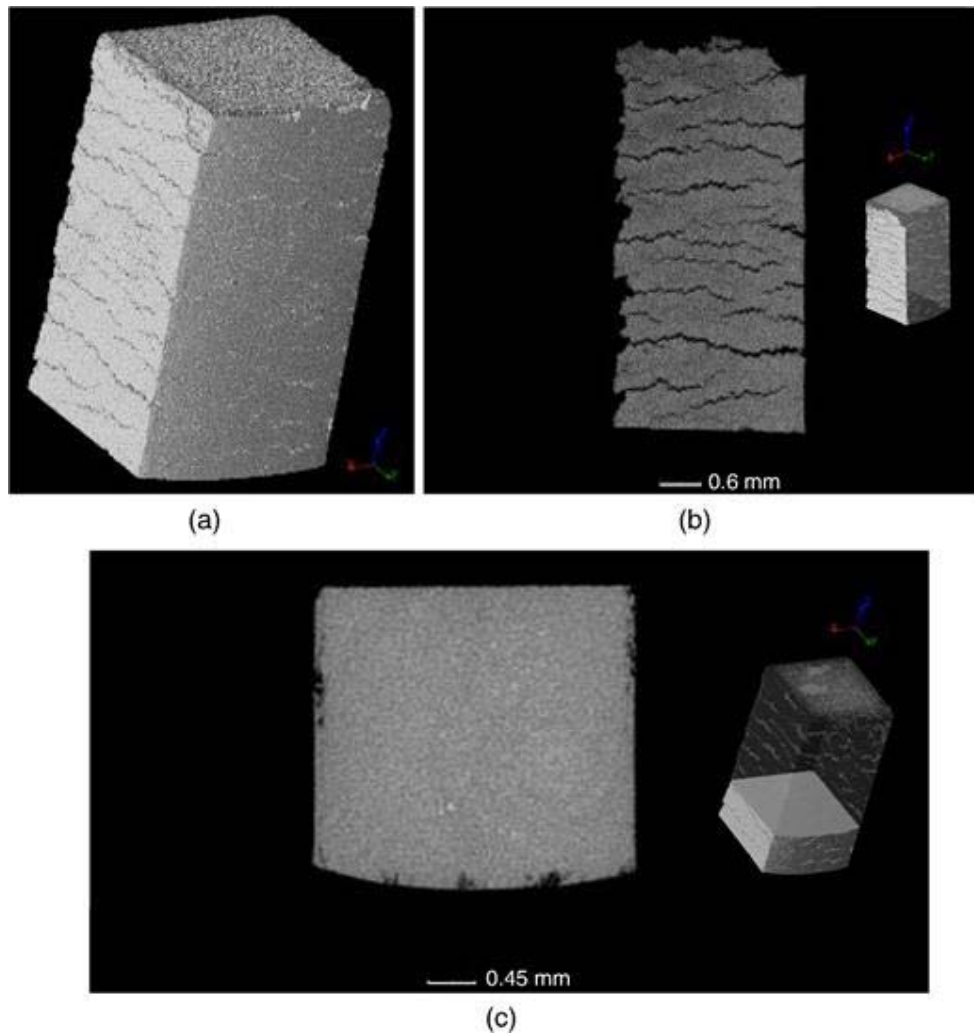
Figure 4. Post-tensile test micro-XCT images of the EXCO-exposed specimens, with (a) full-volume micro-XCT specimen, (b) a section near the exposed surface showing the intergranular tearing due to grain-boundary embrittlement, and (c) the cross-sectioned area shown in the right image included.

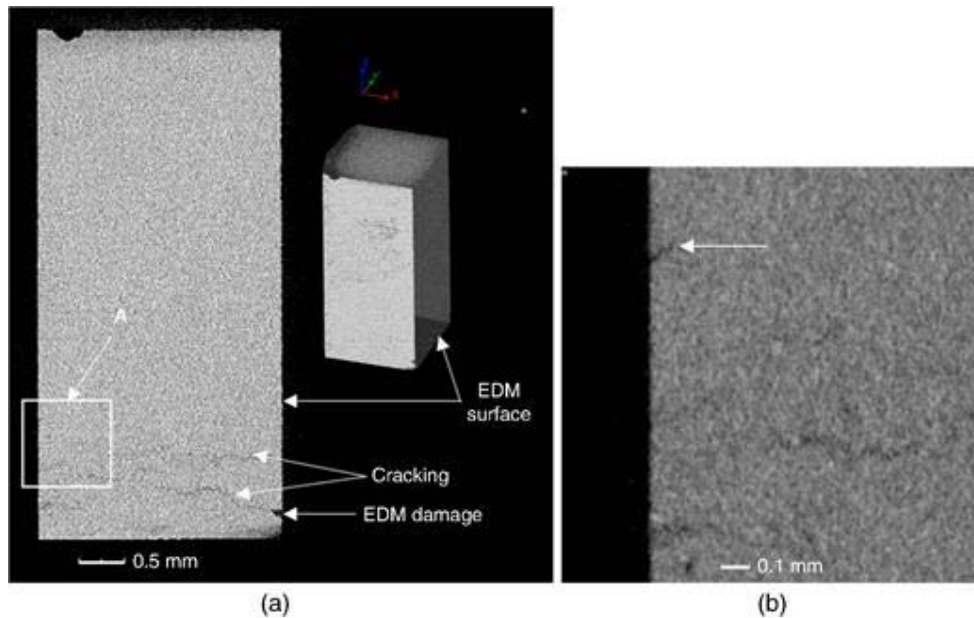
Figure 5. (a) Micro-XRCT image of 2 h EXCO exposed AA2024-T3 tensile specimen after the application of 2% engineering strain and (b) higher magnification of section A, showing that the secondary cracking extends to an approximate depth of 0.05 mm from the exposed surface.

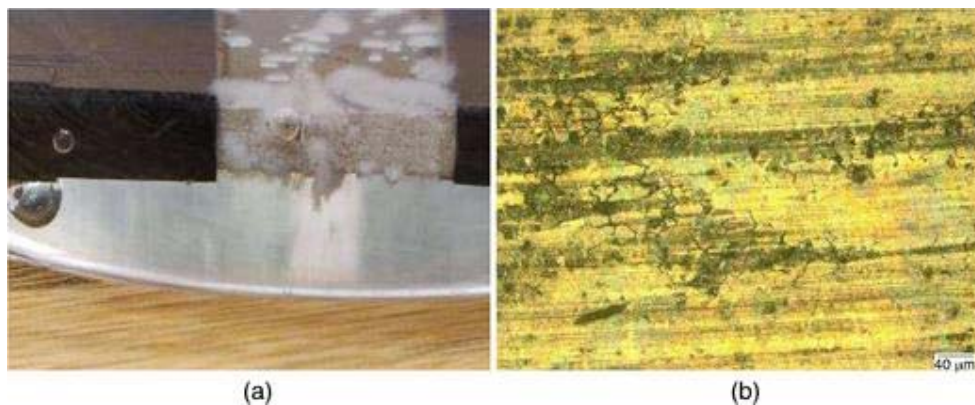
Figure 6. (a) Photograph showing the white precipitate layer on the specimens surface after 24 h immersion in the 3.5 wt% NaCl solution and (b) optical micrograph (200× magnification) showing the significant pitting and intergranular attack within the area where white layer (Al(OH)₃) formation occurred.

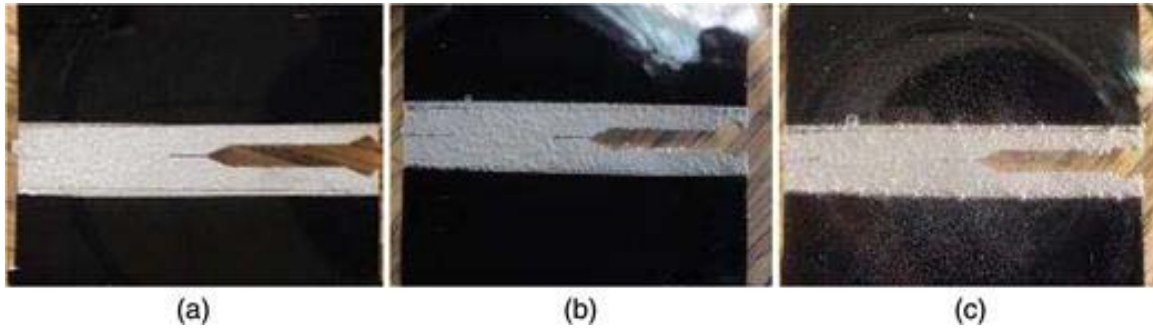
Figure 7. Hydrogen bubble formation during EXCO exposure after (a) 15 min, (b) 30 min, and (c) 90 min.

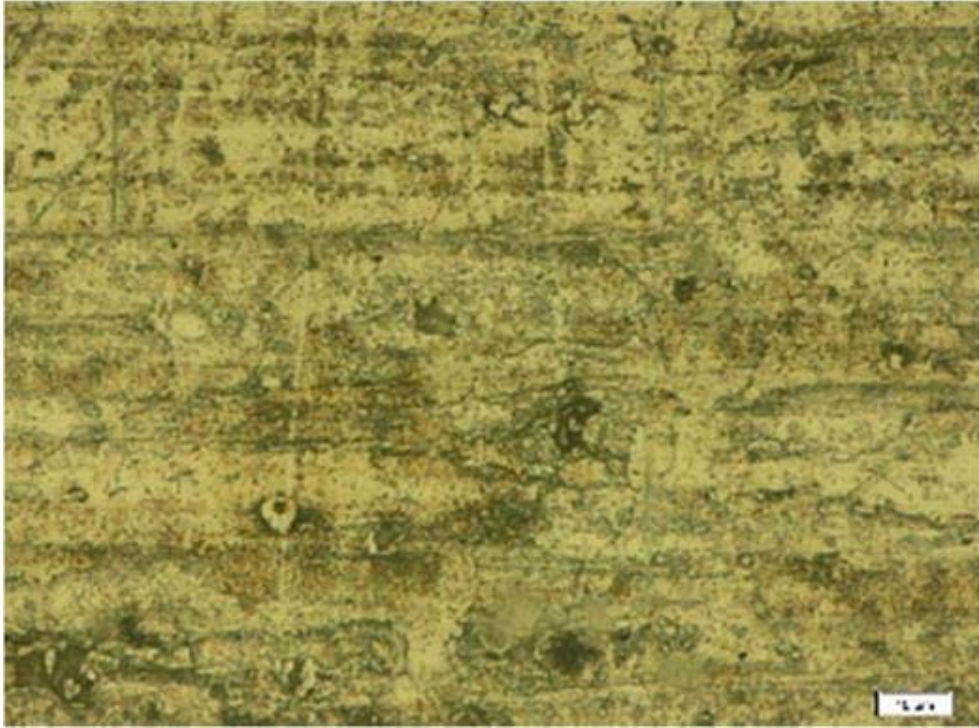
Figure 8. High-magnification (1,000 \times) optical micrograph of the C(T) (L-T) specimen surface after the 2 h exposure to the EXCO solution, showing no signs of significant pitting or intergranular corrosion.

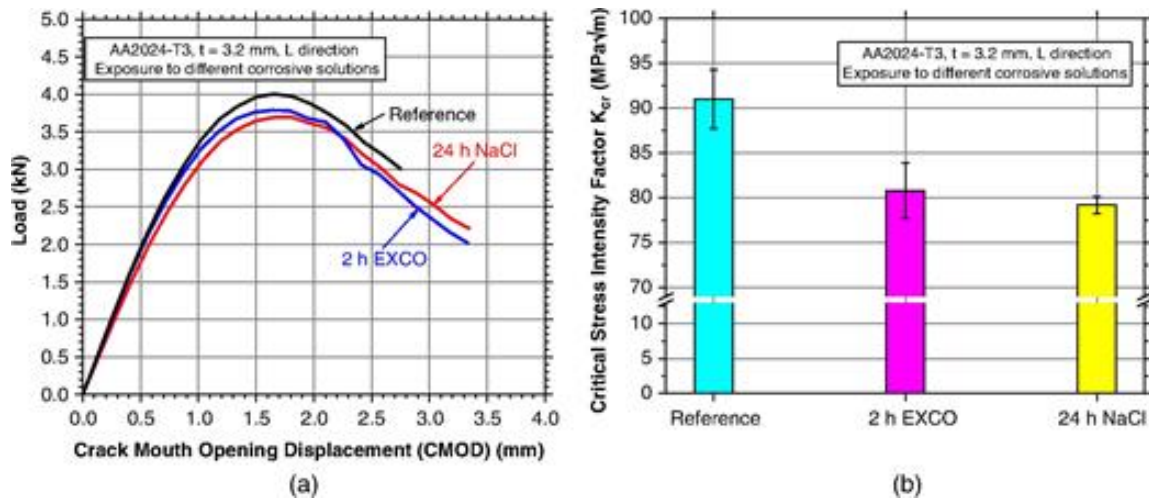
Figure 9. (a) Load-CMOD curves and (b) evaluated critical stress intensity factor (K_{cr}) values of AA2024-T3 specimens after prior exposure to different corrosive solution.

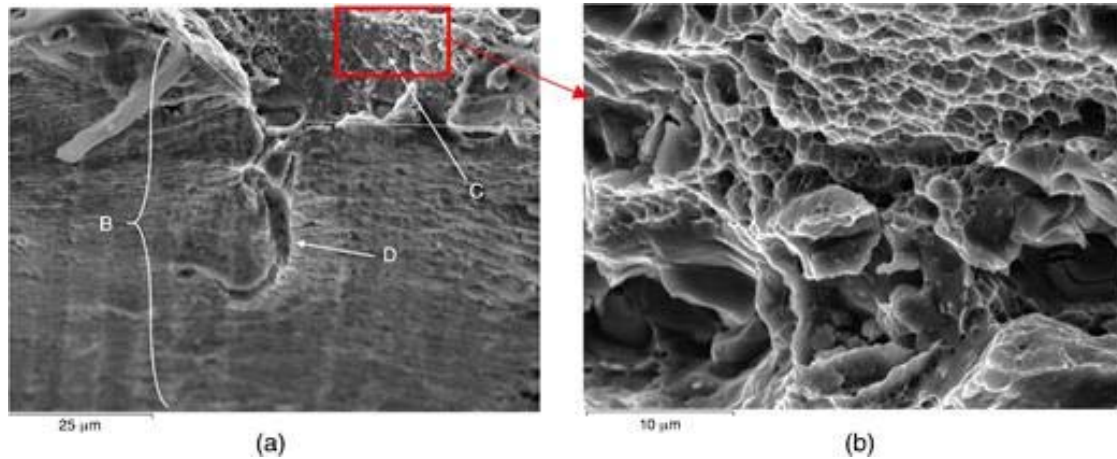
Figure 10. (a) SEM image near the surface (B until dashed lines) of the NaCl exposed specimen, showing the ductile (dimpled) fracture surface (C) immediately adjacent to the specimen surface, with (D) the point where intergranular corrosion has occurred and (b) higher magnification.

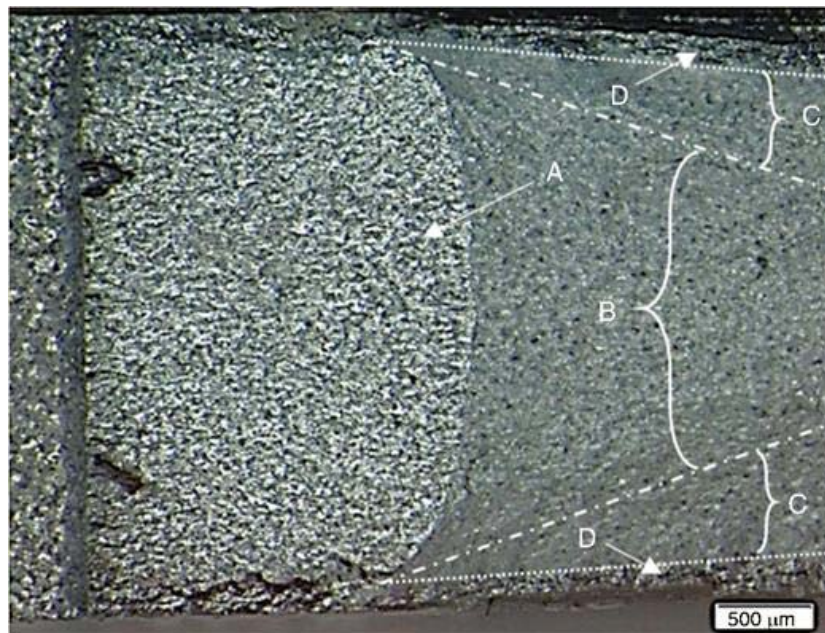
Figure 11. Optical micrograph showing the typical fracture surface of the EXCO-exposed specimens, with (A) the fatigue pre-crack, (B) the stable crack extension, (C) shear-lip (ductile) fracture, and (D) intergranular fracture.

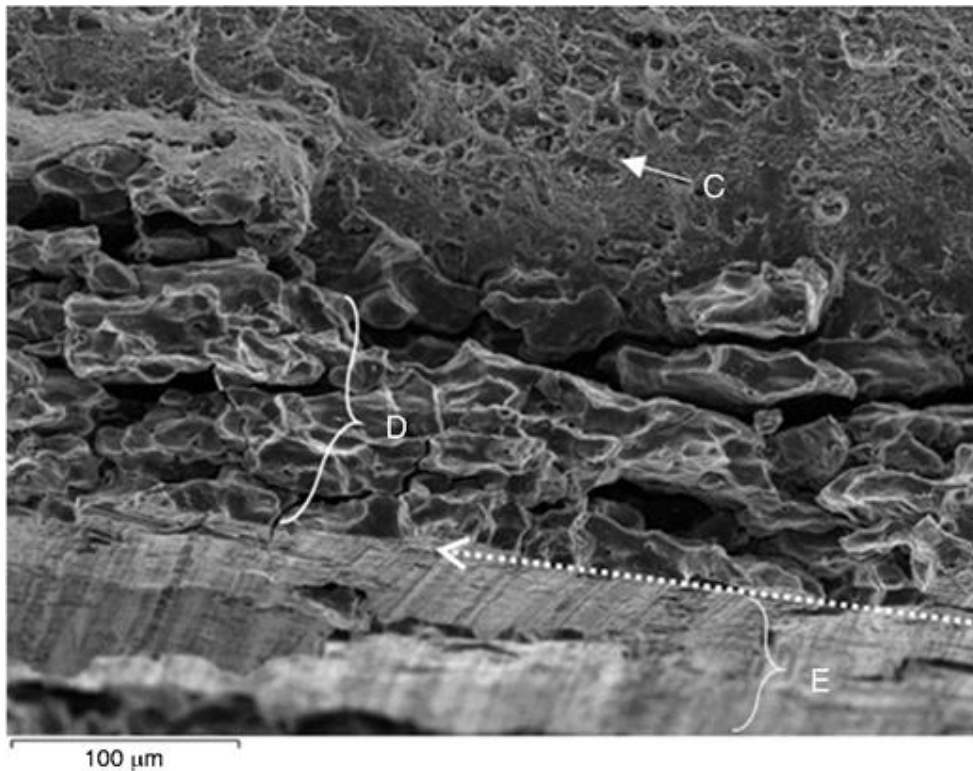
Figure 12. SEM image of the post crack-growth resistance evaluation fracture surface (D) near the exposed surface (E) of the EXCO-exposed C(T) (L-R) specimens.

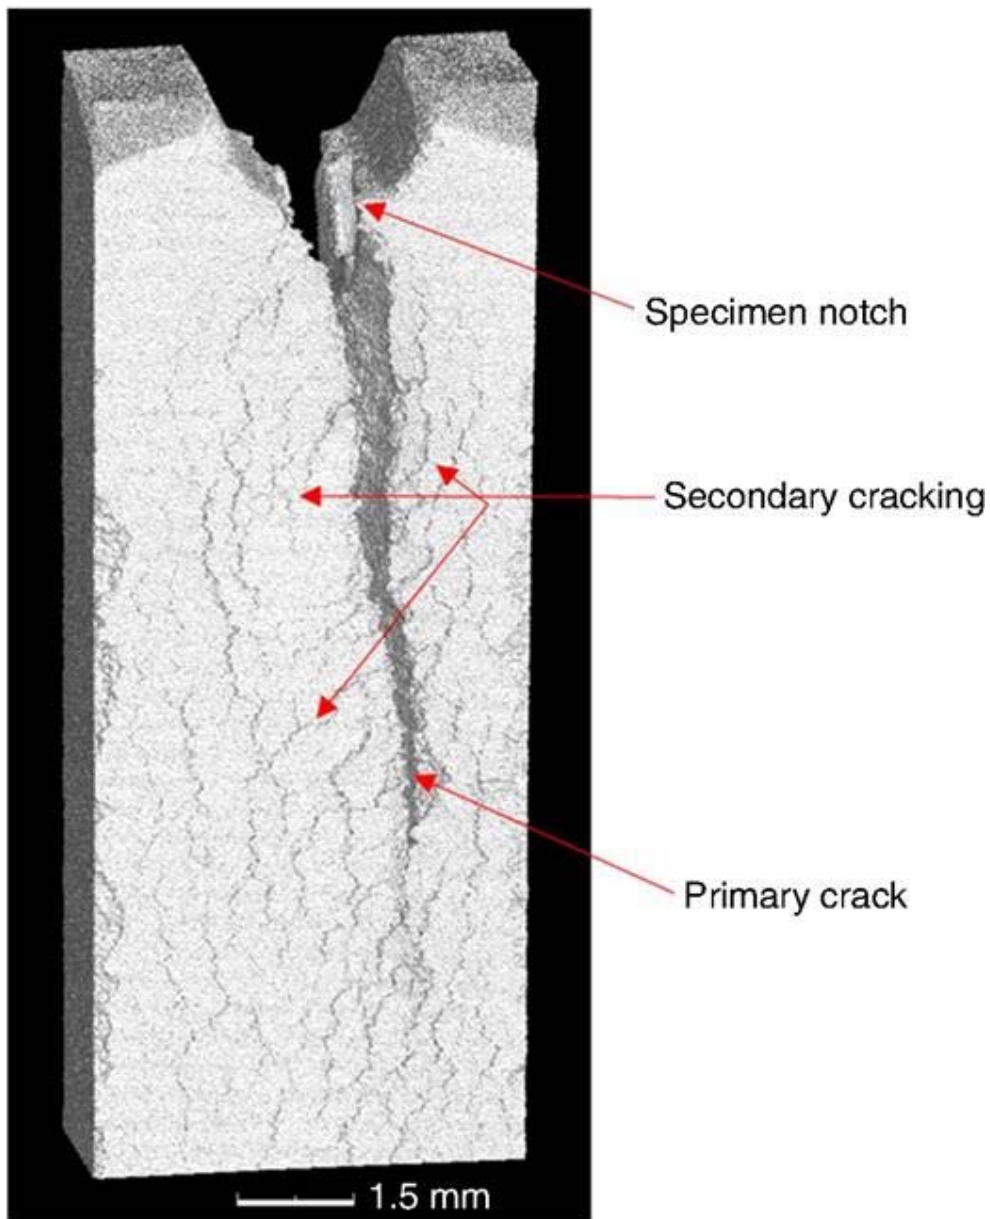
Figure 13. Post crack-growth resistance XCT image of the EXCO-exposed specimen B2, showing the secondary cracks that formed within the plastic zone near the primary crack front.

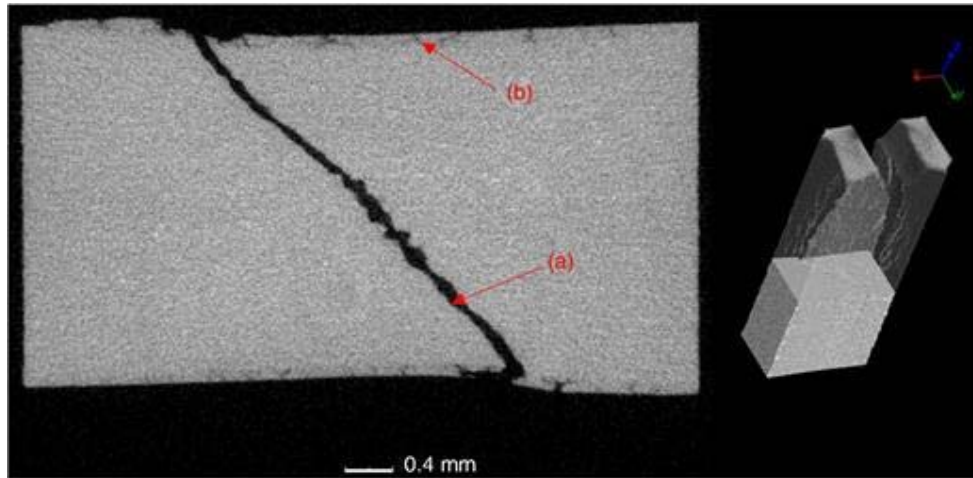
Figure 14. Post crack-growth resistance XCT images of the EXCO-exposed specimen B2, with the left image showing the (a) primary and (b) secondary cracks and the cross-sectioned area shown in the right image.
