Site C

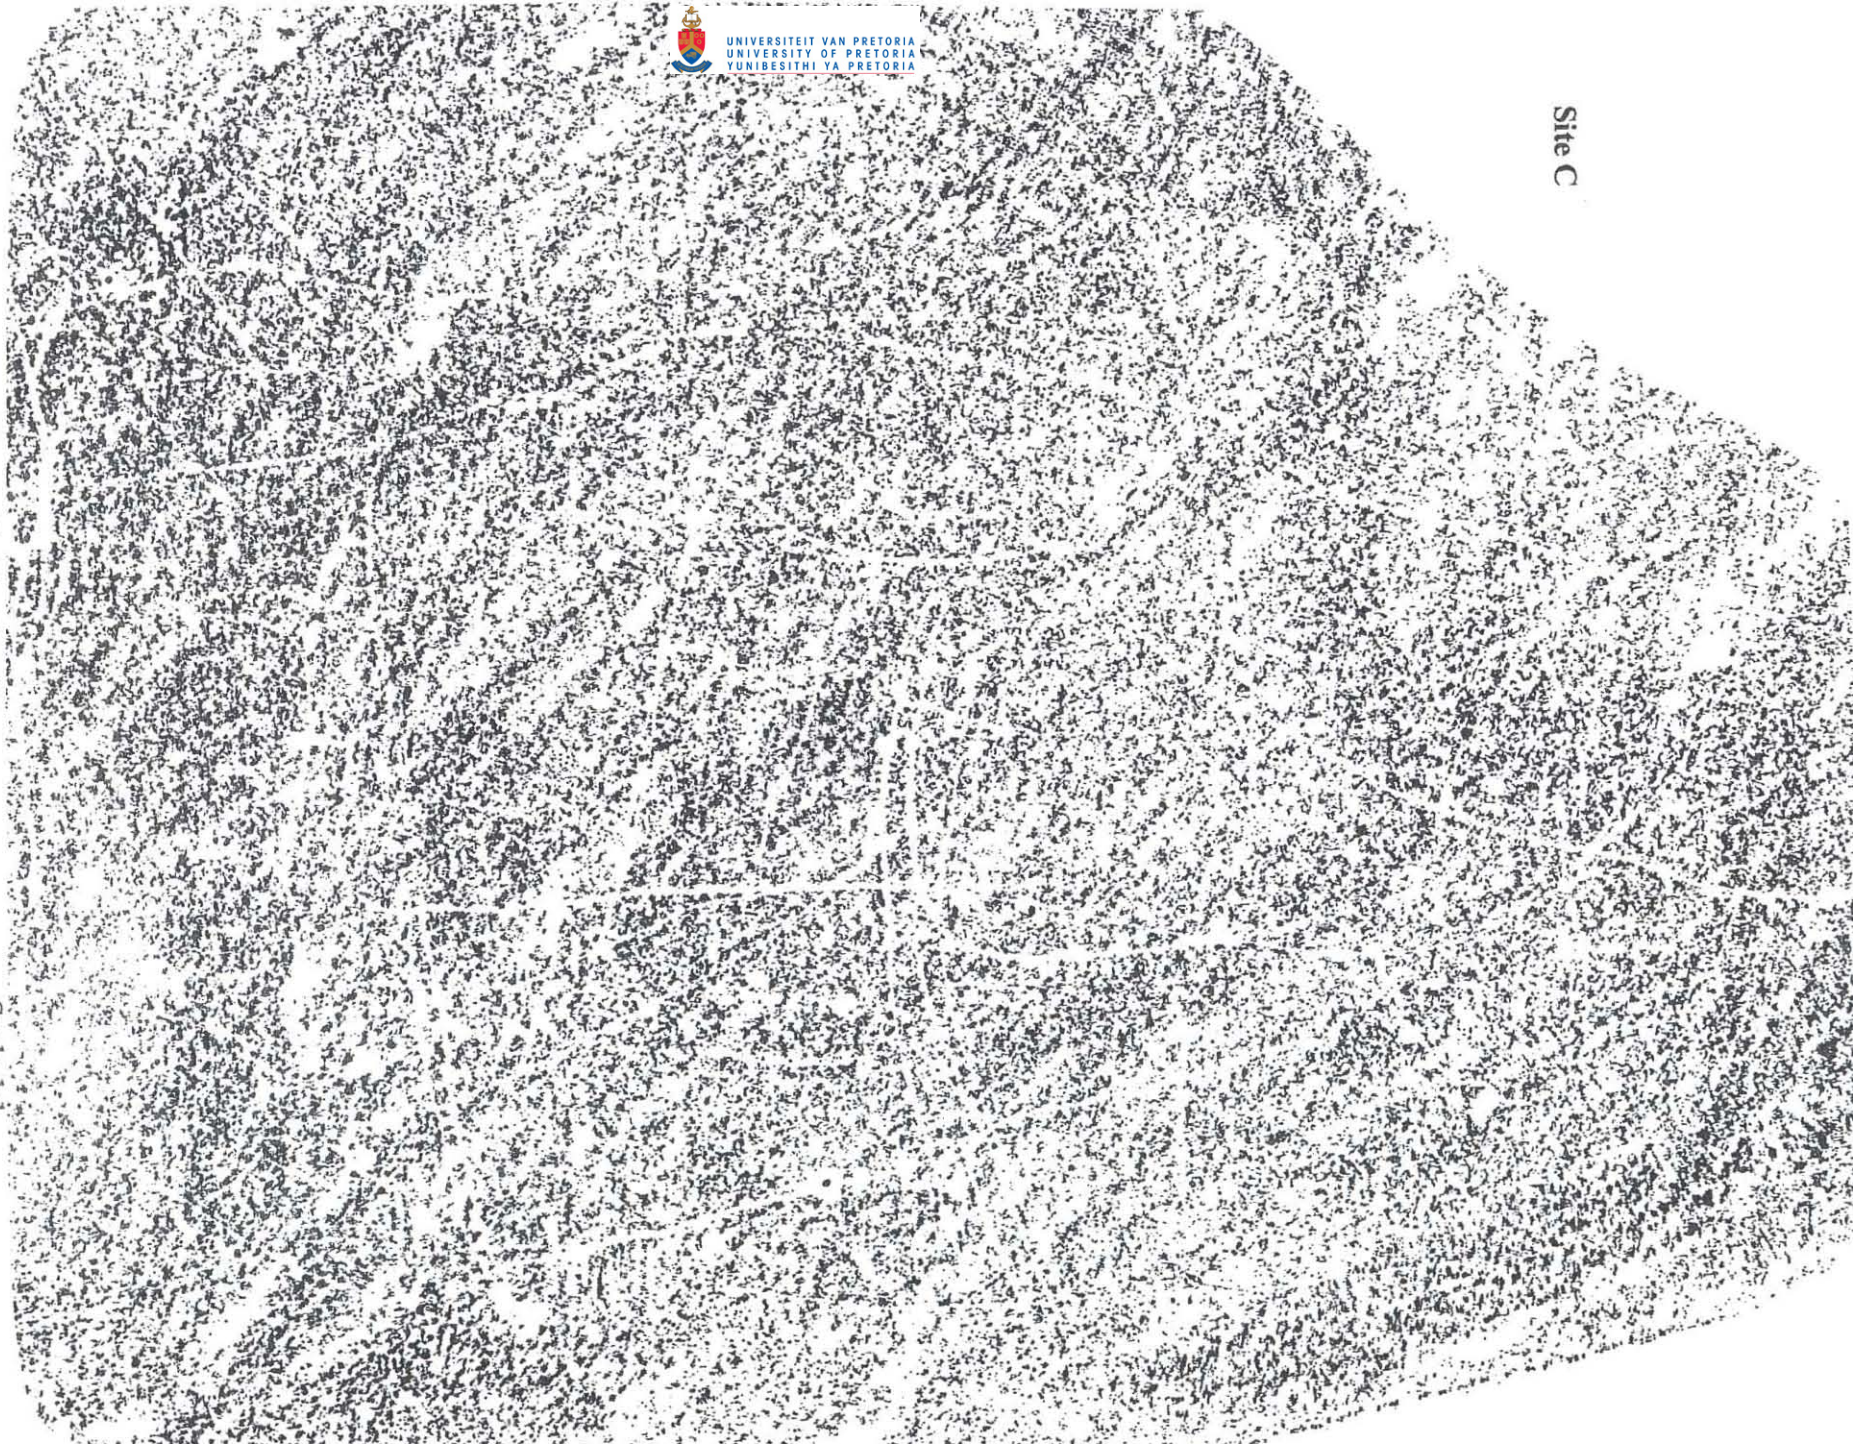
(Figure C1: The Eland)

Figure C1- **The Eland** (*Tragelaphus Oryx*) - Latitude 27° 29' 10.2" E
Longitude 25° 54' 14.2" S
Actual Size Length: 19cm Breadth: 28cm

A single partially naturalistic animal profile of an eland was engraved (Figure C1). The engraving was incised making use of a fine line technique. The caudal appendage, hindquarters and characteristic nuchal hump are naturalistic in style but the head and legs are not. The head is portrayed as an oval shape and the legs are two simple parallel lines, the horns are also distorted. The eland was engraved grazing with its caudal appendage in the air as if to be swatting flies. There are numerous other incised lines, on which the eland is superimposed. They are not arranged in any specific order and don't appear to be related to the eland in any way. They appear to be more weathered than those incisions of the eland, and thus were there long before it (Figure C1 defined).

The engraving faces south- east. The texture of the rock surface is medium grained, with a few small erosion marks located all over the surface, they don't however interfere with the engraved work. The condition of the engraving is good, with its only threat being the elements and possible bush encroachment, due to the fact that it is located on the periphery of the site.

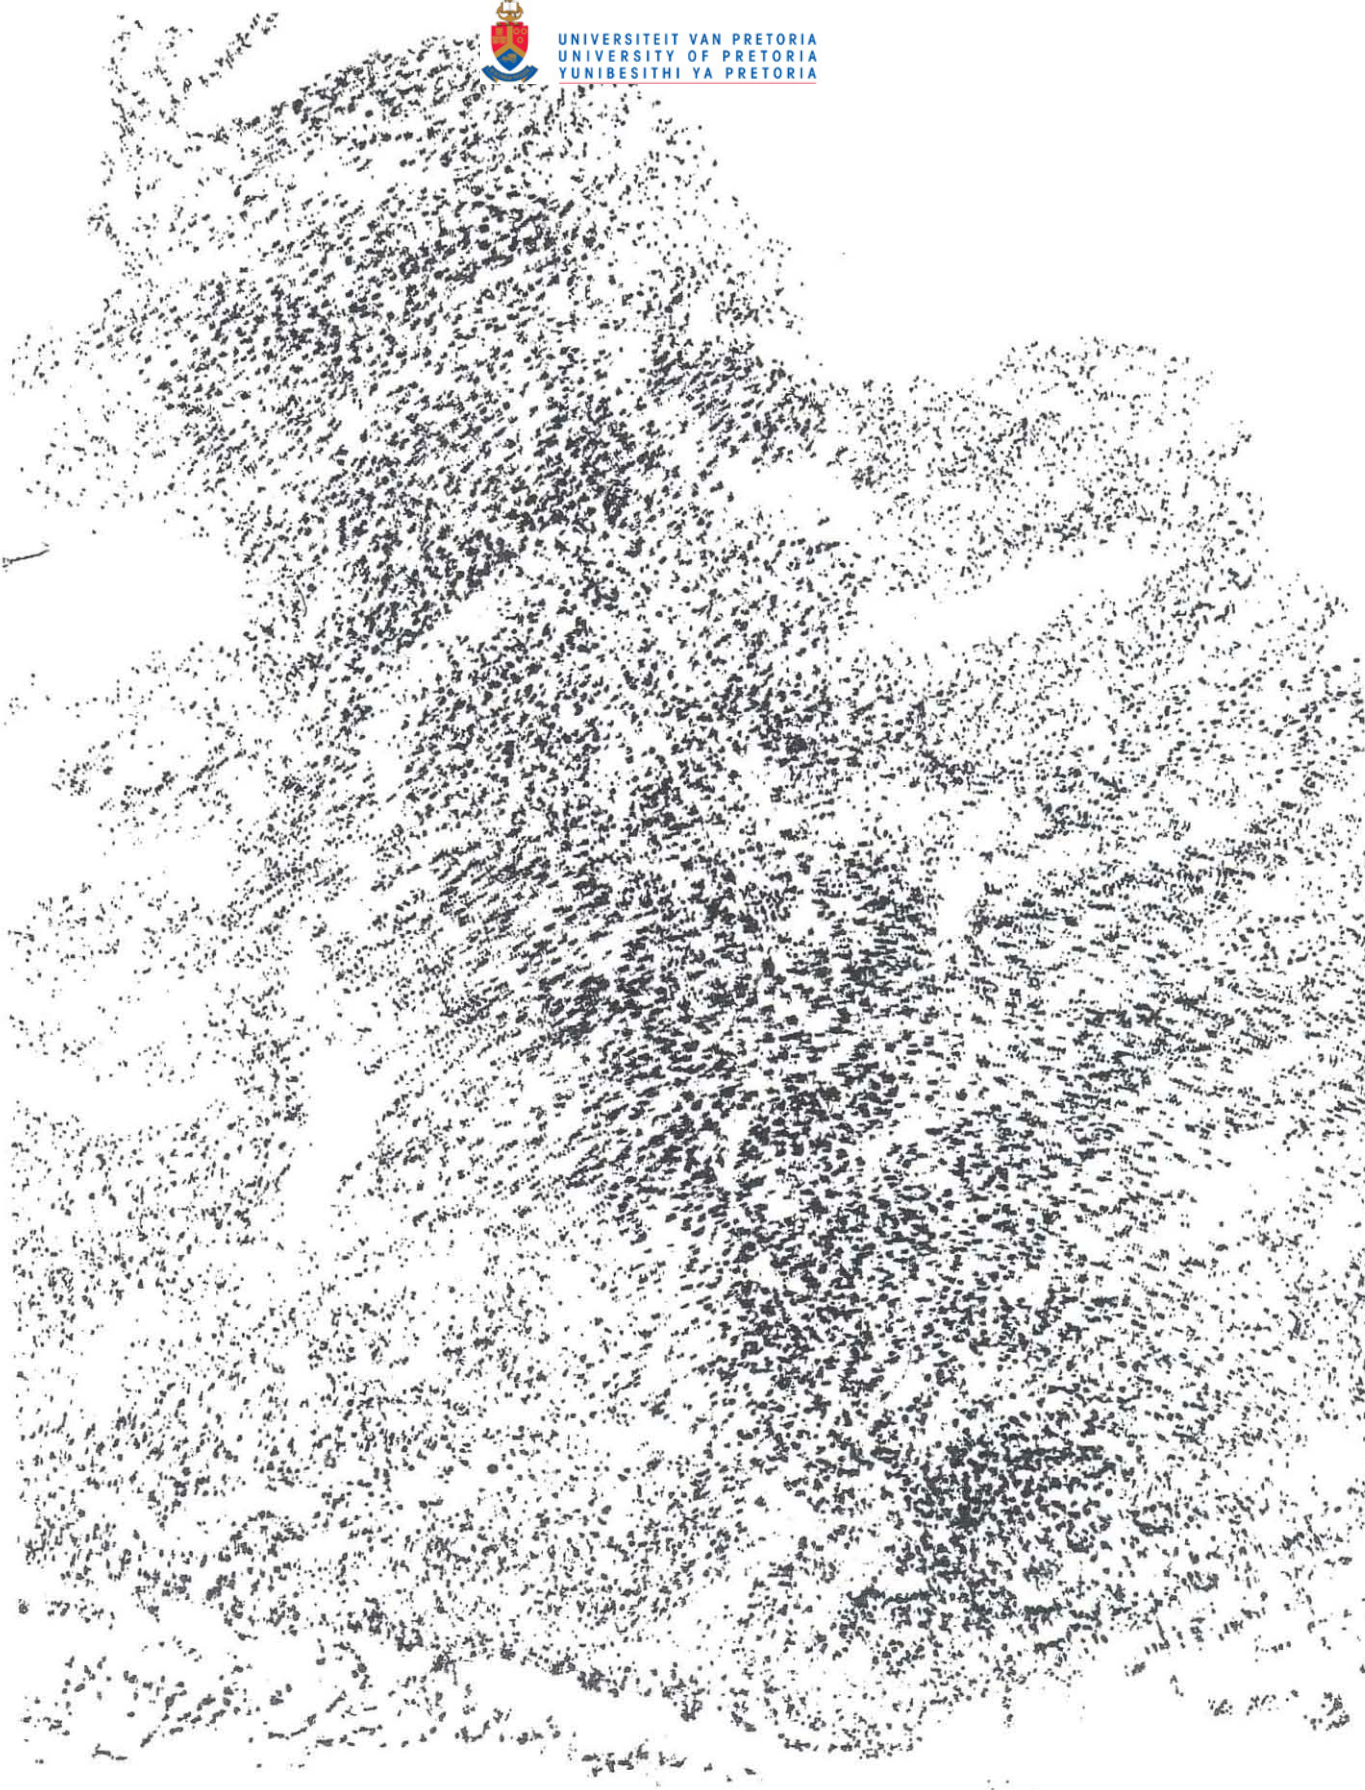
(Figure C2: Linear work)

Figure C2 - Linear Figure

The engraving is geometric in style and simplistic in nature (Figure C2). It was engraved making use of a fine lined incision technique. The engraving comprises of approximately six isolated parallel lines due to the rough texture of the rock they are hard to count (Figure C2 defined). A number of similar engravings can be found around Doornkloof, they seem to be made during the sharpening of the tools used to make the engravings.

The texture of the rock surface is very rough, with no erosion marks, but the rough surface makes the visibility of the engraving difficult. The condition of the engraving is good, with its only threat being the elements. The engraving faces south towards the water source.

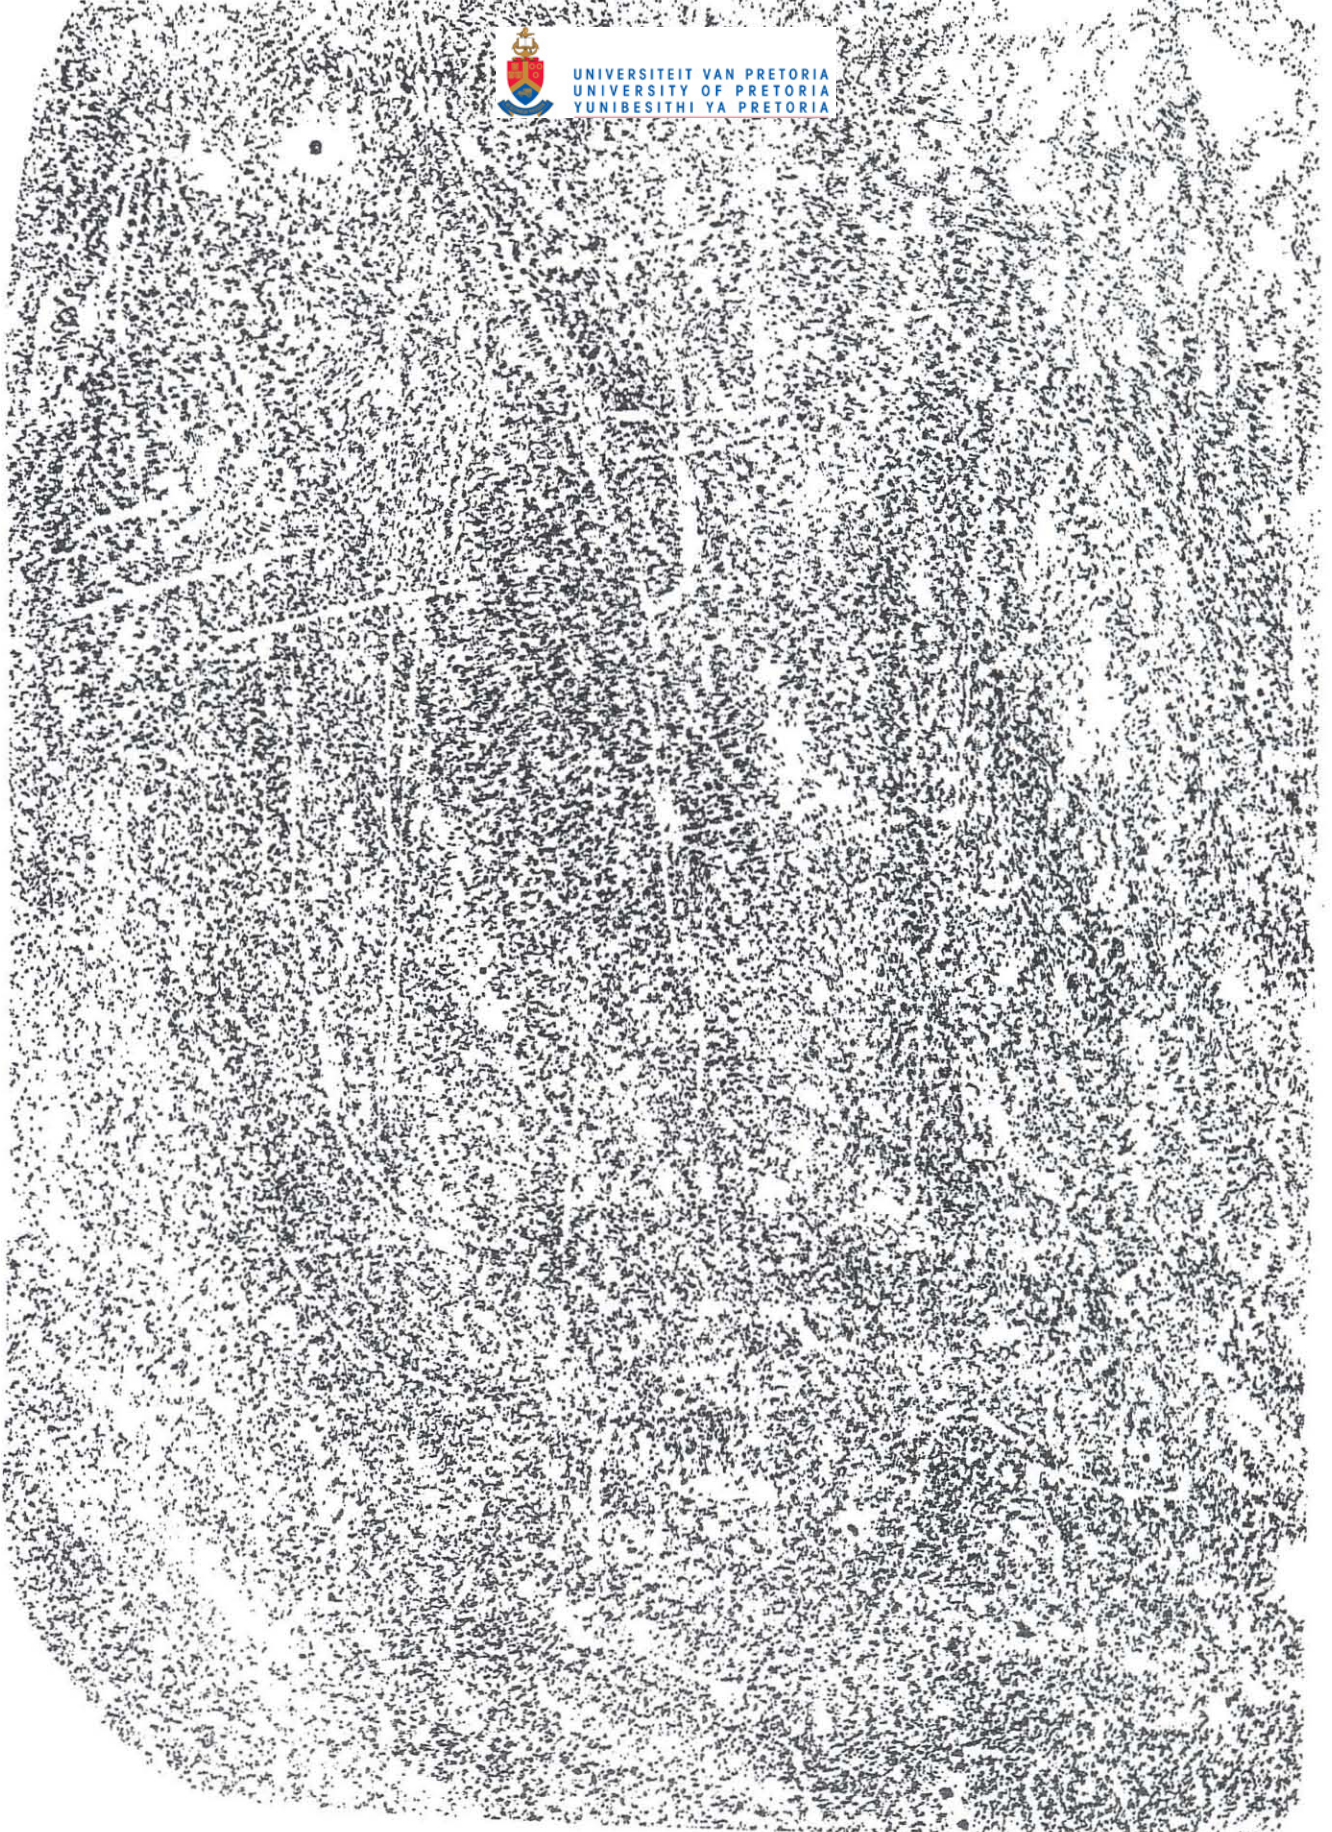
(Figure C3: Linear Motif)

Figure C3 - Linear Motif

The engraved work is geometric in style and incised making use of a fine lined technique (Figure C3). The engraving consists of an incised motif of converging and parallel lines. They don't appear to create any formal pattern, but could be a crude attempt, by a beginner who made numerous attempts at some form of animal (Figure C3 defined).

The texture of the rock surface is medium grained, with numerous small erosion marks on the surface. The condition of the engraving is satisfactory, with its only threats being bush encroachment, due to its location on the periphery of the site and the elements. The engraved work faces south towards the water source.

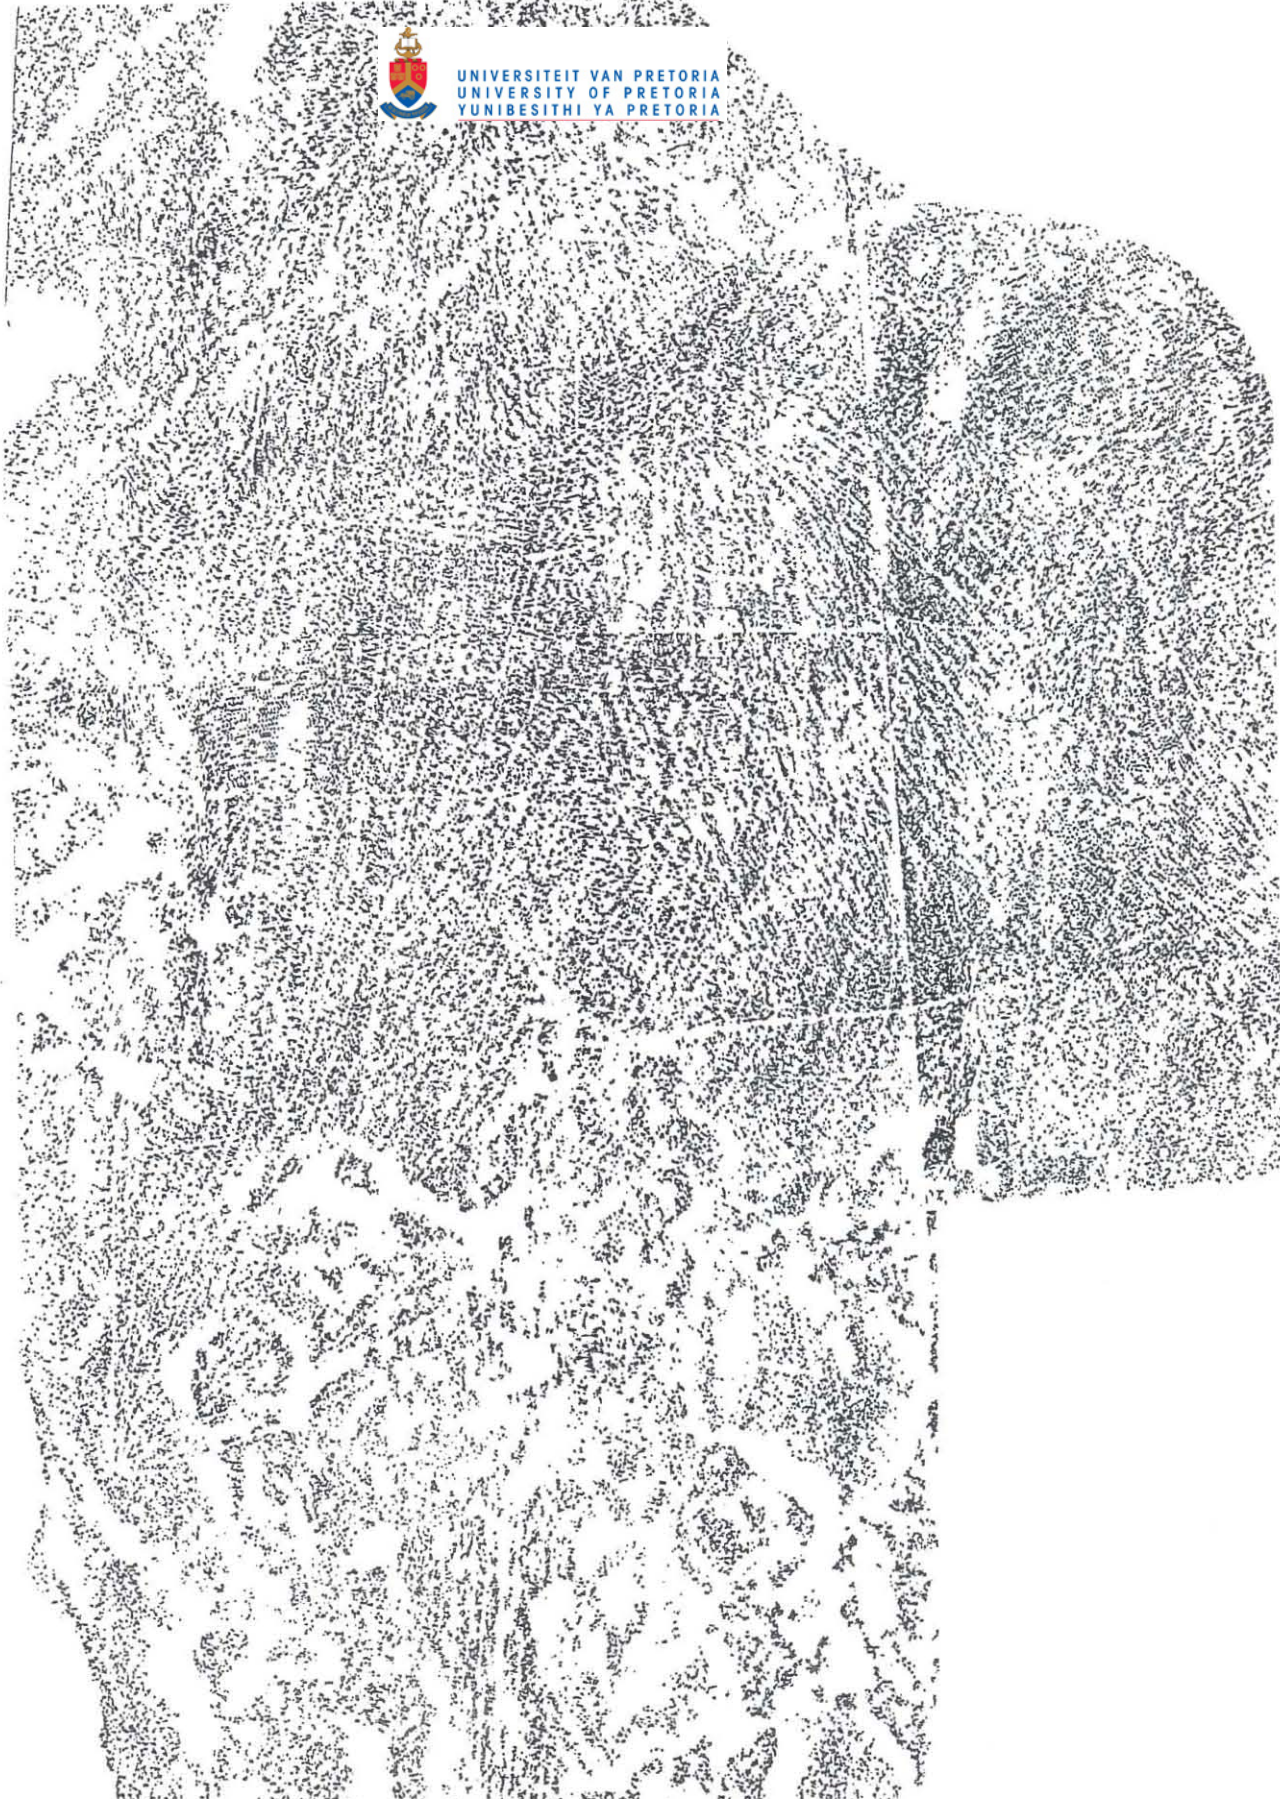
(Figure C4: Pattern Motif)

Figure C4 - **Pattern Motif**

The engraved work is geometric in style and was engraved making use of a fine lined incision technique (Figure C4). Approximately 25 converging lines between two points form the main pattern work on the rock surface. The pattern work resembles a rainbow. This pattern work is also characteristic of entoptic phenomenon, brought on by hallucinations and trances, resembling parallel curved entoptic lines, which to date was said not to occur in the Magaliesburg. These lines are however difficult to distinguish due to the rough texture of the rock and the weathering that has taken place.

Numerous parallel lines are found on the north and east sides of the pattern work. Those found on the east side resemble the sharpening lines of figure C2 and overlap the pattern work. The scratching found on the north side of the pattern also overlap the pattern work. Various upside down "V" shaped lines are also visible above and to the right of the pattern (Figure C4 defined).

The texture of the rock surface is medium to rough grained, with numerous large and small erosion marks located all over the surface. The erosion marks interfere to a large extent with the rubbing made of the engraving, but in reality the condition of the engraved work, is satisfactory. The condition of the engraving is deteriorating due to the natural weathering of the rock surface, but there are no other threats.

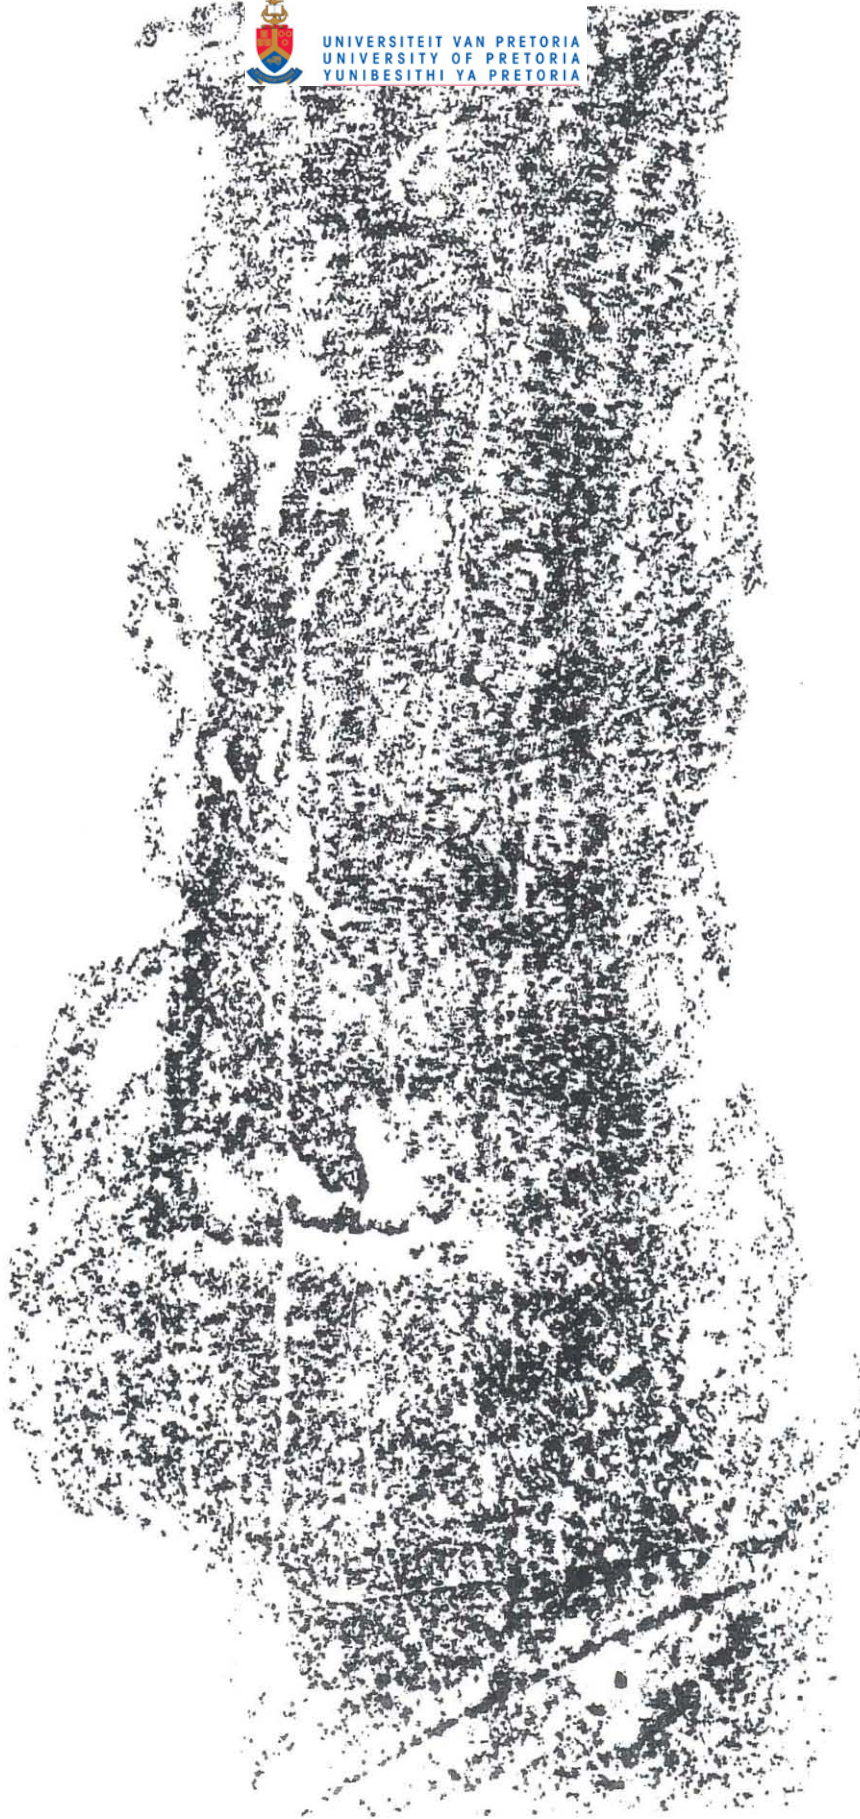
(Figure C5: Isolated parallel lines)

Figure C5 - **Isolated Parallel Lines**

The work is geometric in style and incised making use of a fine lined incision technique (Figure C5). Three isolated incised parallel lines can be seen with various horizontal lines at periodic intervals, creating a ladder. The horizontal lines protrude past the three vertical ones. The whole design is simplistic in nature (Figure C5 defined).

The texture of the rock is rough, making visibility of the engraving difficult. There is weathering of the rock surface that interferes with the engraved work. The condition of the engraving is satisfactory, with its only threat being the elements.

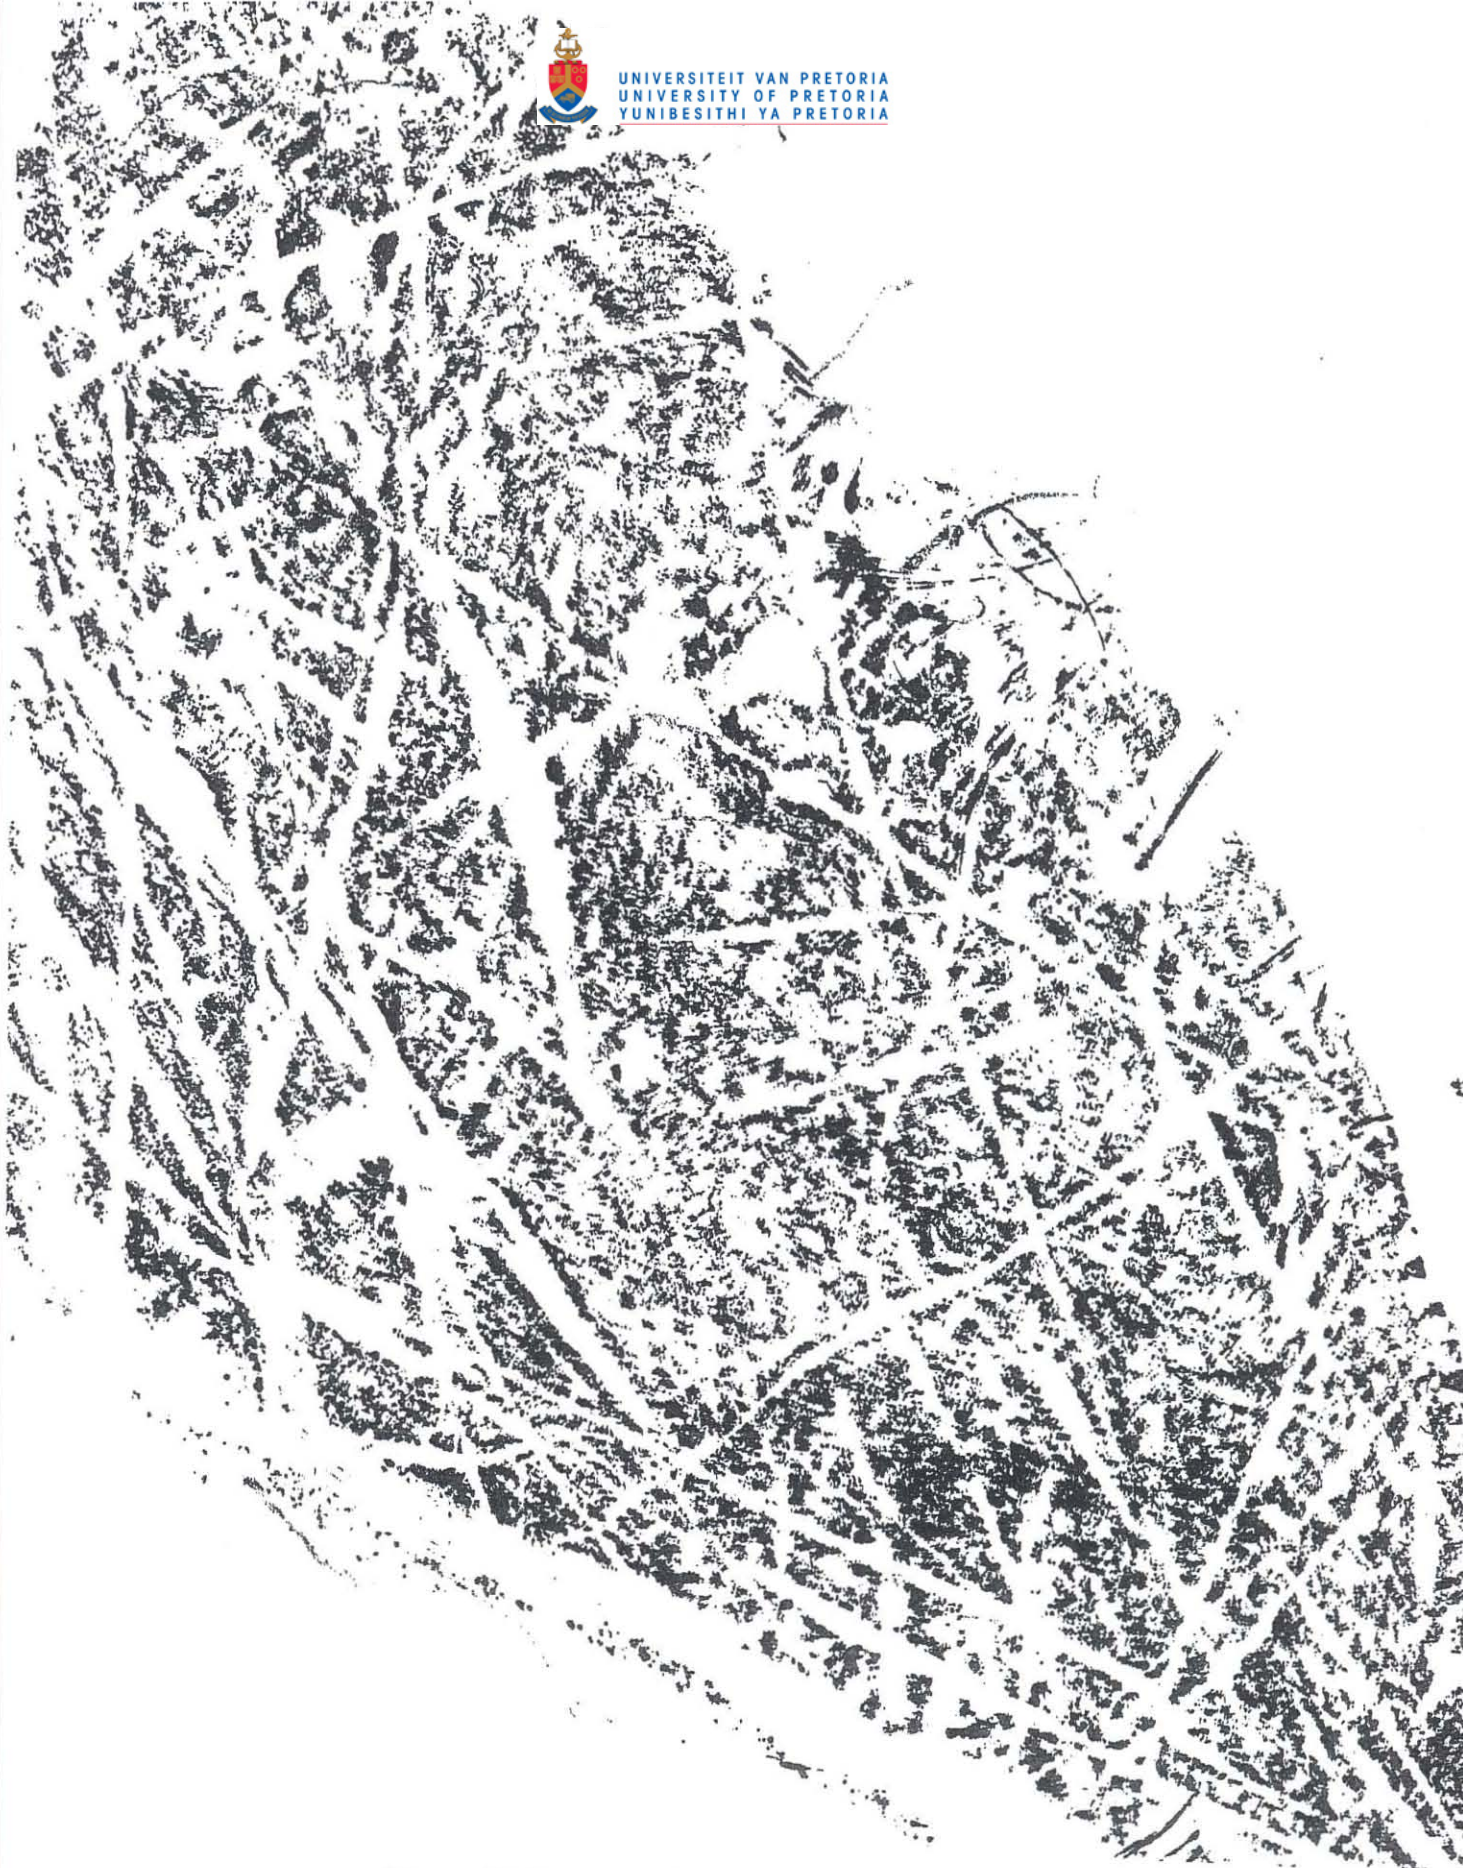
(Figure C6: Pattern work)

Figure C6 - **Pattern Work**

The pattern work is geometric in style and engraved making use of broadline incision technique (Figure C6). A rectangle with multiple criss-cross shapes all over the engraved surface. The pattern work has no particular structure or purpose. A number of excessively broad scrapings that can be seen, are the result of cattle walking on the rock surface (Figure C6 defined).

The texture of the rock surface is medium to fine grained, with numerous small erosion marks all over the surface, they don't however interfere with the engraved work. The condition of the engraving is good, with its only threat being the elements.

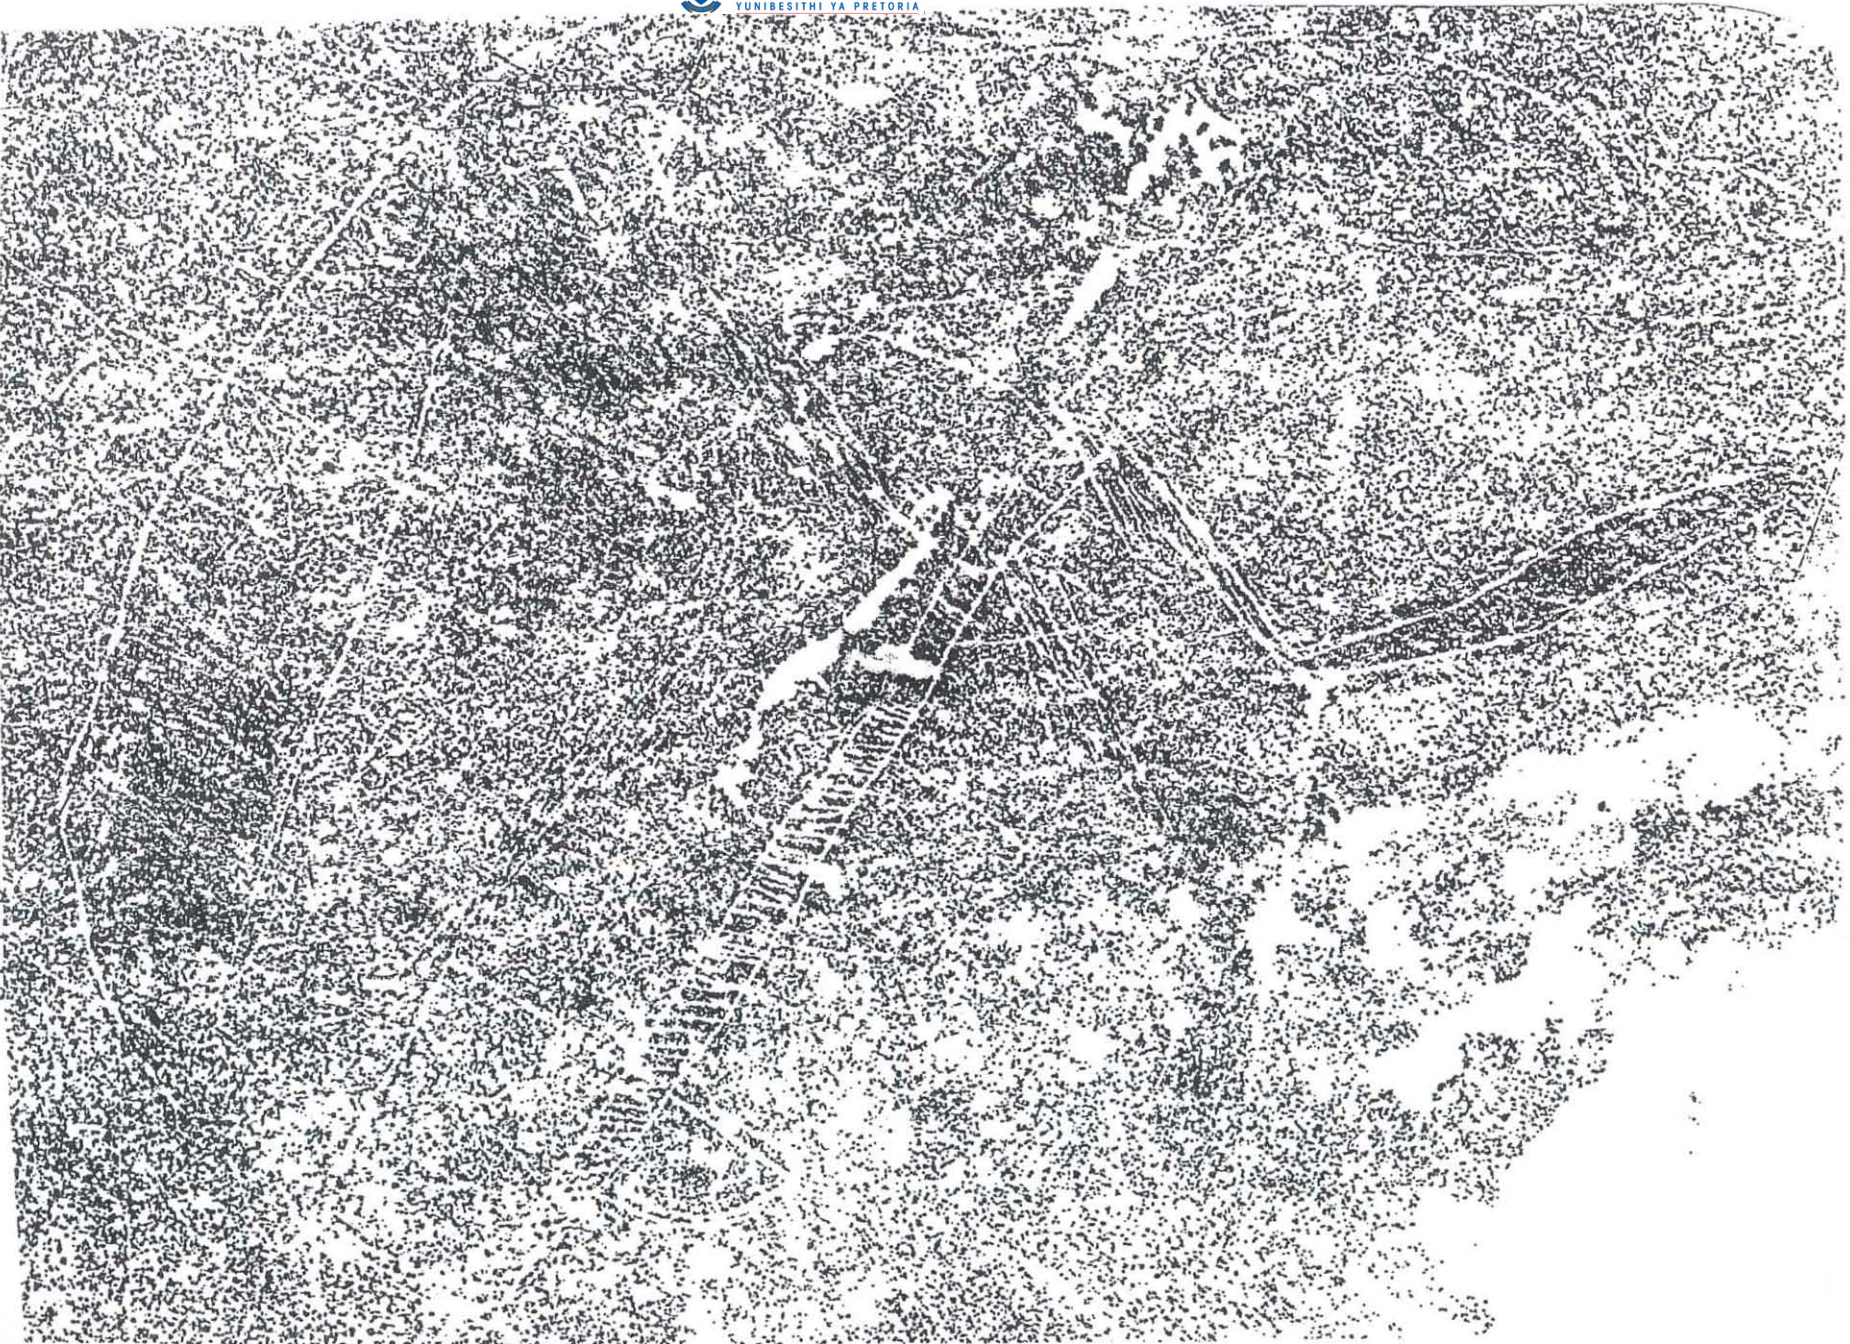
(Figure C10: The Cameleon)

Figure C10 - **The Chameleon** (*Chamaeleo dilepis*) - Latitude 27° 29' 06,0" E
Longitude 25° 54' 15,9" S
Actual Size Length: 21,5cm Breadth: 26cm

The engraving is naturalistic in style and engraved making use of an incised fine lined technique (Figure C10). The engraving is a naturalistic reptile profile of an isolated chameleon sitting on a branch. Multiple and single incised lines were used to portray the chameleon. The front legs, face and body are well proportioned and detailed, however the hind legs are lacking in character, portrayed as two oblong blobs. The head is detailed in that an eye is present. The front legs are made with multiple incised lines. There is pattern work present on the ridge of the chameleon's back, portraying camouflage. The tree branch is easily distinguished from the chameleon as numerous horizontal lines were incised between the two parallel lines making up the branch. Several leaves are located around the head adding to the idea of the chameleon being in a tree (Figure C10 defined). There are several other stray lines present that appear to bear no relation to the engraving.

The texture of the rock surface is medium grained, there's some weathering present below the front legs, but this doesn't interfere with the engraved work. The condition of the engraving is good, with its only threat being the elements. The engraving is placed towards the top of the hill and faces a southerly direction, towards the water source. To date this is the only known engraving of a chameleon in South- Africa.

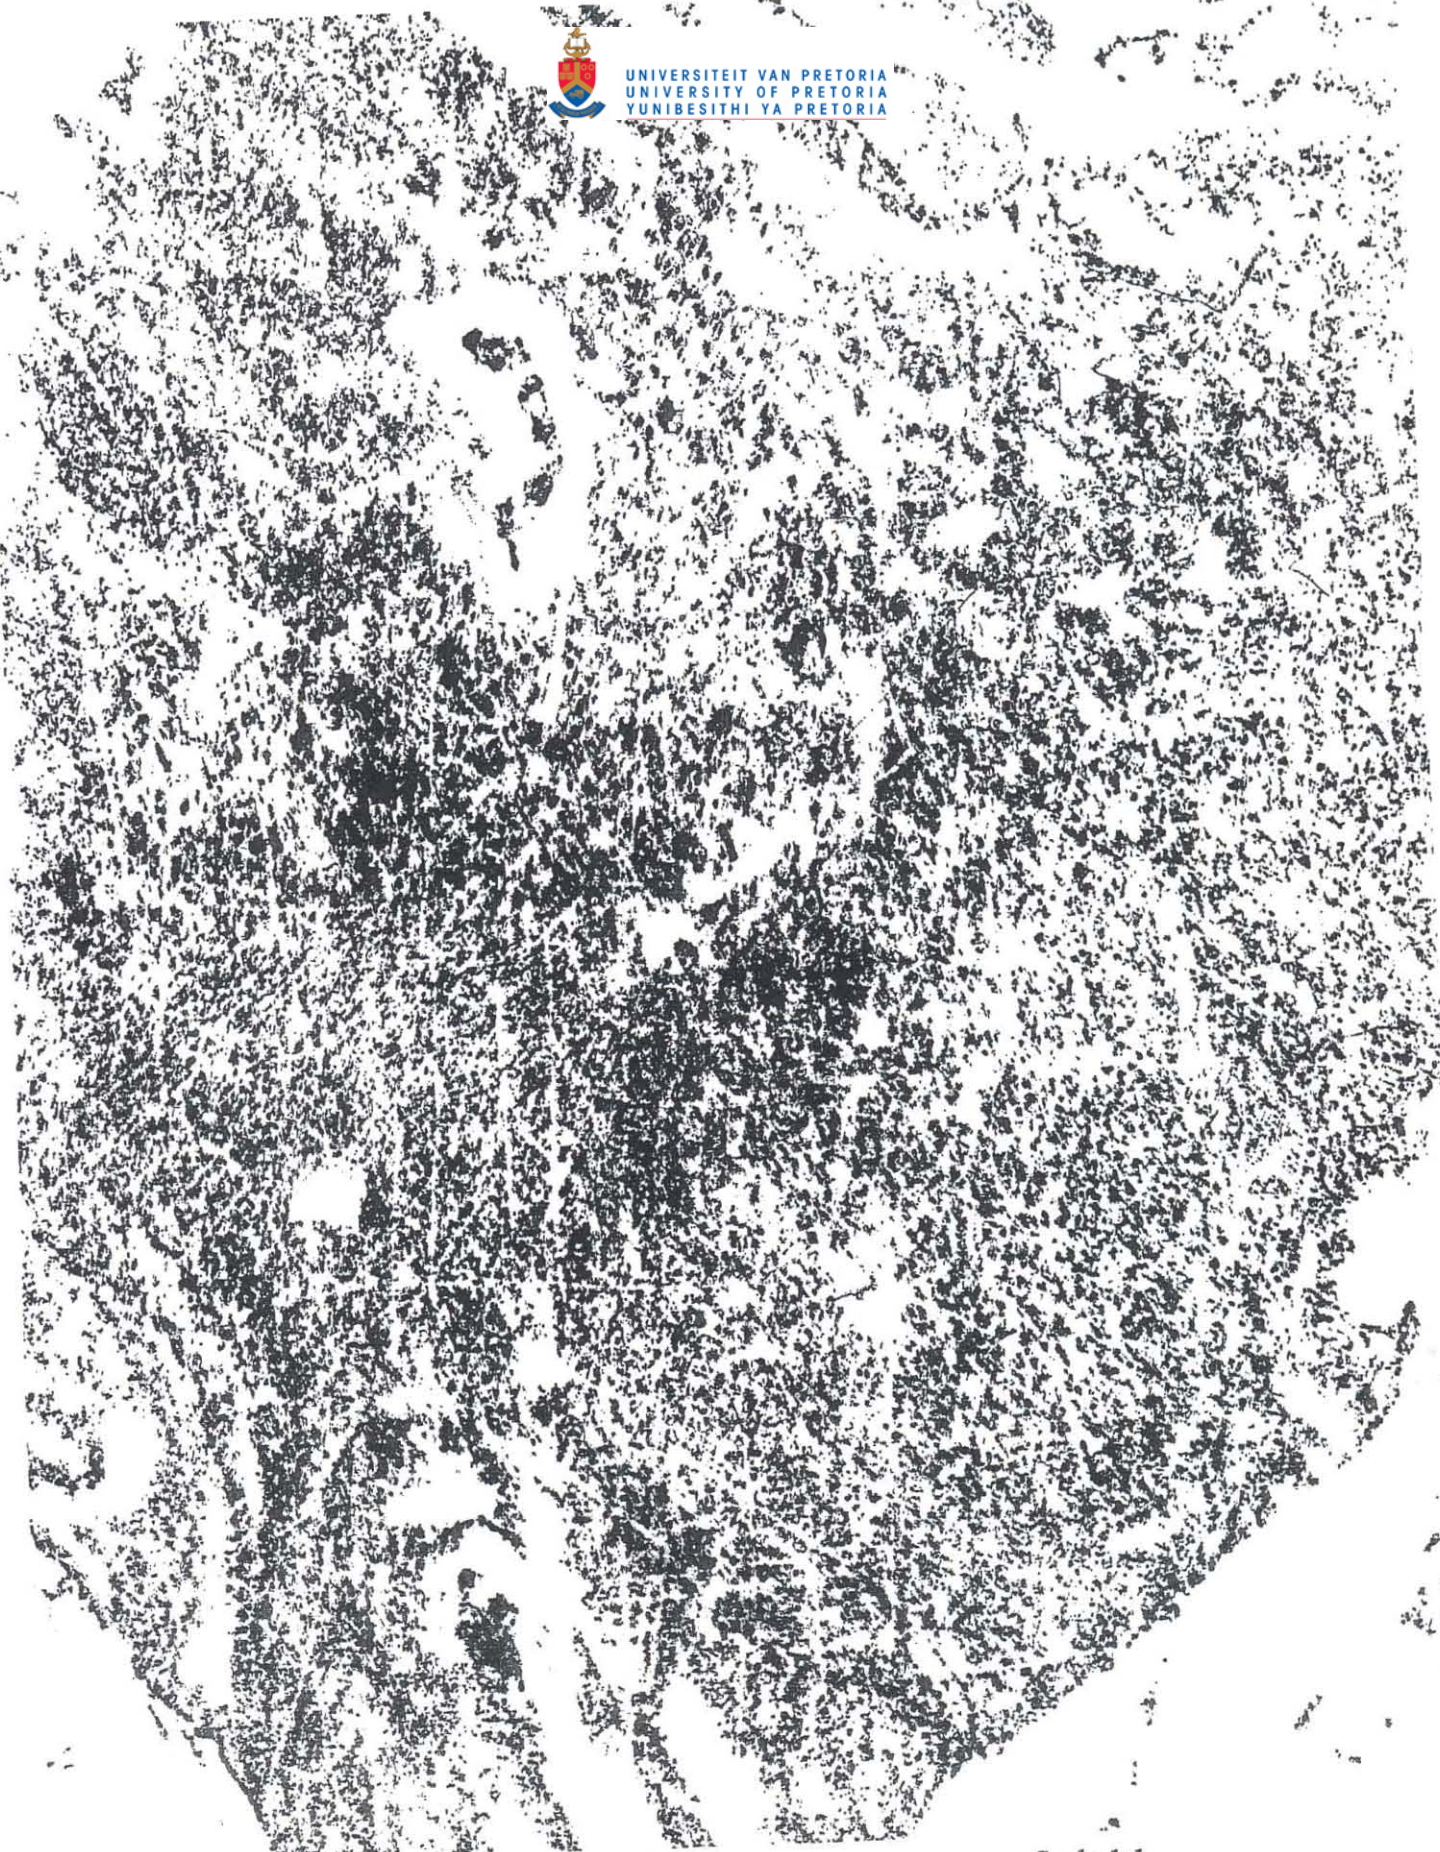
(Figure C11: Pattern Work)

Figure C11 - Pattern Work

The engraving is geometric in style and incised making use of a fine lined technique (Figure C11). The engraving comprises of various lines drawn in all directions. Some of the lines run parallel to each other, others criss-cross these parallel lines and still some other parallel lines have zigzags running in-between them (Figure C11 defined). This engraved pattern work is typical of the kind Professor J. D. Lewis-Williams, classifies as entoptic phenomenon, brought on by hallucinations and trances, (Lewis-Williams, 1988).

The texture of the rock surface is very rough, with extensive weathering all over, making it difficult to study the lines. The condition of the engraving is poor. The engraving lies mid-way up the hillside, facing south. Its only threat is the elements that will increase the weathering.
