Site C

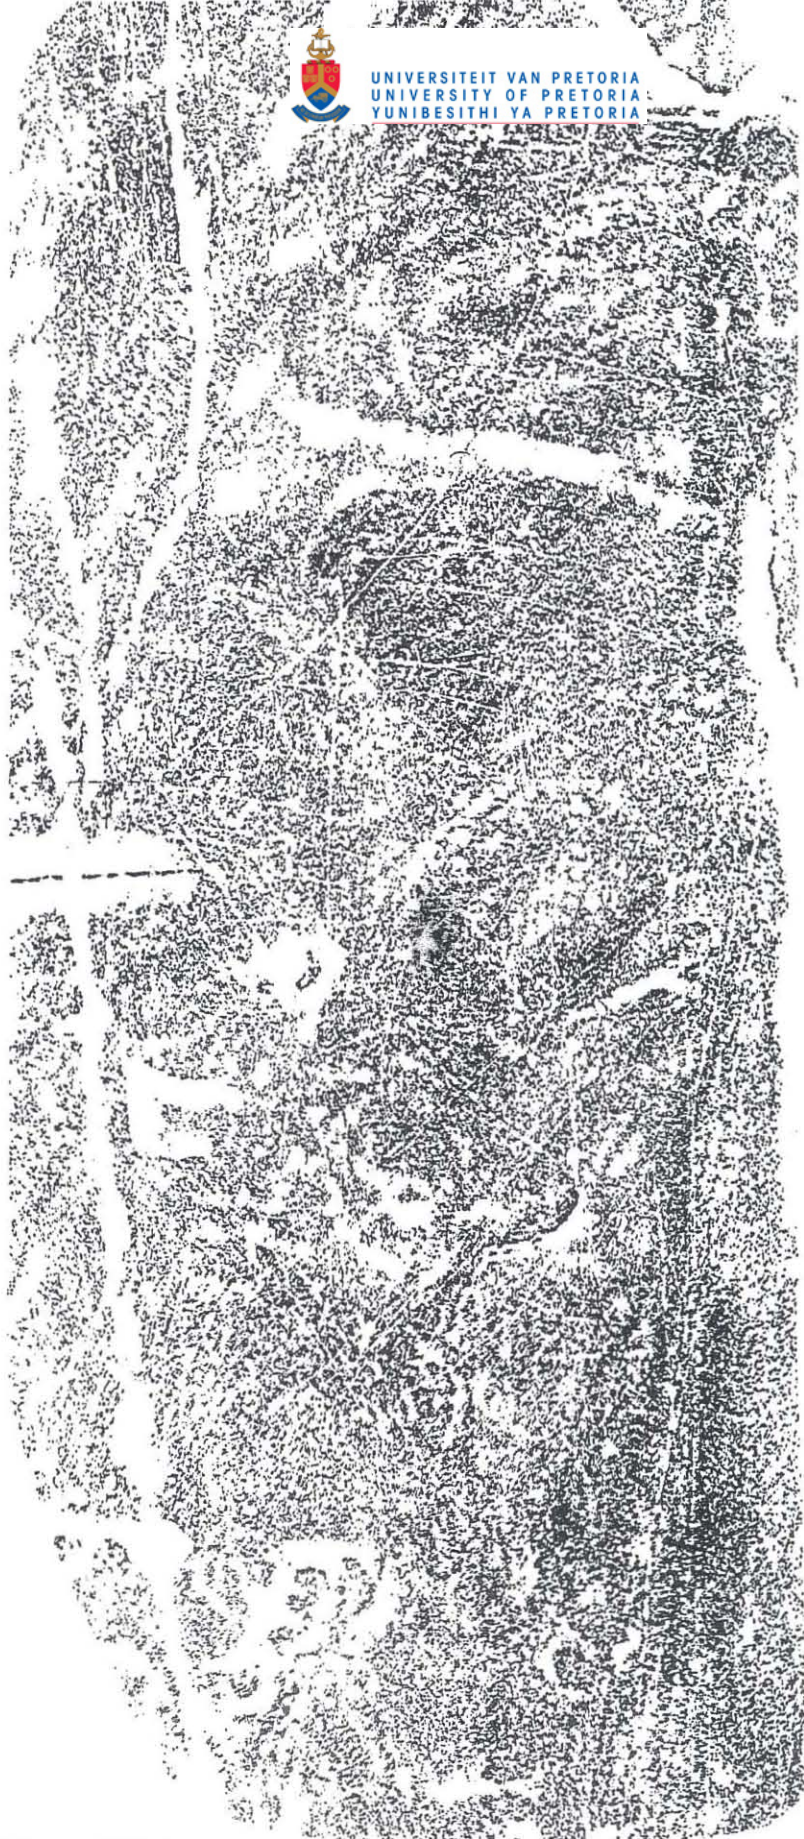
(Figure C12: Pattern work and parallel lines)

Figure C12 - **Pattern Work and Parallel lines** - Latitude 27° 29' 06,5" E
Longitude 25° 54' 14.1" S
Actual Size Length: 17cm Breadth: 41cm

The engraved work is geometric in style and incised making use of a fine line technique (Figure C12). There is one main triangle (triangle 1), which has parallel lines running lengthways across the inside of it. These lines are prevalent on the right half of the triangle, but decrease in length while phasing out in the left half. The outer lines of this triangle are not straight, but curve slightly concave. From the third parallel line on the left to the last parallel line on the right there is a box like "u" shape, lying on its side, the top leg of the "u" being double that of the bottom. There is a squiggle on the right hand corner of the main triangle and a criss-cross and some stray lines in the centre of the main triangle. At the base of the last parallel line on the left of the main triangle a smaller triangle (triangle 2), is located. A triangle (triangle 3), of exactly the same size is found to the left and in line with triangle 2, they overlap each other. Above triangle's 2 and 3 a larger triangle (triangle 4), is found, its base is in line with that of triangles 1,2 and 3. It makes use of triangle 3's left arm for its own left side, but extends beyond it, its right side criss-crosses triangle 1 and 2. Below triangle 2 is a 5th triangle, partially sharing the other triangles base line. All the triangle lines were used and two extra lines were added to create a crude house, consisting of a square with a cross in it and a triangle for a roof. Lastly at the bottom left and top right of the pattern work multiple incised lines are found. The lines located on the top right, appear to have been made during the sharpening of a tool. (Figure C12 defined).

The rock surface is medium grained, with extensive weathering in and around the pattern work. The condition of the engraved work is satisfactory. The only threat present is further weathering.
