## **Lightning Metallization Injury**

#### **CASE SUMMARY**

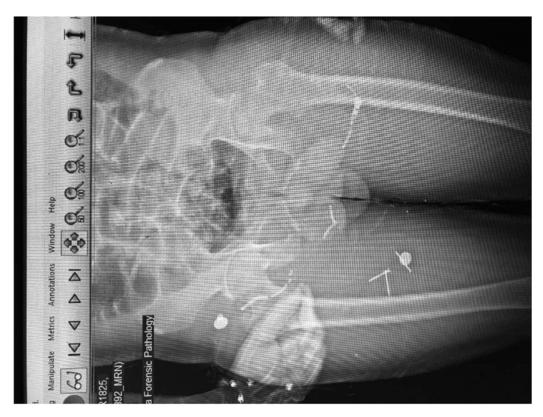
FIGURE 1. Lodox examination, showing the ruptured zipper.

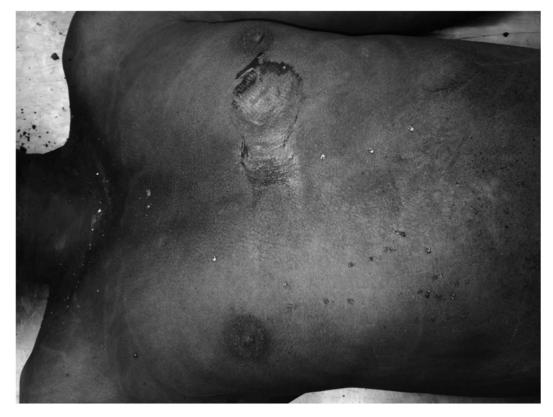
Autopsy examination showed an adult male with linear, longitudinally orientated scorch burns over the left side of the neck, front of the chest, left inguinal region, and inner aspect of the left thigh. The right eardrum was ruptured. There was singeing of the pubic hair. The clothing was torn and tattered and showed synthetic material melting at places. Internal organ examination proved nonspecific. Features were in keeping with the available history of a direct lightning strike.

FIGURE 2. Photograph of the anterior aspect of the chest and abdomen

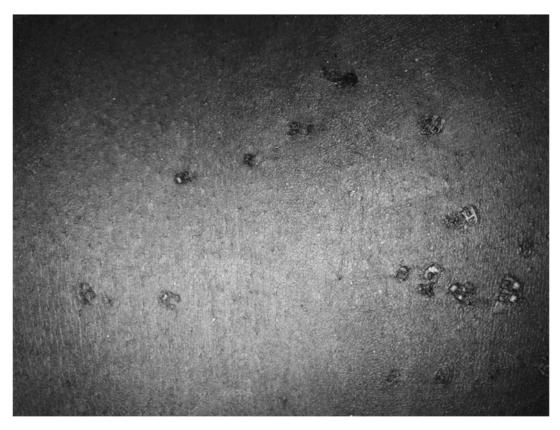
There was an area measuring approximately 10 x 7 cm overlying the anterior-lower aspect of the right side of the chest, which showed metal-chain-link-burn imprint marks. Multiple small metallic links (teeth from the exploded zipper) could be seen in relation to these small burn marks. Several of these links had melted and embedded into the skin.

FIGURE 3. Close-up photograph of the metal-chain-link-burn

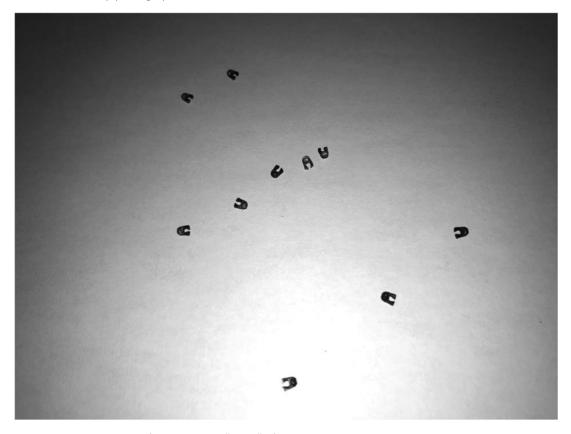
FIGURE 4. A photograph of the exploded "teeth" of the zipper

Most necklaces are not solid wire-like structures but are made of hundreds of loosely connected links. So too, the teeth of a zipper, also known as elements, act like connected links. It is likely that these wire links are made of different types of metals, with different melting points. Some metals may evaporate and others may not. Apart from the melting effect, the intense lightning current may create micro arcs across these links causing a sufficiently large mechanical force to rip the neckless, or zipper, into multiple fragments. This phenomenon may be seen as an explosion of the wire-linked metal item. The melted links suggest a thermal component to this phenomenon.

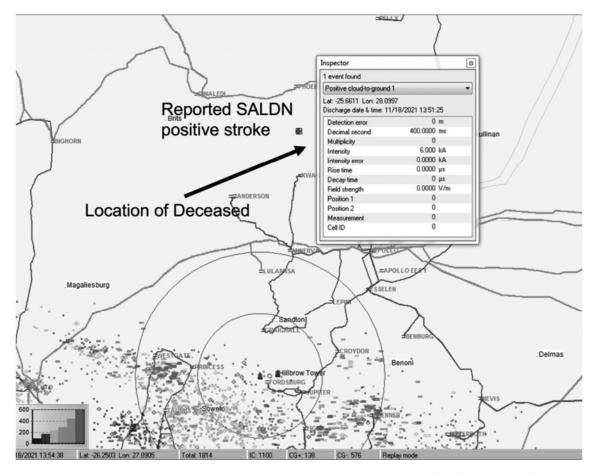
The South African Lightning Detection Network detected a positive cloud to ground lightning strike with a peak current of 6 kA at 15:51:25.4 South African Standard Time (13:51:25.4 Coordinated Universal Time). The event was far away from the moving storm, indicating the "bolt from the blue phenomenon."

FIGURE 5. Reported SALDN lightning events on November 18, 2021. Positive 6 kA "bolt from the blue" reported stroke near the location of the deceased at the estimated time.
