CHAPTER 4: RESULTS

4.1.1 Which indicators were detectable with which sensor type?

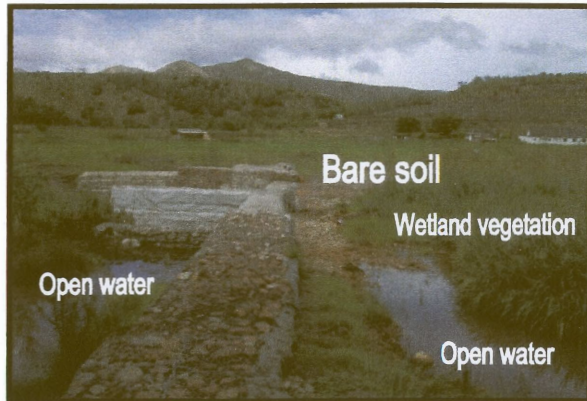
Figure 87: Gabion structure at site 5 (Hudsonvale) of the Kromme River Wetland.

Figure 89 is a subset of the SPOT 5 imagery showing some of the indicators that could be mapped (Figures 87 and 88) with verification in the field. Figure 90 shows the same area but classified into the indicator classes. The images cover an area of 60 x 60 m with a 10 m resolution for all four bands. Availability and quality of data are usually very good, depending on the cloud coverage over the study areas. It should be mentioned that a panchromatic band with 2.5 m (resample) resolution is available that could be used with the multispectral data to map the structures in more detail.

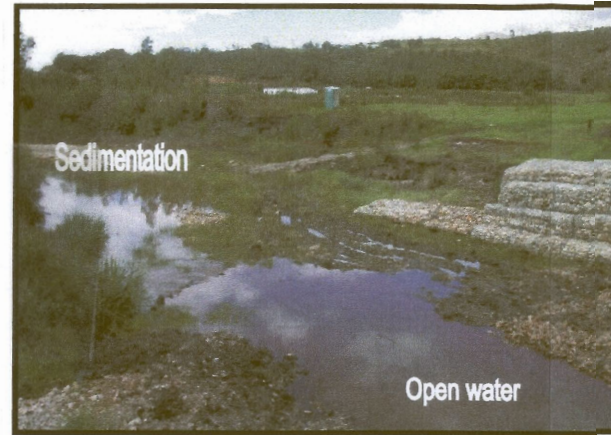
Figure 88: Sedimentation downstream of the gabion structure at site 5.

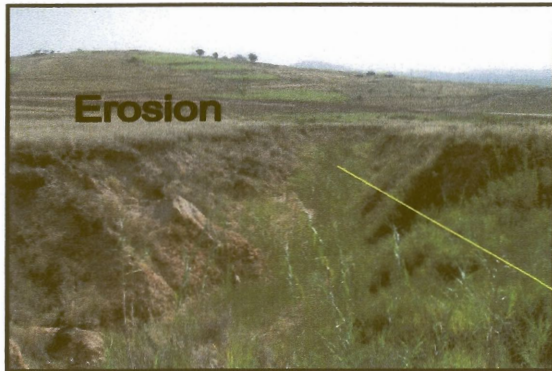
Figure 91: Erosion downstream at the Uvova site.

Example 1: Mbongolwane wetland: Uvova. Photos depicting the site details are shown in Figures 91, 92, 94, 95 and 96. Figure 93 is a subset of the Uvova site (refer to example 1 used in section 11.2.5 DuncanTech CIR).

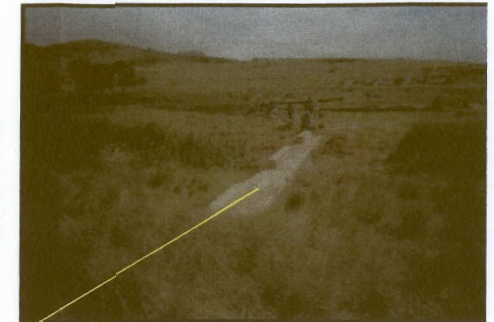
Figure 94: Concrete weir.

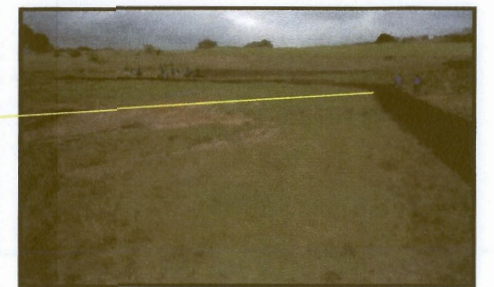
Figure 95: Earthen embankment.

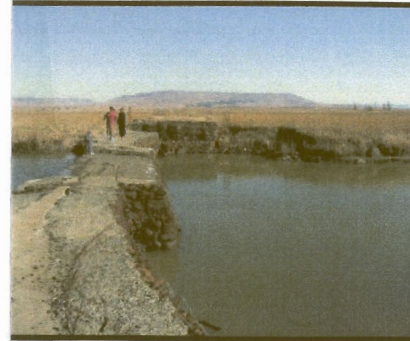
Figure 98: Site 3 at Merel's vlei. Photo taken July 2002.

Example 2: Seekoeivlei wetland. Figure 97 is a subset of the EROS satellite image of sites 3 and 4. Figures 98, 99 and 100 are photos depicting the rehabilitation structures at sites 3 and 4. Figure 101 is a photo of an aerial view of flooded Seekoeivlei wetland covering sites 3 and 4.

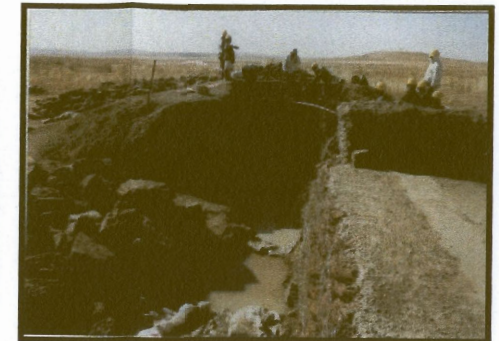
Figure 99: Maintenance on the structure at site 3. Photo: J.v.d. Schyff (July 2003).

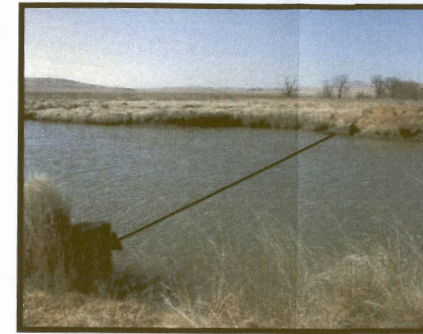
Figure 100: Site 4 at Merel's vlei. The weir is drowned below the water surface.

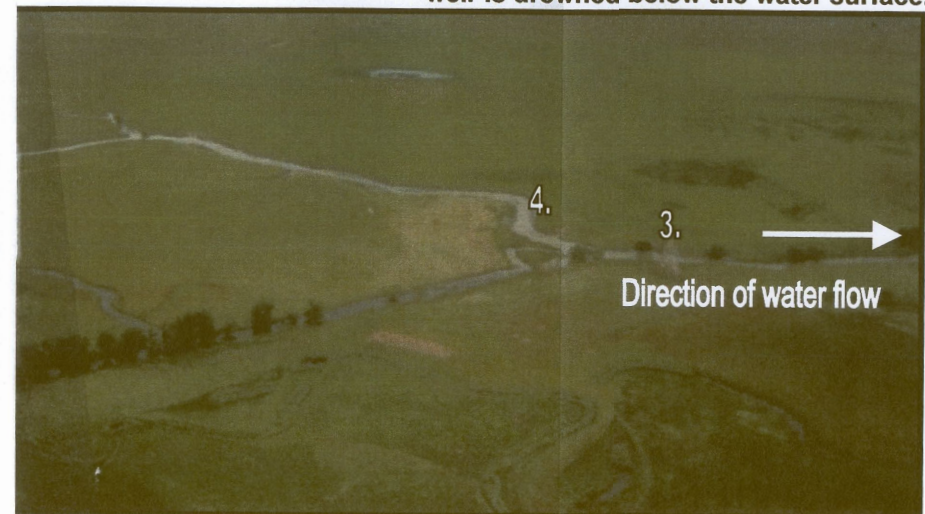
Figure 101: Aerial view of sites 3 and 4. Photo: G. Wandrag.

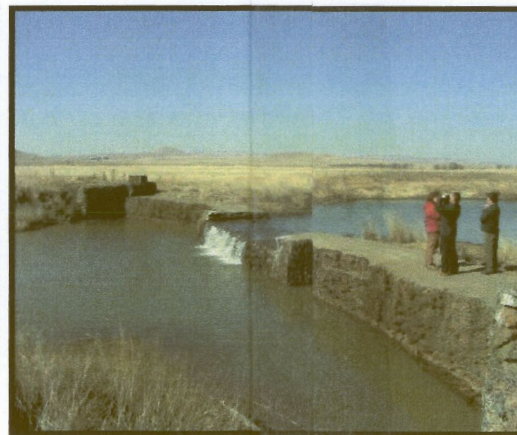
Figure 106: Site 5 photo in July 2002.

Example 3 of site 5 at the Seekoeivlei wetland shows that an EROS image together with other multispectral data with lower resolution could be used with success. Figure 102 is a subset of an EROS image at site 5 (resolution 1.8 m). For this project Landsat TM and Landsat ETM data were used with a resolution of 25-30 m (Figure 103). A resolution merge with a Browey transform and cubic convolution resampling technique was done with the data stretched to 8-bit values. The result of the resolution merge is a colour image with 1.8 m resolution which makes interpretation easier although some of the colour quality is lost (Figure 104). A resolution merge was done using the best 3 bands (Figure 105) from archived Landsat data available at ISCW. Figure 106 was taken at site 5 in July 2002. These images were used only for interpretation and not for classification. This technique could be used to interpret vegetation change but not for the visual inspection of rehabilitation structures. The erosion due to floodwaters along the edges of the rehabilitation structure at site 5 was not clear on the images. Figure 107 of site 5, taken in July 2003, shows the maintenance work that had to be done as a result of the side erosion at the structure. The sedimentation recorded on site, behind the structure, is a result of the intervention of man and not the success of the structure. Note the sandbags on the sedimentation bank in Figure 107.
