4.1.1.4 KODAK DCS 420 (Near infrared).

4.1.1.5 DuncanTech CIR.

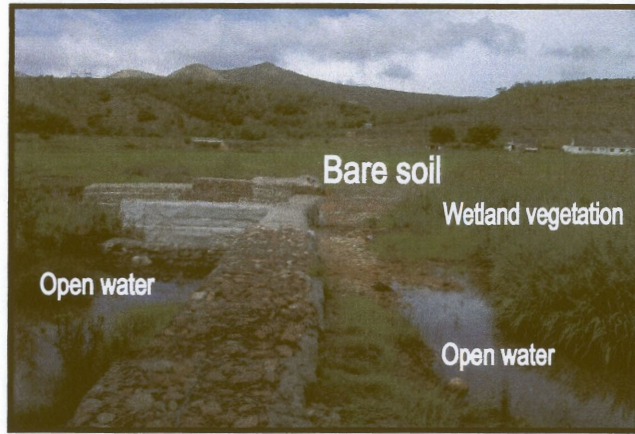
Figure 109: Gabion structure at site 5 (Hudsonvale) of the Kromme River Wetland.

All three bands were used to optimize the spectral range in identifying the different wetland rehabilitation indicators (e.g. rehabilitation structure 5: Gabion weir at Hudsonvale, Figures 109 and 110). All the classes and structures were

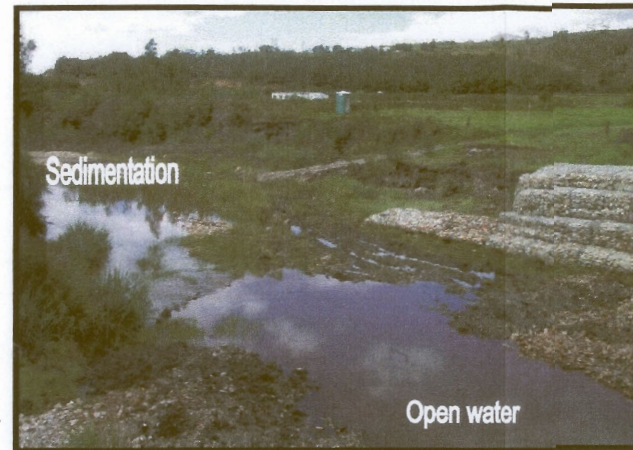
Figure 110: Sedimentation downstream of the gabion structure at site 5.

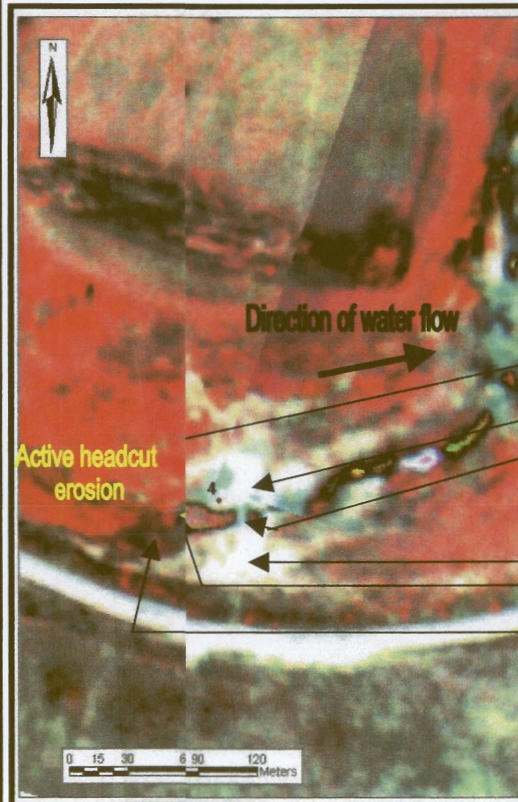
Figure 117: Set of the Kodak DCS 420 image at site 4. Resolution: 1 m. Acquisition date: 22/01/2003

At Kompanjiesdrif (Figures 115 and 116, rehabilitation site 4: Gabion weir) measurement of the active headcut erosion could be determined successfully (Figure 117). It was also possible to map the wetland vegetation with this sensor. It is important to have adequate field points for the classification and verification of the data.

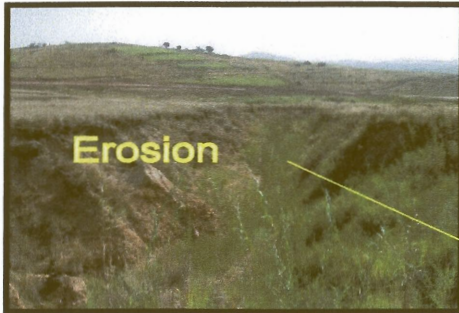
Figure 119: Erosion downstream at Uvova.

Various wetland rehabilitation indicators and structures (Erosion - Figure 119; Concrete weir - Figure 120; Earthen embankment - Figure 121 and Sandbag groyne and sediment - Figure 122) are evident in Figures 123 and 124. They give a good indication of the level of detail this sensor is capable of. Figure 125 illustrates the level of detail including erosion, rehabilitation measures and sedimentation, using DuncanTech true colour imagery.

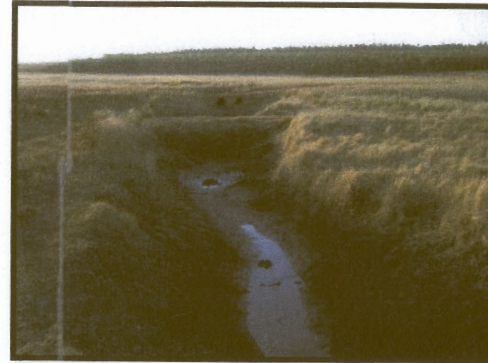
Figure 26: Drains with clay plugs and evidence of wetness. Photo taken 26/05/2003.

The main drain with clay plugs (Figure 126) and the road infrastructure (Figure 127) are evident in Figures 128 (DuncanTech CIR) and 129 (DuncanTech true colour). Dominant terrestrial vegetation replaced the aquatic plants in the wetland. Spectrally the wetland and grassland vegetation could not be adequately distinguished.

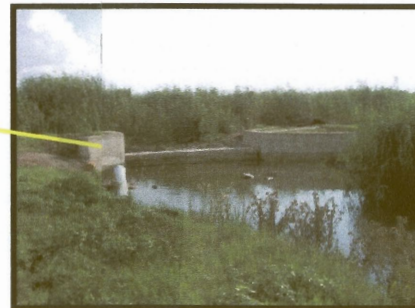
Figure 3: Concrete weir at site 4. Note the wetland vegetation (tall emergent, *Phragmites australis*) behind the structure.

Site details at rehabilitation structure 4, 5.1 and 5.2 are shown in Figures 130 – 133. Figures 134 (DuncanTech CIR) and 135 (DuncanTech true colour) are subsets of the DuncanTech imagery and display the different wetland vegetation (tall and short emergent). It would be possible to map differences in vegetation types using the detailed field data collected by *Venter et al.* (2003) in the different wetland zones (permanent, seasonal and temporary). This could be processed together with an image acquired during the wet summer rainfall season and followed up with another image at the same time of the year but in a different year. This could be used for change detection and to monitor the status of the wetland. All the bands have been determined to be very useful in assessing vegetation characteristics.

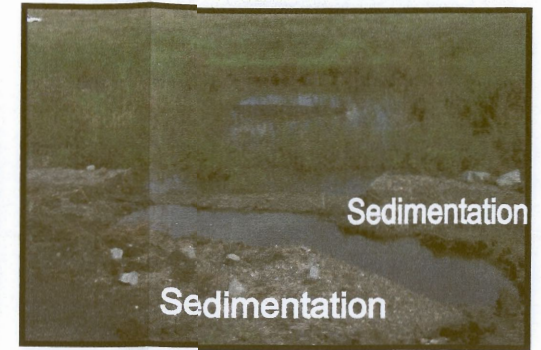
Figure 131: Site no 5.1.. Sedimentation taking place behind the structure.
