5.6 McKenzie Street

5.6.1 Analysis of current situation

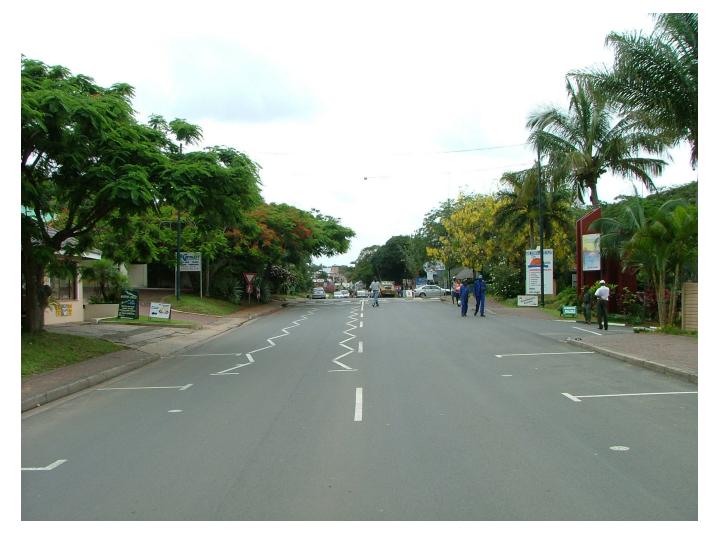
Figure 72 shows a typical view down McKenzie Street: The two traffic lanes are each 3, 5 meters wide with parallel parking bays and pedestrian walkways on both sides of the road. Together the parking bays, pedestrian walkway and a small landscape area make up the road reserve.

72 Typical view of McKenzie Street looking south.

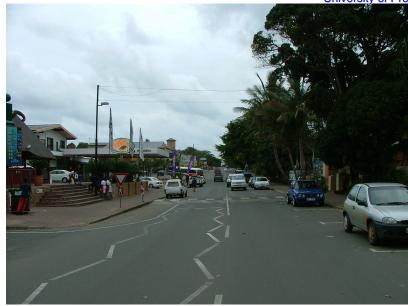
73 Visual clutter due to signage, road markings and exotic planting

The combination of signage, road markings and varied landscaping contribute to the visual clutter of the street.

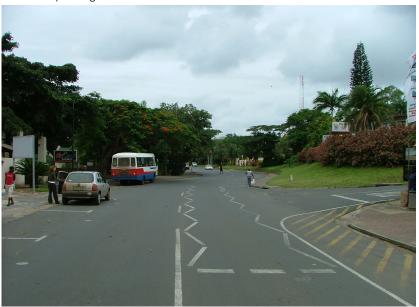
The vegetation is mainly exotic, consisting of palms species and Delonix regia (Flamboyant tree).

74 Exotic planting

Planting needs to be indigenous. Due to the harsh sun and humidity more shade providing trees need to be planted along McKenzie Street. The planting pallet should be restricted and form continuity between the varied building form and styles.

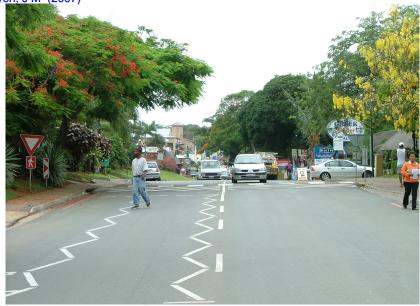
McKenzie Street is relatively direct and vehicles tend to speed. To control speeding pedestrian crossings occur every 300m in the form of speed-bumps, see Figure 75. To make them more visible road marking have been applied to the road.

75 Speed-bump pedestrian crossing

Walkways need to be made bigger. Pedestrian crossings could be incorporated with the speed bums with less road markings to elevate visual clutter.

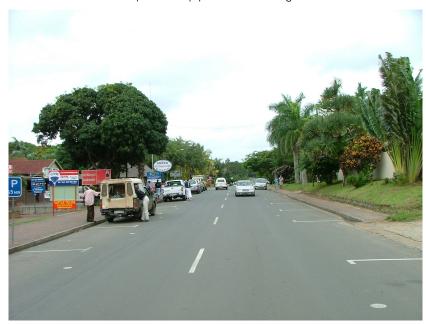
76 View to the north. Easter sidewalk has a slopes

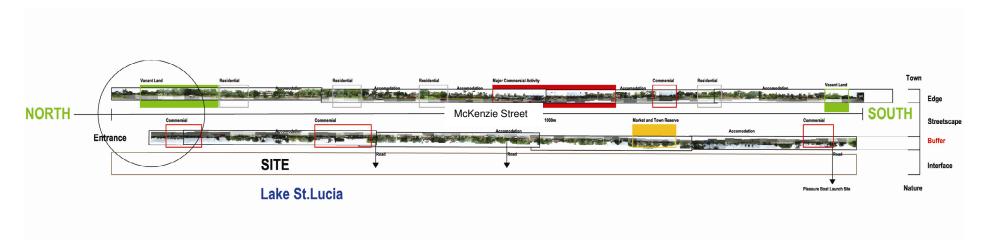
77 Functioning of McKenzie Street

Figure 77 analyses the functioning of McKenzie Street. The Diagram identifies current land use of the street, as well as opportunities to break through the privately owned accommodation buffer and reconnect the town and the lake.

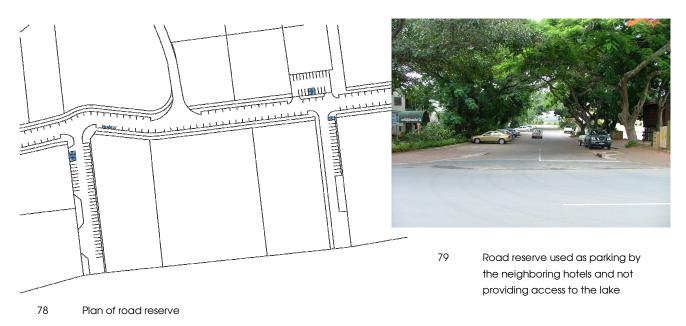
Please refer to Figure 78, 79 and 80. There are two road reserves left open to serve as connection between the town and the Lake. Currently they are being used as parking. The accommodation establishments bordering the reserves do their best to hide these connections in an effort to provide exclusive access to their client. The road reserves need to be opened up and form part of the strategy to connect the town and the lake

80 Road reserve camouflaged as private property and not connecting the town and the lake
