## CHAPTER 4

### MADLIKI: A STUDY IN COMMUNITY-BASED SOIL CONSERVATION

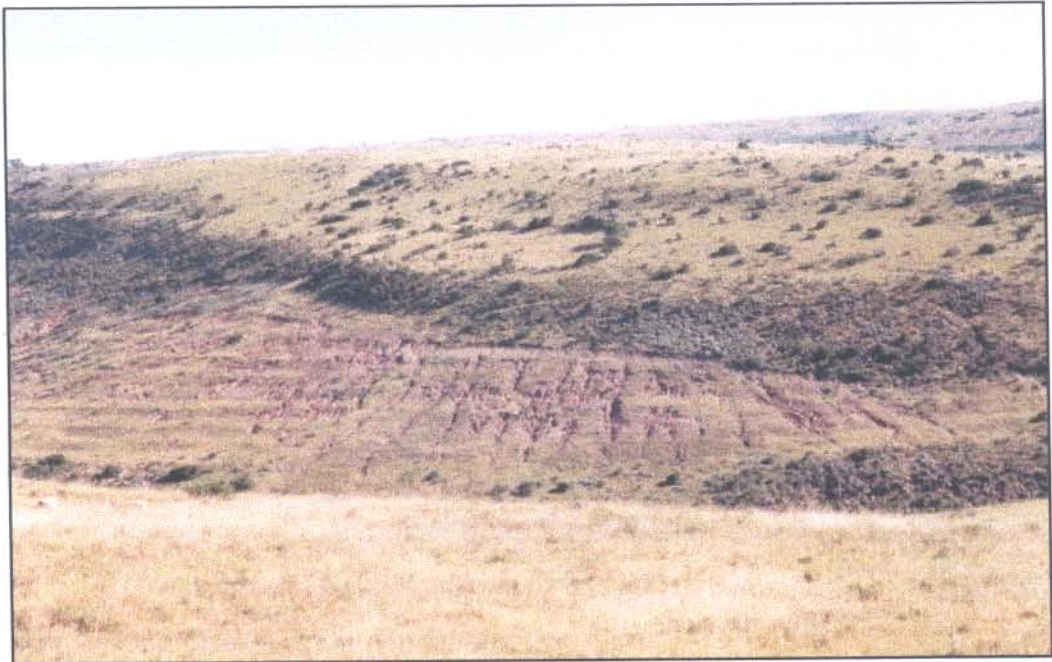
**Plate 4.1 – Abandoned cultivated area, demarcated by planners for cultivation, at Madliki. Note contouring still visible (Photograph: N.N. Maswana)**

Agricultural production is through dryland cropping. Poor yields are a norm due to poor resources (see Section 4.3) and bad farming practices. The croplands are typical of the drier areas of the Eastern Cape, i.e. severely eroded (with dense networks of big gullies), despite the fact that "betterment planning" determined their locality and contouring was done. As outlined earlier, this is due to the fact that the planners had inadequate knowledge of soils and did not adapt land suitability evaluation to the specific qualities of the different soils. Most people stopped ploughing and abandoned their arable lands due to soil erosion (Plate 4.1)
