URBAN ANALYSIS

Positioning the investigation within the north-western quadrant of Pretoria's inner-city

SCHUBART PARK

This chapter investigates the Schubart Park housing complex as site for intervention. The history, decay and current status of Schubart Park is outlined, its potential future discussed and the theoretical framework it related to discussed

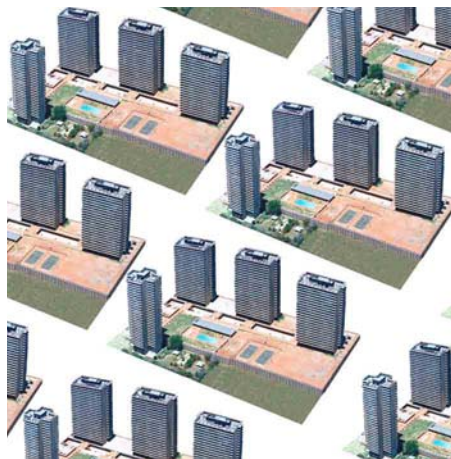
Fig. 4.23 Collage image interpreting the original planning intention of duplicating developments such as Schubart Park throughout the North-West quadrant

Schubart Park, was to be the “launch project” and was, according to architect Clive Biddington (2010), envisioned as prototype for multiple new buildings (figure 4.23) in the vicinity. Schubart Park, along with the Kruger Park housing development, was according to Naude (1991:107), an attempt to settle people (whites) in Pretoria’s “fallow”.

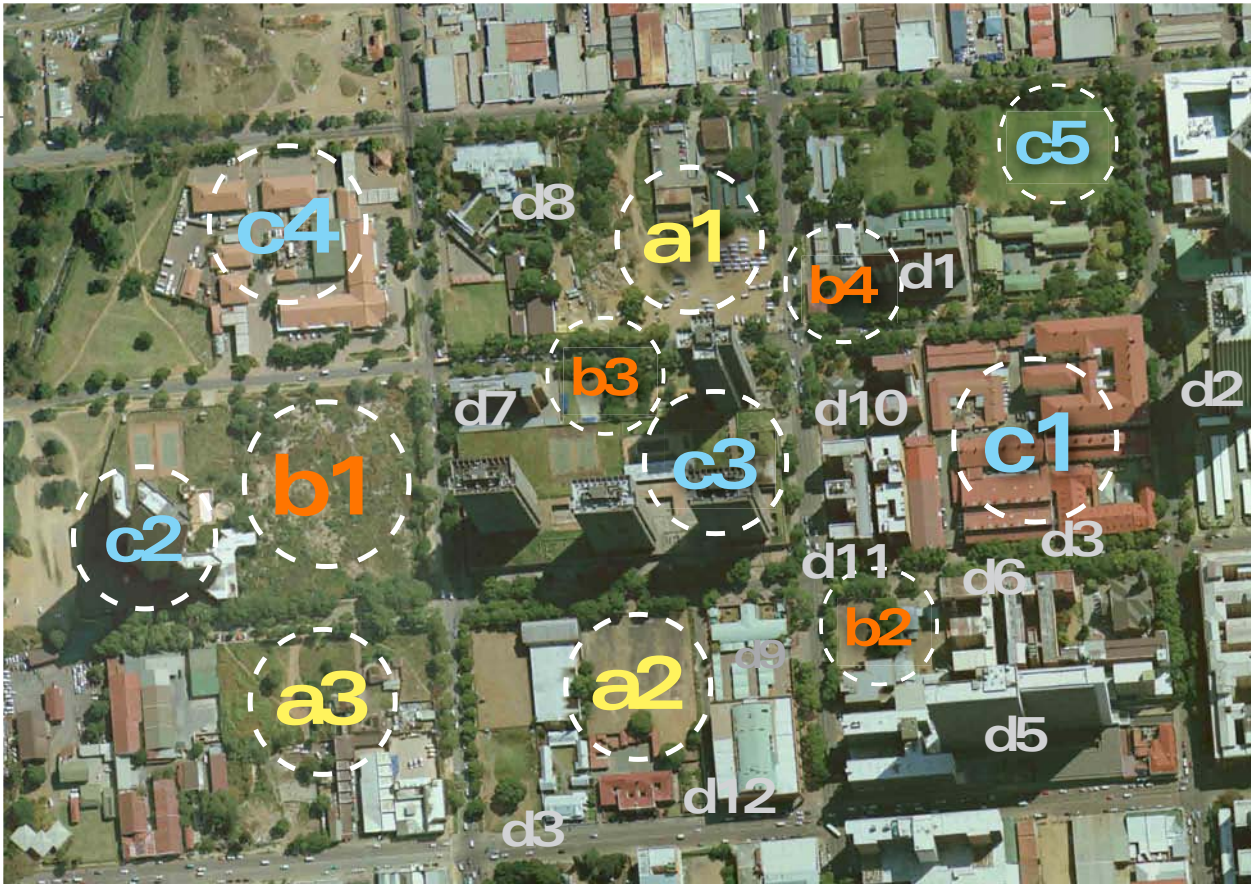
Fig. 4.30 Precinct map indicating development proposals

(as indicated on fig. x)

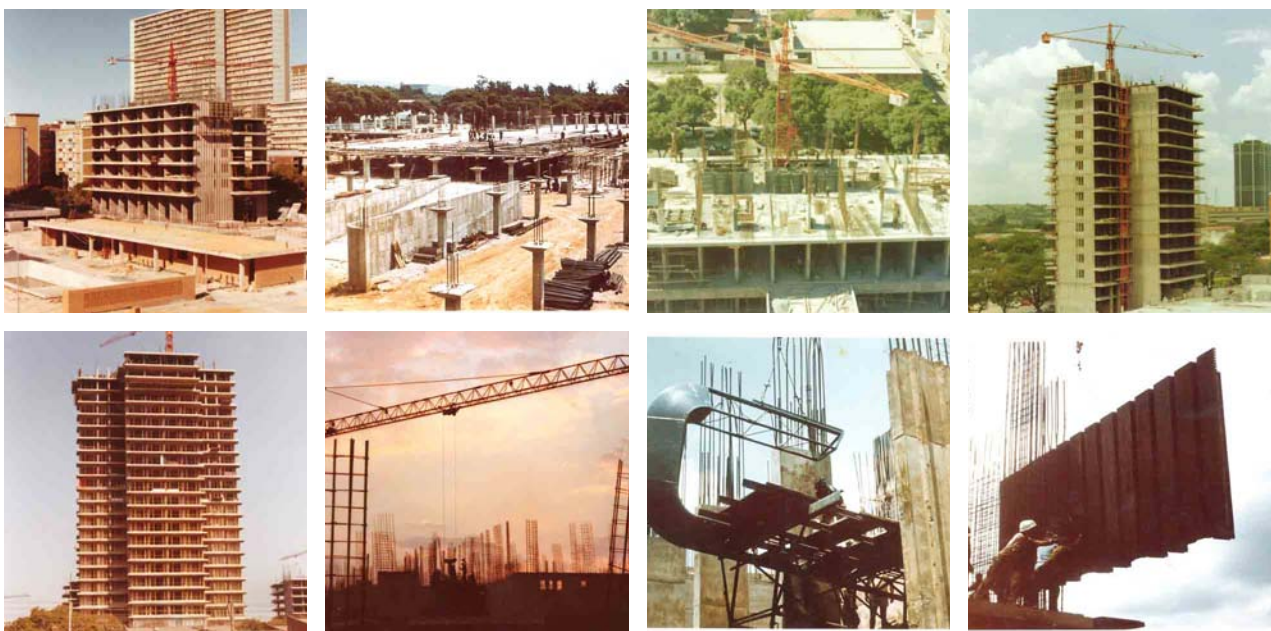
Fig. 5.8 Collage of photos of the Schubart Park's construction captured during 1975

-Figure 5.7 and 5.8

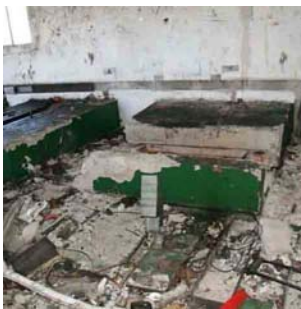
Fig. 5.15 Conditions within Schubart Park’s Tower D: Total destruction of lift-room

"all doors, steel and aluminium windows have been removed... solid brick walls and division walls have been broken down and the rubble is lying in heaps... holes where service shafts were are 2sqm in size and have been made on at least 10 floors" (see figure 5.15 - 5.17).

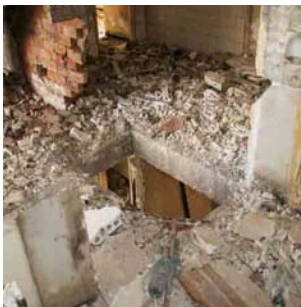
Fig. 5.16 Conditions within Schubart Park’s Tower D : Ducting and internal walls removed

Signs of vandalism and building decay at Schubart Park is evident (figure 5.16) and garbage keeps piling up in various parts of Schubart Park (figure 5.20). Building services are left to disintegrate: drinking water (figure 5.22) and sewerage (figure 5.21) leaks continuously from damaged pipes. According to Ramotlhale (2010) conditions at the complex have become exponentially worse during the last 5 years.

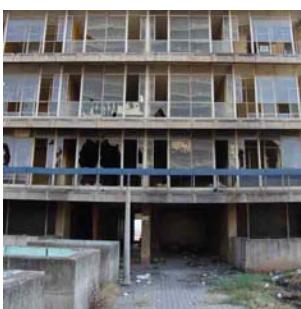
Fig. 5.18 Damage to Schubart park;s Tower D caused by vandalism and looting

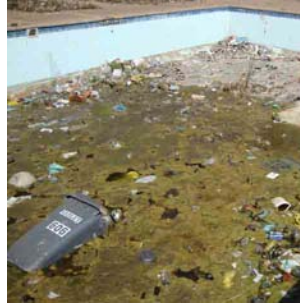
Fig. 5.19 Conditions at Schubart Park posing potential health risks

Current conditions within Schubart Park pose a biohazard risk (figure 5.19) due to poor management (Claasen, 2010), there is no fire-equipment in the entire Schubart Park and rubbish heaping up on certain floors could cause structural damage.

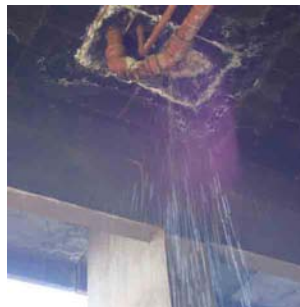
Fig. 5.21 Sewerage leaking from damaged pipes

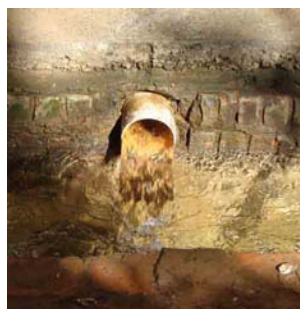
Fig. 5.22 Clear drinking water flowing from the building into the storm-water system

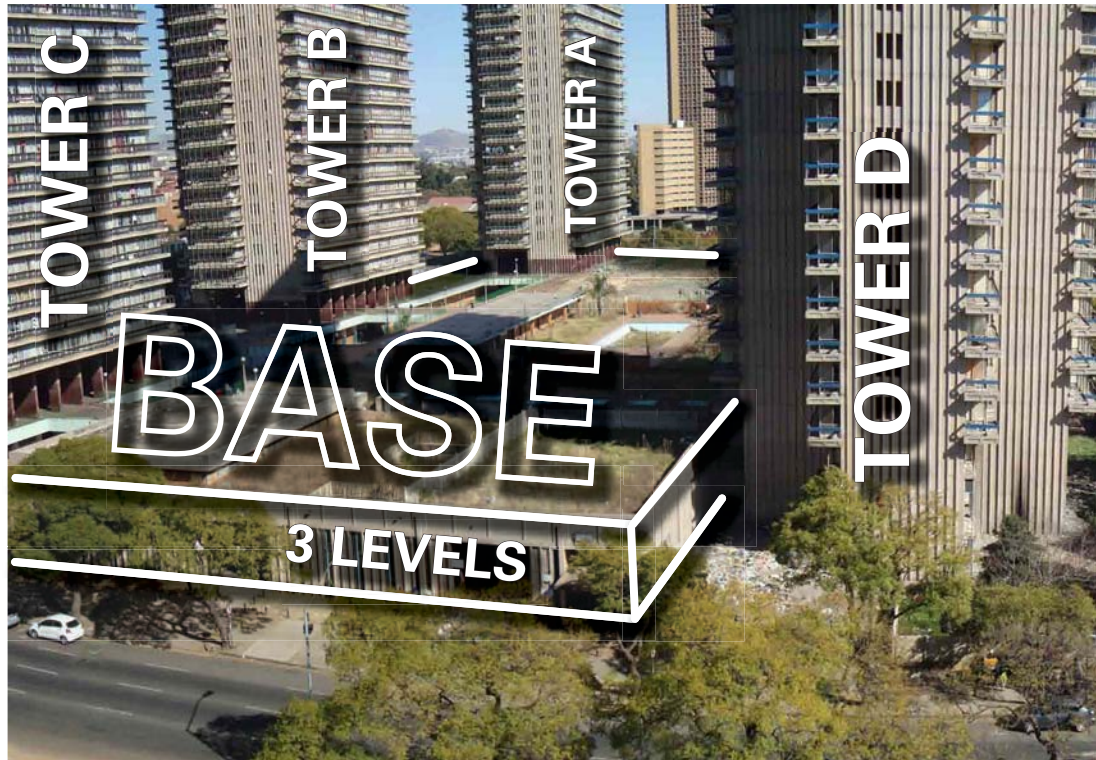
Fig. 5.39 Basic components of the Schubart Park complex
