Collapse of Residual Archaen Granitic Soils in South Africa

A Dissertation Presented to the
DEPARTMENT OF NATURAL AND AGRICULTURAL SCIENCE
UNIVERSITY OF PRETORIA

In Partial Fulfilment of the Requirements for the Degree of Masters of Science in
Engineering Geology

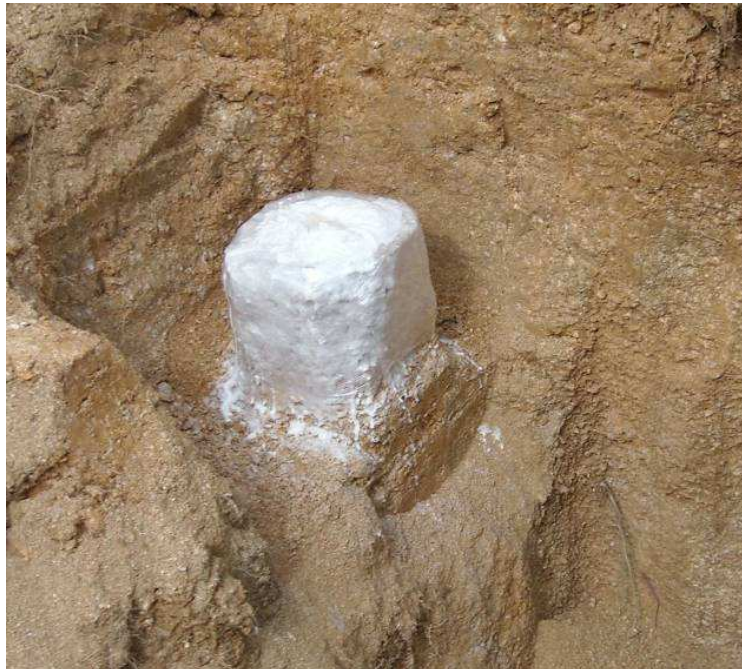
Figure 8.1: Sample being covered in wax

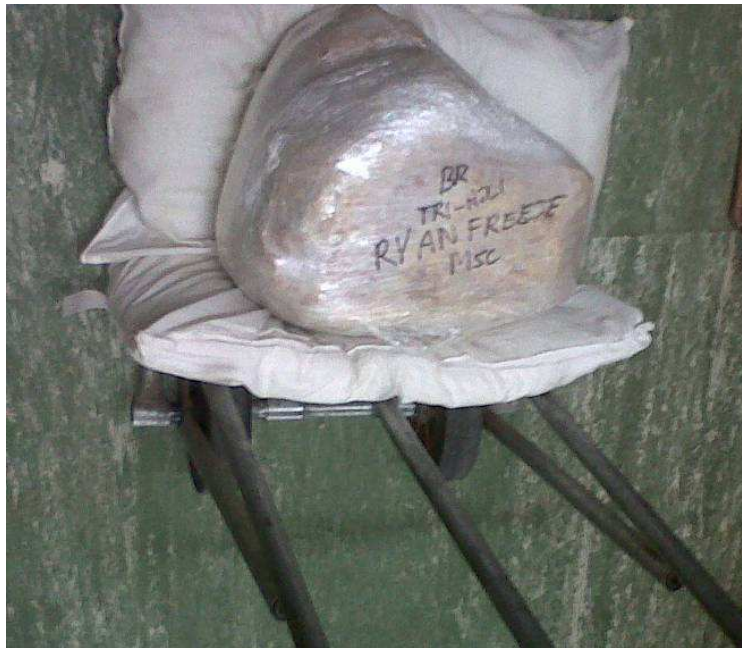
Figure 8.2: Sample being transported

The profiles from which the samples were retrieved were described according to SANS 633 (2009). Photographs and co-ordinates of the sampling sites were also taken. Undisturbed block samples were carved out of the residual soil horizon (with minimum dimensions of 250 mm x 250 mm x 250 mm) using shovels, picks, geological picks and carving knives. These block samples, whilst still in-situ, were covered in molten wax (Figure 8.1) to prevent moisture loss and to give the sample added strength when being removed from the horizon. The samples were then removed and completely covered in wax before being wrapped in layers of cling film and finally covered in aluminium foil as prescribed by Heymann and Clayton (1999). This method of packaging the samples was shown to decrease moisture loss to a minimum whilst maintaining the soil structure of the sample (Heymann and Clayton, 1999). The samples were transported to the laboratory with great care to minimize the damage to the structure of the sample prior to testing (Figure 8.2).

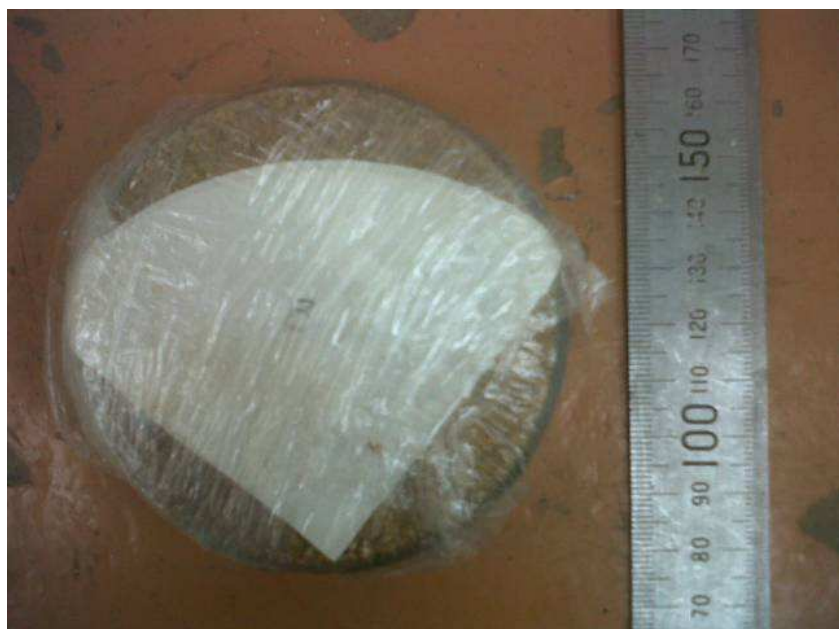
Figure 8.4: Pore fluid suction measurement

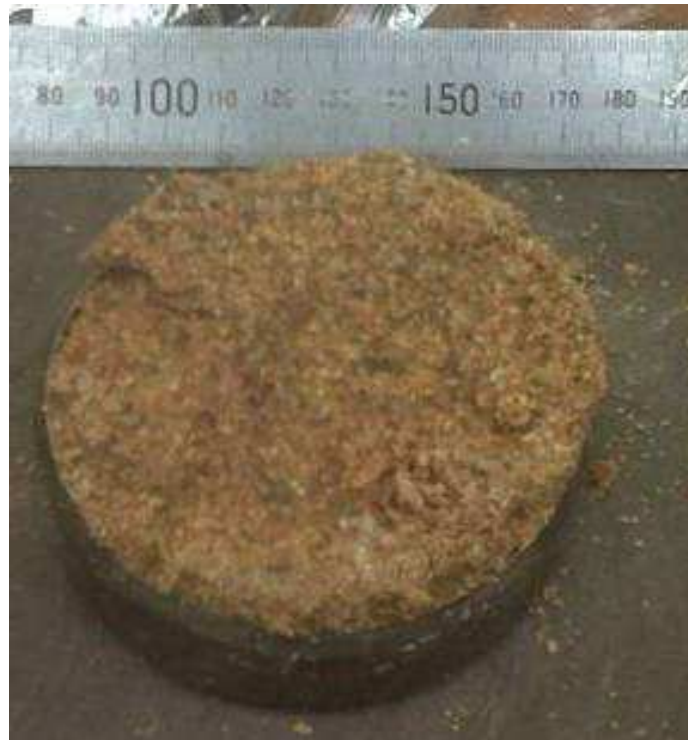
Figure 8.6: Un-smoothed oedometer sample

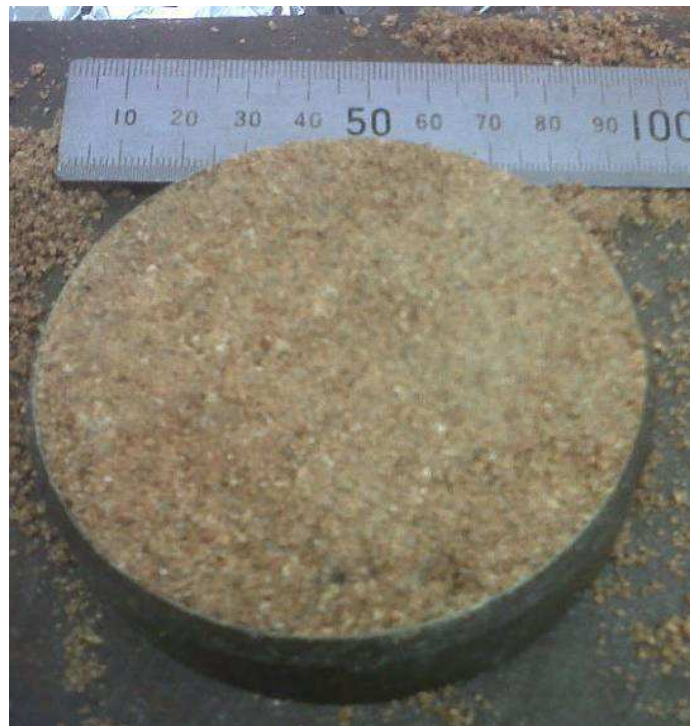
Figure 8.7: Smoothed oedometer sample

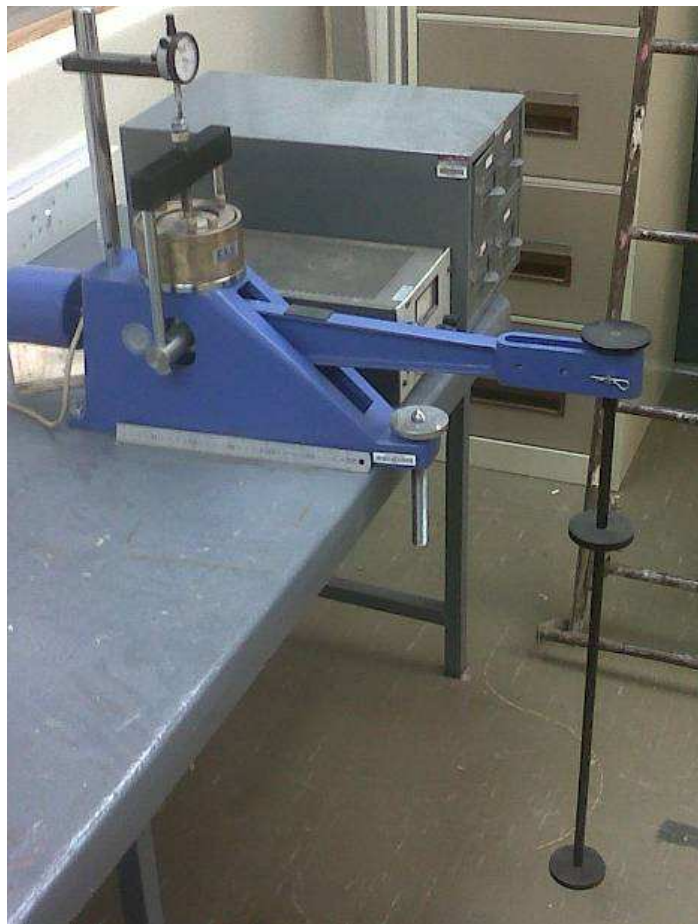
Figure 8.9: Oedometer apparatus used in testing

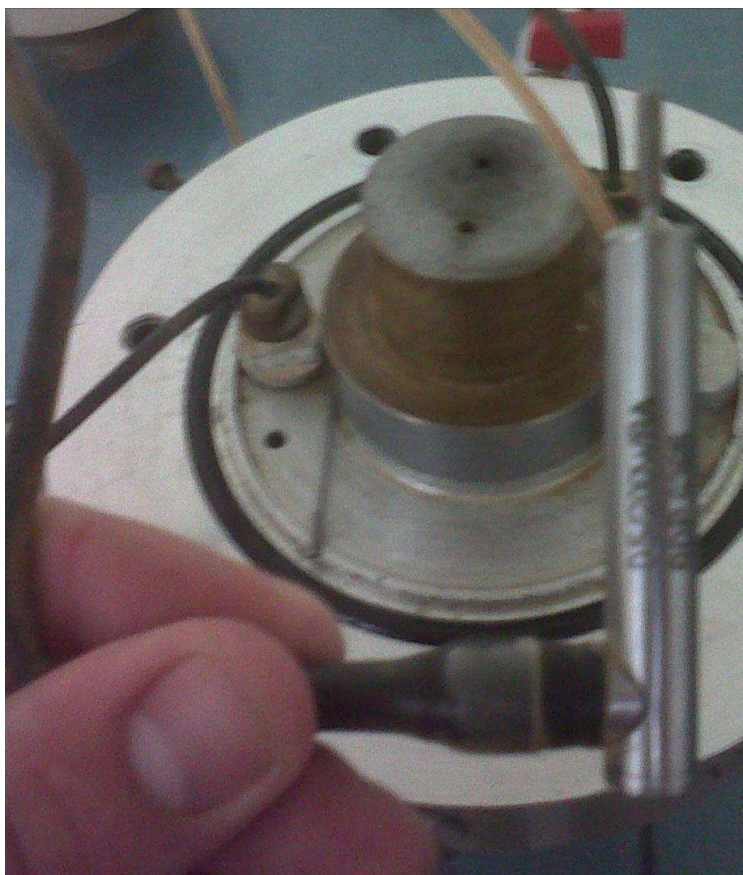
Figure 8.11: LVDT used for testing

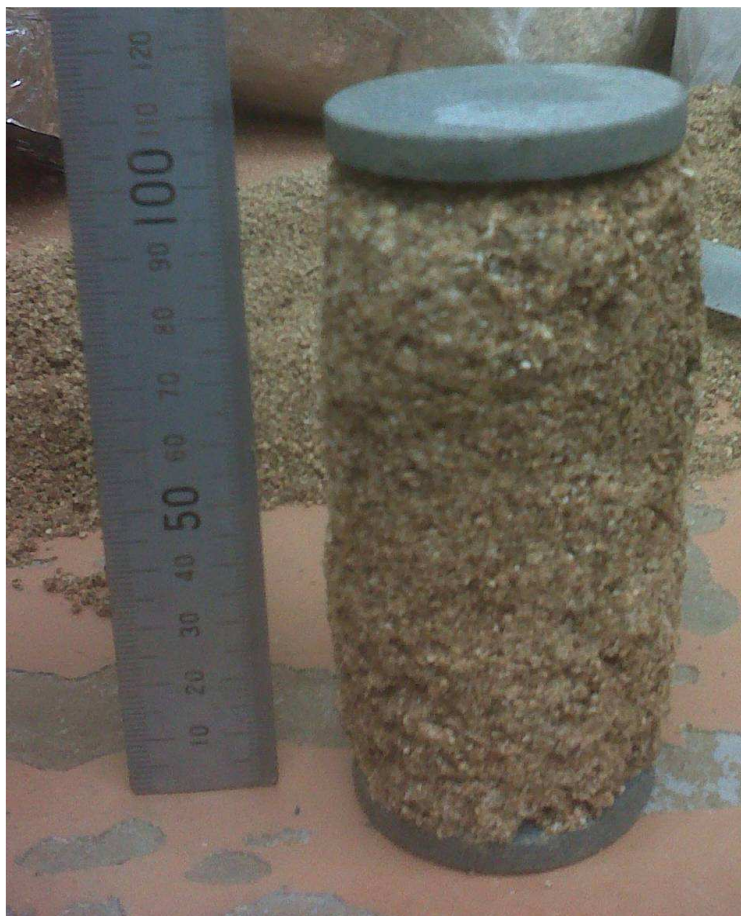
Figure 8.14: Completed carved triaxial sample (Midrand)

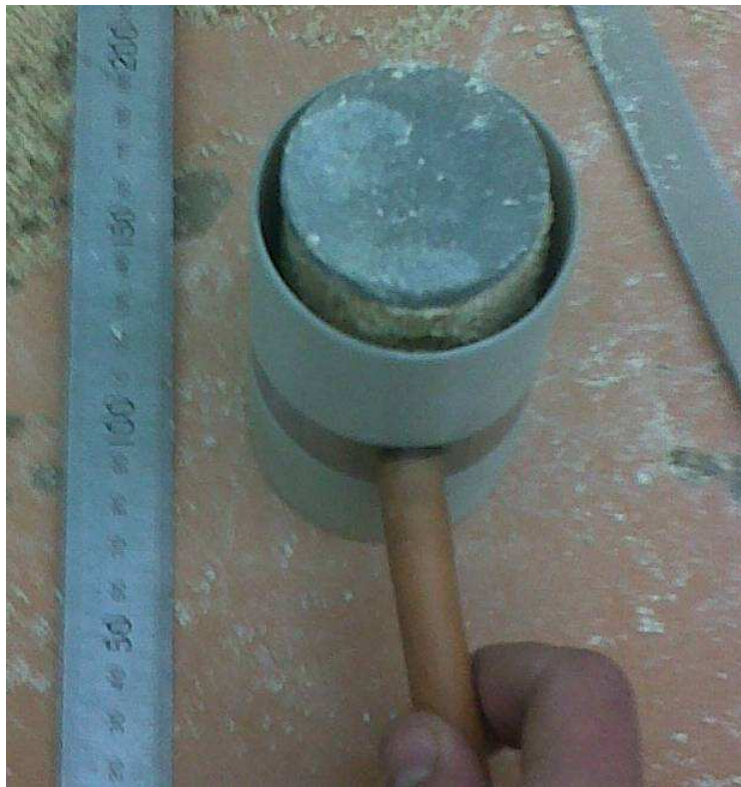
Figure 8.15: Membrane being placed around sample (Paulpietersburg)

Two dry sintered brass porous disks were then placed on either end of the sample and it was quickly covered in a latex triaxial membrane (Figure 8.15), whilst in the membrane the sample was weighed and the exact height and diameter of the sample was measured (Figure 8.16). The weight and thickness of the membrane and the porous disks must be taken into account when calculating the weight and dimensions of the sample.

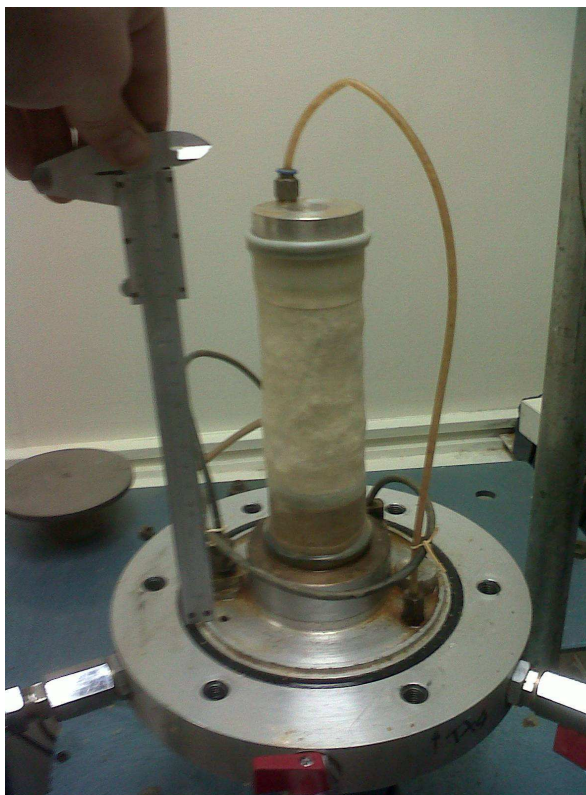
Figure 8.17: Sample (Paulpietersburg) placed on base pedestal with top cap and o-rings

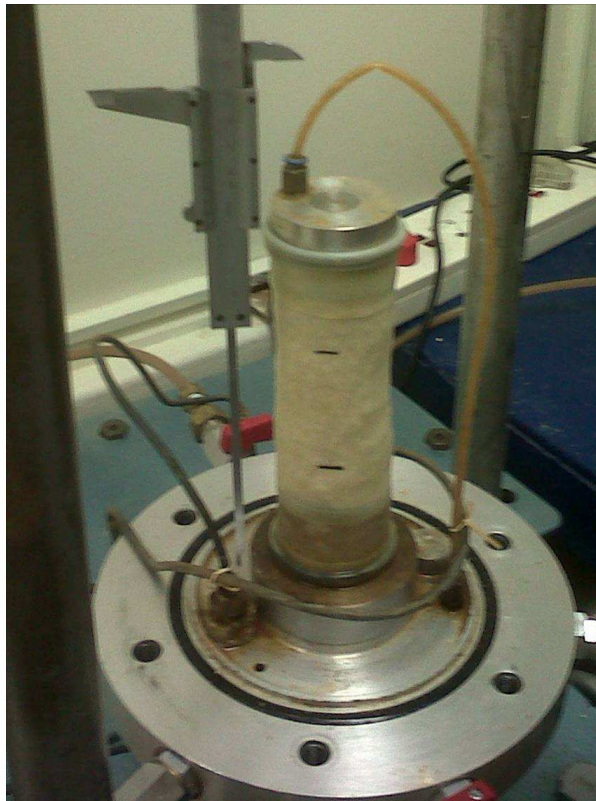
Figure 8.18: Markings made to indicate the section of the sample to be tested and assist in placing the LVDT's

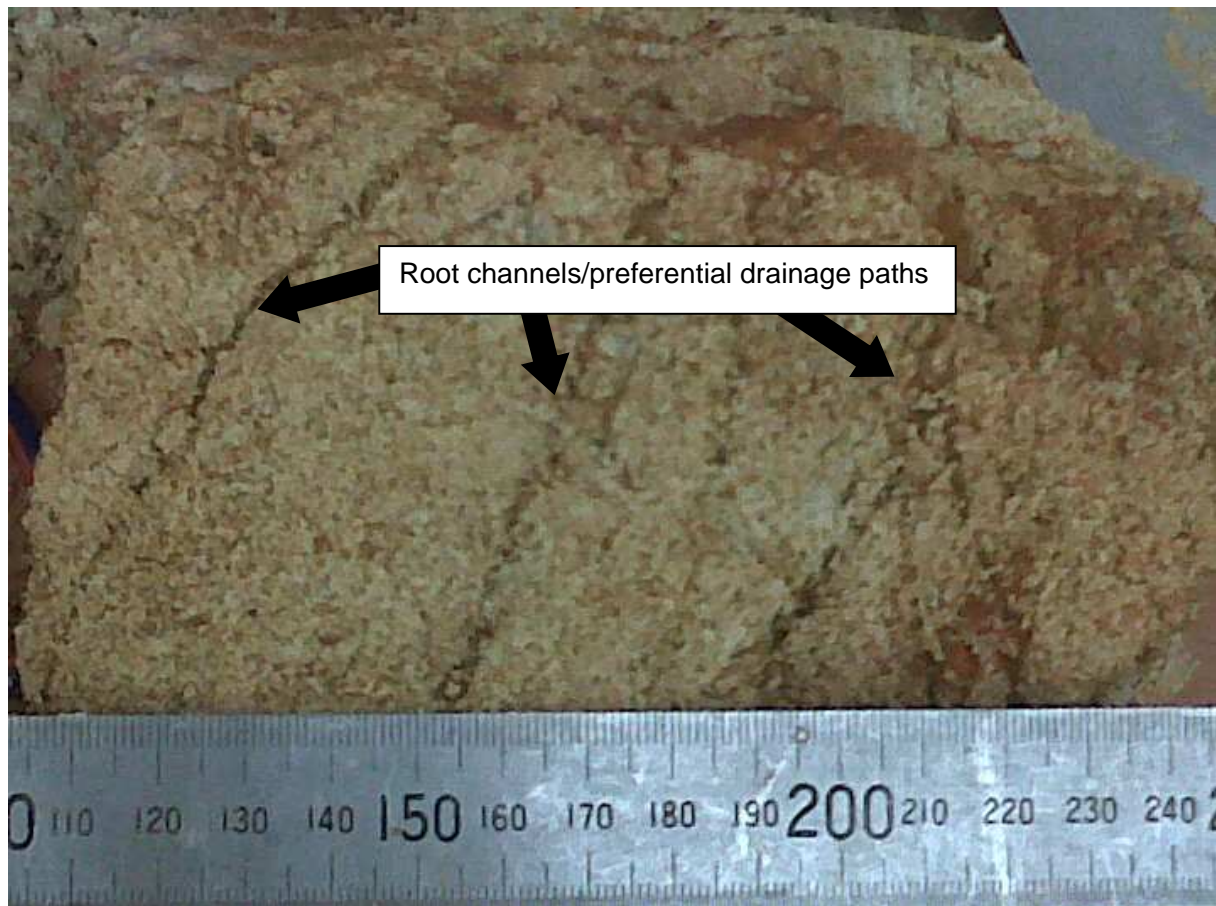
Figure 9.1: Preferential drainage paths in sample (Bushbuckridge) indicated by black arrows

(Muxart et al.,1994). An example of these preferential drainage zones and resultant anisotropy in a residual granitic soil can be seen in Figure 9.1.

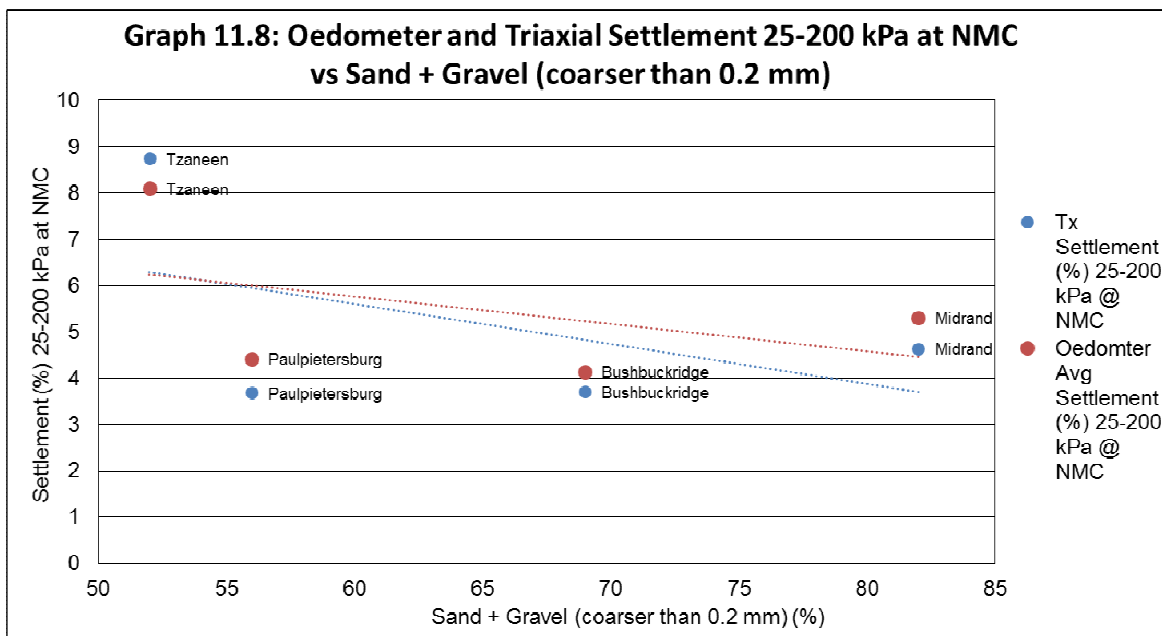
The sum of the gravel and sand content of the samples (% coarser than 0.2 mm) can be seen in relation to the collapse potential and settlement in Graphs 11.7 and 11.9.

As anticipated for residual granitic soils, sand and gravel made up the majority of all four samples with 52-82% coarser than 0.2 mm. The coarser fraction content of the soil didn't correlate to the measured collapse potential or settlement in these materials.

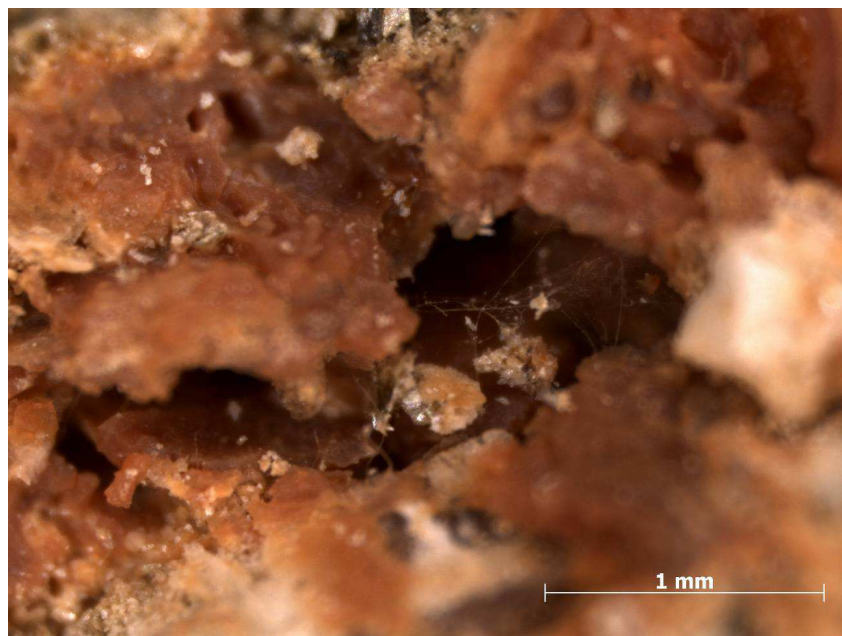
Figure 11.3: Midrand sample in-situ (un-compressed) at X50 magnification

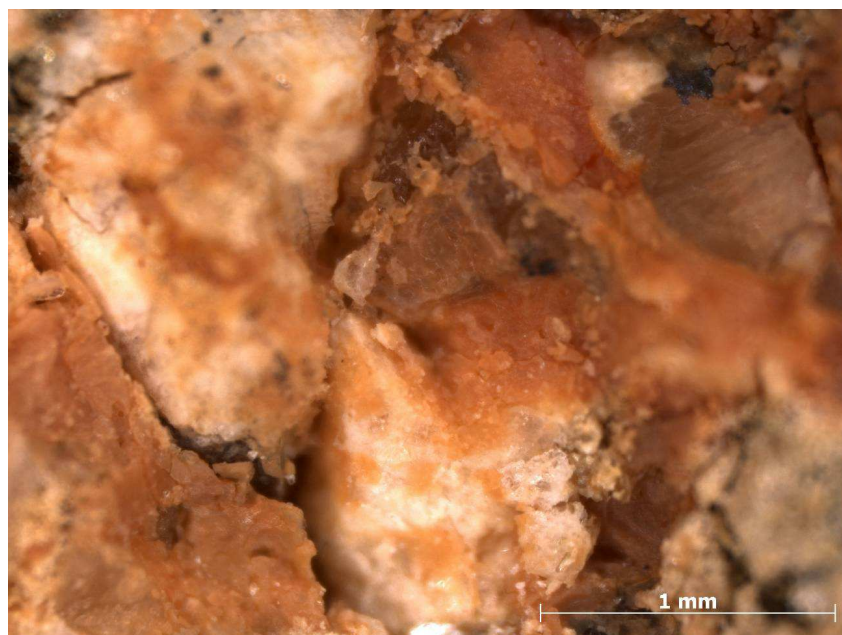
Figure 11.4: Midrand sample after testing (compressed at 600-800 kPa) at X50 magnification
