STRUCTURAL FAILURES ON MOBILE MATERIALS HANDLING EQUIPMENT

**A dissertation submitted in partial fulfilment of the requirements for the degree of
MASTER OF SCIENCE (STRUCTURES)
in the
FACULTY OF ENGINEERING
UNIVERSITY OF PRETORIA**

January 2014

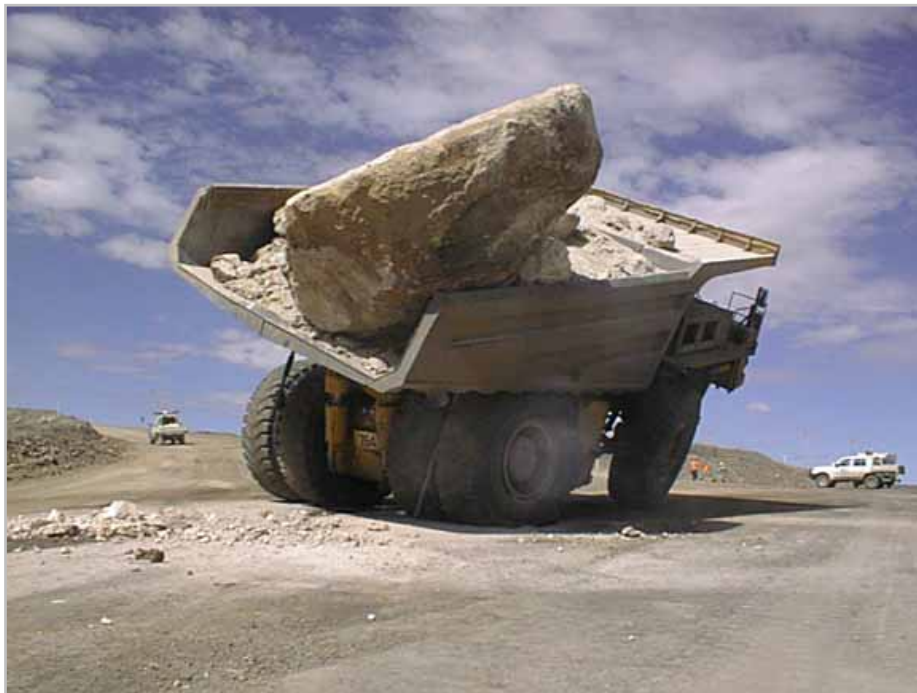
Figure 1.1: Overloaded mine hauling truck.

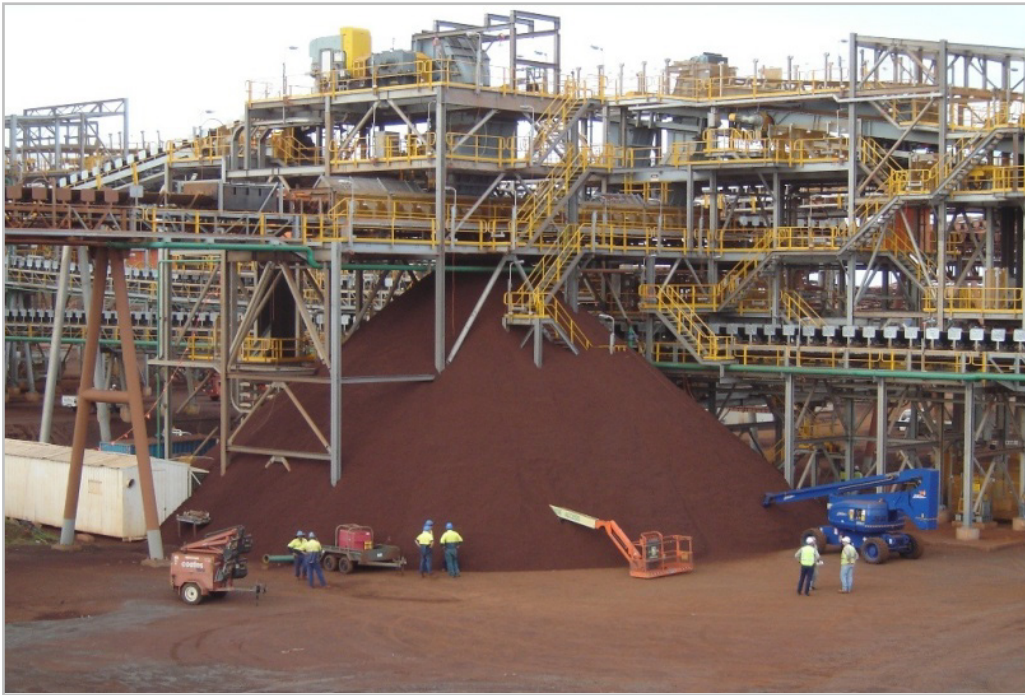
Figure 1.2: Unforeseen loads exerted on support structures.

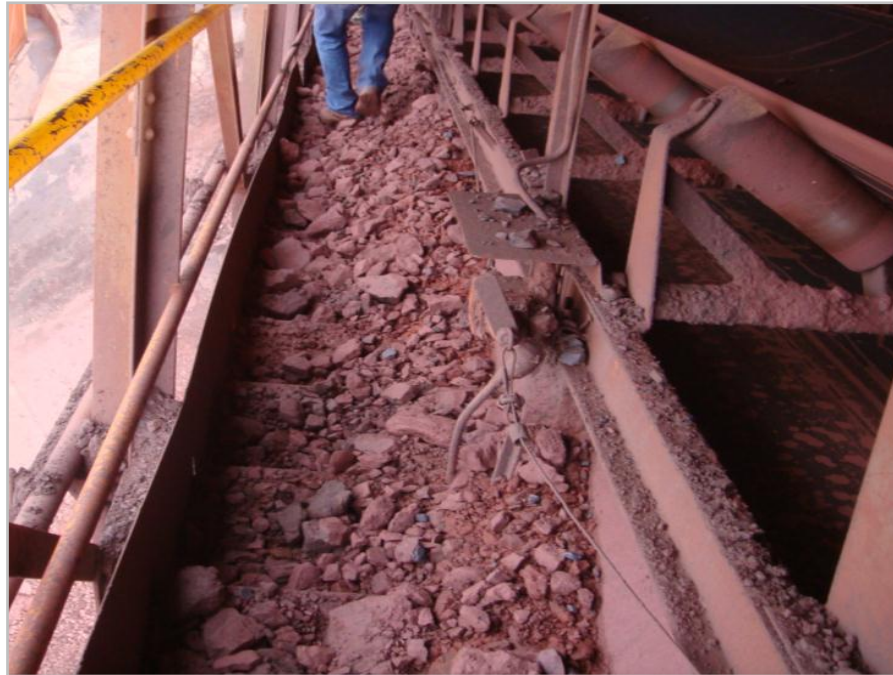
loads are dictated. Of particular interest is the live load value of 2,5 kPa specified for conveyor gantries, which is an attempt to cater for unintended spillage loads. Figure 2.1 below shows a typical example of the spillage which is often encountered on conveyor gantries due to belt wander, overloaded belts or the sliding of wet material down a steeply inclined belt. Manual unloading of belts onto walkways following an electric trip of the drive, which cannot start with a loaded belt, is not unusual.

Figure 2.1: Conveyor walkway spillage.

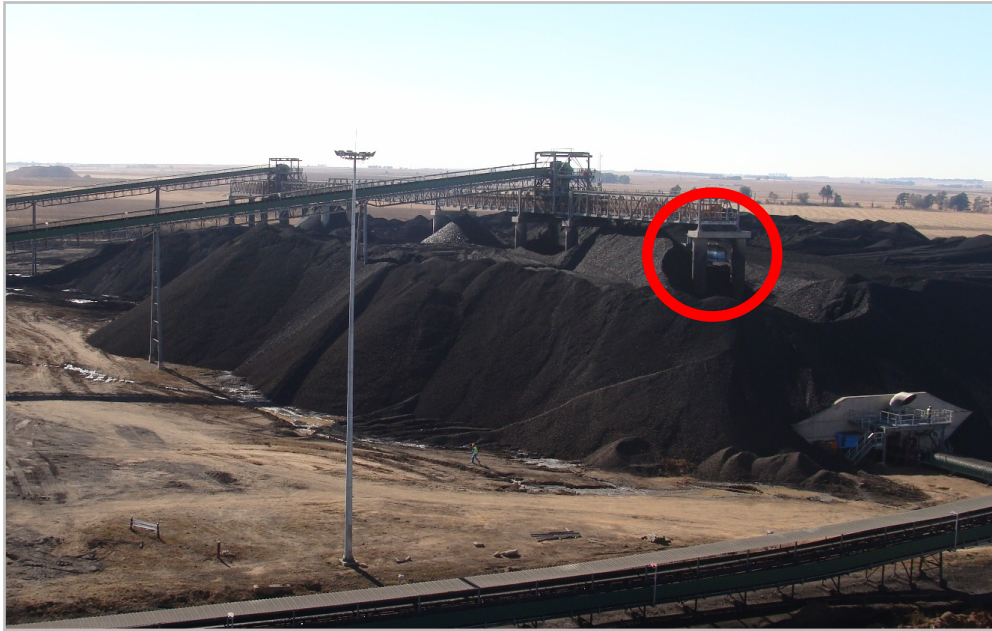
Amongst several other items listed for consideration is the impact of vehicles and other moving objects. This does not imply that conveyor structures, as shown in the Figure 2.2 below, be designed for dozer impact loads, but rather that the need for an operating procedure to manage such a risk should have been a documented action item following on from the compulsory risk assessment.

Figure 2.2: Dozer activity on an over-filled stock pile.

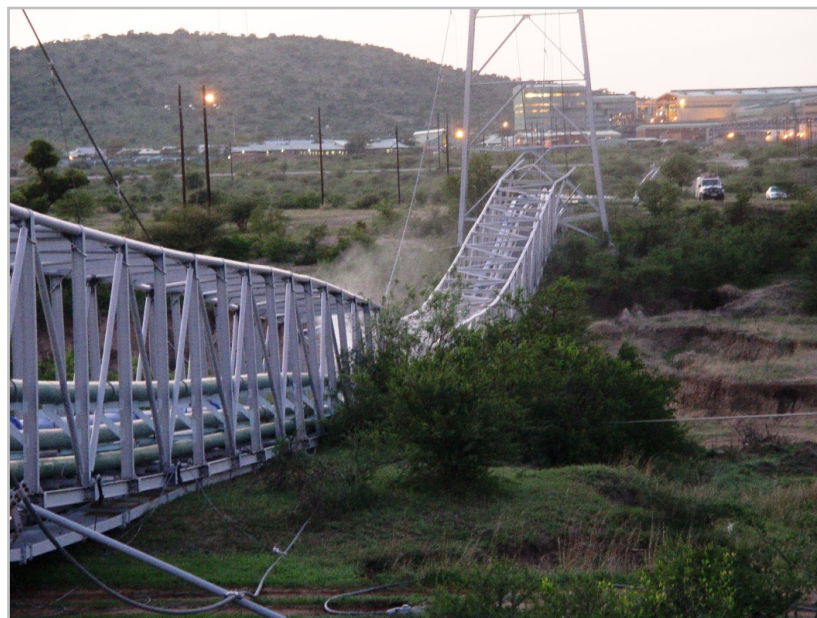
A collapsed cable suspension bridge is shown in Figure 2.3 below. Severe corrosion due to the entrapment of moisture around the rope anchors caused the failure after a relatively short service life.

Figure 2.3: Suspension bridge failure due to corroded rope anchors.

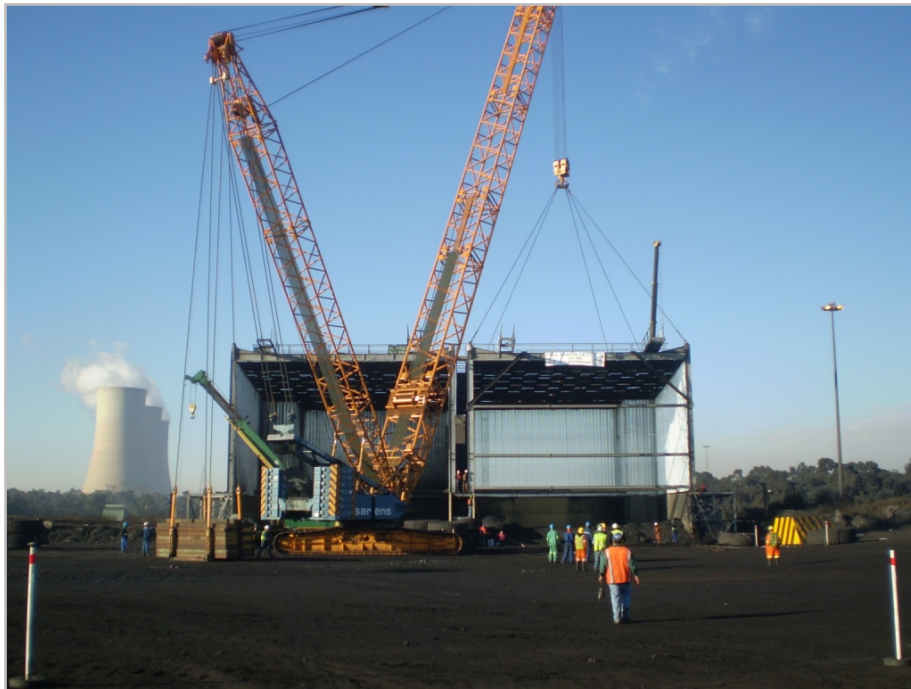
Rigging loads are non-routine lifts and are classified as safety critical. The impact factor caters for the dynamic effects associated with rigging operations. Figure 2.4 shows an example of major construction rigging activity at a mining operation site.

Figure 2.4: Major construction rigging, 80 ton single lift.

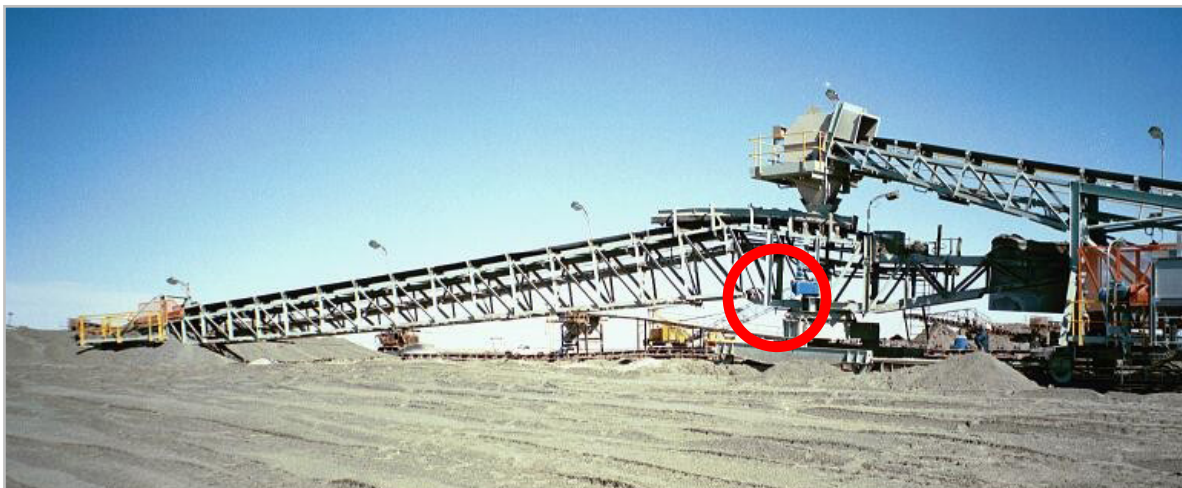
Shortly after the commissioning of the spreader, high wind loads associated with a thunder storm in the region caused the failure. The buckling of the boom's bottom chord initiated the collapse (26). The machine was designed in accordance with ISO 5049-1 (1994). The author had already commenced with the design audit, on request of the client, when the collapse occurred. Figure 3.2 below shows the collapsed machine on top of the dump, while Figure 3.3 provides a close-up view of buckled structural members.

Figure 3.2: Waste spreader failure.

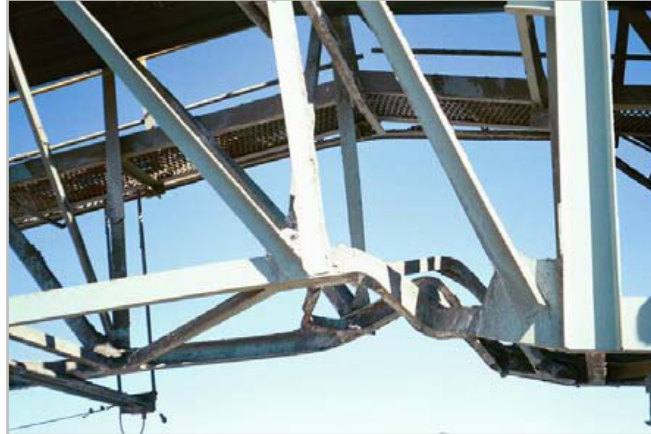
Figure 3.3: Close-up of buckled truss bottom chords.

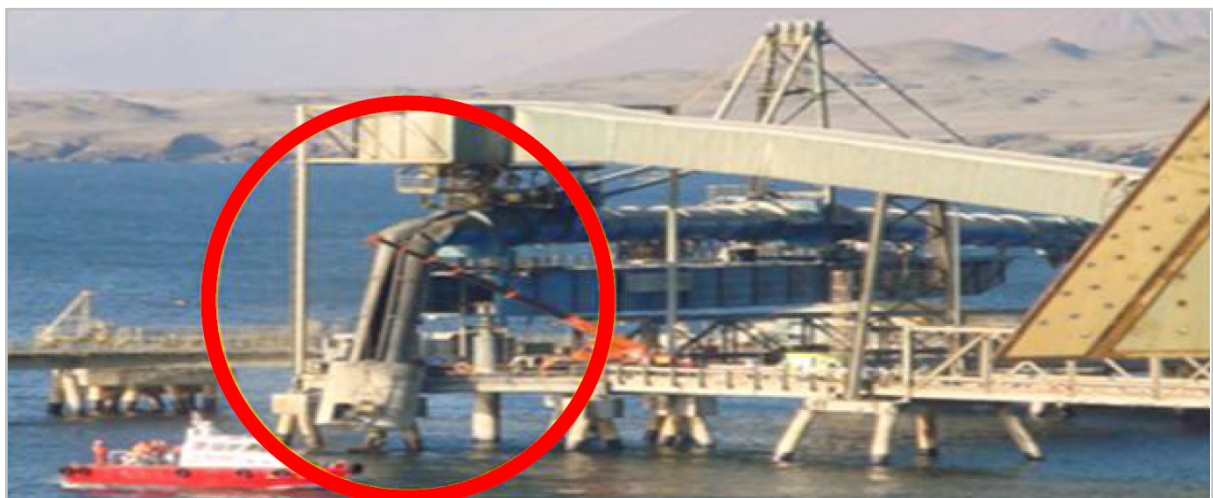
During the project design phase, the need for a light-weight ship loader structure was identified primarily due to severe prevailing seismic conditions. The marine support structures had to be light enough to be carried by slender piles which would be able to move laterally under the influence of an earthquake. The tubular boom concept was subsequently developed since it could satisfy environmental and structural design considerations. The sudden collapse occurred after the ship loader had operated successfully for over a decade. The partially collapsed ship loader is shown in Figure 3.11 below.

Figure 3.11: Ship loader, partially collapsed.

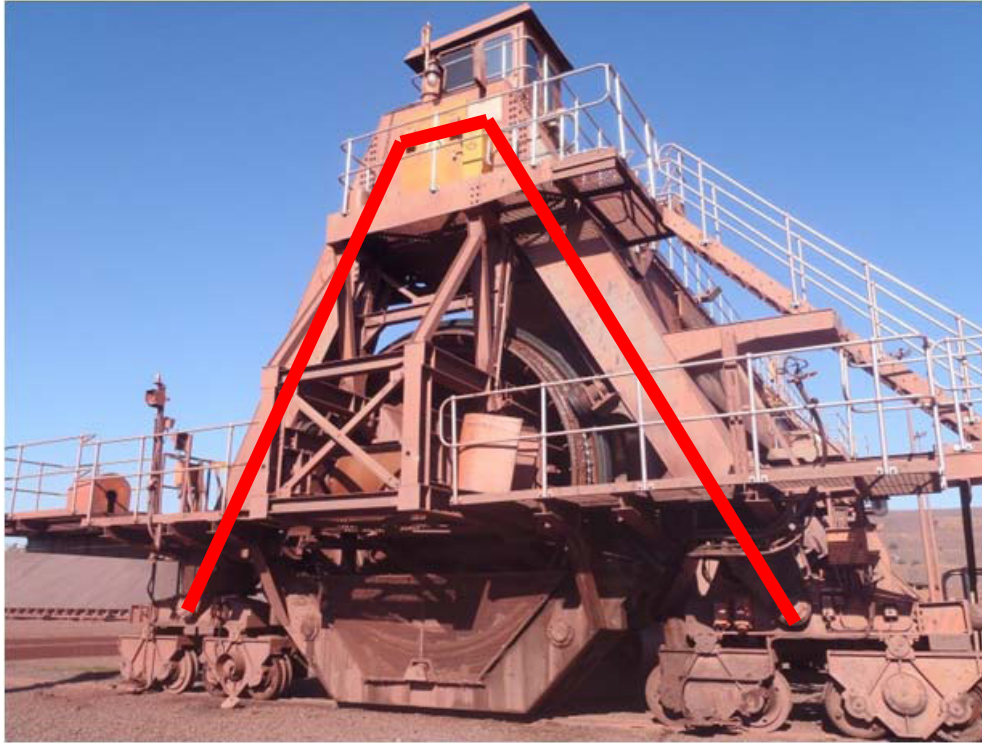
The machine's main structure is supported by four sets of bogie wheels at each end. Independent drive systems are located on both sides of the machine. The overall machine control system was originally configured without interlocks between the two systems and was operated like that for decades. When the control system for the drives on the one end malfunctioned, the drives on the opposite end continued with the long travelling sequence until the drives tripped on overload as a consequence of the skewing of the machine. Severe local damage and permanent deformation was caused to the boxed plate structural section of the fixed legs. The fixed legs had already been replaced twice. Figure 3.13 shows a side elevation of the machine with the fixed leg highlighted.

Figure 3.13: Side view of drum reclaimer, fixed legs highlighted.

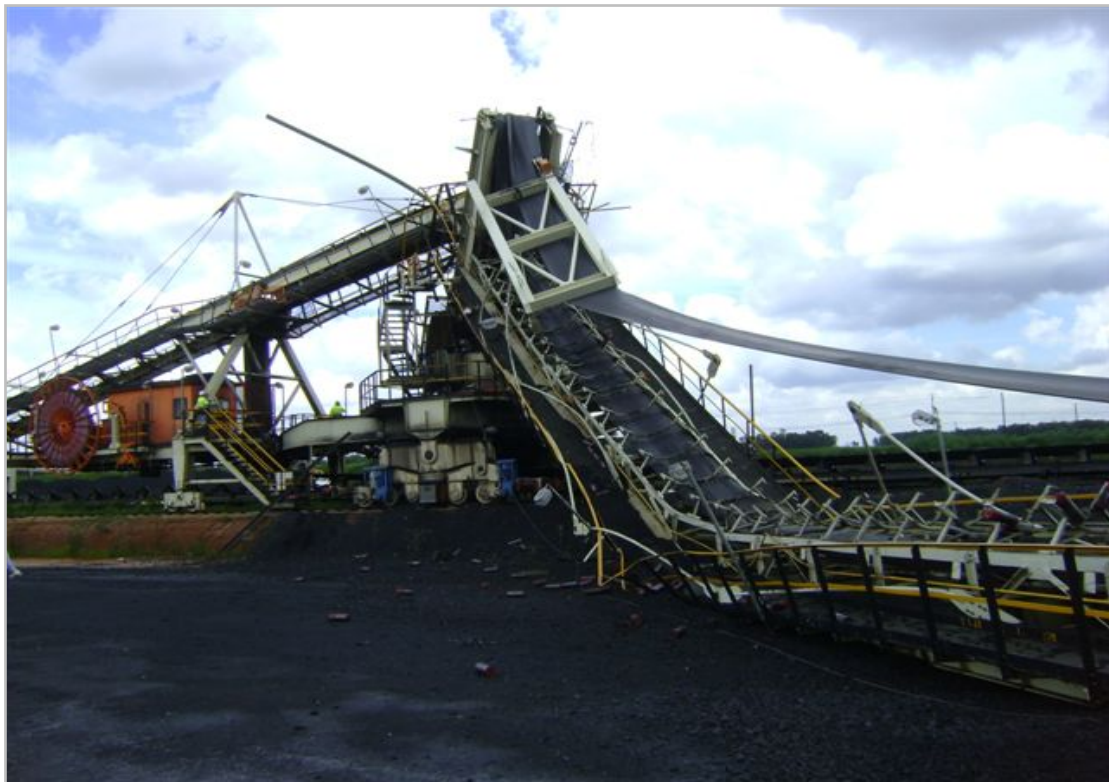
The machine was successfully operated for approximately a year before collapsing completely. An incident in which the boom conveyor belt was overloaded preceded the failure. A tie-back system, with a combination of tie rods and beams, was incorporated in the design to reduce the overall mass of the boom structure and to limit static deflection. Refer to annotations 13 and 7 in Figure 5.1 above. The failure of a critical tie-beam connection initiated the collapse of the boom and ultimately ruined the entire machine. The extent of the damage can be seen in Figures 5.2 and 5.3 below.

Figure 5.2: Collapsed stacker viewed from the north.

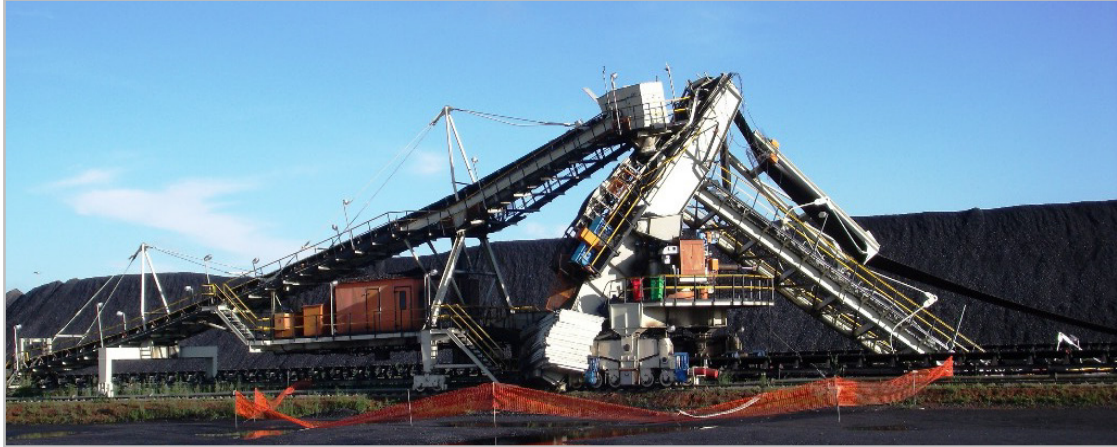
Figure 5.3: Collapsed stacker viewed from the south.

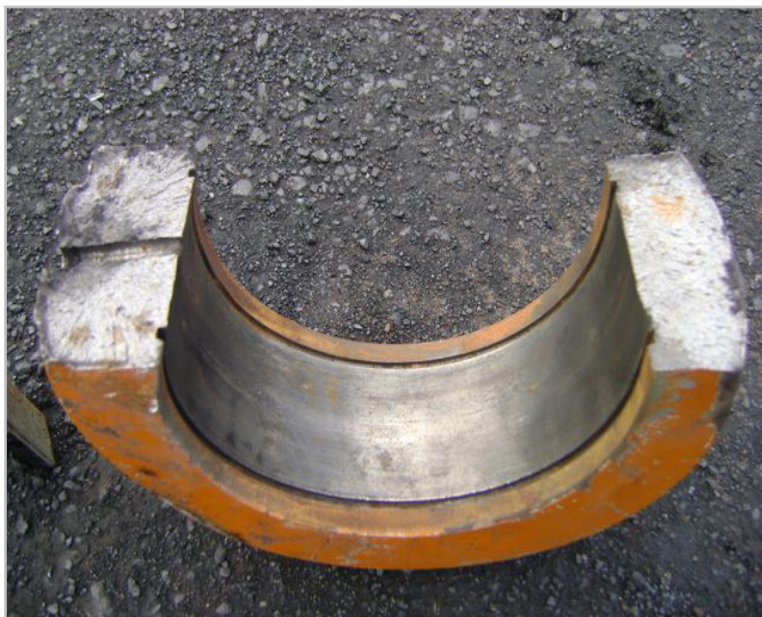
High-resolution images of the collapsed machine and site surroundings were taken from various angles. From team discussions, it was anticipated that the failed hydraulic cylinder clevis, shown below in Figure 5.4, and the tie-beam connection, shown in Figure 5.5, could possibly provide critical clues which would lead to understanding the root cause of the failure.

Figure 5.4: Failed cylinder clevis half.

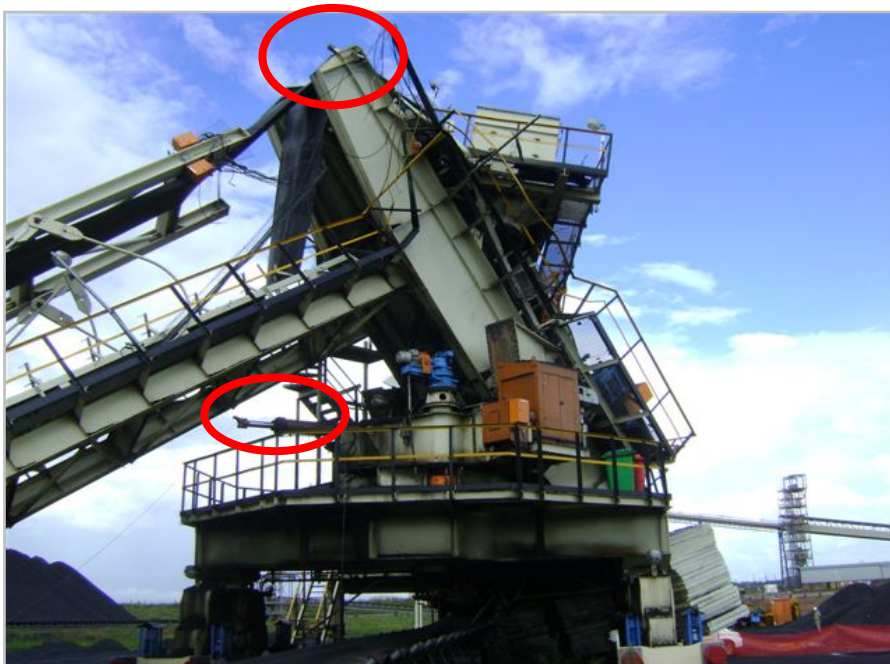
- The boom would rotate upwards due to the counterweight acting under gravity.
- The tie beams would crash into the superstructure of the tripper car.
- Note that the machine operator perceived an upward movement of the boom at the time of the collapse.
- Tie-beam connections are expected to fail in shear as a consequence of impact against the tripper car structure.
- The boom would drop down under gravity when the tie-beam connections are lost.
- The counterweight mass would drop down resulting in a boom failure at the main connection as shown in Figure 5.7 below.

Figure 5.7: Collapsed machine with luffing cylinder and main boom connection highlighted.

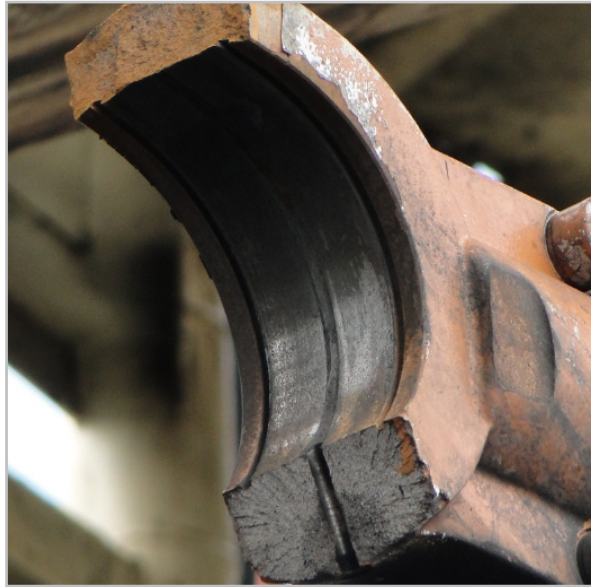
If a clevis failure under overload conditions can be proven, it would be possible to eliminate the first failure postulate which is based on a defective or inadequate clevis capacity. Both failure postulates are nevertheless based on a cylinder clevis failure under a direct tensile load. In the second failure postulate, however, the cylinder clevis failure did not cause the collapse. Images obtained from the site do not provide any reason to suspect a compression failure. The fracture plane is shown in Figure 5.9 below.

Figure 5.9: Cylinder clevis fracture plane, lubrication channel noticeable.

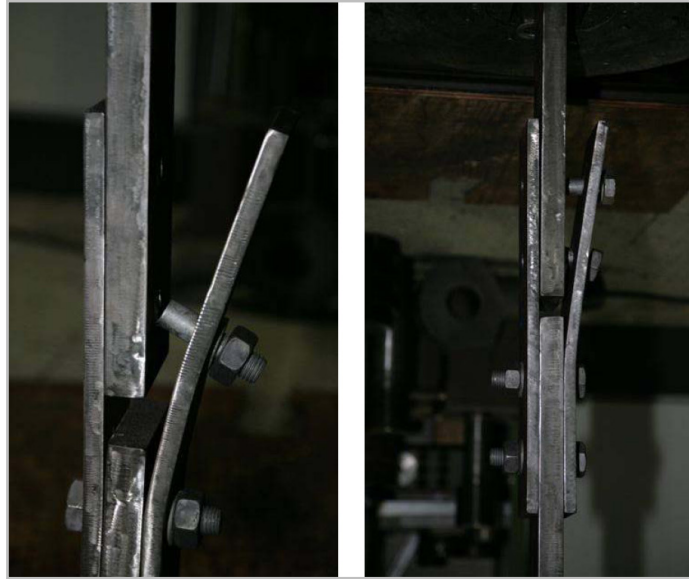
Shown below in Figure 5.14 are images of 4 bolted connections (i.e. 2 bolts per side) after the laboratory tensile test.

Figure 5.14: Typical 4-bolted connections after the tensile test (19).

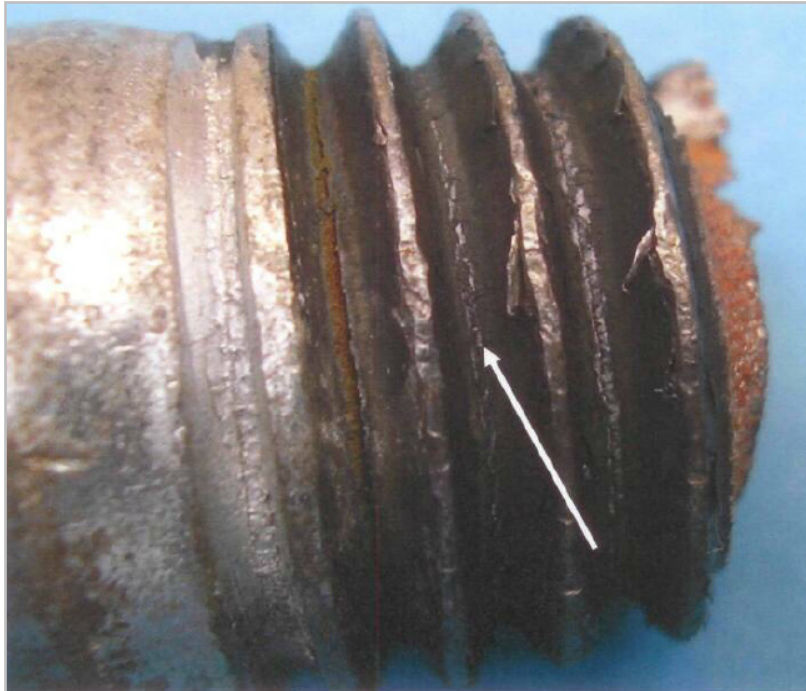
Cracks within the thread roots are shown in Figure 5.16. The metallurgical test report concluded that these cracks “were likely due to hydrogen embrittlement ...”

Figure 5.16: – Bolt specimen, cracks shown in thread roots (17).

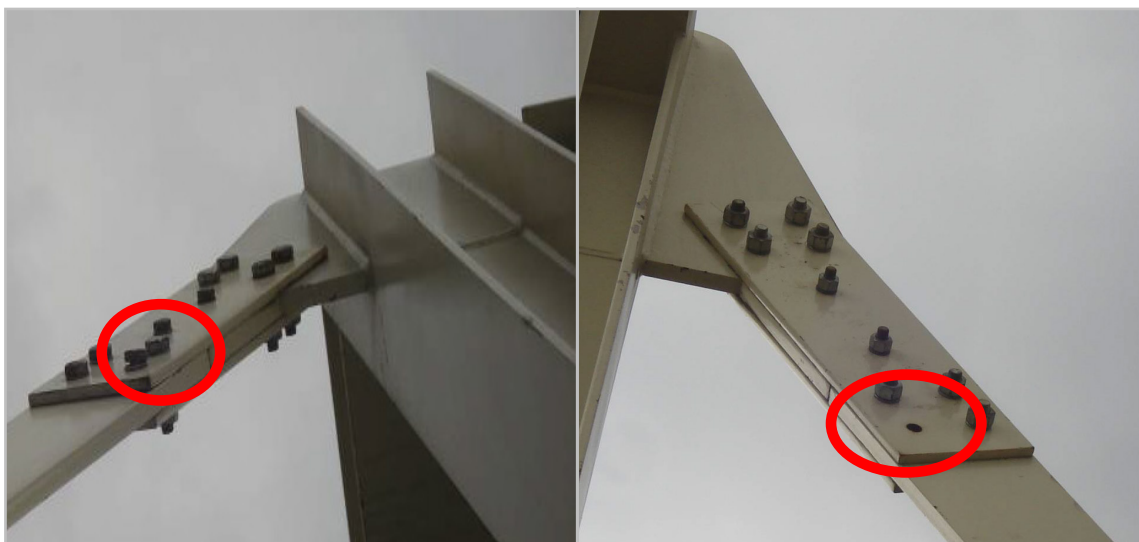
Although hydrogen embrittlement on high-strength fasteners is not unknown in the industry, the topic remains controversial. Evidence revealed by metallurgical testing, as discussed above, can nevertheless be supported by photographic evidence taken a few months prior to the collapse of the stacker (14). Figure 5.17 below shows two views of a failed bolt located on the eastern tie-beam connection (at normal boom stacking position) from both sides.

Figure 5.17: Fractured bolt at tie-beam connection months prior to the collapse (14).

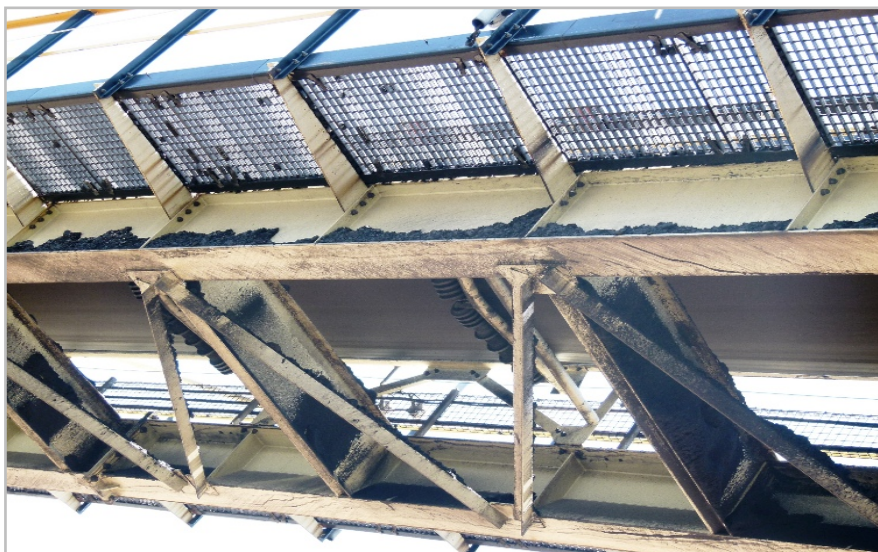
The default machine operation mode is the automatic mode in which the stacker's long travel and stack-out operations are controlled by the selected PLC program. It is nevertheless possible to select a manual operational mode. The possibility of operator abuse was investigated since photographic evidence shows interaction between the stockpile and the stacker boom as shown in Figure 5.18 below.

Figure 5.18: Scrape marks at the bottom of a stacker boom.

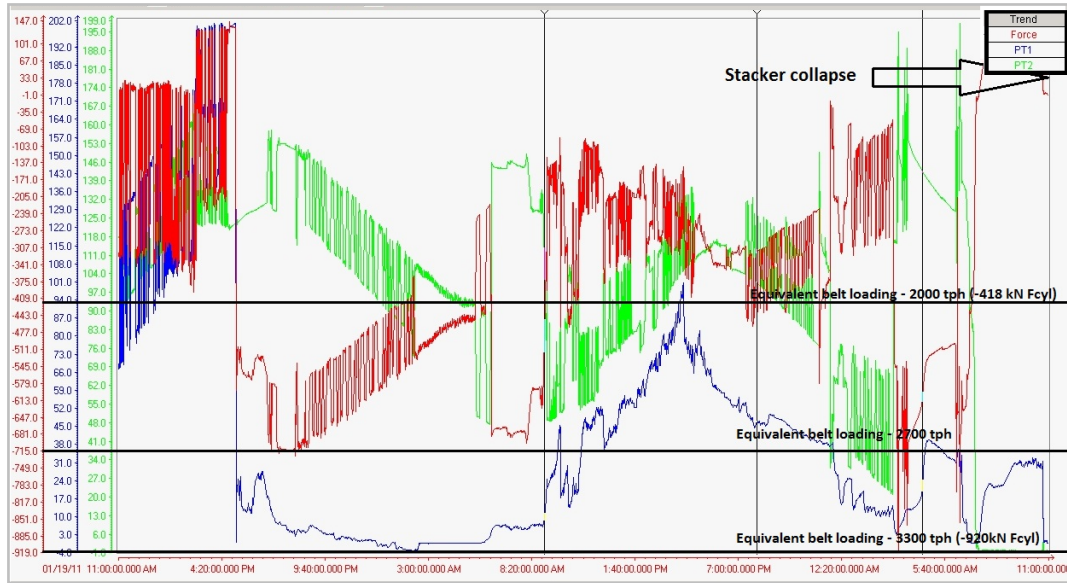
Figure 5.23 below shows a snapshot of the luffing cylinder pressures and corresponding cylinder force exerted over the time just prior to the collapse. Refer to the red scale for cylinder forces with equivalent belt loading values marked for 2000 ton/hr, 2700 ton/hr and 3300 ton/hr, respectively. The PLC relies on an algorithm to calculate the system cylinder force based on the cylinder pressures recorded.

Figure 5.23: SCADA recordings prior to collapse.

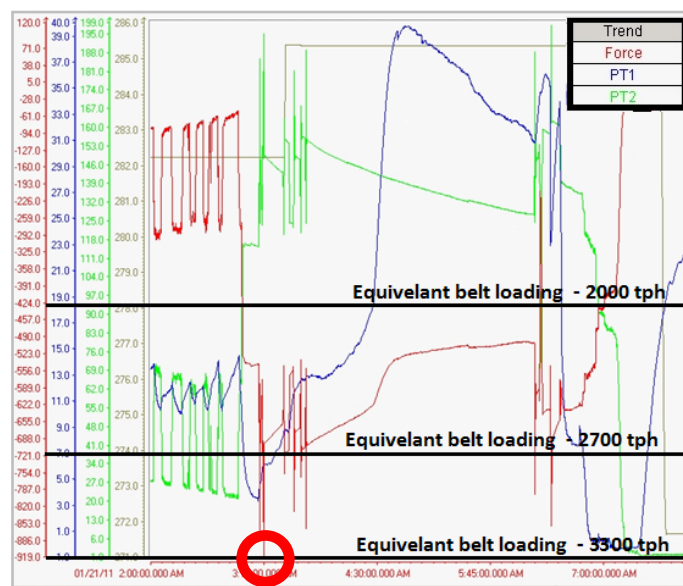
From the SCADA recordings prior to the collapse, it is clear that normal boom loading was significantly exceeded and attempts to luff the stacker boom were recorded. The cut-off value on the recordings was limited at -920 kN (C) as shown in Figure 5.24 below.

Figure 5.24: SCADA recordings showing cylinder force value in excess of -920 kN (C).

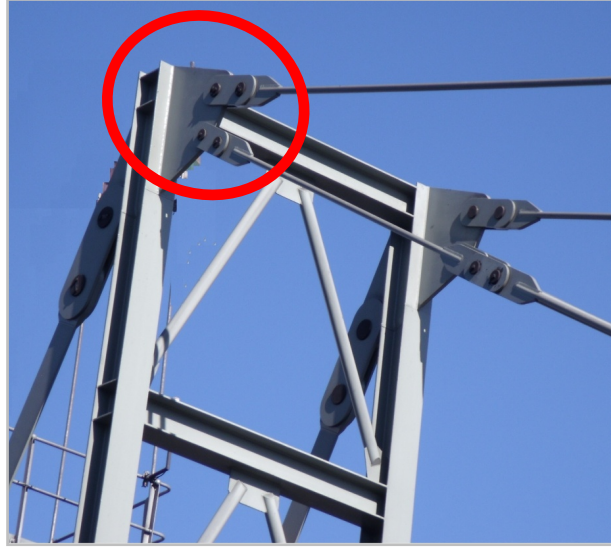
Figure 5.26: Revised tie-beam connection design, pins in double shear.
