Fracture behaviour patterns of cusp-replacing fibre strengthened composite restorations

SADJ October 2015, Vol 70 no 9 p390 - p395

ABSTRACT

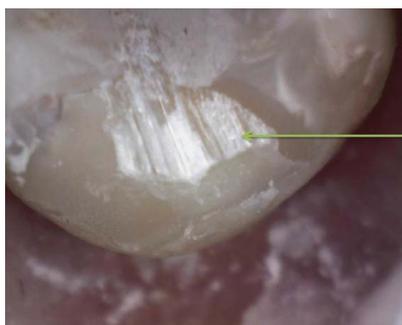
Photo 4a: Fracture between fibre sub-structure and composite resin (x10 magnification)

According to the literature^{35,36,42} some researchers also use a broad classification system based on the type of fracture, being either cohesive or adhesive. (Photos 2 and 2a). A more detailed investigation of fracture patterns in the current study (Graph 2) show that in Group A, the fractures were more or less evenly distributed between cohesive and adhesive types (Graph 2). 52% or 13 out of 25 specimens were cohesive fractures (Photo 3 and 3a). This differs from the finding of Taha (2011)⁵¹ who found mainly adhesive fractures. In Group B most of the fractures were cohesive (68%, 17 out of 25 specimens), while in Group C 76% (19 out of 25) of fractures were cohesive, and 16% (4 out of 25 specimens) of fractures were adhesive. This is similar to the finding of Tezvergil (2005).⁴⁹ In all 76% of cohesive failures the fracture occurred between the fibre substructure and the composite resin as illustrated in Photo's 4 and 4 (a).
