Chemical wear analysis of a tap-hole on a SiMn production furnace

by J.D. Steenkamp*§, P.C. Pistorius*†, and M. Tangstad‡

Synopsis

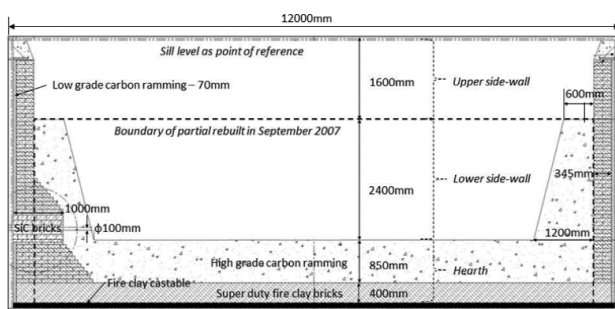
Figure 1—SiMn lining design (drawing to scale)

The SAF under investigation was of circular design with an open roof and outer diameter of 12 m. The furnace containment system consisted of a refractory lining installed in a steel shell. The refractory design from the hearth to the top of the sidewall is indicated in Figure 1. The compositions of the refractory materials of interest are presented in Table I.

In the hearth, fireclay was cast onto the steel shell to level the floor. The fireclay is an aluminosilicate aggregate with alumina cement binder. Five layers of super-duty fireclay bricks were installed as back lining, with high-grade carbon ramming as working lining. In the lower sidewall, a single layer of super-duty fireclay brick was installed as back lining with high-grade carbon ramming as working lining. As safety lining, a low-grade carbon ramming was emplaced between the steel shell and the back lining. In the upper sidewall, the lining design was similar to the lower sidewall but with the super-duty fireclay brick layer forming both the working lining and the back lining, *i.e.* no high-grade carbon ramming was installed. The two single-level tap-holes were built with SiC bricks supported by super-duty fireclay bricks.

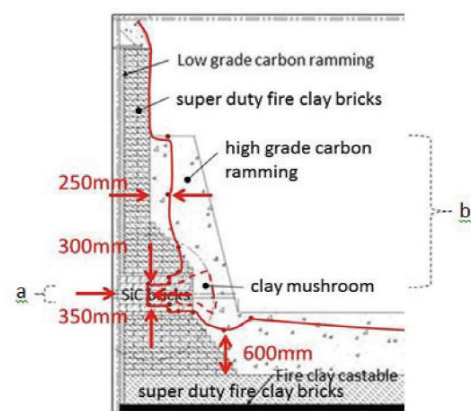
Figure 3—Refractory design drawing with red line indicating the refractory hot face as determined during excavation, indicating (a) the worn tap-hole filled with slag-and-coked-bed top layer and (mainly metal) bottom layer (refer Figure 6), and (b) the worn 500 mm wide channel partially filled with slag with coke bed (refer Figure 4). Drawing to scale

In Figure 3 the dimensions of the worn lining are superimposed onto the refractory design drawing presented in Figure 1. The dimensions of the red-line drawing were obtained on a vertical plane passing through the centre of the tap-hole.

As can be seen in Figure 3 and the series of photographs in Figure 4 to Figure 9, wear of the tap-hole area was extensive. As indicated in Figure 3, more than 50% of the SiC brick was worn away, with most of the wear occurring at the hot face of the sidewall. Wear of the SiC brick was more extensive above the tap-hole than below. Furthermore, the carbon ramming above the SiC brick was worn all the way to the top of the carbon. In plan view (not indicated), the wear pattern was in the form of a channel 500 mm wide, with fairly straight sidewalls rather than funnel-shaped as is typical of the wear pattern in open bath furnaces. The SiC brick and the carbon ramming paste in the hearth in front of the tap-hole were worn away both below and above the tap-hole.

To put the results in Figure 15 into perspective, the actual refractory consumption was calculated over the lifetime of tap-hole B. The results are reported in Table IV. The mass of refractory worn was calculated from the wear profile in Figure 3. The total amount of slag tapped through the tap-hole was calculated from production figures (see Table V).

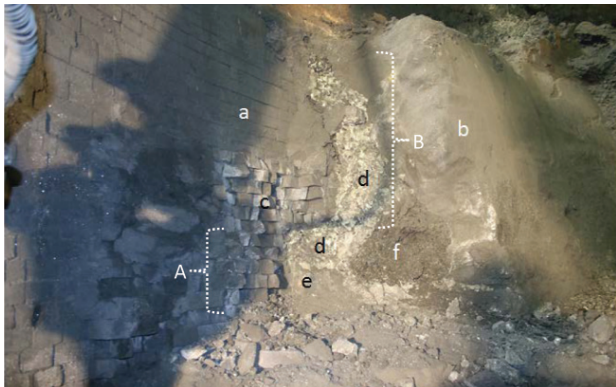
Figure 4—Side view of tap-hole region with (a) super-duty fireclay bricks, (b) high-grade carbon ramming, (c) SiC bricks, (d) slag with burden and/or coke bed material, (e) mixed material containing metal, and (f) clay mushroom. The tap-hole (Figure 8) is to the left of (e) and lower (d), with (A) indicating the worn tap-hole filled with a slag and coke bed top layer and (mainly metal bottom layer and (B) the worn channel 500 wide and partially filled with slag with coke bed

Figure 4 shows a side view of the tap-hole region (compare Figure 3) with the high-grade carbon ramming and SiC tap-hole extension (c) removed on the left-hand side, exposing the super-duty fireclay brick installed as back lining

(a). On the right-hand side, the high-grade carbon ramming (b) was left intact. The 500 mm wide slot worn into the high-grade carbon ramming and SiC all the way vertically from the tap-hole to the top of the ramming crucible is clearly visible (d). The vertical slot was partially filled with a slag/burden layer (d) that extended into the upper part of the worn tap-hole. The lower part of the tap-hole was filled with mixed material containing metal (e). A clay mushroom, which formed when clay forced through the tap-hole spread radially when coming in contact with burden, was observed (f). Instead of the clay rebuilding the tap-hole by forming a new interface between the refractory and slag/metal, the slag and metal channelled around the clay mushroom before exiting the furnace through the worn tap-hole. Note that the mushroom was not in contact with the tap-hole, as would be expected of a reconstructive tap-hole clay (Dash, 2009; Ko, Ho, and Kuo, 2008; Inada *et al.*, 2009; Nelson and Hundermark, 2014). The lack of attachment of the mushroom to the taphole broadly agrees with the suggestion by Nelson and Hundermark (2014) that ferroalloy furnaces generally do not develop a mushroom attached to the taphole.

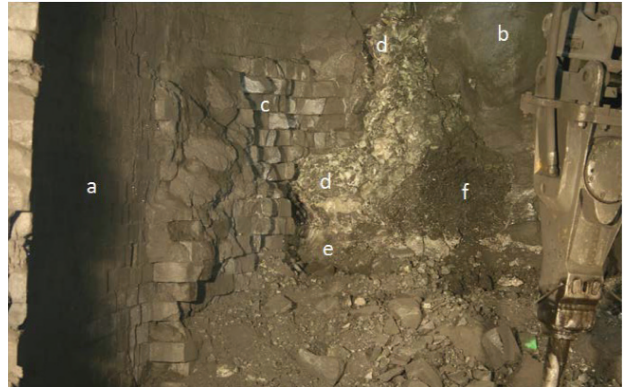
Figure 5—Closer view of tap-hole B showing (a) super-duty fireclay bricks, (b) high-grade carbon ramming, (c) SiC bricks, (d) slag with burden and/or coke bed material, (e) mixed material containing metal, and (f) clay mushroom

Figure 5 and Figure 6 show the tap-hole area in close-up, making it easier to distinguish the different zones, comprising super-duty fireclay brick back lining (a), high-grade carbon ramming crucible (b), SiC bricks used to build the tap-hole (c), slag with burden and/or coke bed material present either in the worn channel (vertical section or upper (d)) or in the worn tap-hole (horizontal section or lower (d)), mixed material containing metal (e), and tap-hole clay mushroom (f).

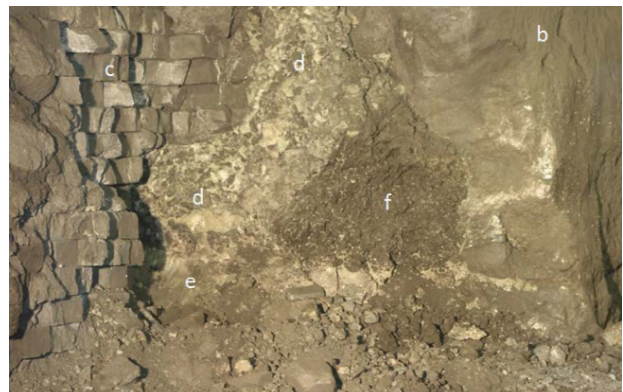
Figure 6—Closer view of zones in front of tap-hole B, showing (b) high-grade carbon ramming, (c) SiC bricks, (d) slag with burden and/or coke bed material, (e) mixed material containing metal, and (f) clay mushroom

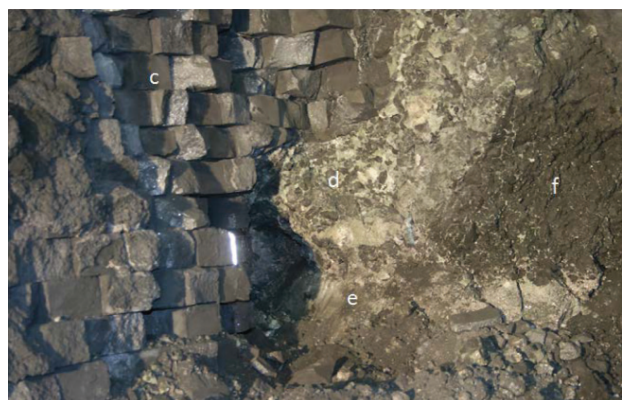
Figure 7—Detail of tap-hole B with (c) SiC bricks, (d) slag with burden and/or coke bed material, (e) mixed material containing metal, and (f) clay mushroom infiltrated with slag

Figure 7 and Figure 8 show the interior of the tap-hole, illustrating the extent to which the SiC brick in the tap-hole had worn away.

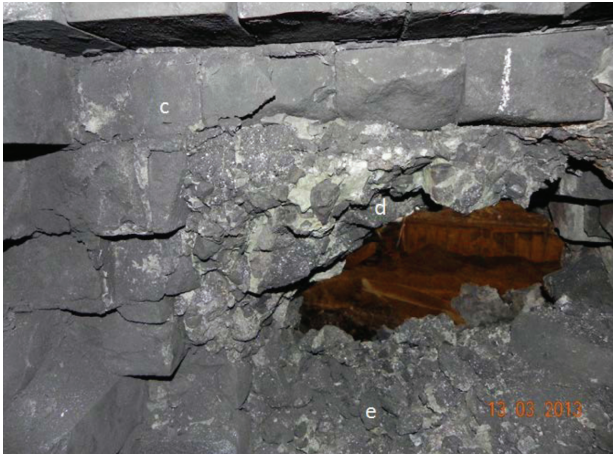
Figure 8—Interior of tap-hole B with (c) SiC bricks, (d) slag with burden and/or coke bed material, and (e) mixed material containing metal

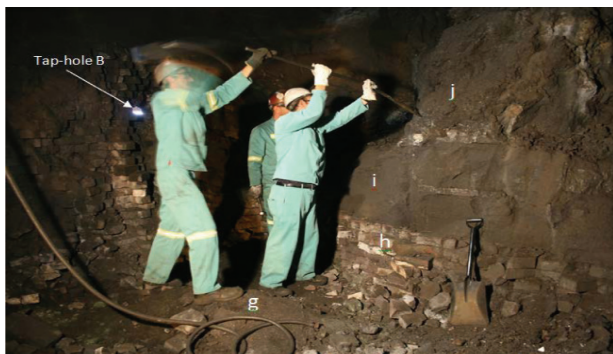
Figure 9—Tap-hole B in perspective. The operating personnel, standing on the steel shell/fireclay castable of the furnace hearth (g), are sampling the metal layer at the interface between the high-grade carbon ramming (i) and burden (j). Also note the five layers of super-duty fireclay bricks (h) in the hearth

Figure 9 shows the tap-hole in perspective, with operating personnel standing on the steel shell/fireclay castable of the furnace hearth. This photograph was taken at the same stage of furnace excavation as was the photograph in Figure 8.

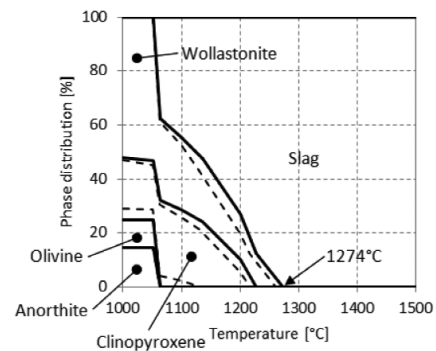
Figure 10—Equilibrium phase composition of industrial slag based on Table IV. Solid lines: slag corrected for metal entrainment; dotted lines: uncorrected

The predicted equilibrium phase compositions, for both as-received slag not corrected for metal entrainment and slag corrected for metal entrainment, are presented in Figure 10. In both instances the slag would be fully liquid at the temperatures under investigation (1500–1700°C) with the calculated melting points at 1260°C and 1274°C respectively. As the composition of liquid slag phase was not changed by the presence of a second phase, the slag composition in Table II could therefore be used ‘as is’ in thermodynamic calculations to study the potential of chemical reactions between slag and refractory.

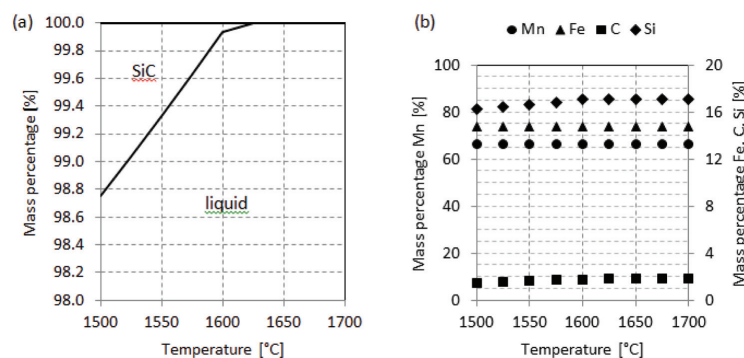
Figure 11—Predicted (a) phase composition of as-received metal and (b) chemical composition of liquid metal phase, as a function of temperature

The predicted equilibrium phase composition of the as-received metal and chemical composition of the metal phase as a function of temperature are presented in Figure 11. At temperatures below 1625°C the metal is saturated in SiC, as seen by the precipitation of SiC as a separate phase and the lower Si and C contents of the liquid metal phase. As the temperature increases, the solubility of the SiC in the metal increases to the point (above 1625°C) where the metal becomes unsaturated in SiC. This is in agreement with the C solubility diagram for Si-Mn-Fe alloys presented in Figure 12 and constructed from thermodynamic calculations conducted in FACTSage 6.4 (Bale *et al.*, 2002). Once the temperature has increased to such an extent that the metal is unsaturated in SiC, the metal will dissolve any SiC it comes into contact with, except for limitations posed by reaction kinetics (Einan, 2012).

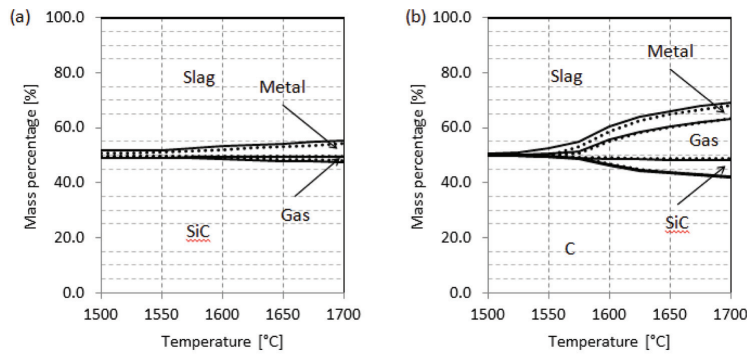
Figure 13—Predicted phase composition of 100 g slag reacted with 100 g of (a) SiC and (b) C-based refractory material, as a function of temperature. Solid lines represent the borders for phase composition calculated from the as-received slag analysis, and dotted lines calculated from the corrected slag analysis

The predicted equilibrium phase compositions when slag reacts with SiC or C refractories are presented in Figure 13, and chemical compositions of the slag, metal, and gas phases in Figure 14. The difference in phase composition of slag not corrected for metal and slag corrected for metal was insignificant. The remainder of the discussion will focus on slag corrected for metal only. This means that the elements actively participating in slag/refractory interaction were considered as being Mn, Si, O, and C (Fe excluded).

The reaction products for SiC-based refractory reacting with slag consist of metal and gas phases (Figure 13a). Metal formation is significant throughout the temperature range under investigation (1500°C to 1700°C). Metal formation increases with increasing temperature from 1575°C, which is the temperature at which gas formation also becomes significant. The formation of SiMn metal (Figure 14b) is associated with a decrease in the MnO content of the slag (Figure 14a), a decrease in SiC (Figure 13a), and formation of a CO-rich gas phase (Figure 14c). Wear of the SiC-based refractory was therefore due to the formation of a metal phase – through both the reduction of MnO and the subsequent dissolution of SiC into the metal phase formed – and formation of a CO-rich gas phase.

The reaction products for C-based refractory reacting with slag are metal, gas, and SiC phases (Figure 13b). Metal formation commences at 1525°C and SiC formation at 1575°C, with gas formation being significant from 1550°C. The formation of SiMn (Figure 14b), metal, and SiC is associated with decreases in both MnO and SiO₂ contents of the slag (Figure 14a), a decrease in C (Figure 13b), and formation of a CO-rich gas phase (Figure 14c). Wear of the C-based refractory was therefore due to the formation of metal phase (through the reduction of MnO and SiO₂ and subsequent dissolution of C into the metal phase formed), formation of a SiC-phase through reduction of SiO₂, and formation of a CO-rich gas phase.

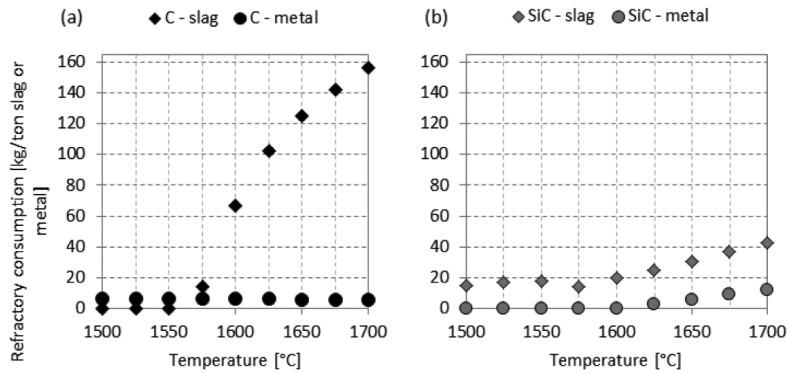
Figure 15—Refractory consumption when reacting 100 g metal or 100 g slag with 100 g of (a) C-based or (b) SiC-based refractory material, as a function of temperature

The predicted refractory consumption is plotted as kilograms of refractory consumed (W_{ref}) per ton of slag or metal in Figure 15.

The highest wear predicted was for carbon-based refractory reacting with slag at temperatures exceeding 1675°C, followed by SiC-based refractory reacting with slag.

This is expected, as slag reactions involve both chemical reaction and dissolution as discussed above, whereas metal reaction involves only dissolution. Dissolution of SiC into metal (Figure 15b) occurs only once the metal becomes unsaturated in SiC (Figure 11a and Figure 12), whereas the metal is already unsaturated in C (Figure 12), with carbon potentially dissolving in metal throughout the temperature range (Figure 15a).

From Table IV and Table V the actual refractory consumption relative to the total amount of slag tapped through the tap-hole was calculated. The result obtained – 0.07 kg refractory per ton of slag – was far lower (by a factor of a thousand) than the predicted equilibrium consumption (around 70 kg refractory per ton of slag, depending on temperature) (see Figure 15).

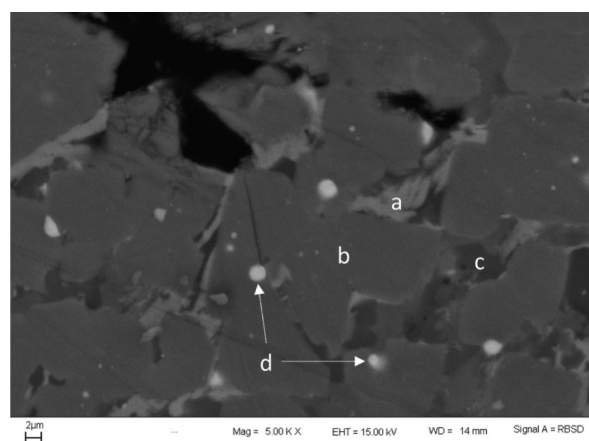
Figure 16—SEM BSE image of industrial slag (scale bar 2 µm) with three different slag phases (a, b and c) and metal phase (d) indicated

Four different phases were identified – see Figure 16. Three were slag phases (a-c) and one metal phase (d). None of the three slag phases contained Fe. The only phase that contained Fe was the metal phase (d). ♦
