INNOVATIVE PPP SAVES CHAPMAN'S PEAK: PPP BRINGS TOGETHER THE PUBLIC AND PRIVATE SECTORS FOR REHABILITATION OF THE FAMOUS ROAD

W DREYER, K BREYTENBACH, M WATTERS, W VAN OUDENHOVE and P PARRING

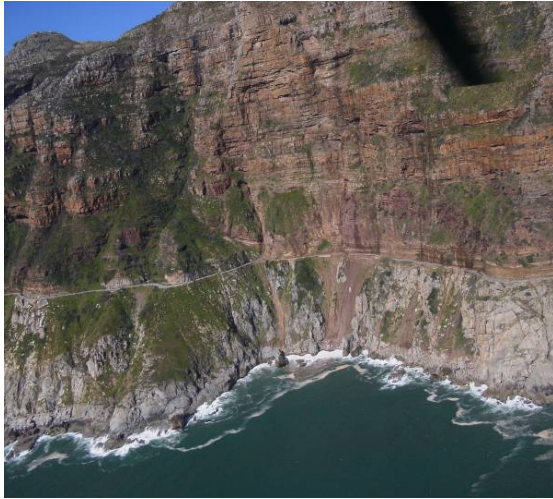
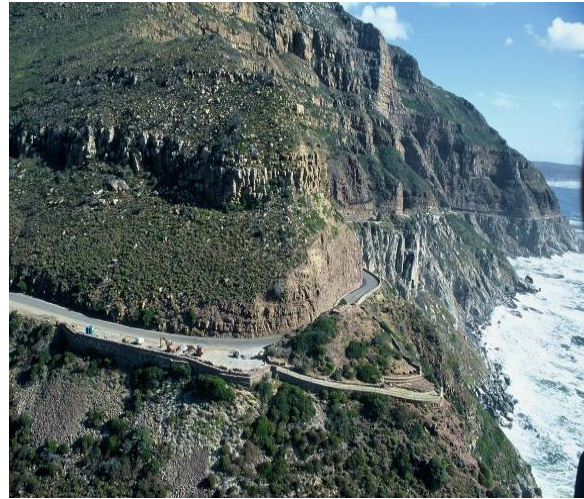
There are two prime sources of instability, namely those resulting from the natural slopes and cliffs of the mountainous terrain which tower above CPD and those emanating from the man-made cuttings in hard rock for the construction of the road over 80 years ago.

Cliffs and View of Mountain

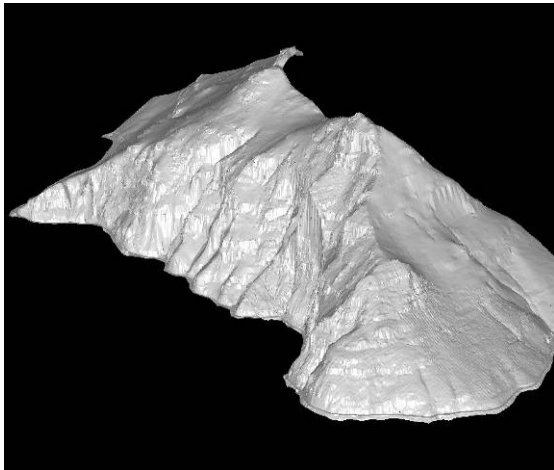
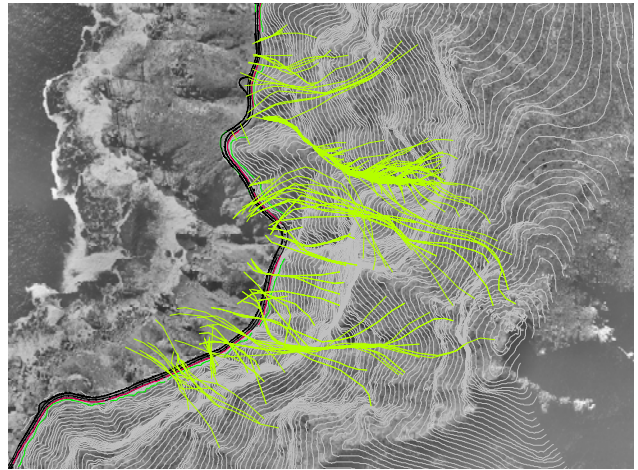
To this end three dimensional simulations of rockfalls were undertaken in association with Swiss specialists at an intensity and scale never attempted before. The input required for this modelling included a very detailed Digital Terrain Modelling (DTM) and the interpretation of very high resolution aerial photography to undertake an Engineering Geological Classification of the mountainous ground above CPD.

The results of these simulations allowed the distributions of both the relative frequency and the energies of simulated rocks of various sizes to be determined. In this manner a rational approach to selecting, sizing and placing of the required rockfall protection measures as described in the following sections was achieved.

Modelling and 3-D Mapping of Chapman's Peak Drive

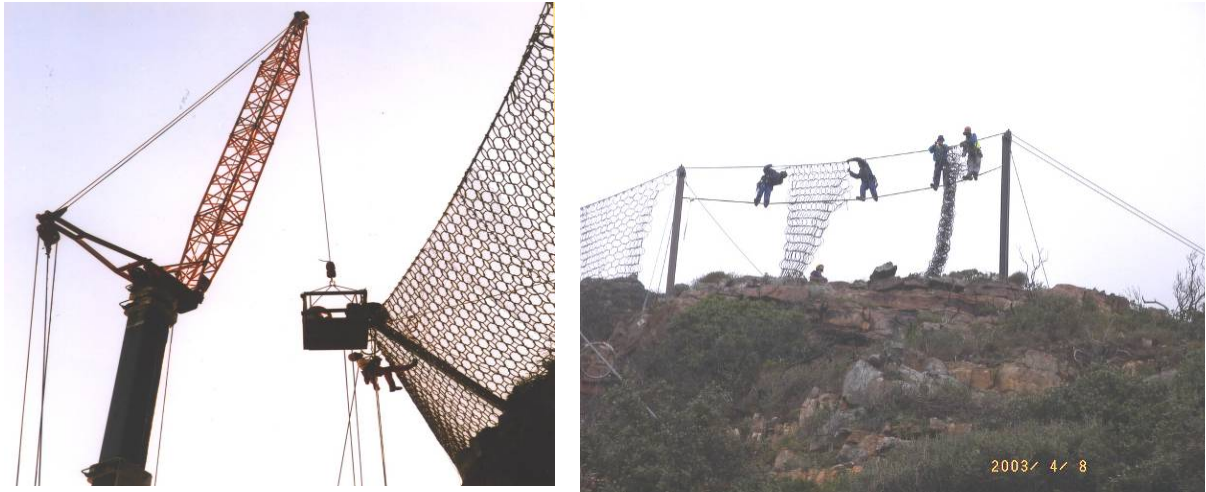
The primary protection measure adopted is the provision of nearly 1 600 metres of flexible high energy absorbing catch fences. These fences consist of steel posts made of heavy H-beam profiles. The posts are pinned so as to hinge on steel base plates which are anchored to the ground. Top and bottom straining cables are laced between the posts and are tied and tensioned to lateral ground anchors at either end of the fence. Depending of the capacity of the fence, friction brakes, being wire rope loops, are laced into the straining ropes and steel ring nets draped and tied to these straining ropes with a final upside layer of Tecomesh laid over the ring nets to absorb high velocity impacts. The fences vary in height from 4 metres to 9 metres.

Catch Fence and Details

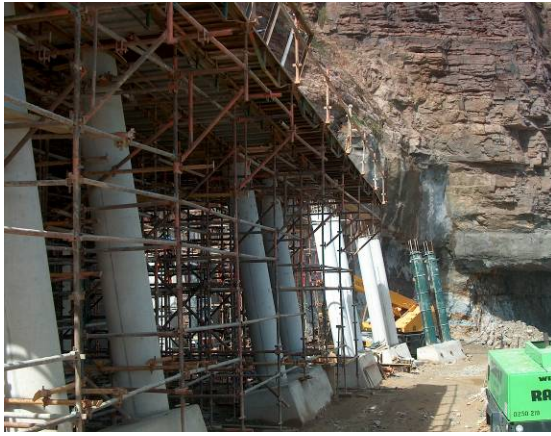
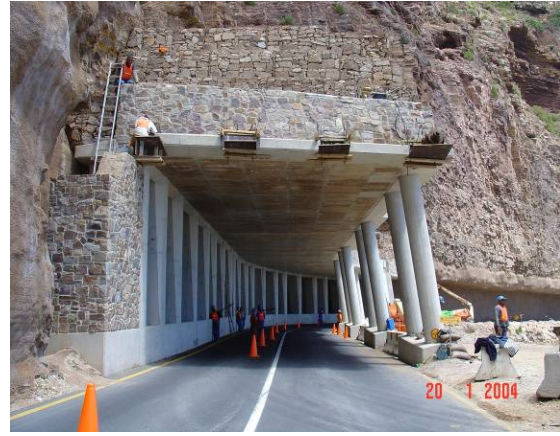
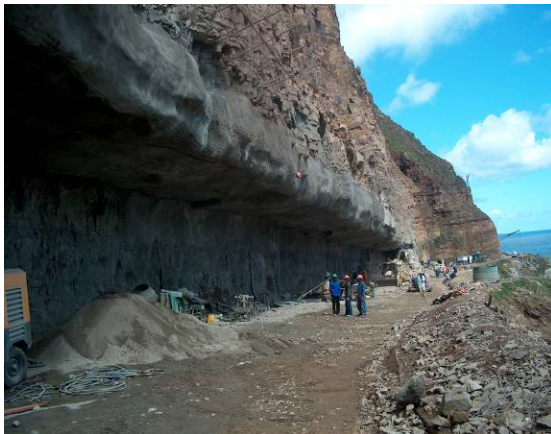
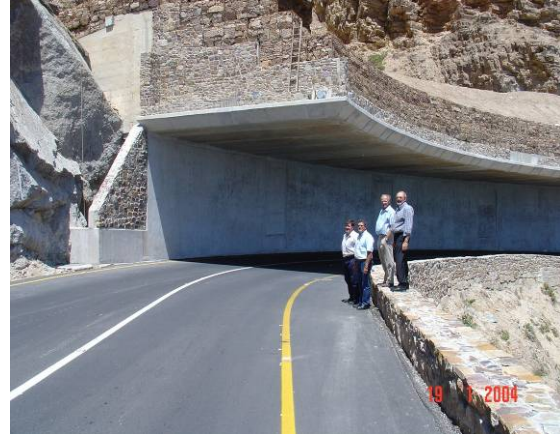
Two concrete canopy structures have been included as part of the rockfall protection measures for the rehabilitation of CPD. The first 40 metres long curved structure is located in a sharp bend in the road at the confluence of three gullies, where stormwater flow is combined with frequent rockfalls and debris deposits. This structure cantilevers over the full width of the road, giving a clear view to the sea. The second structure is located where the road has been cut back into the cliff face to align it with the northern entrance to the half tunnel. This is in the area with the highest rockfall energy, and where the cliffs extend up to 400 metres above the road. This structure is propped along the front by a series of round sloping columns.

Canopies in Construction and Complete

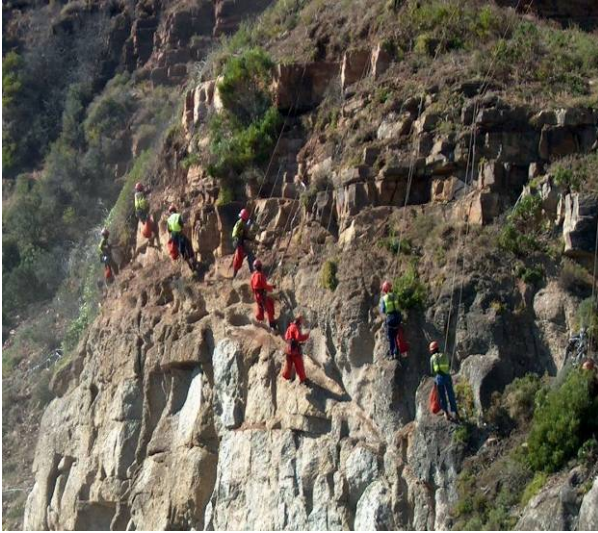
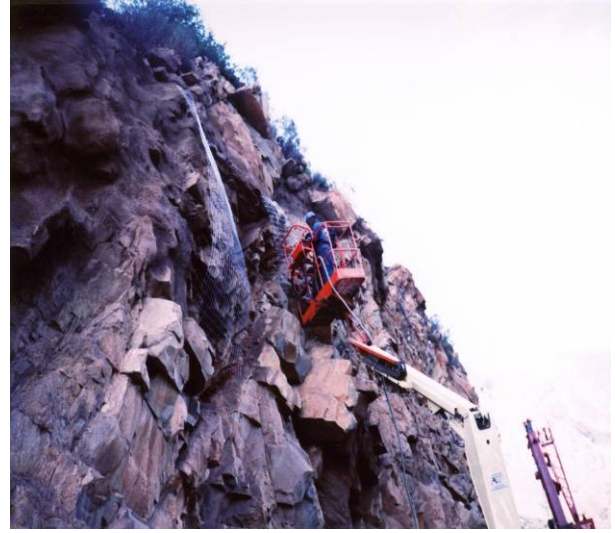
- On the natural slopes and cliffs above Chapman's Peak Drive a selected amount of barring down of only the very large blocks of rock, which might otherwise have posed a risk to the rockfall protection structures, was undertaken to eliminate rockfalls from the man-made cuttings below the level of the catch fences.
- Extensive barring down over the full length of the drive of all loose rock, the installation of grouted steel bars to pin back any remaining potentially unstable blocks, and the application of pigmented shotcrete with or without galvanised mesh over friable areas, was done.

Abseilers Barring Down and Shotcreting

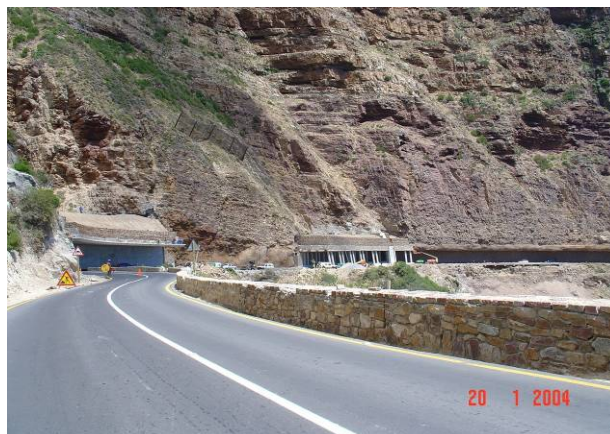
Photo of Road Showing Cantilever Canopy Propped Canopy and Half Tunnel

A 180 metre long section of the CPD traverses an area where sheer cliffs result in some of the highest energies and most frequent rockfalls. Both catch fences and concrete canopies would require frequent maintenance at this location and could even be prone to severe damage from time to time. For this section a 6 metre wide by 6 metre high slot or half tunnel has been excavated into the base of the sandstone cliffs to accommodate a new road alignment. Given the prevailing rock conditions, this structure requires to be supported by way of 95 tonne upwardly inclined rock anchors, up to 18 metres long.

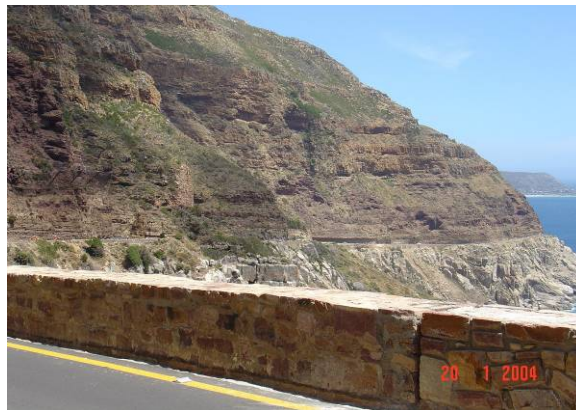
Many of the original rock-packed retaining walls along the route showed signs of distress and these had to be reinforced by innovative means to retain their original appearance. Where shotcrete had previously been used to repair the walls, rock anchors and pigmented shotcrete were permitted by the Independent Environmentalist to resemble the adjacent sandstone and granite outcrops.

Stone Packed Retaining Walls

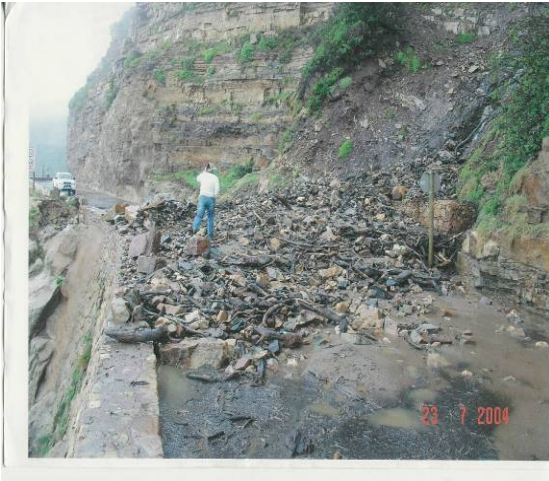
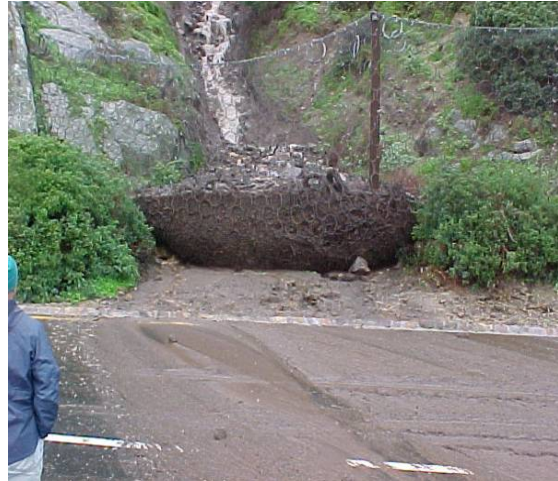
Running into the first winter of the operation, two hundred year rainfall events, in late July early August 2004, triggered massive debris flows and rockfalls damaging several catch fences, which were stressed beyond their limits, and dumped hundreds of tonnes of material across the road. Fortunately our operators took note of the intensity of the rainfall and initiated the closure of the road before the rockfall started. Damage was severe and closure continued for 55 days while repairs were effected.

Photos of Rockfall and Damaged Fences
