ON THE SIGNIFICANCE OF STRATIGRAPHY
IN THE PREDICTION OF THE ENGINEERING BEHAVIOUR OF
SOILS AND ROCKS IN SOUTHERN AFRICA

Submitted in partial fulfilment of the
requirements for the degree of
Doctor of Science in the Faculty of Science,
University of Pretoria

May, 1977

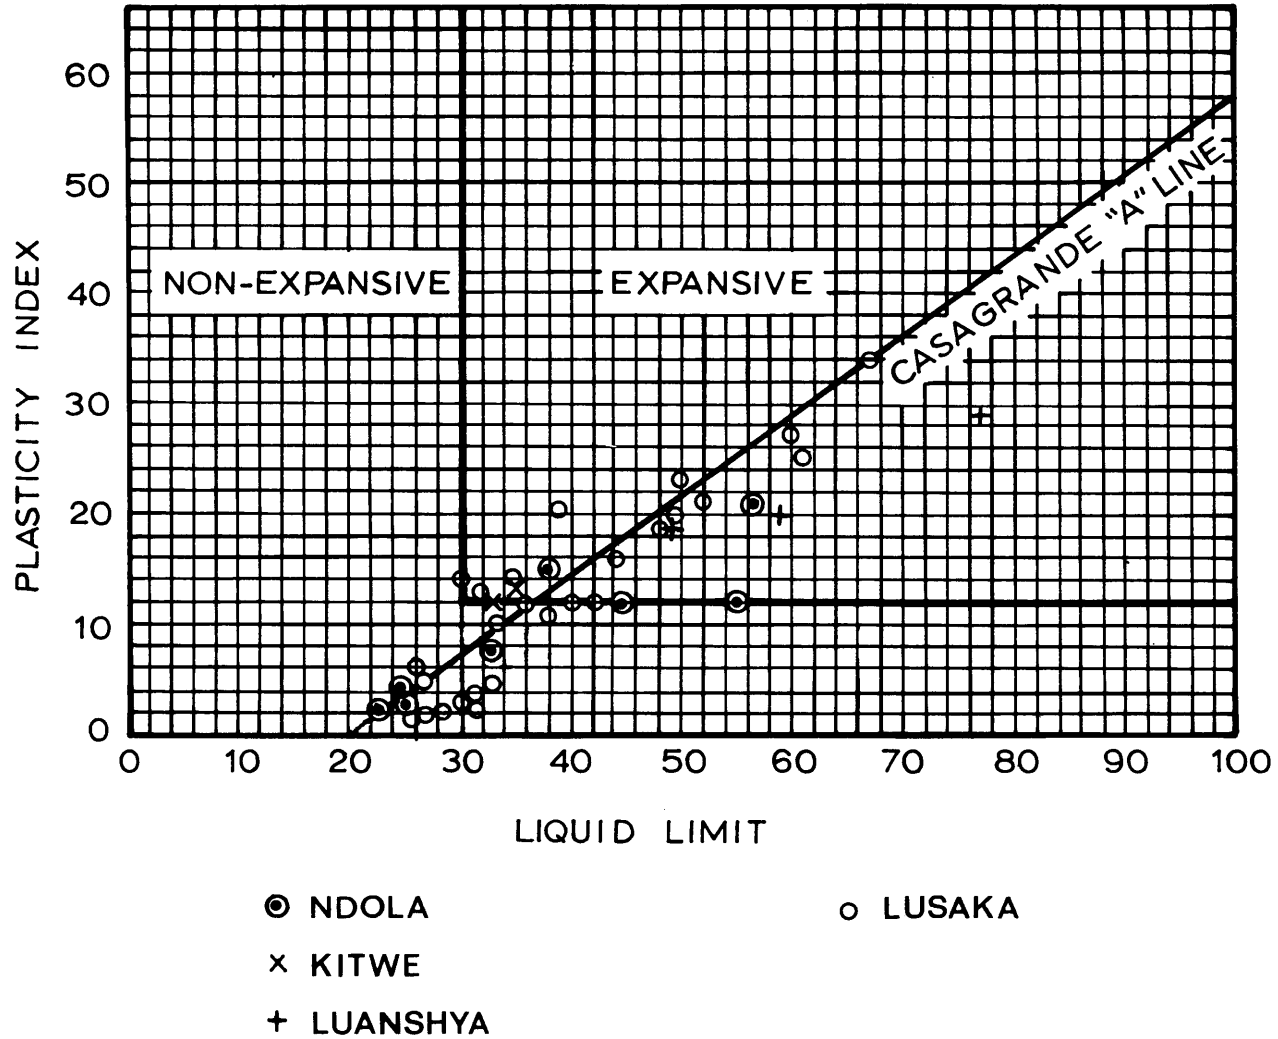
FIGURE 2/5 Atterberg Limit plots for samples of residual mica schist in Zambia from depths between 3 metres and 10 metres
 (After Kantey and Brink, 1952)

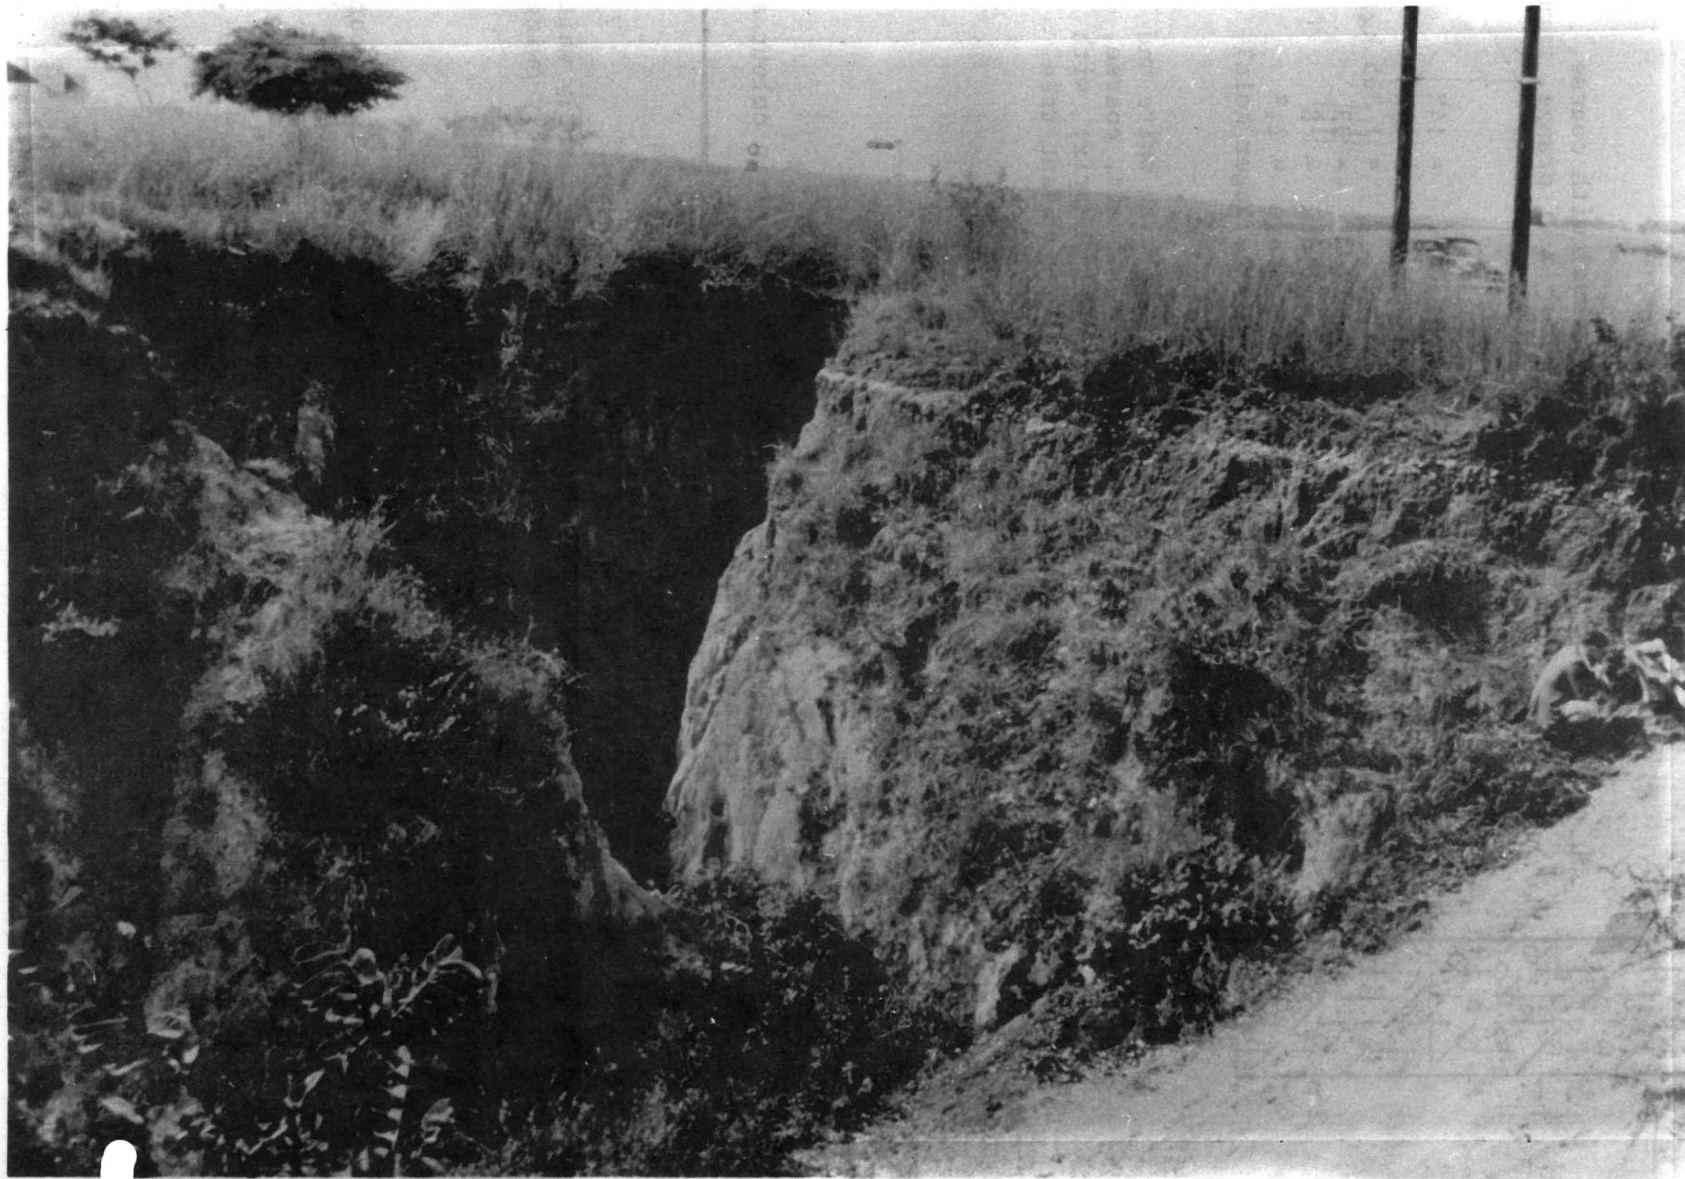
FIGURE 3/7 : *Donga in residual granite near White River water tower, showing biotic stone line*

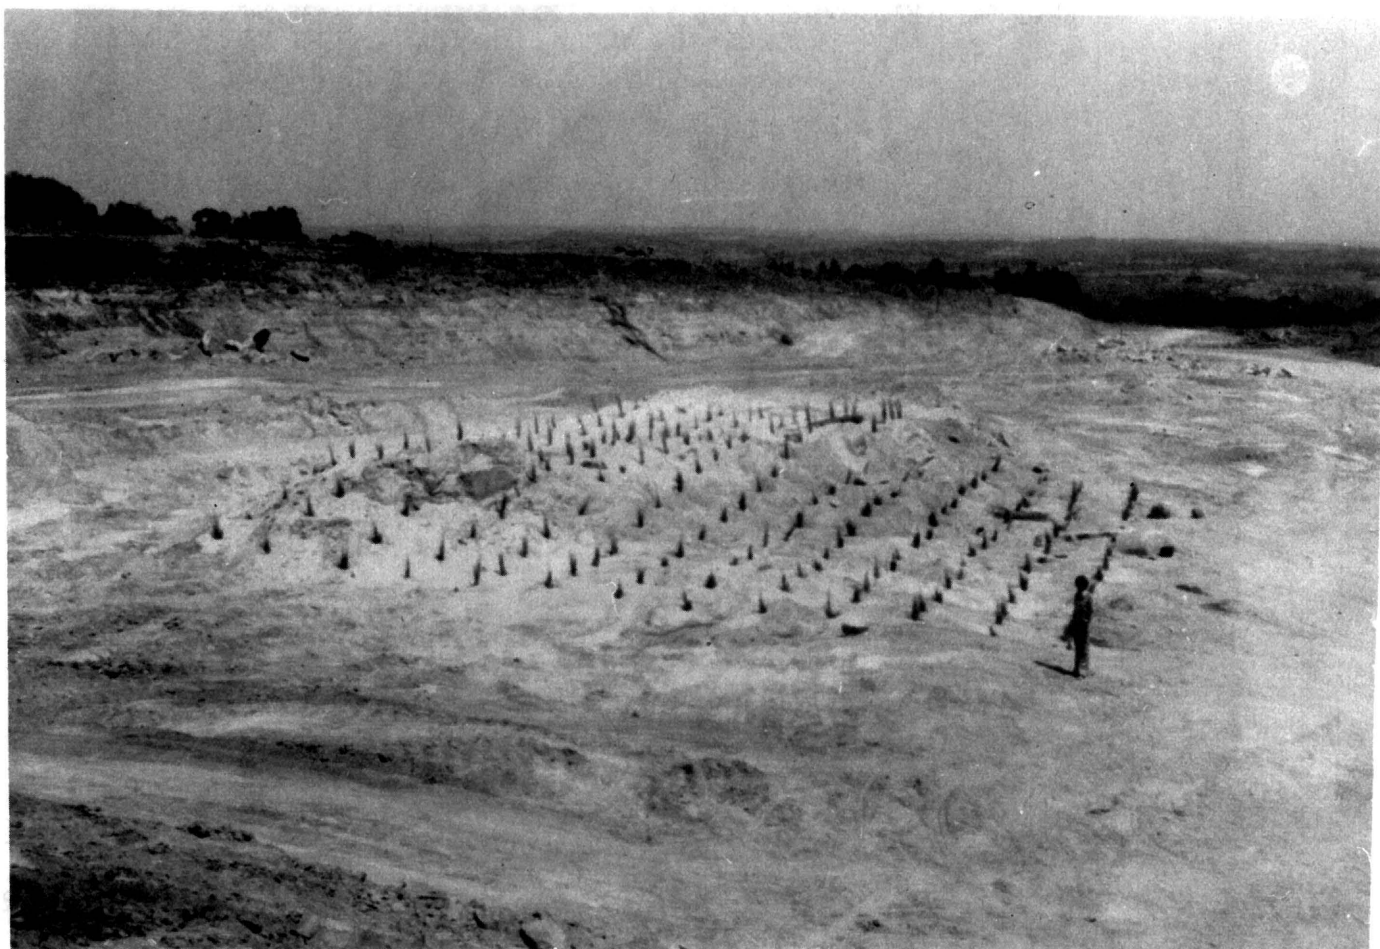
*FIGURE 3/15 : Excavation for part of Johannesburg Western Bypass
(Road N 1-20) showing core-stone-within residual granite*

The core-stone has been pre-drilled ready for blasting

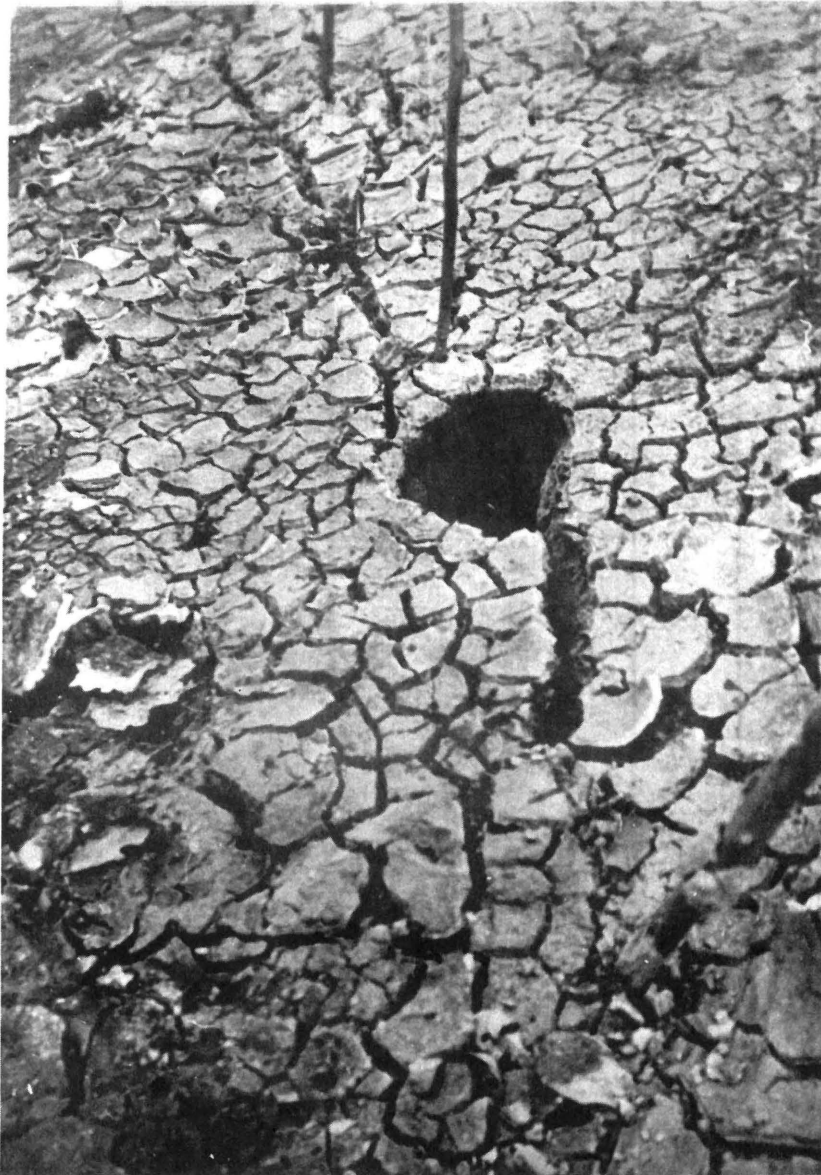
FIGURE 3/20 : Small 'sinkhole' in floor of Westphalia Leidam

The failure of the dam may be ascribed to two related processes: collapse of grain structure in the saturated residual soil below the embankment, coupled with accelerated suffosion resulting from the introduction of an artificial hydraulic gradient.

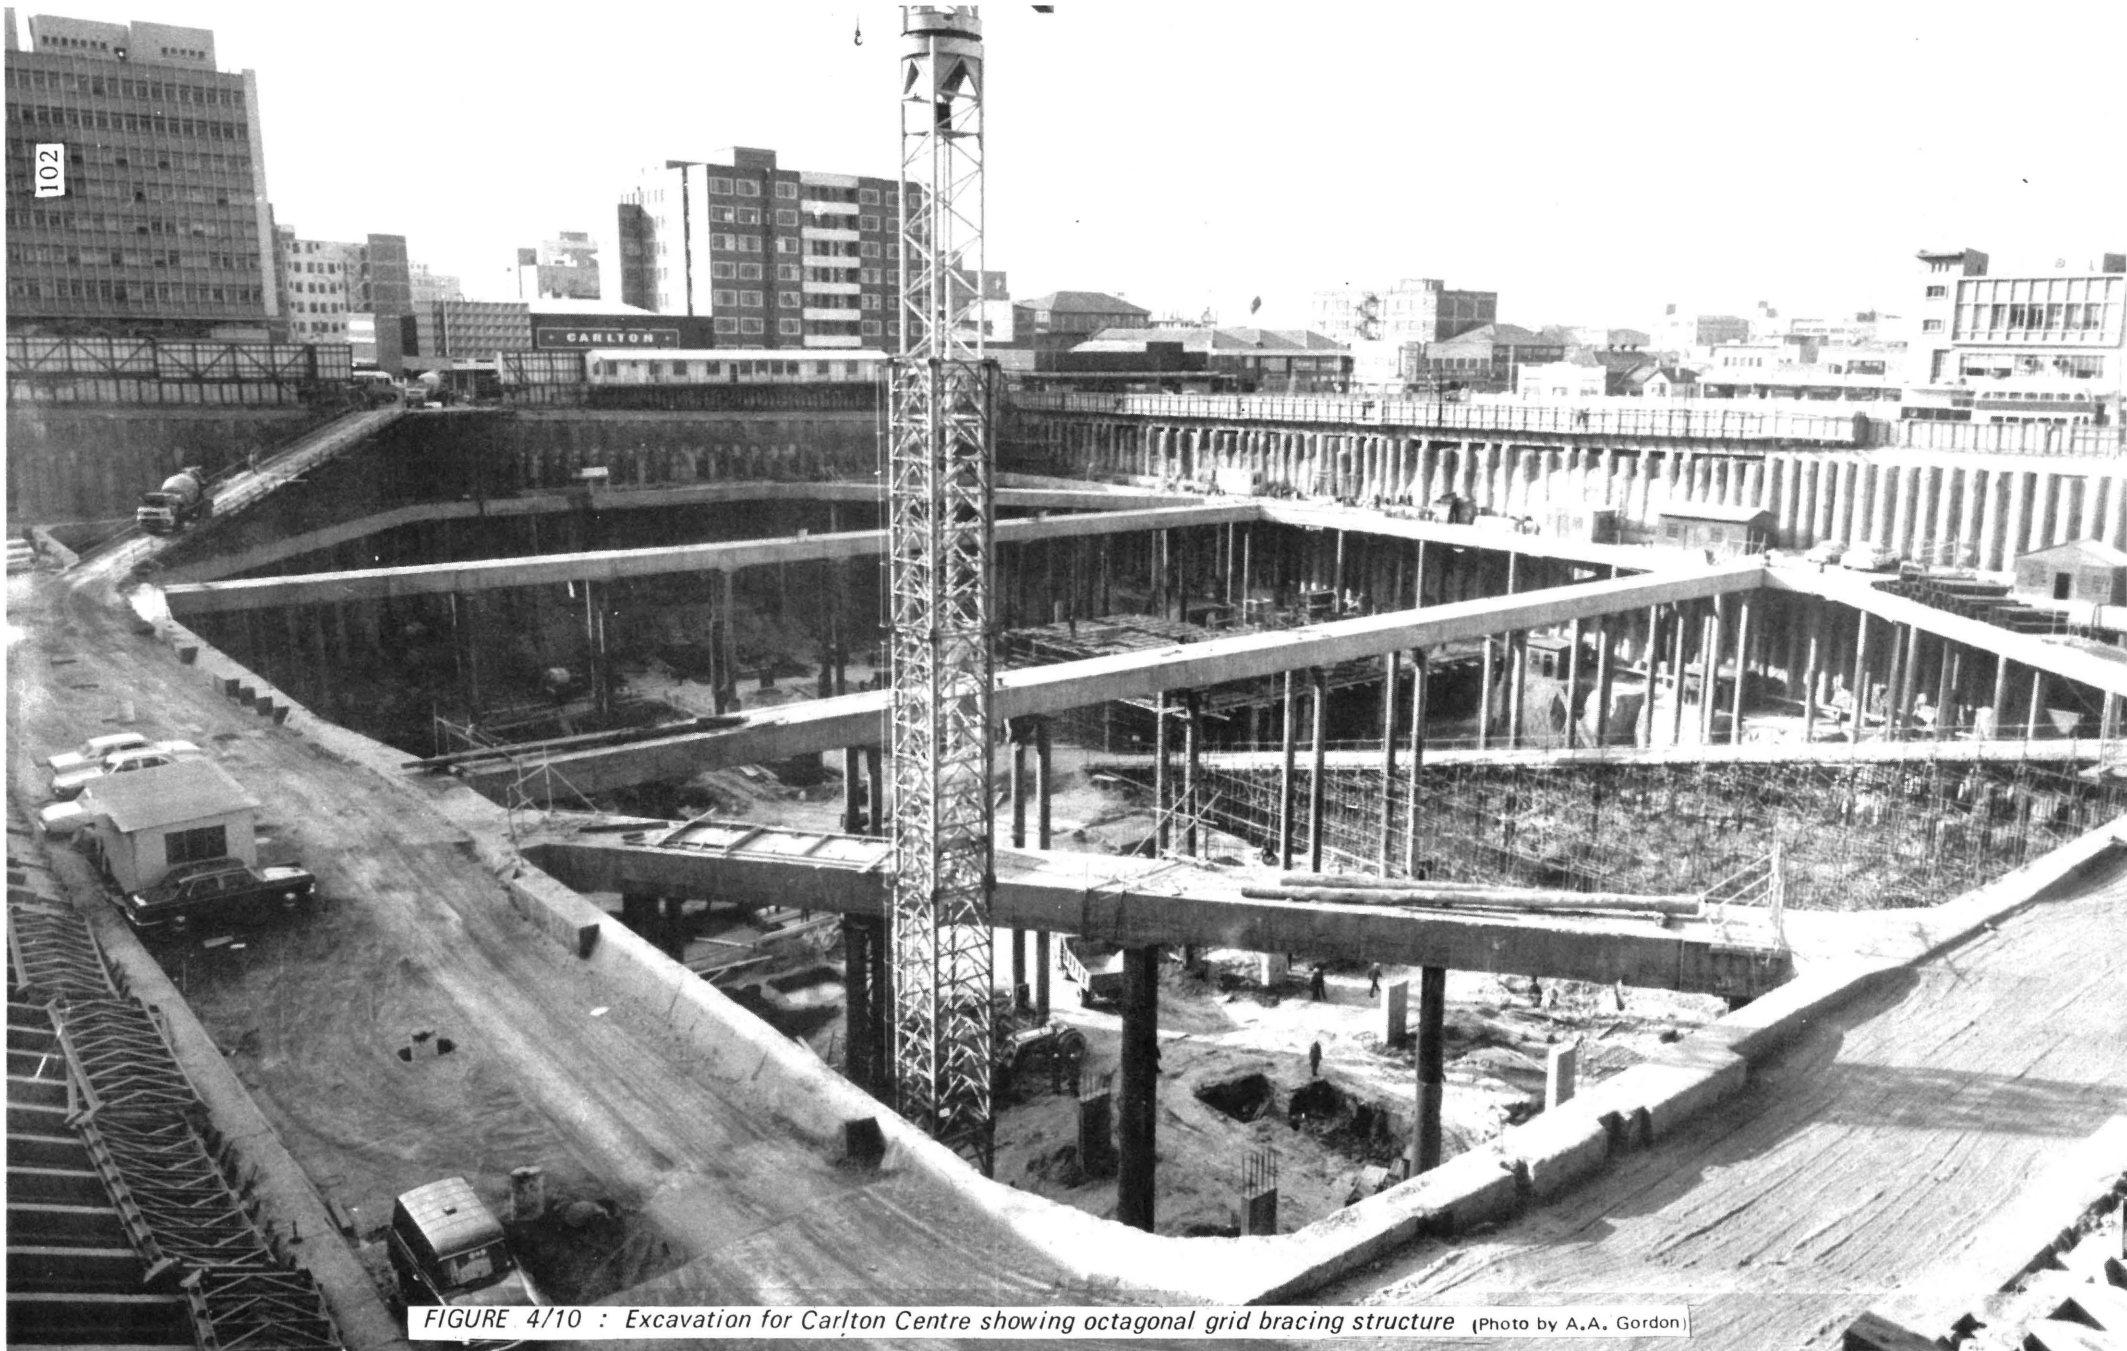
FIGURE 4/10 : Excavation for Carlton Centre showing octagonal grid bracing structure (Photo by A.A. Gordon)

The construction sequence was as follows (Isaacs and Heydenrych, 1967; Heydenrych and De Beer, 1975):

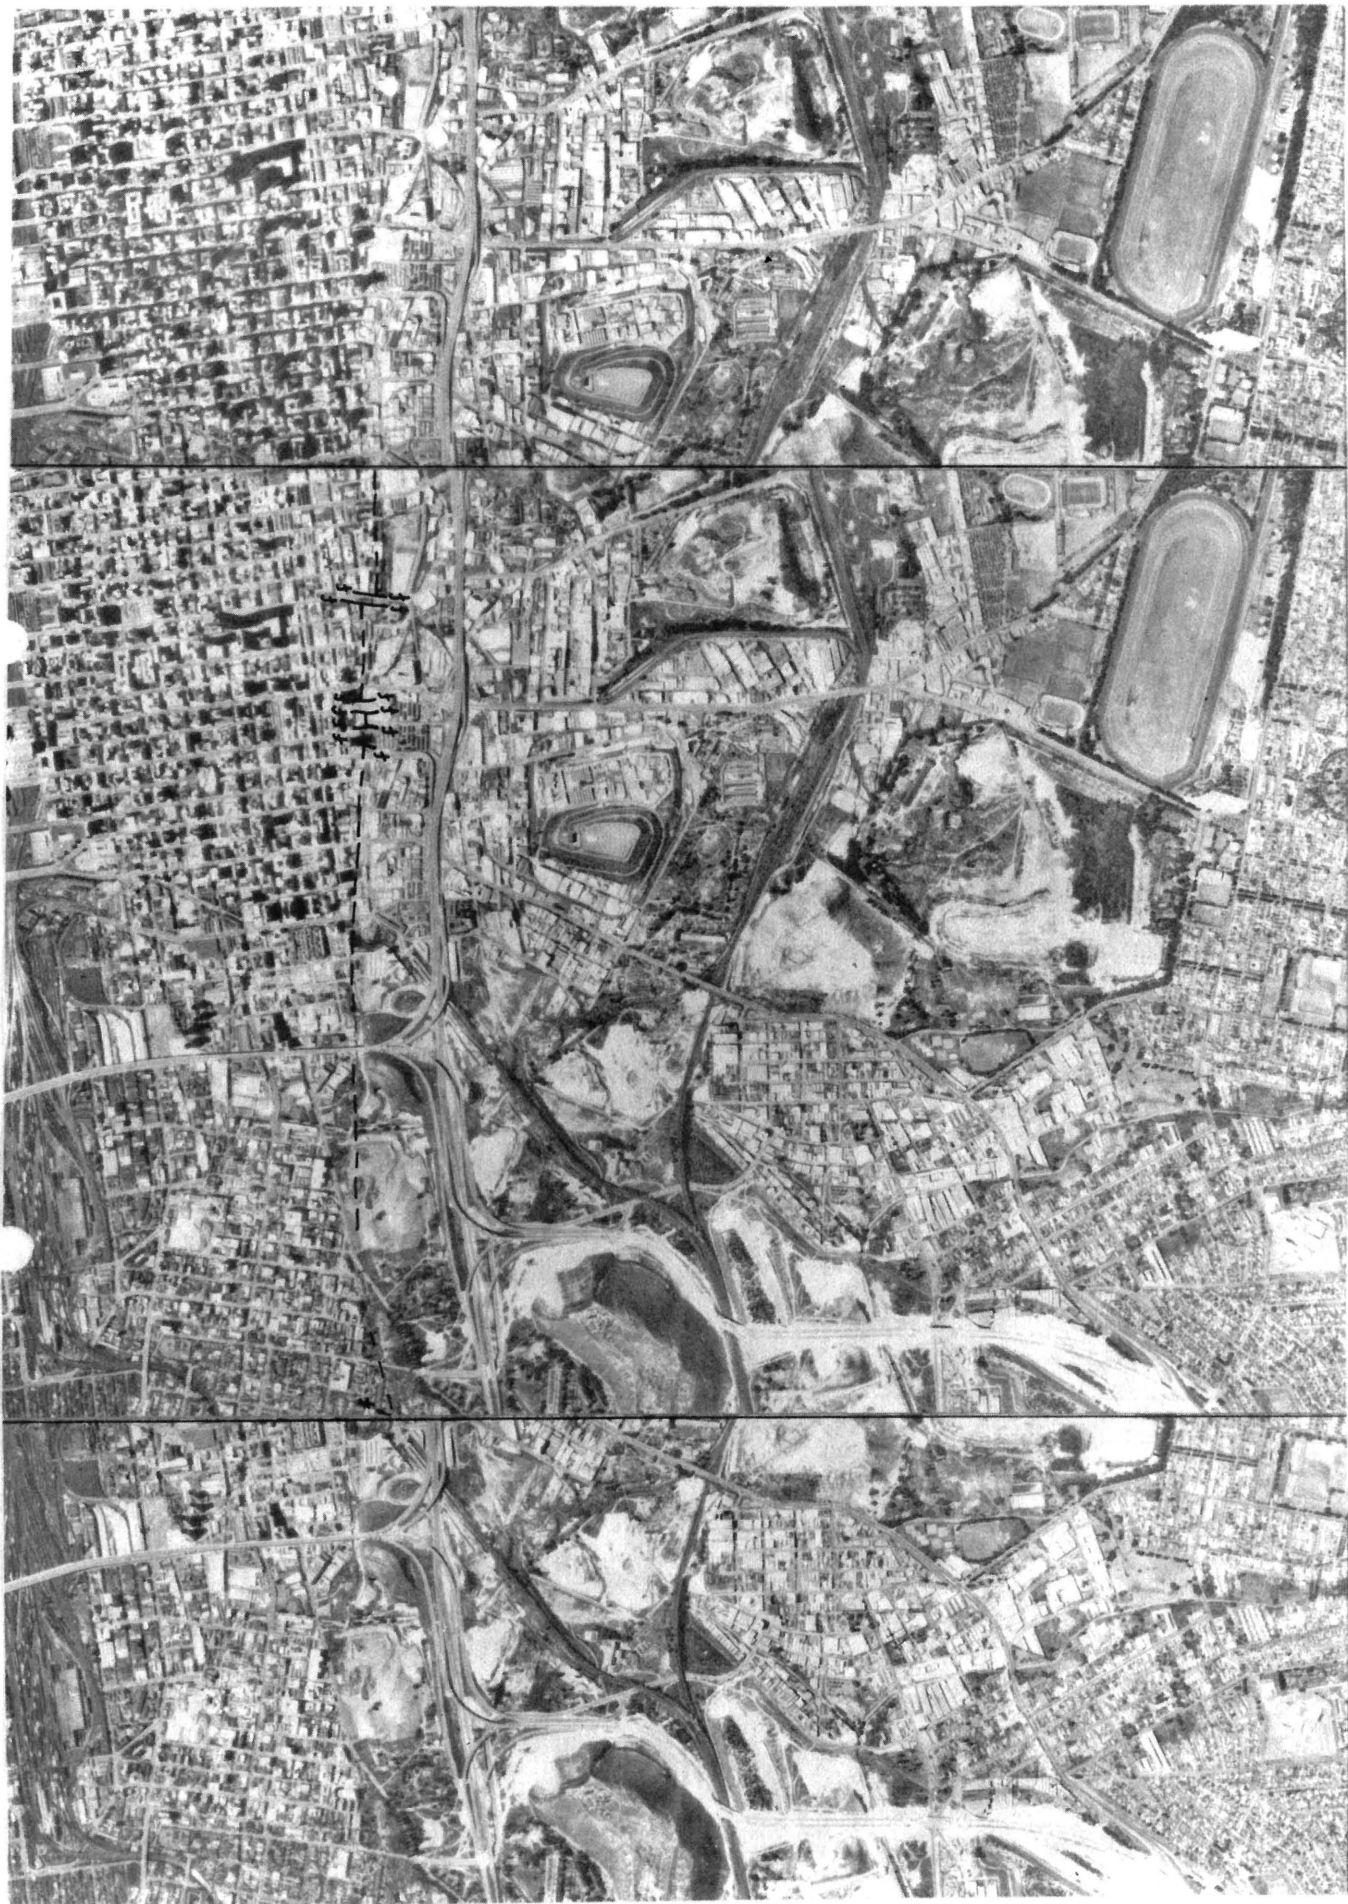
FIGURE 5/4 : Stereo-triplet of aerial photographs from Treu Road in the west to Mooi Street in the east showing Main Reef outcrop

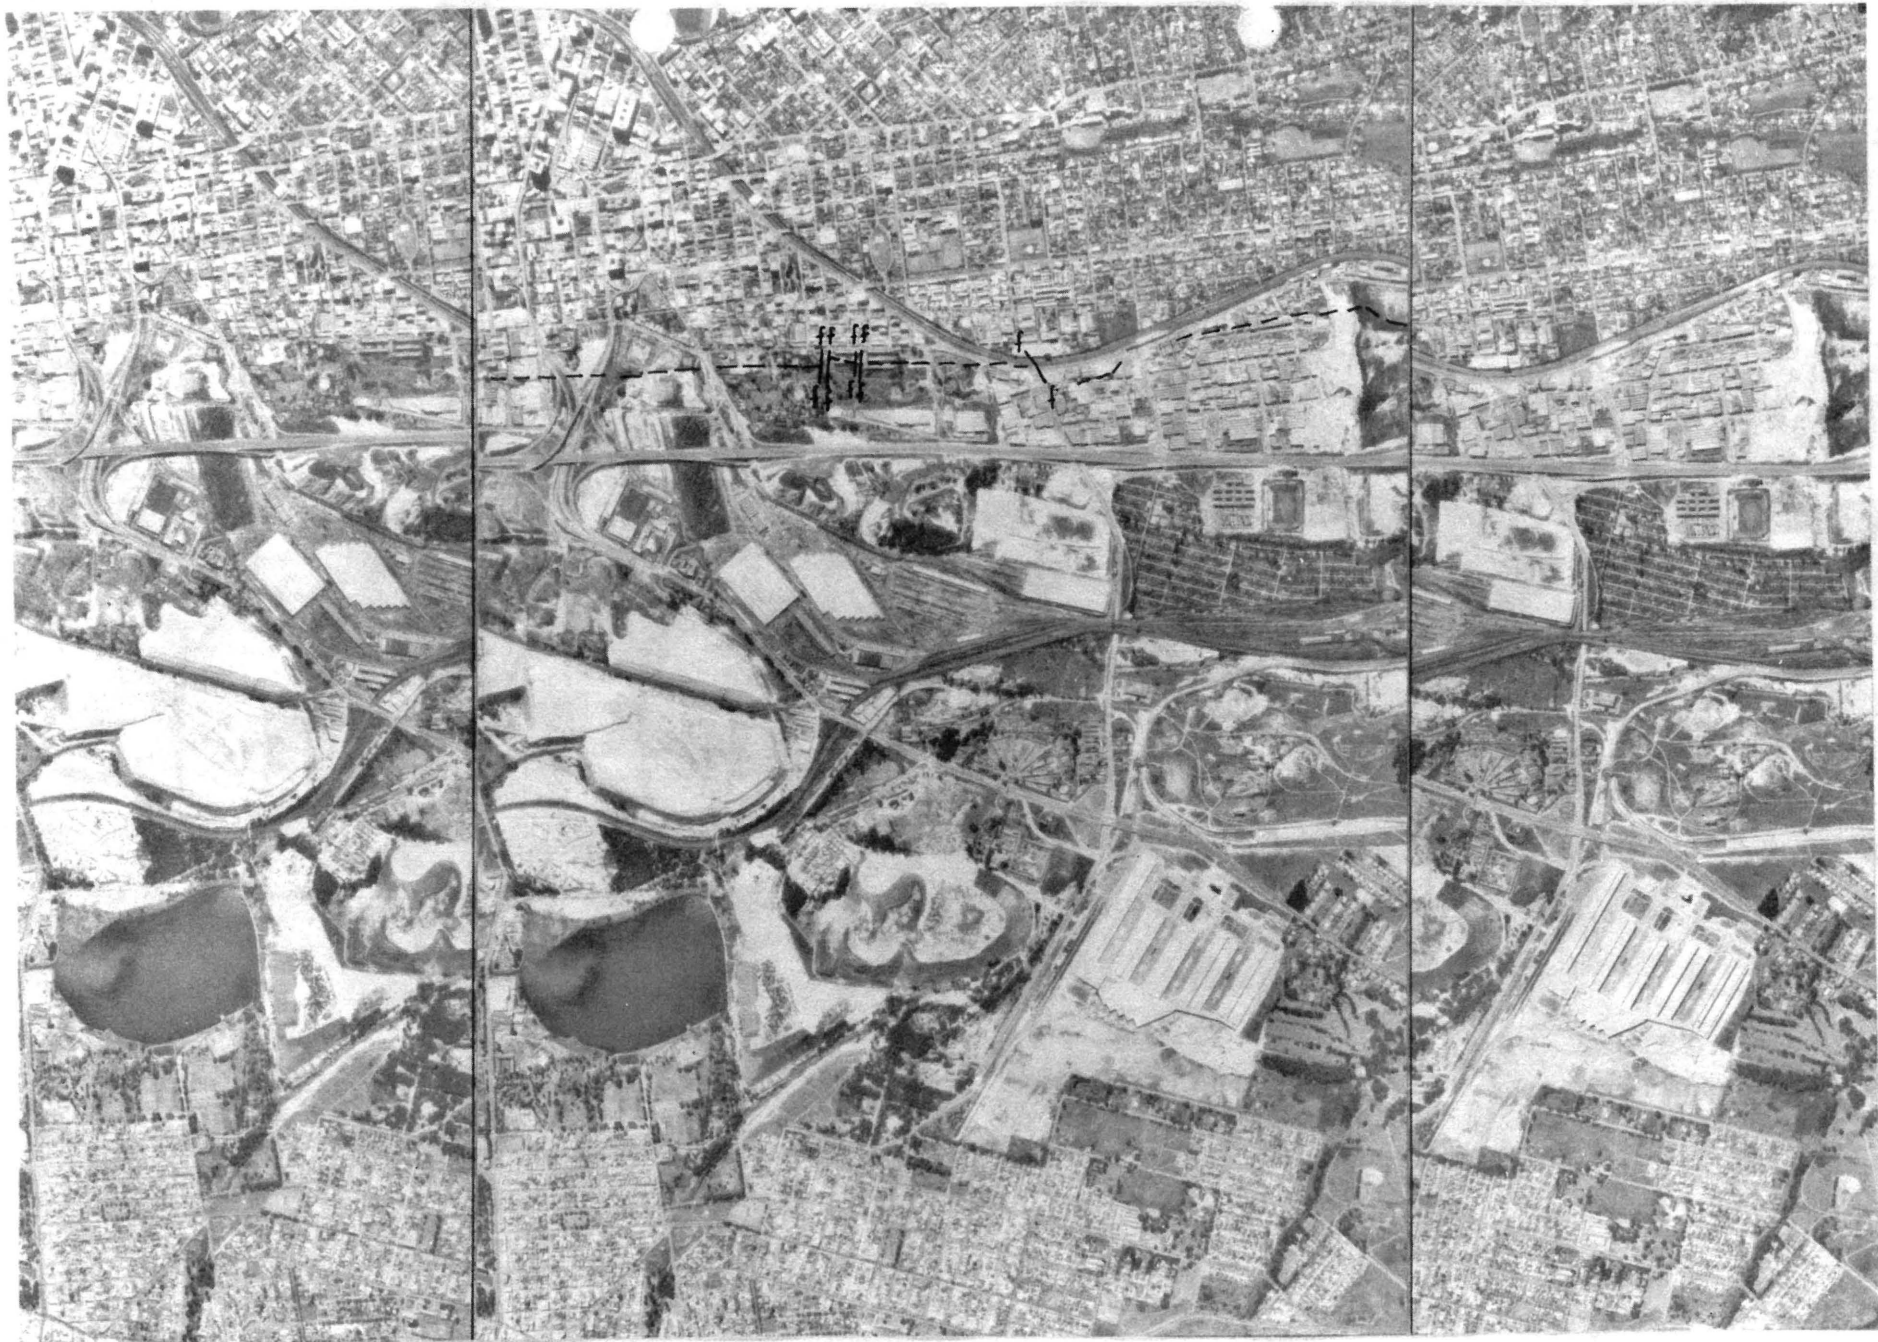
FIGURE 5/5 : Stereo-triplet of aerial photographs from Mooi Street in the west to Pentz Street in the east showing Main Reef outcrop

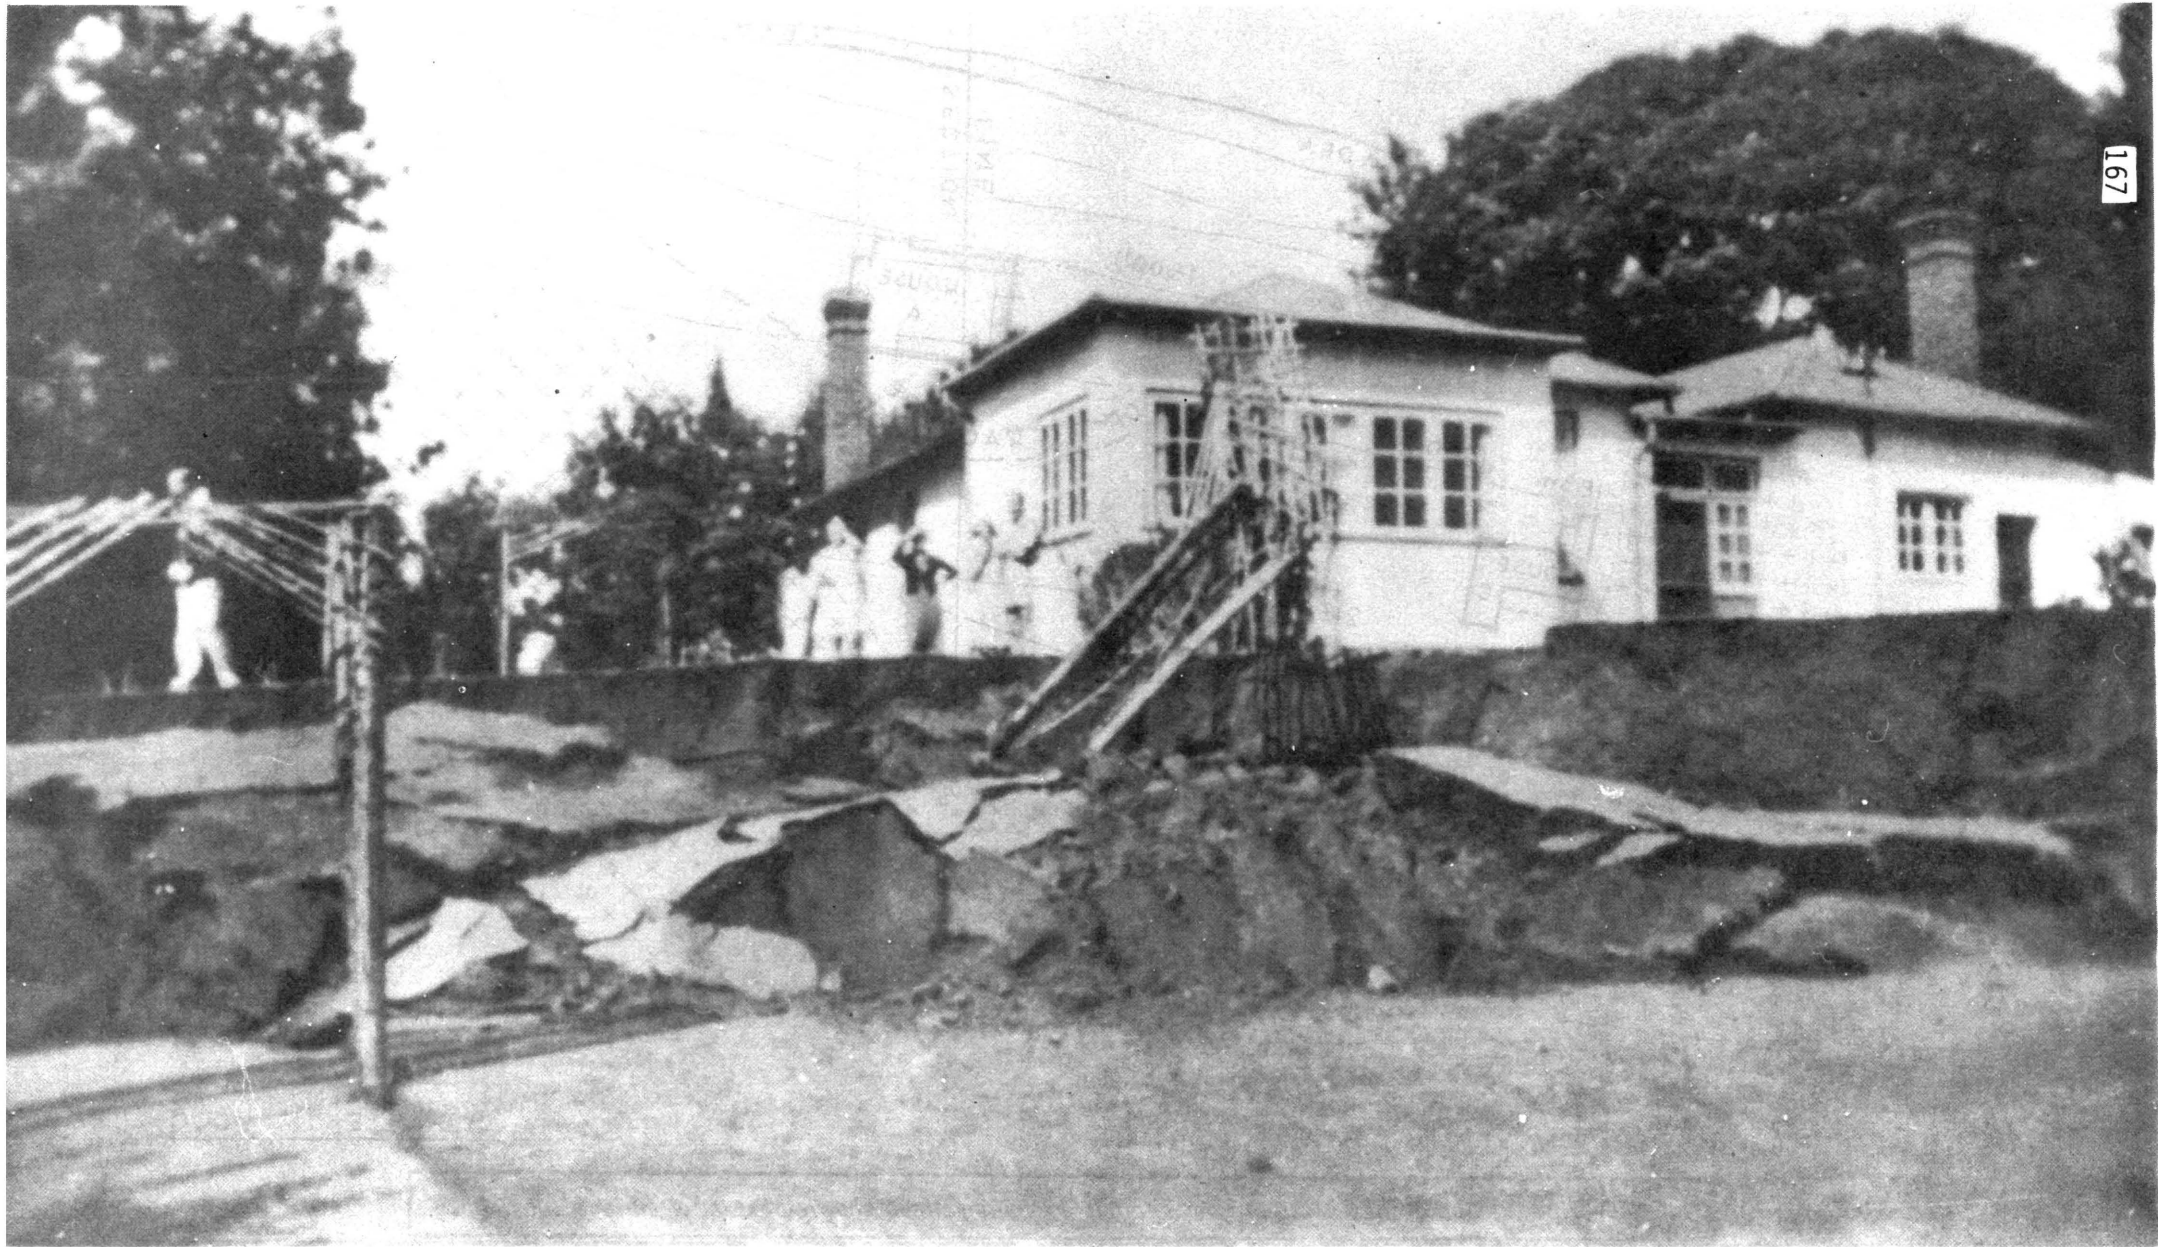
FIGURE 5/39 : 'House B' at Nourse Mines photographed from the north after the subsidence of 3rd May 1942 showing the line of fracture

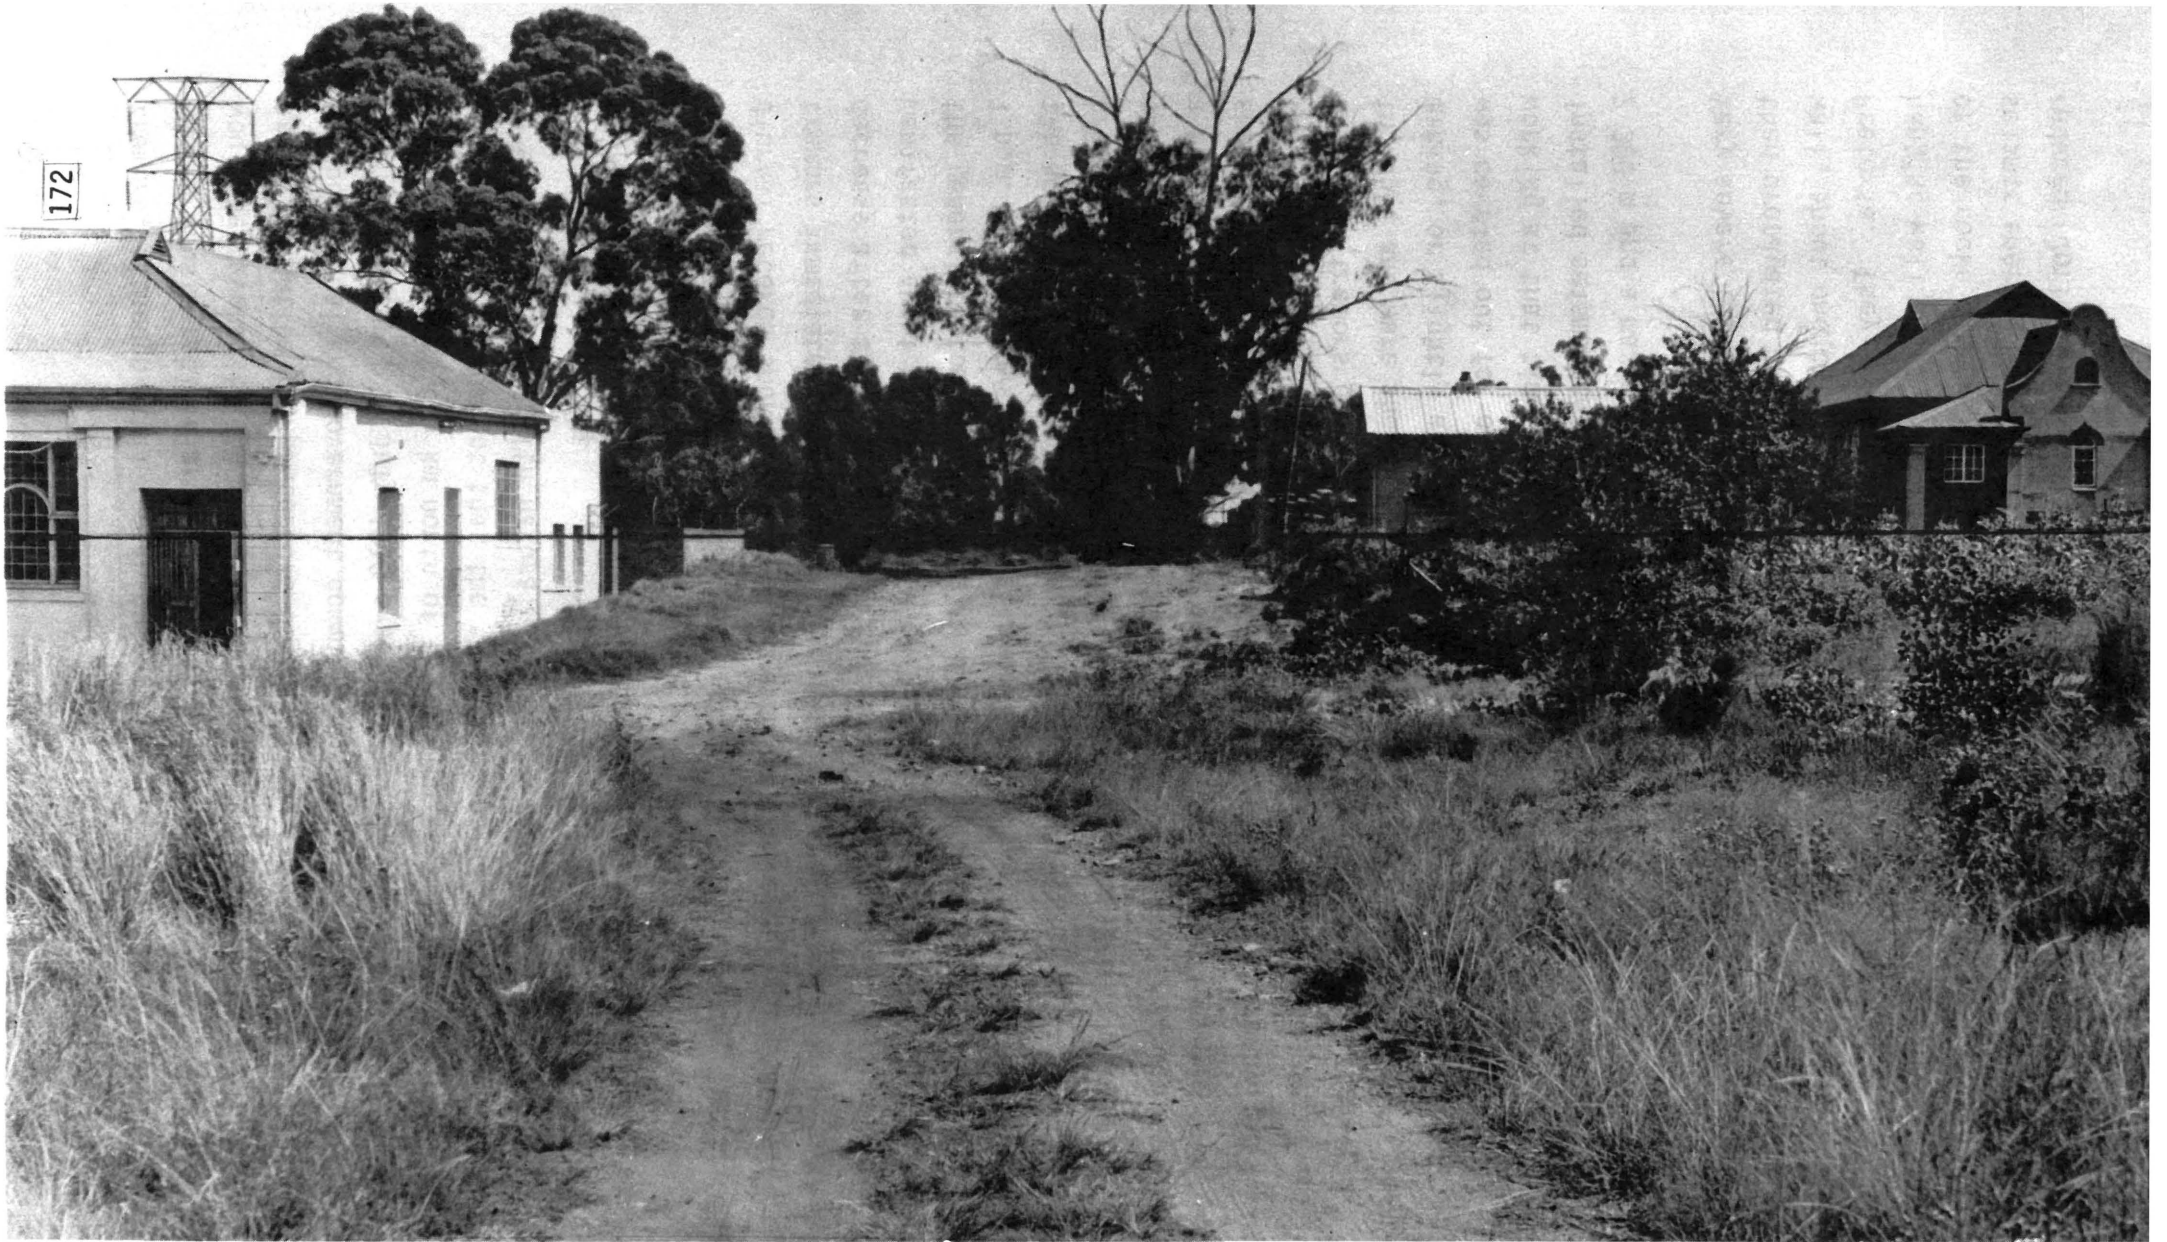
FIGURE 5/43 : Two old mine houses in Cleveland, Johannesburg : house 'A' on the right is situated on the dyke while house 'B' on the left is just off the dyke, the dyke running behind the house ; the amount of subsidence can be judged by the difference in ground level between the two houses, house 'A' being situated at original ground level as indicated by horizontal line.

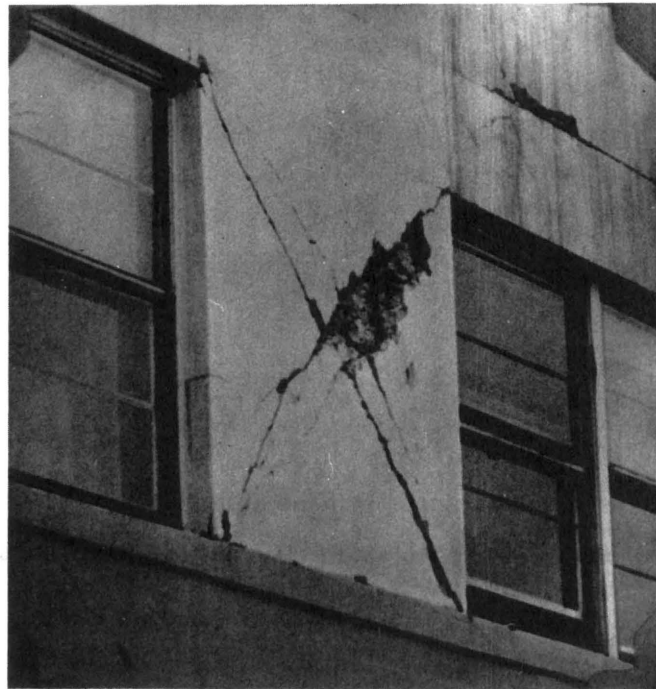
FIGURE 5/46 : Typical example of X-cracking induced by seismic waves in panel within beam and column frame : building in Anchorage, after earthquake of 27.3.1964

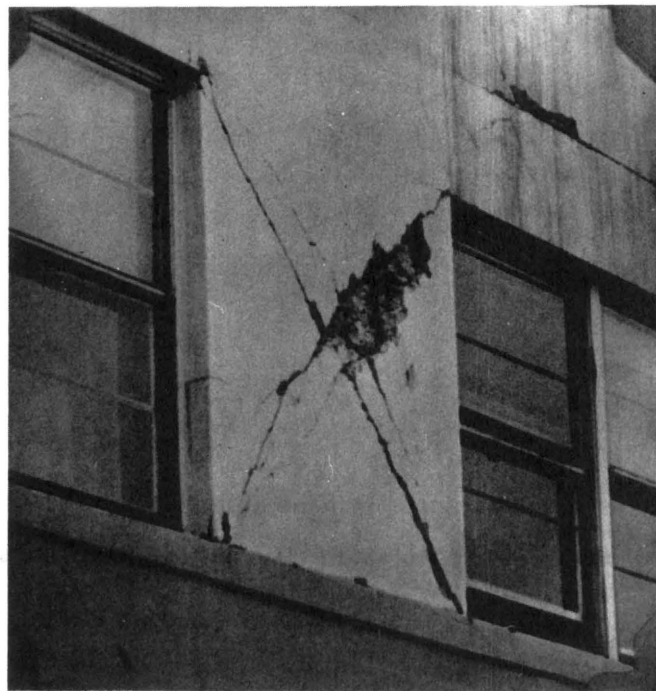
FIGURE 5/46 : Typical example of X-cracking induced by seismic waves in panel within beam and column frame ; building in Anchorage, after earthquake of 27.3.1964

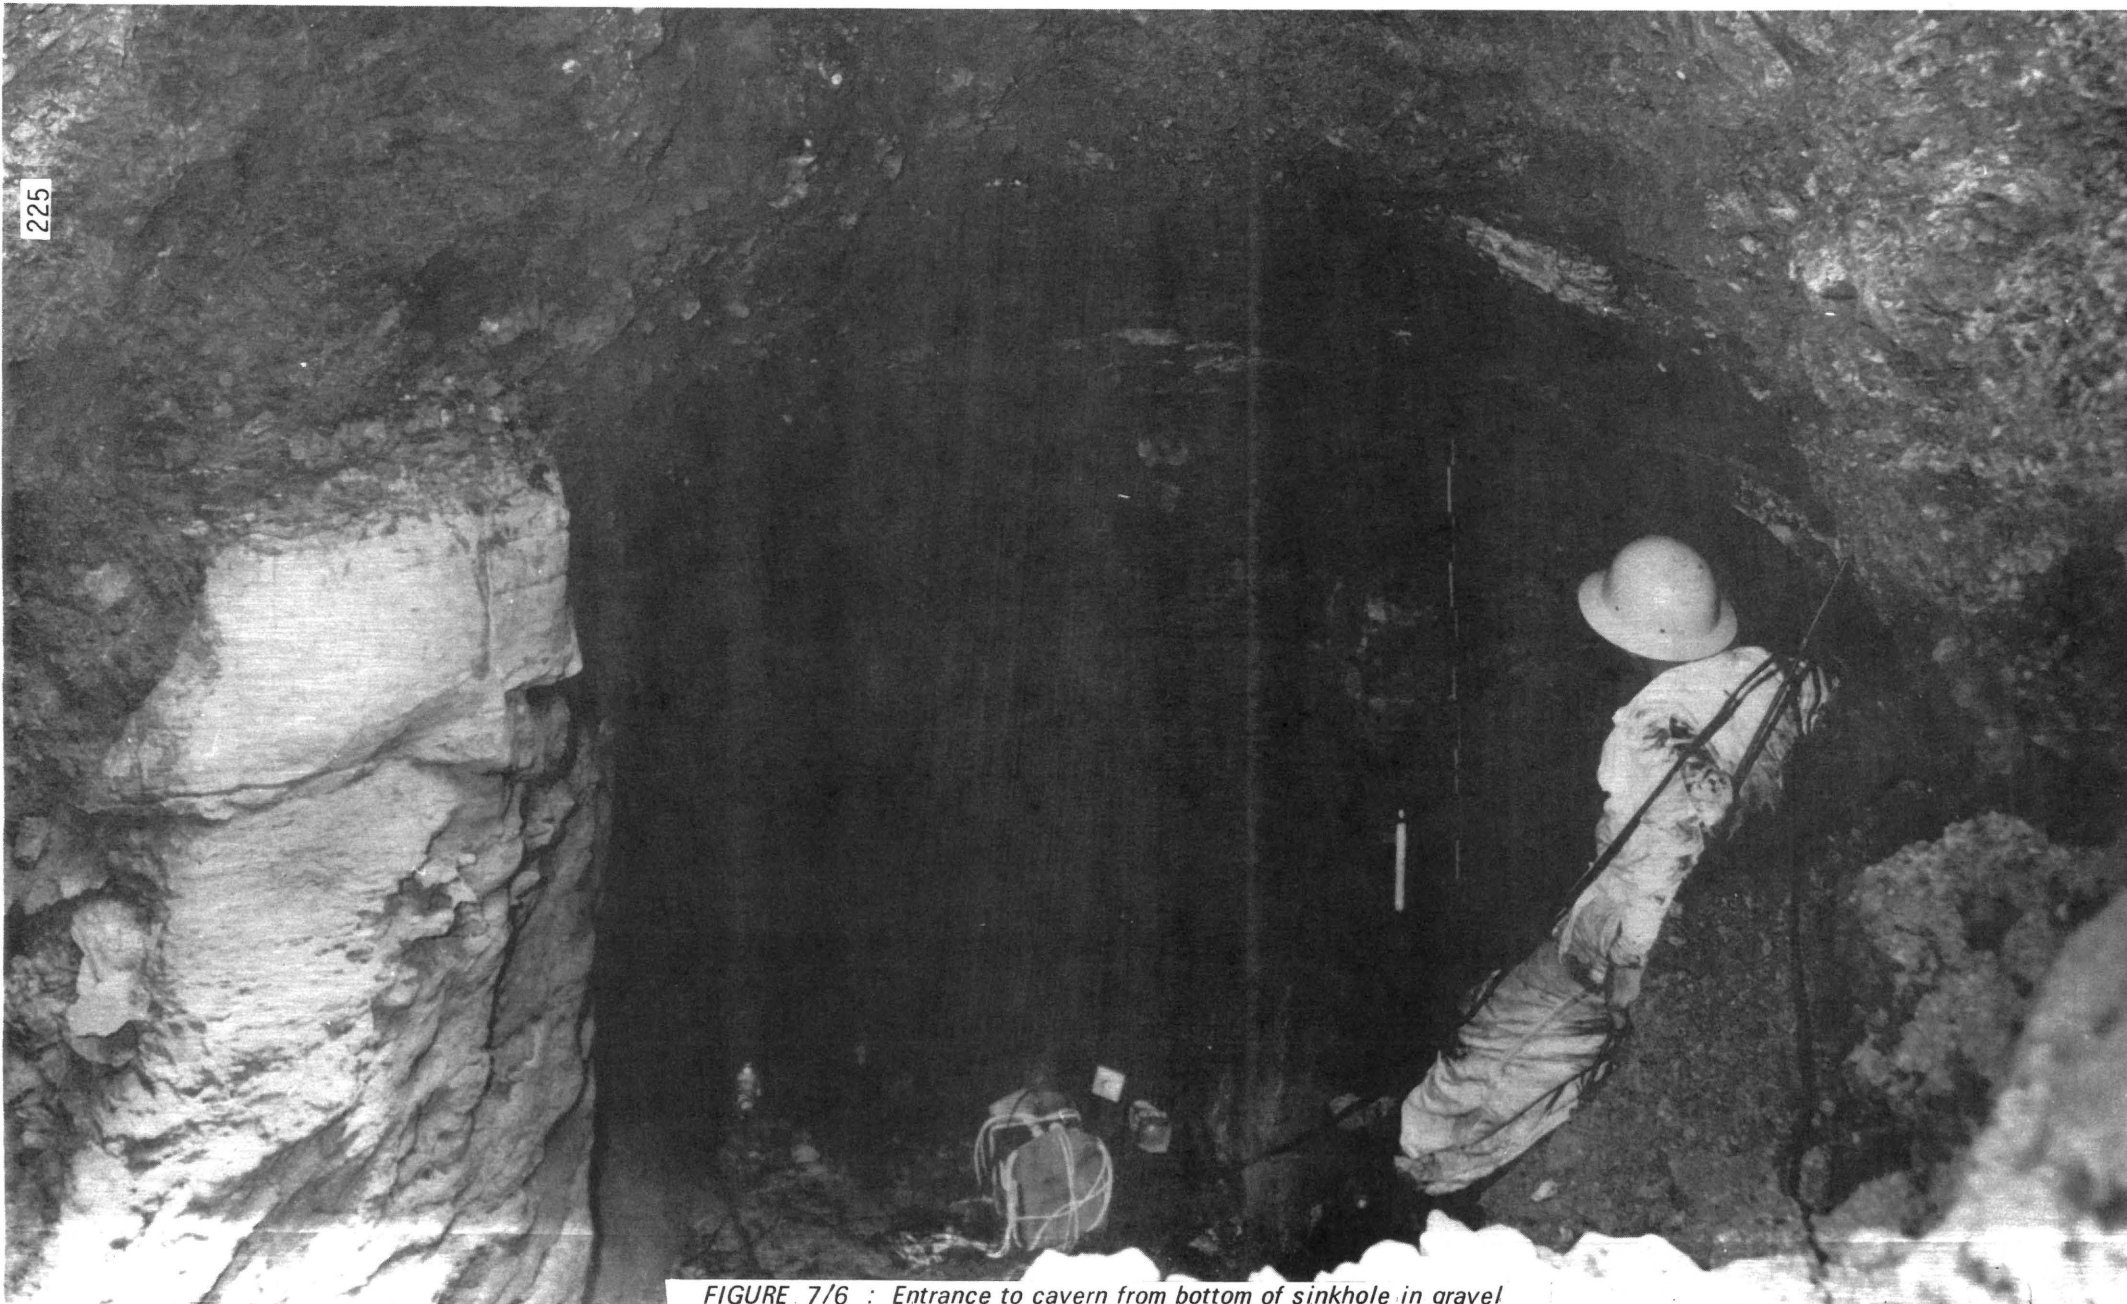
FIGURE 7/6 : Entrance to cavern from bottom of sinkhole in gravel pit next to Johannesburg –Durban Road, 20 km north-west of Heidelberg
