ON THE SIGNIFICANCE OF STRATIGRAPHY
IN THE PREDICTION OF THE ENGINEERING BEHAVIOUR OF
SOILS AND ROCKS IN SOUTHERN AFRICA

Submitted in partial fulfilment of the
requirements for the degree of
Doctor of Science in the Faculty of Science,
University of Pretoria

May, 1977

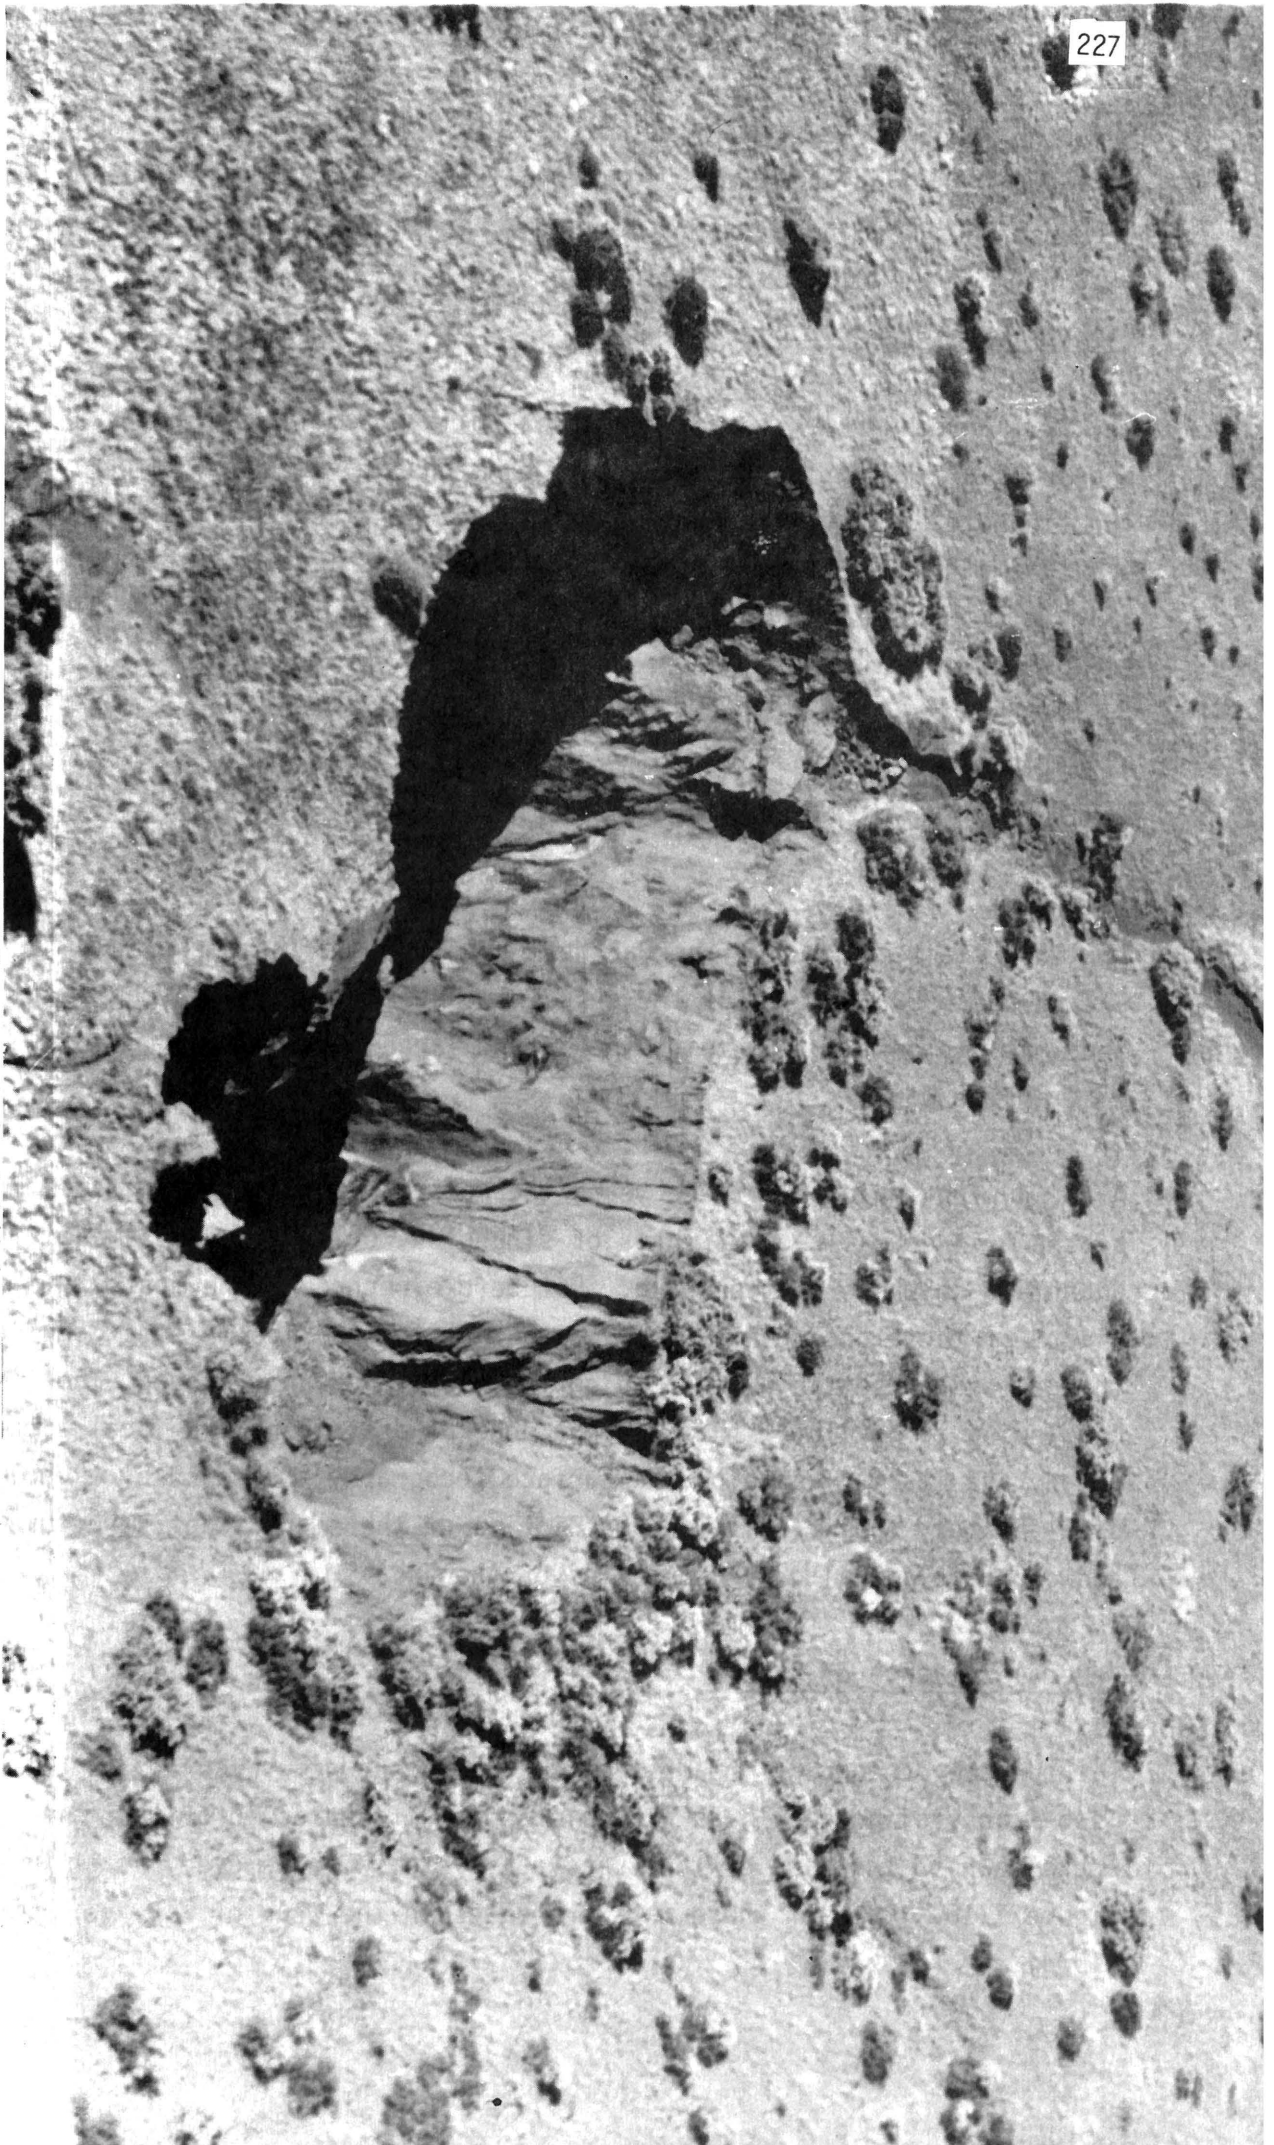
FIGURE 7/8 : *Large isolated sinkhole on the farm Vogelstruisbult near Kuruman*
Note drainage channel discharging into sinkhole at top centre of photograph

area the owner became convinced that the ground was hollow underneath, as he heard 'rumbling echoes'. The final collapse took place during a period of heavy rains when the drought broke in the summer of 1967.

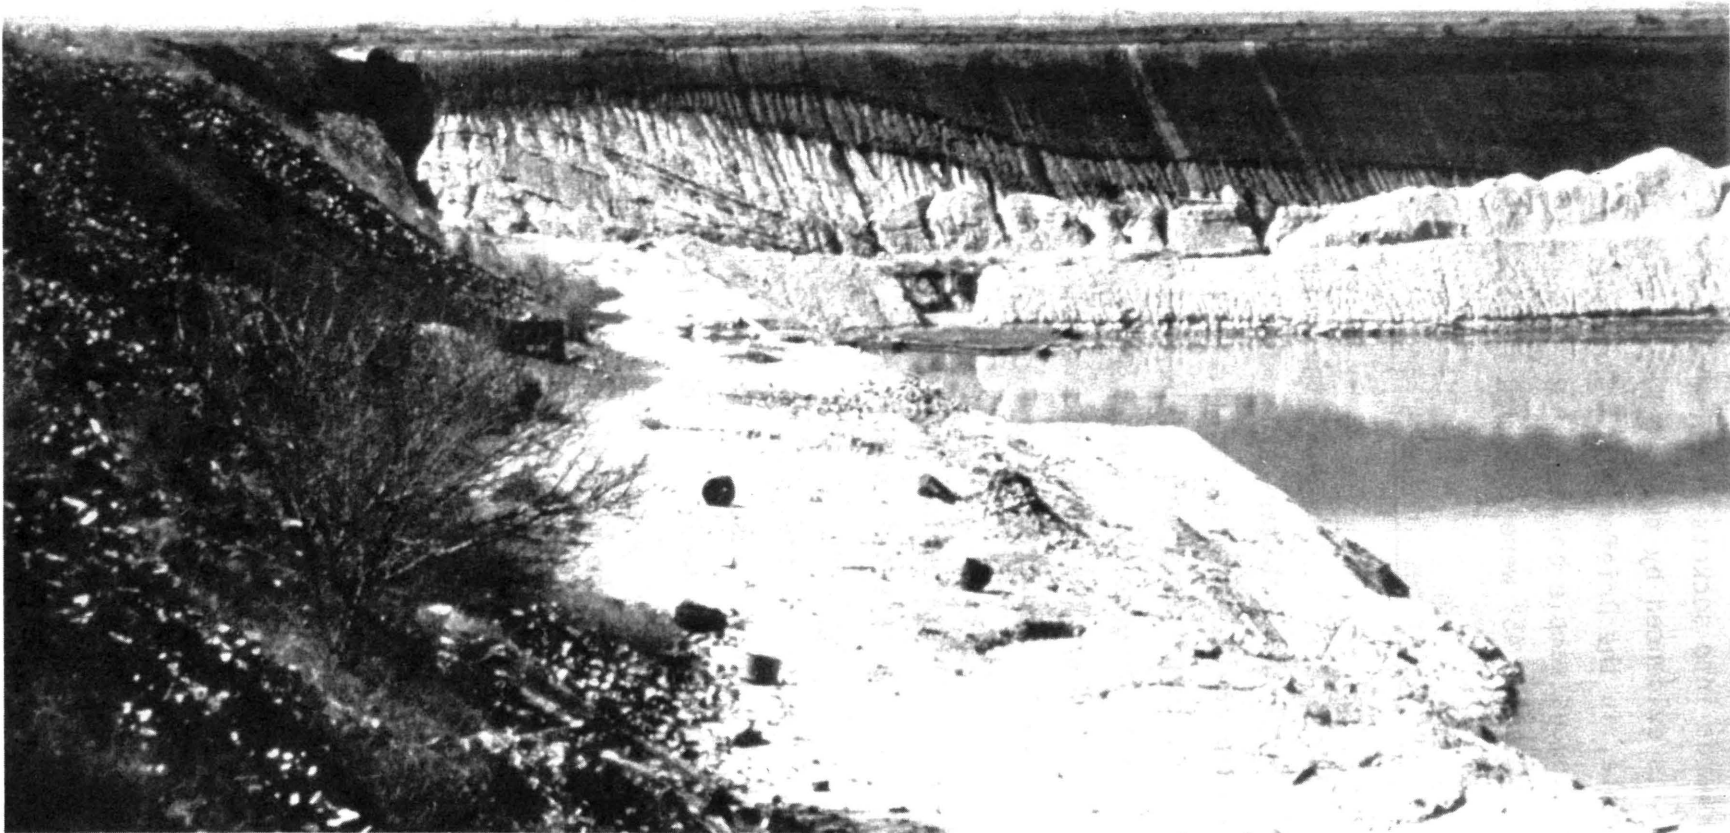
FIGURE 7/18 : Dip of strata in Karoo outlier within the Dolomite Series at Driefontein Brickworks

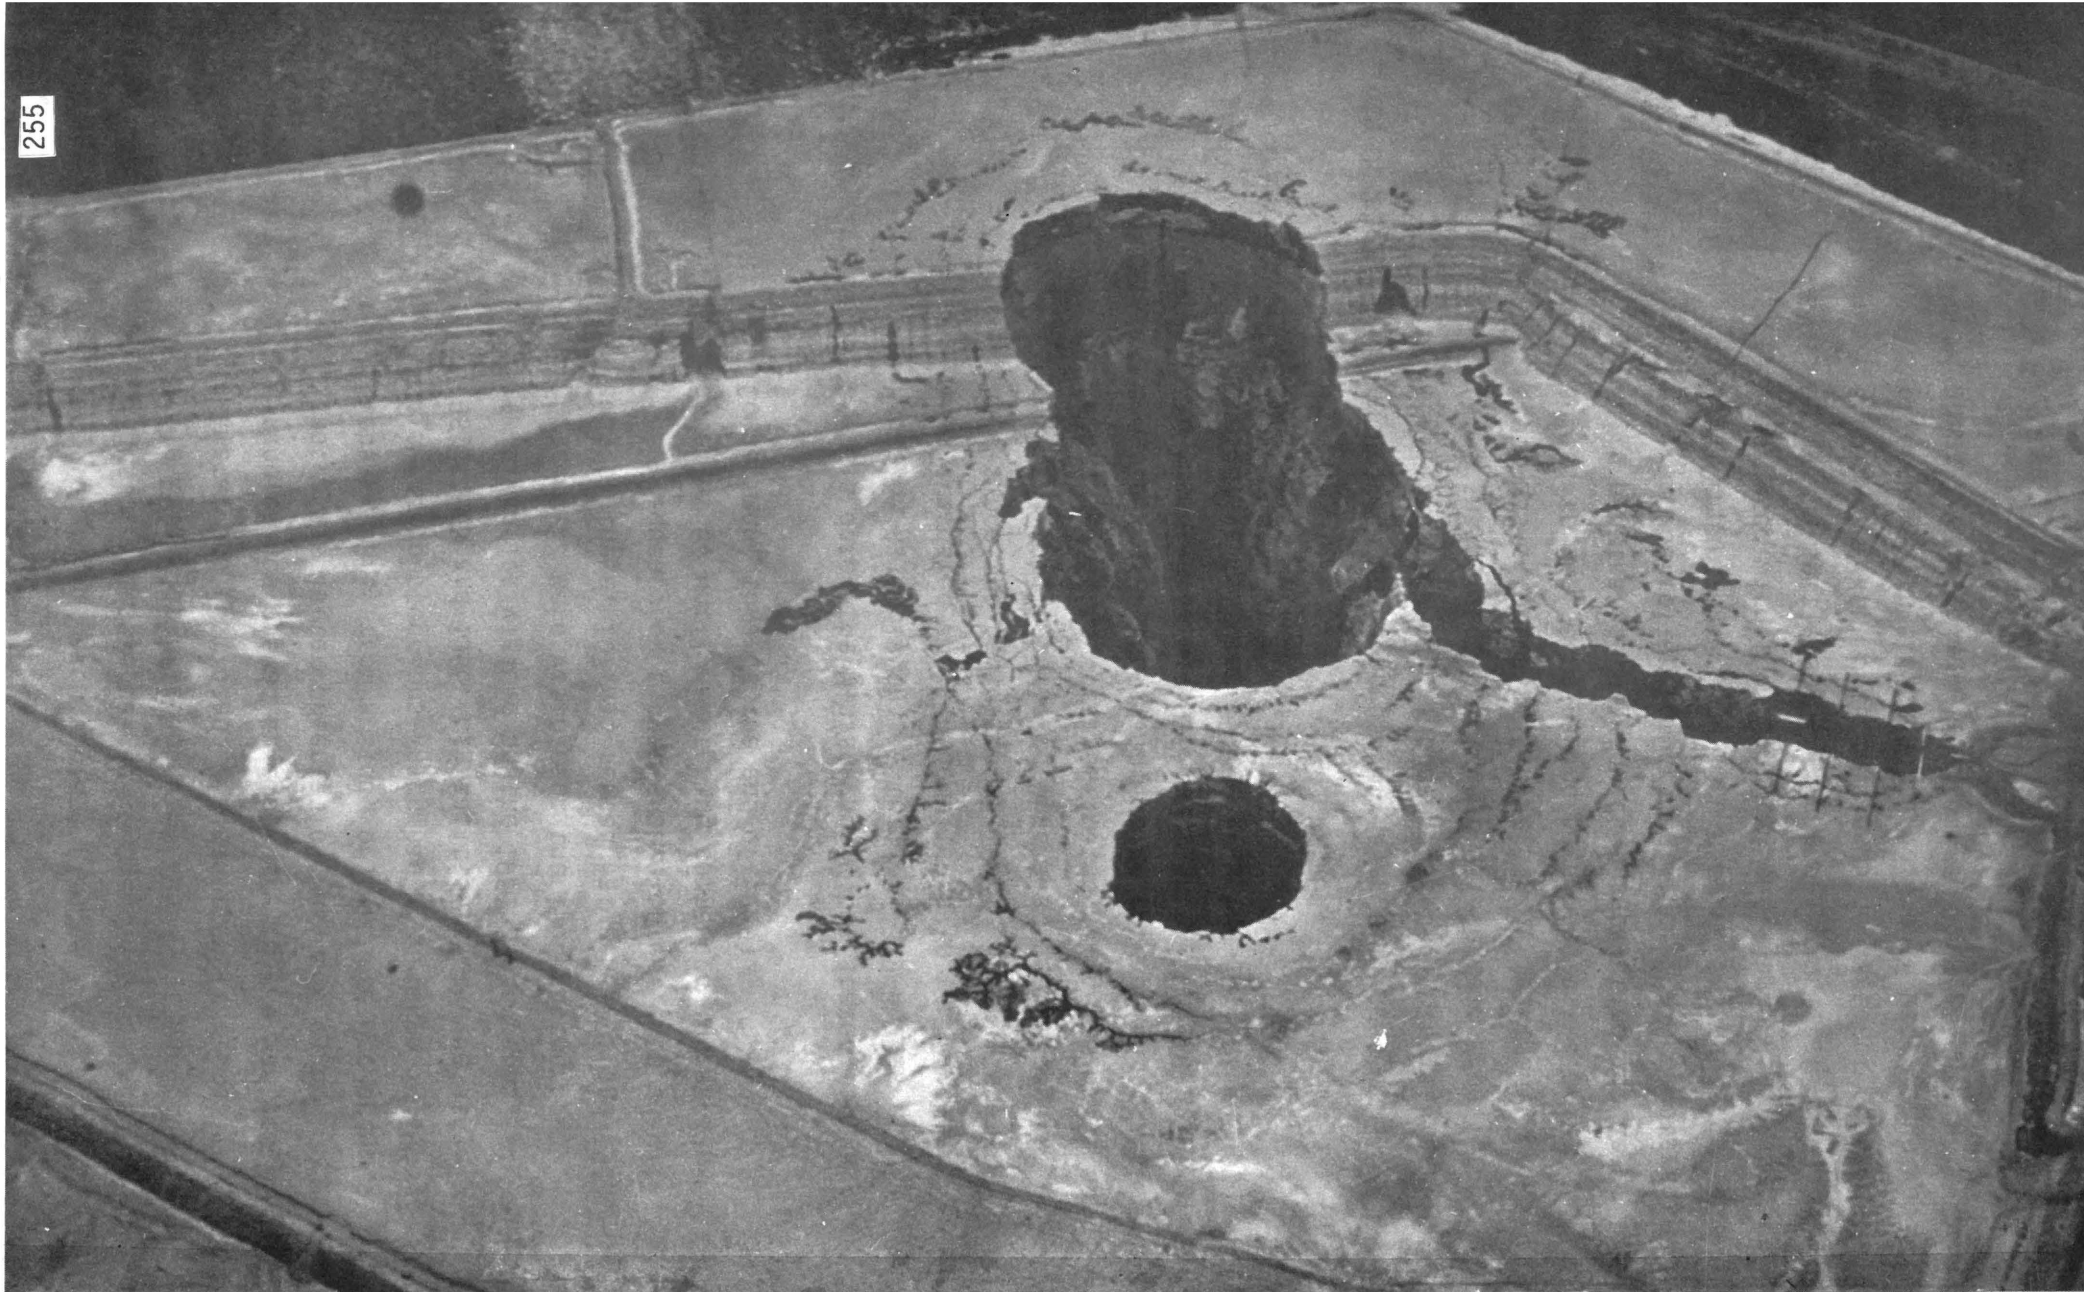
FIGURE 7/25 : Sinkhole at West Driefontein slimes dam

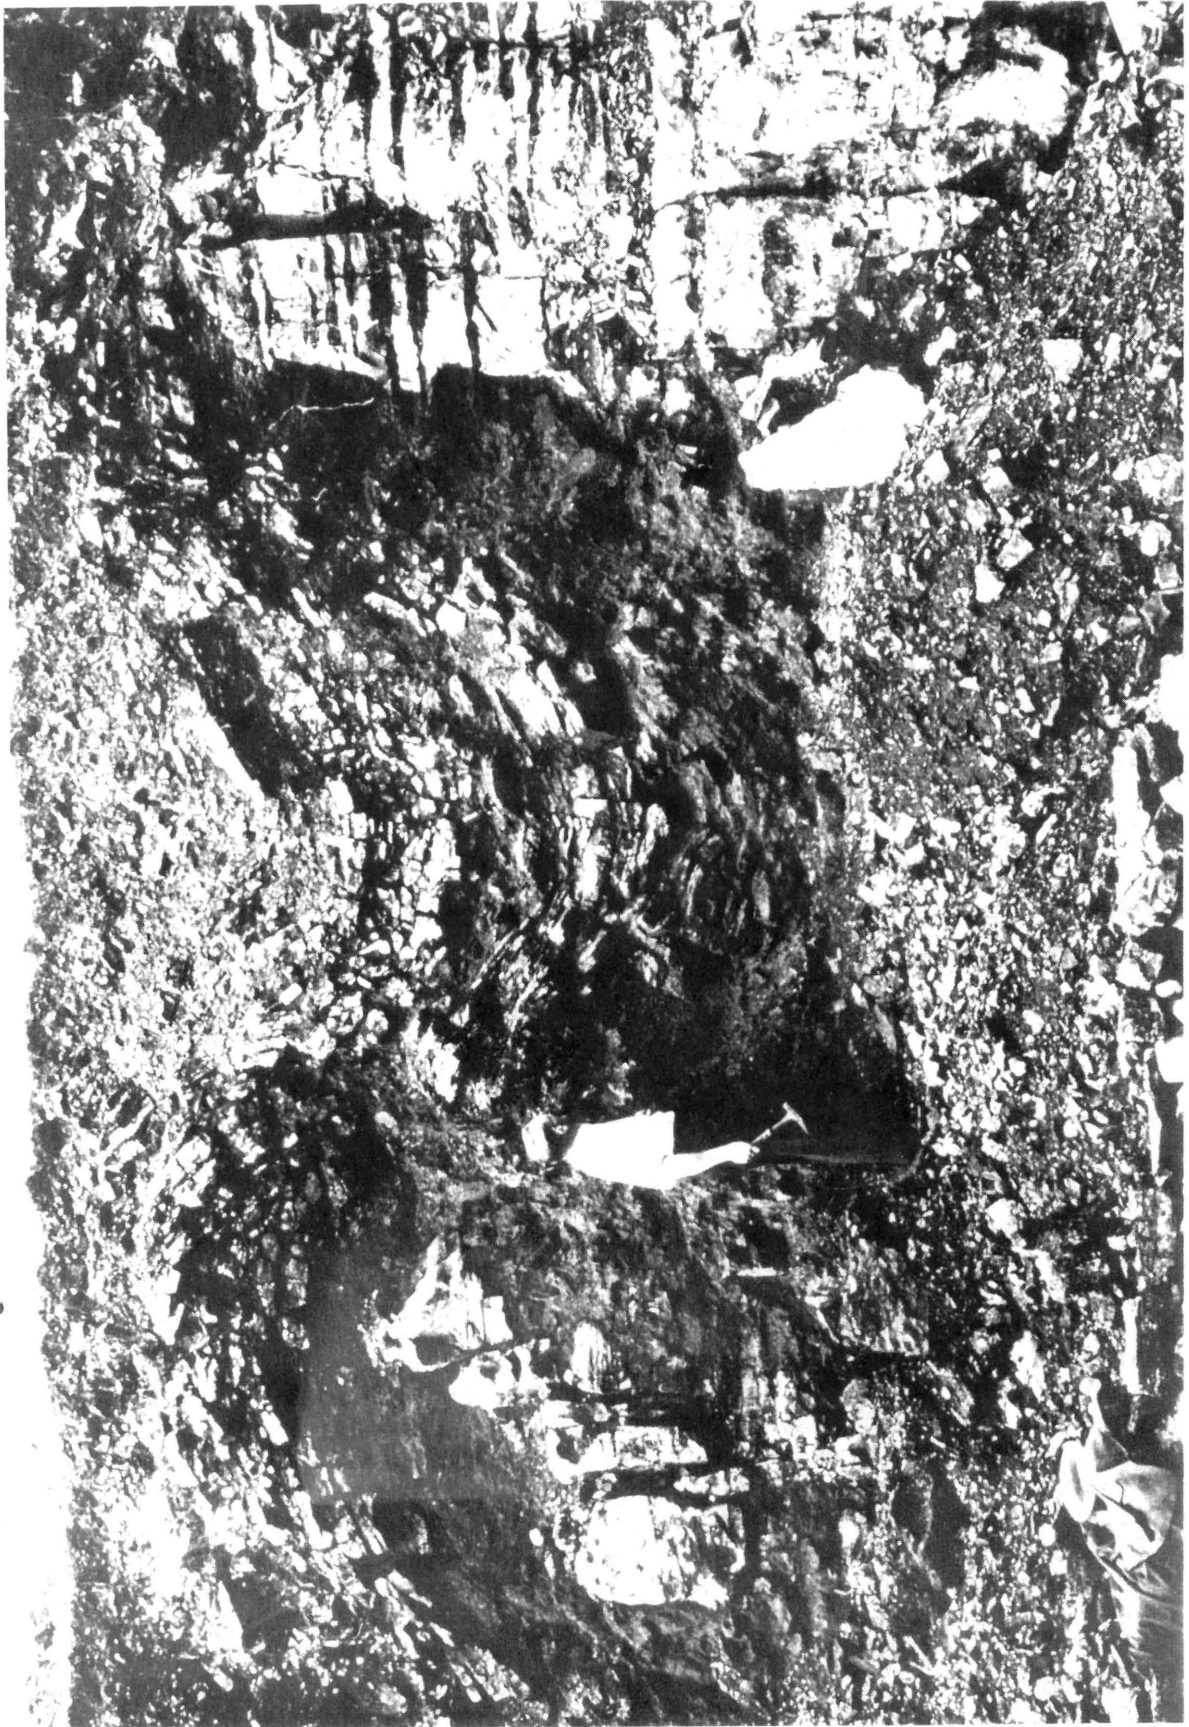
FIGURE 7/28 : Chert residuum sagging between pinnacles of dolomite in excavation for ore-bin at Vaal Reefs

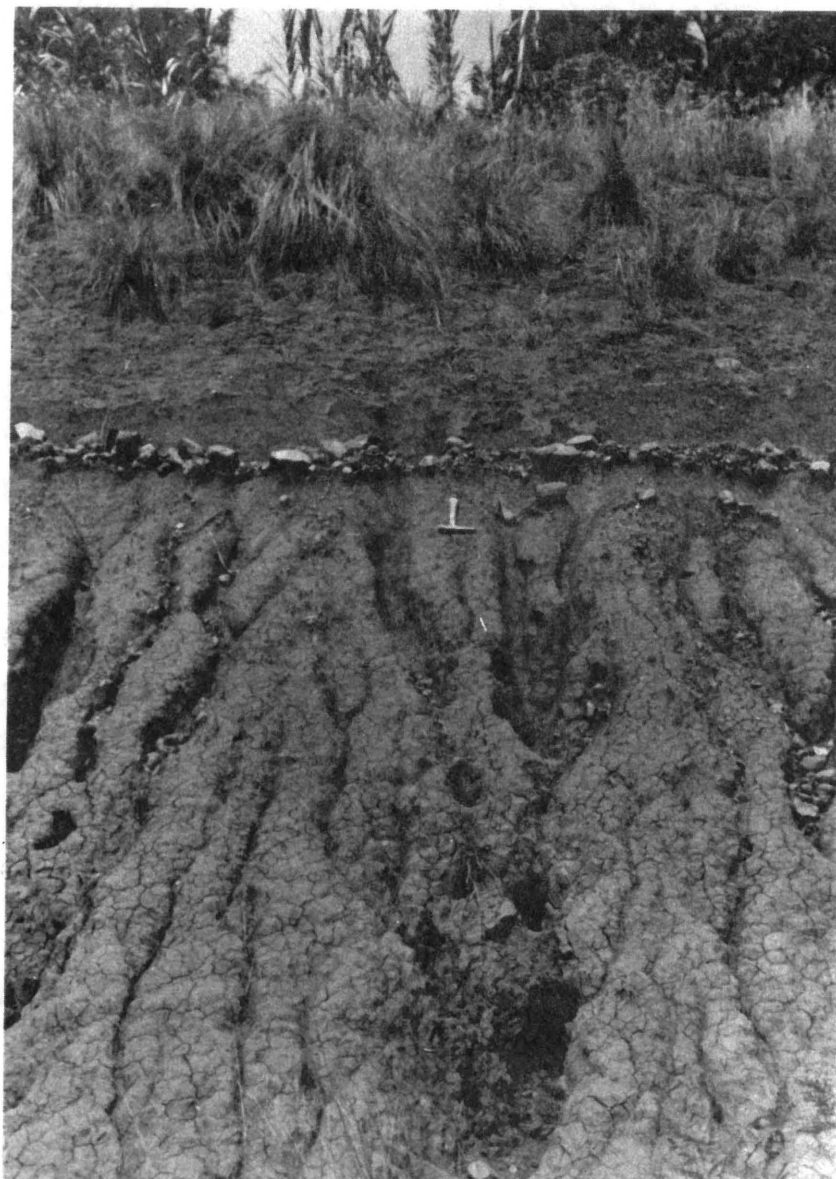
FIGURE 8/4 : Deep residual Ongeluk lava in road cutting north of Scientia, Pretoria.

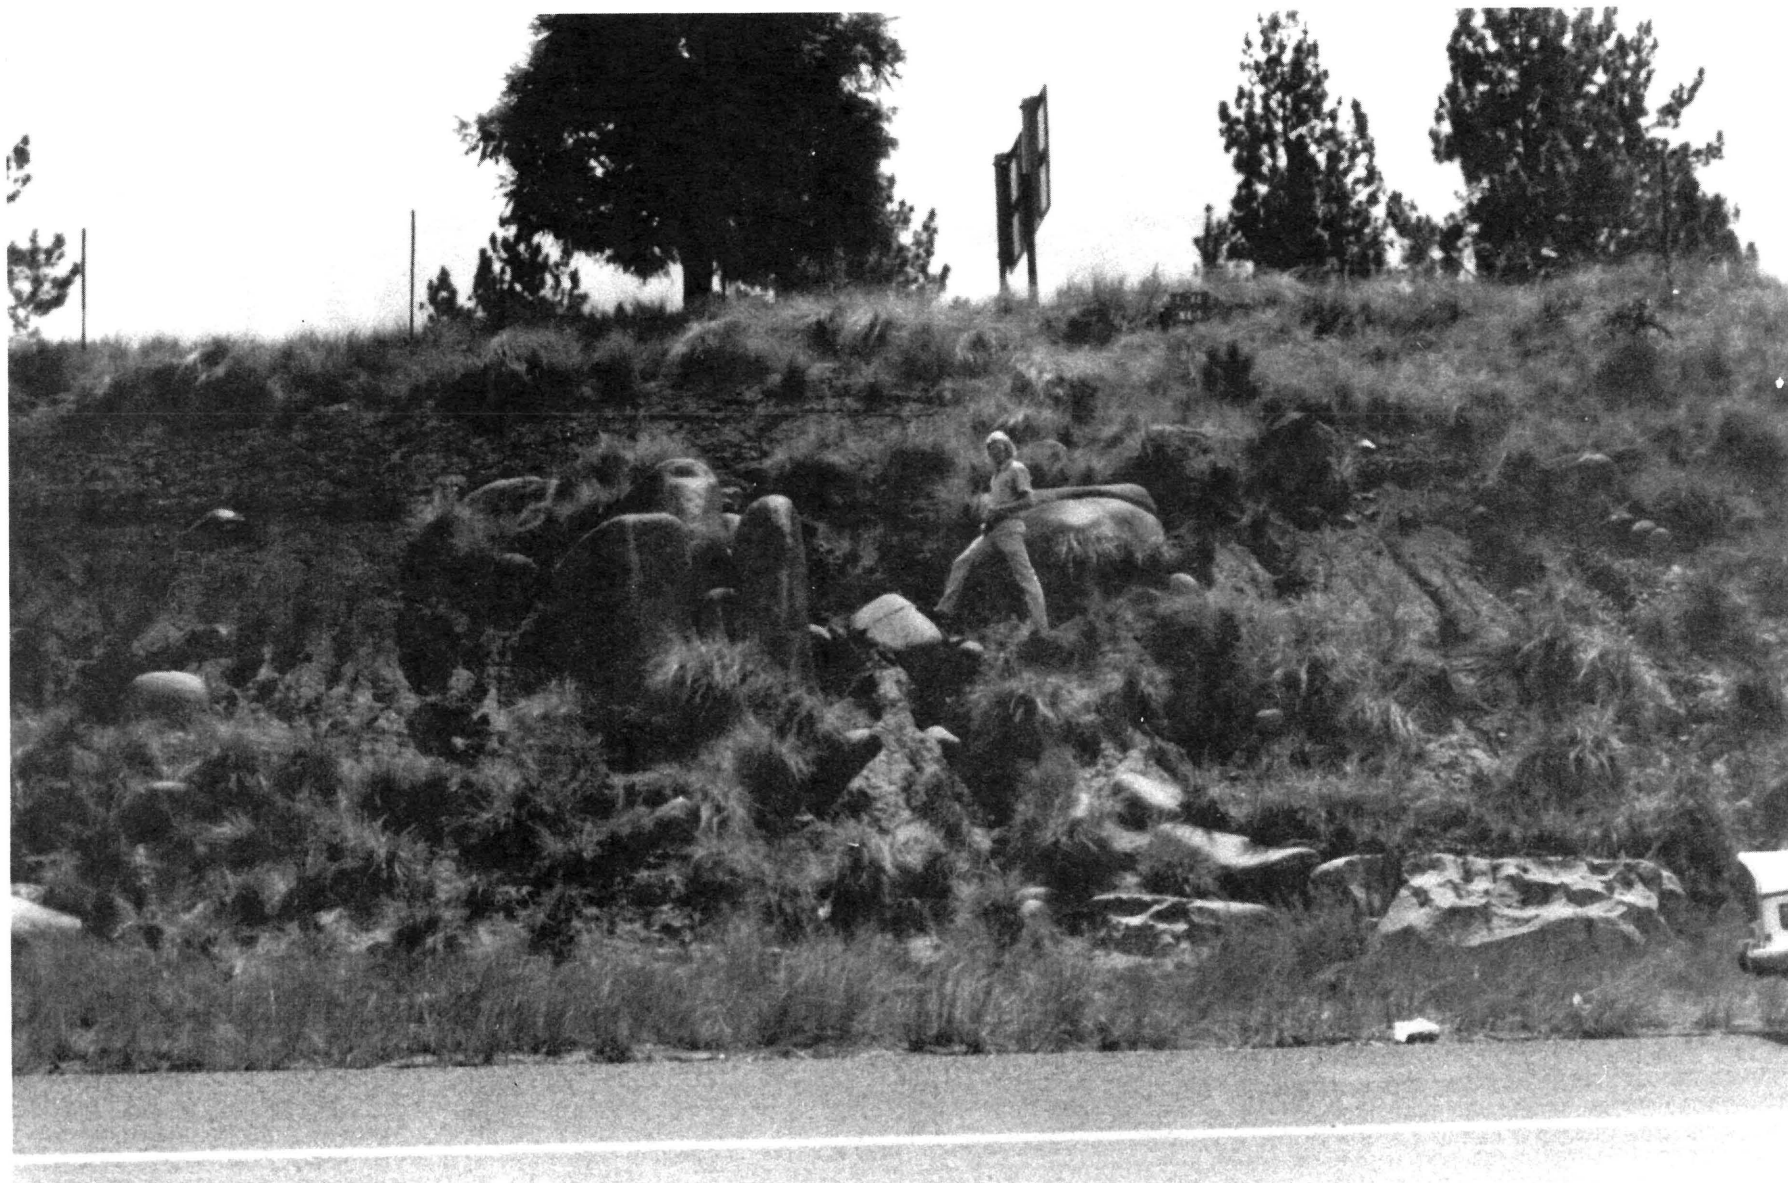
FIGURE 8/5 : Variable depth of residual Ongeluk lava, with bedrock pinnacles and weathering spheroids, in road cutting directly opposite the spot where Figure 8/4 was photographed in Pretoria.

of residual soil from the records of over fifty soil profiles on this formation in Pretoria is 33 m, of which the red zone occupies the upper 20 m. Over most of the area, however, the soils are very much shallower. Of the trial-holes which had been augered to refusal, relatively few encountered solid Ongeluk andesite or indurated shale: in most cases the auger refused on weathering spheroids of andesite. (See Figures 8/4 and 8/5).

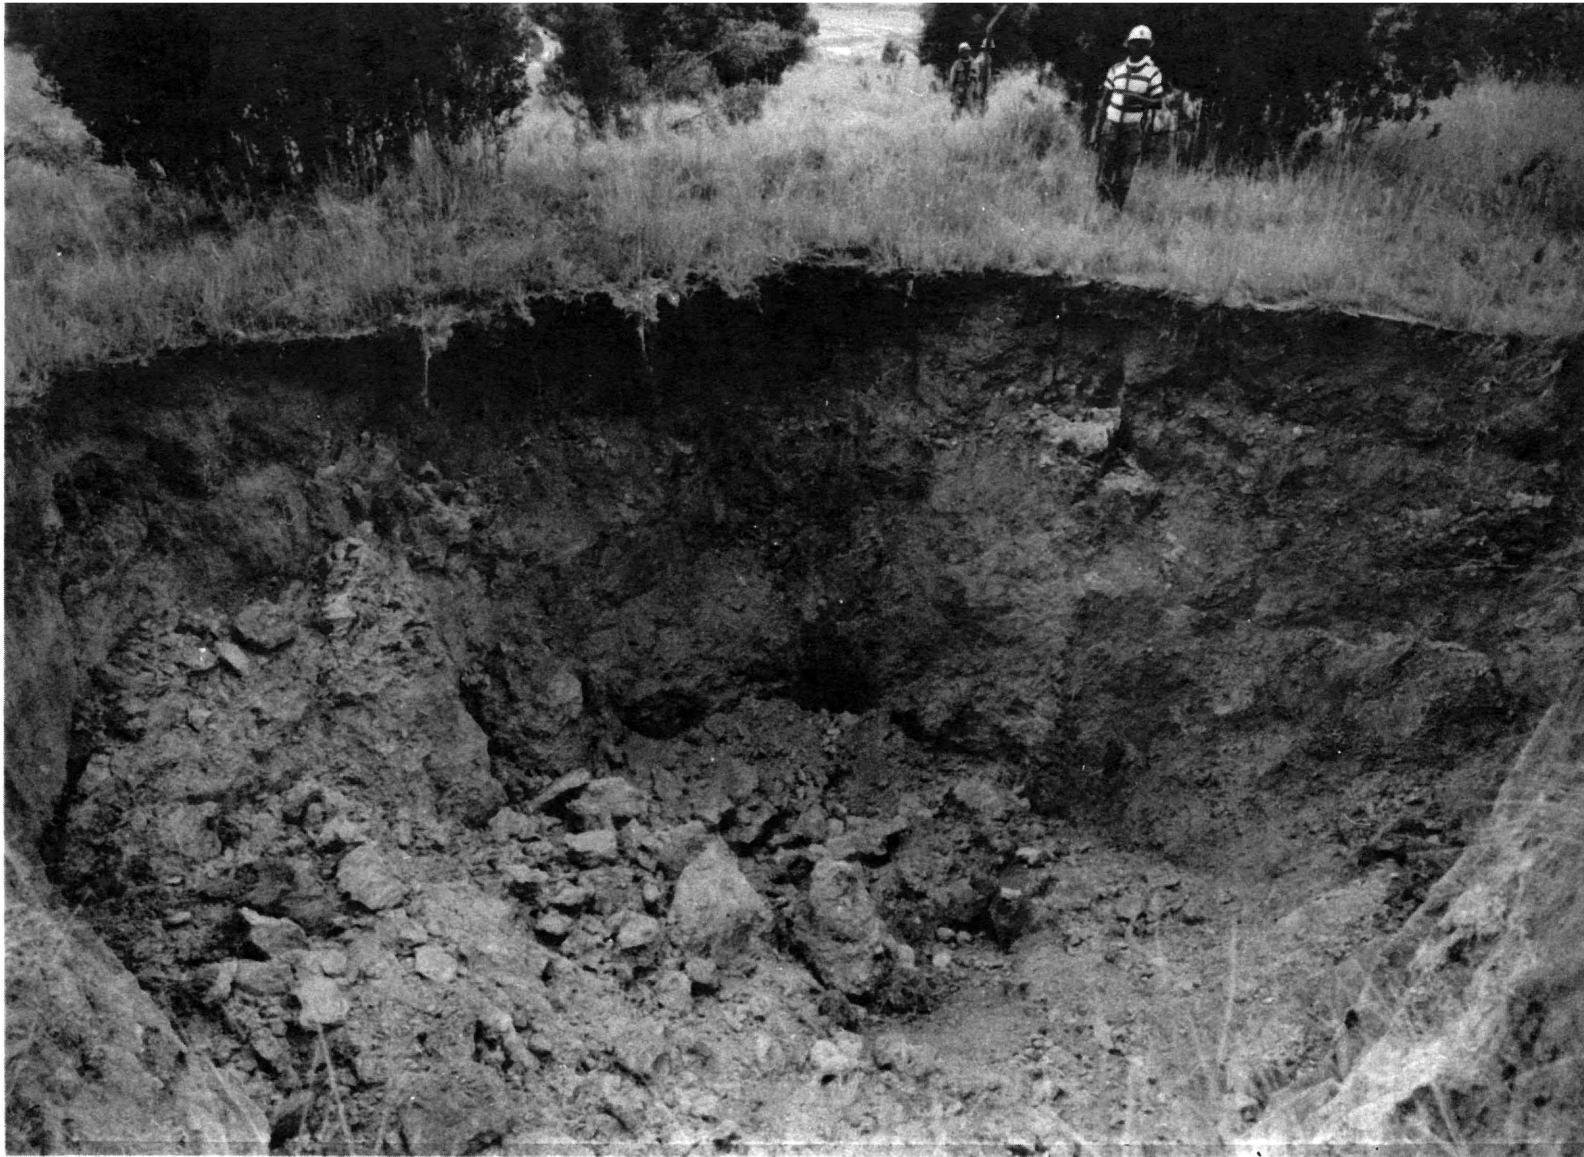
FIGURE 9/2 : 'Sinkhole' which appeared at the surface of a narrow decomposed diabase dyke as a result of flowage into a tunnel situated 15 m below the surface : Diepsloot Outfall Sewer, Witkoppen, Sandton, Transvaal (Photo by Gordon Douglas and reproduced by permission of the City Engineer, Johannesburg)

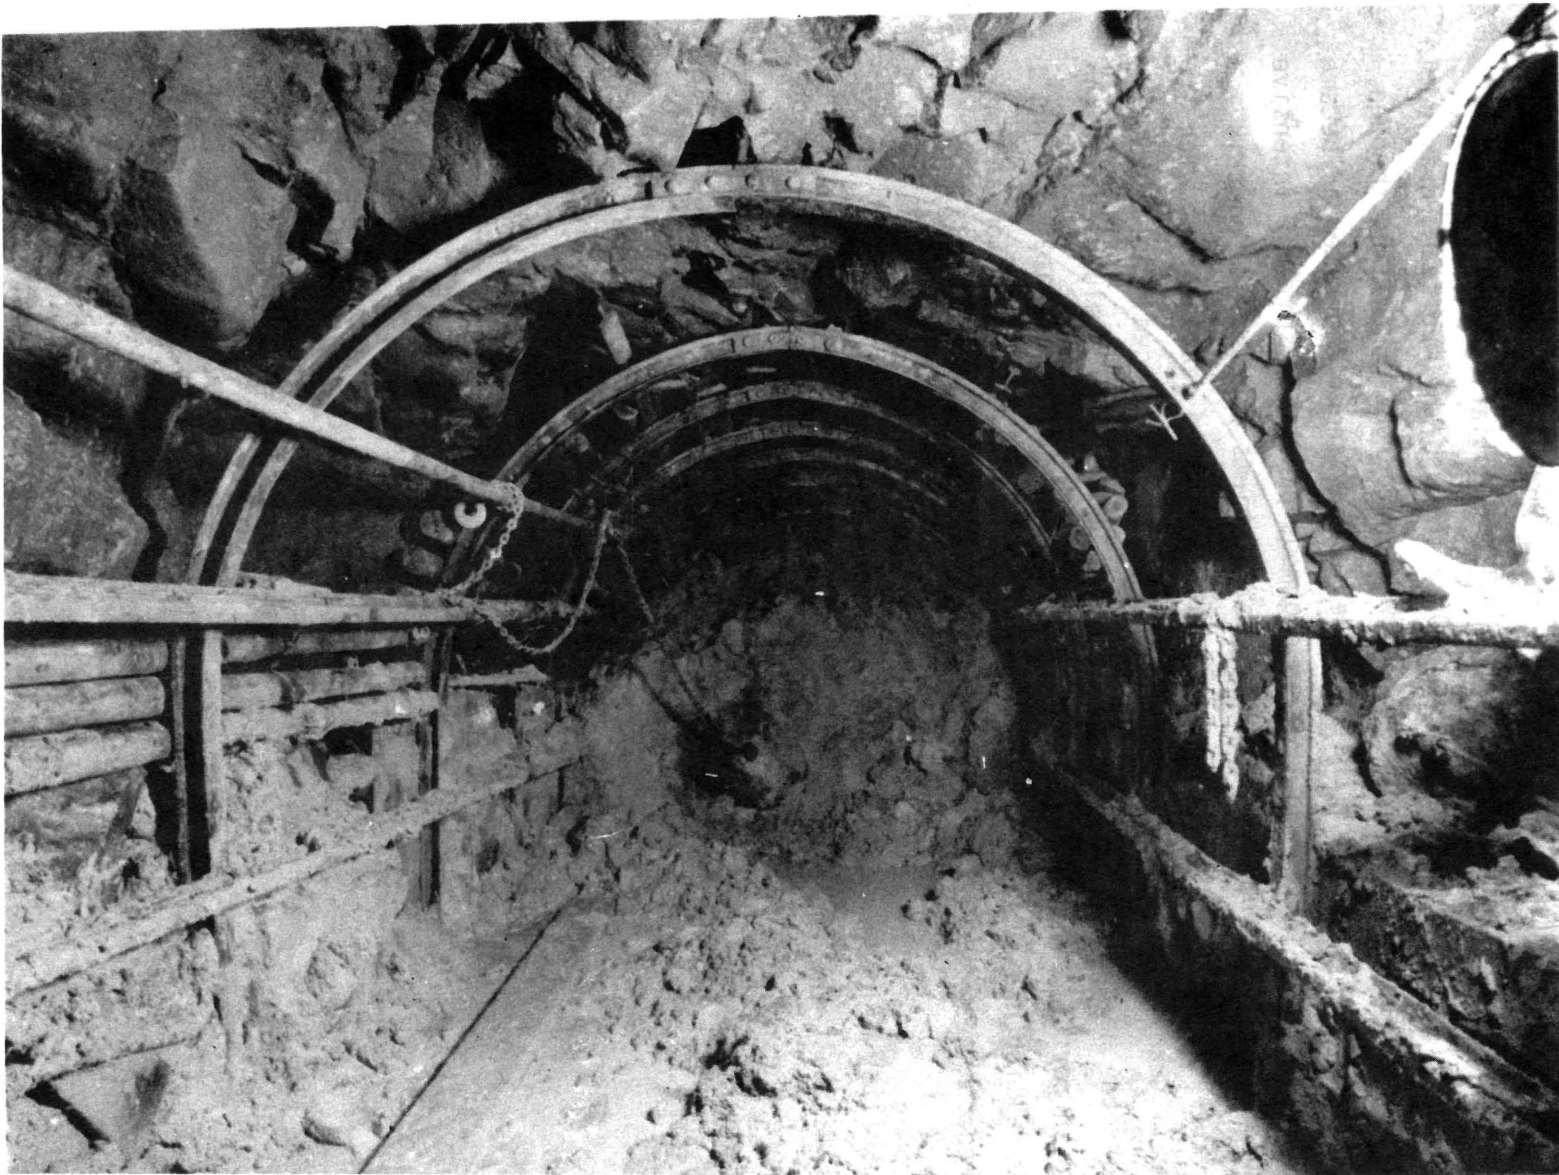
FIGURE 9/3 : Blockage in tunnel caused by mudrush from decomposed diabase dyke referred to in Figure 9/2.
