HOLISTIC APPROACH TO PEDESTRIAN SAFETY - MAUNDE STREET ATTERIDGEVILLE

H Visser and J Coetzee*

City Council of Pretoria
PO Box 1409 Pretoria 0001
*Innovative Traffic Solutions (Pty) Ltd
79 Watermeyer Street Val de Grace 0184

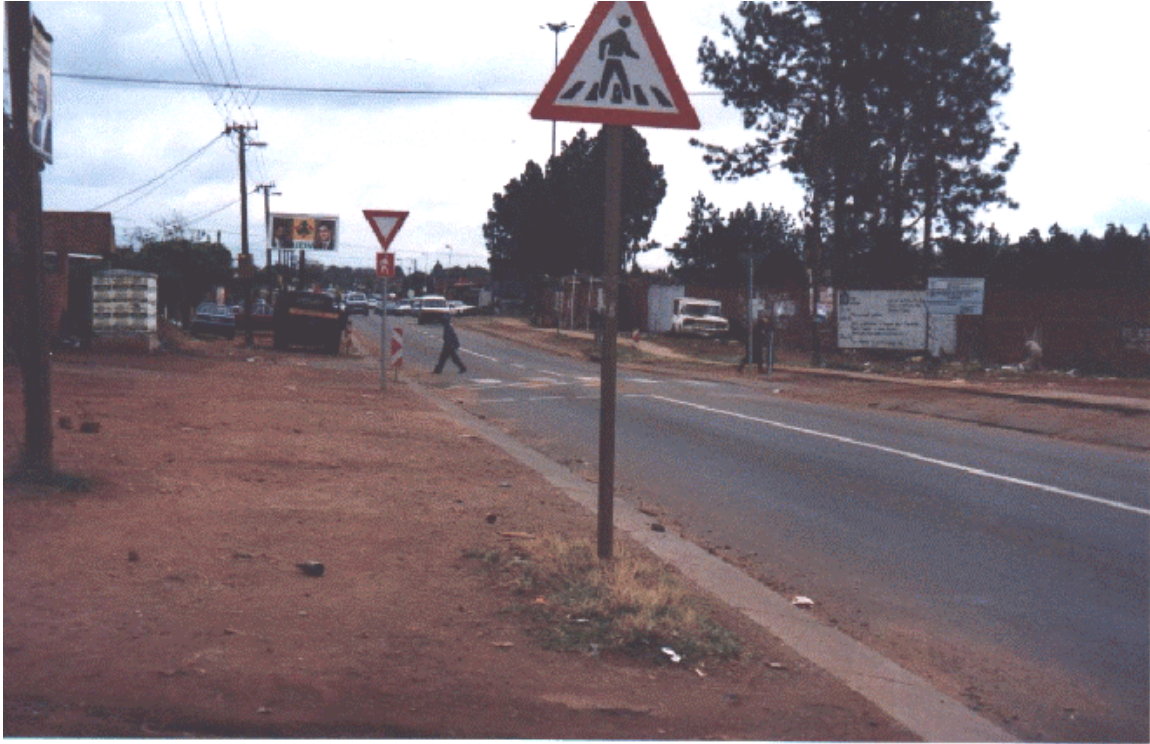
Photo 1: Pedestrian Crossing. Note unpaved sidewalks

There is no paving or grassing of the sidewalk other than where the pedestrian walkway is provided. The spacing between intersections is shown in Table 1 below. The typical sidewalks and intersections are shown in Photos 1 and 2.

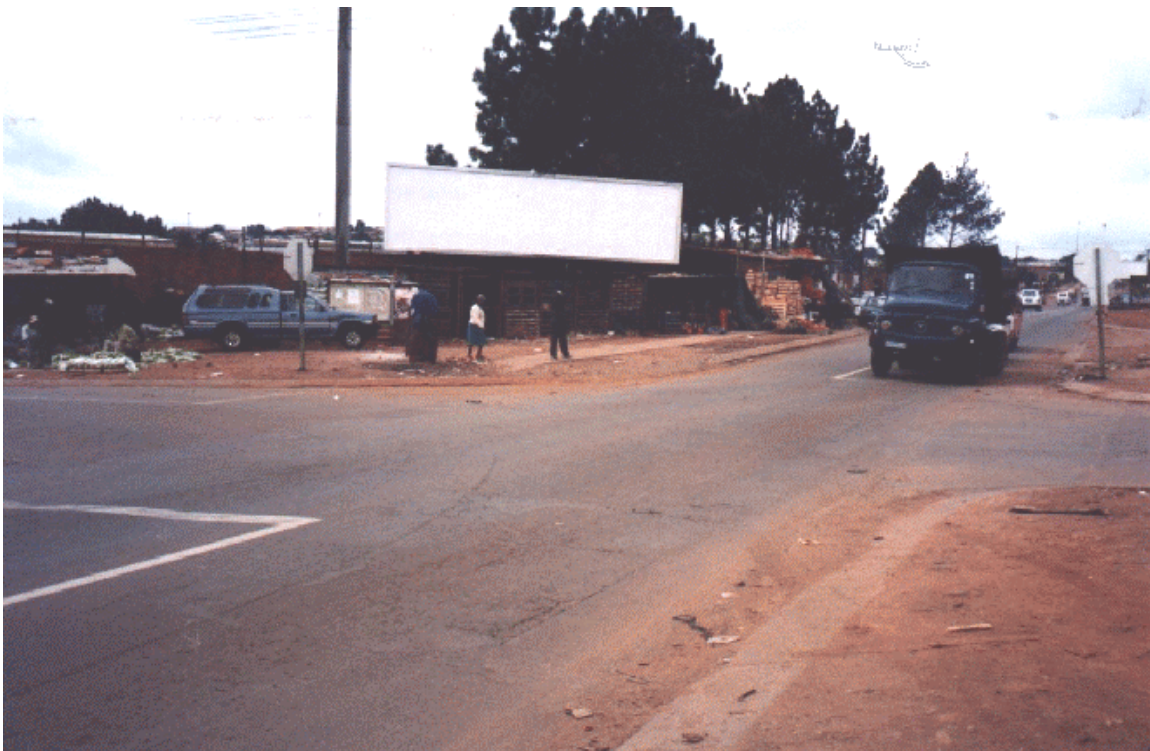
Photo 2: Corner of Hlahla- and Maunde Streets. Note mountable kerb with no protection to pedestrians, as well as hawkers.
