# The Most Common Defects on Housing Surfaces In Northern Cyprus

## **Abstract**

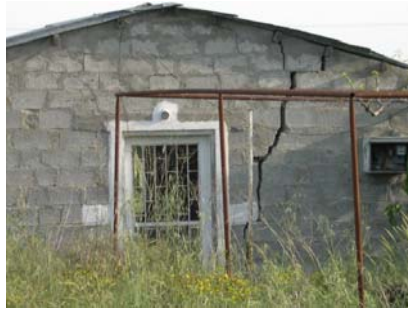
the soil. If the soil test is not considered, sometimes, due to the differential settlements, cracking may happen. For instance, clay type soil is a problematic one in which any change in the water content results in volumetric changes in the soil. Especially during the winter time, when it absorbs the water, volume of the soil increases. Sometimes, soil lifts only at the center of the building may take place according to drying out of the edges [3]. This creates cracks on the surface of the building (Figure 1). Crack width increases by rising depth of the building. If the clay soil at the center of the building dries out, the width of the cracks may be decreased by increasing the height of the building. Cracks may also occur at the corner of the building due to local lifting of the soil in this part of the structure.

Figure 1 : Crack on the building surface (left side) and on the plain concrete on the ground (right side).

For a proper footing design, a soil test is deemed necessary. In Northern Cyprus, occasionally footings are so designed without making any soil test and with a lack of information about the characteristics of

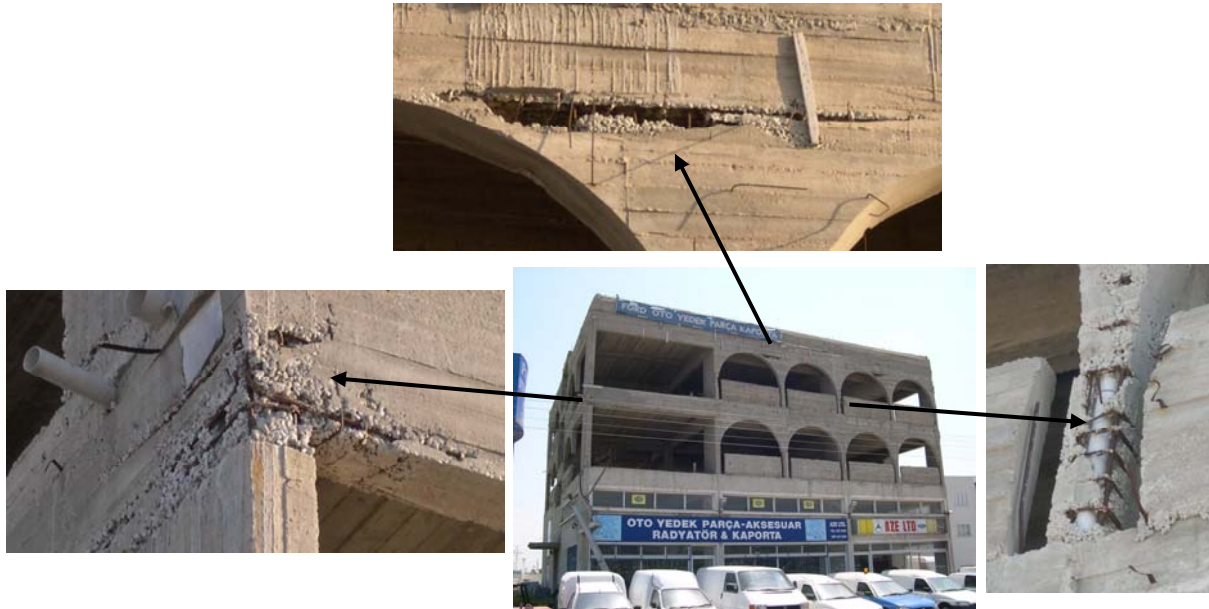
One of the most common defects in buildings is called honeycombing (Figure 2). It is the concrete in which mortar is not filling the spaces between the coarse aggregate particles. In Northern Cyprus, the use of ready mix concrete has been expanding recently. The reason for this problem is attributed to poorly grade concrete mix at the construction site, insufficient spaces between the bars, insufficient vibration and drainage from the gaps and connections of the timber formworks.

Figure 2: Honeycombing and compaction problems.

Insufficient compaction always creates serious problems (Figure 2). In some of the construction sites vibrators are not even used. Also, errors made at the construction site such as adding improper amounts of water to the concrete mix, are frequently observed. This creates a very permeable concrete, especially in slabs, therefore damped proof course is always necessary.

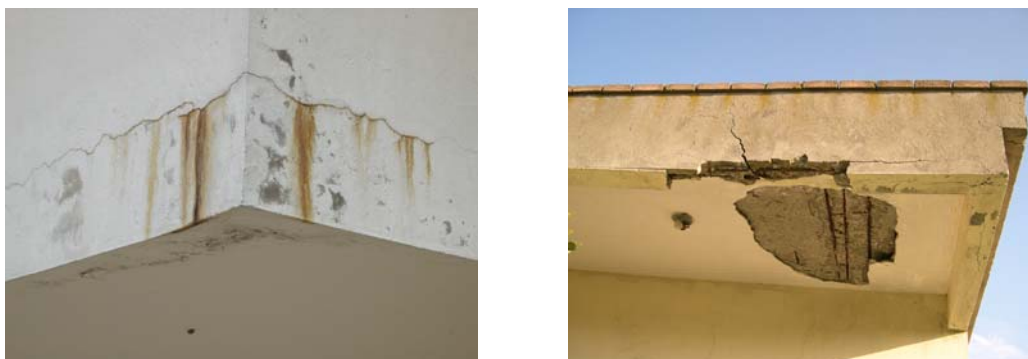
Corrosion of steel results in a two to four fold increase of the volume of steel (Figure 3). Hair-line cracks or rust stain is the sign of corrosion. It gradually destroys the bond between concrete and steel and also spoils the concrete cover. Mainly, corrosion is due to chloride contamination, carbonation of concrete and intrinsic cracks and deterioration in service [4]. Water, oxygen and destruction of the passivation layer are necessary for corrosion of the reinforcement in concrete. In order to protect steel from corrosion, the quality of concrete should be increased, permeability of concrete decreased and the concrete cover of reinforcement increased.

Figure 3: Corrosion of steel.

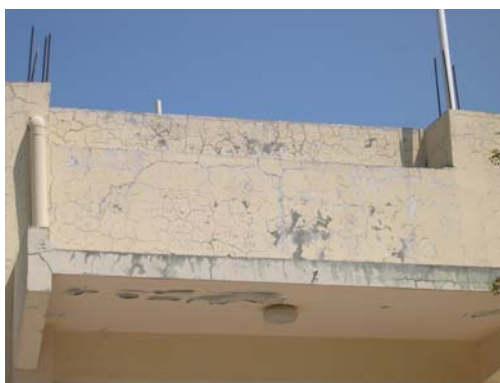
Craze, plastic shrinkage, drying shrinkage, thermal and moisture movement cracks are commonly observed on cementitious surfaces (Figure 4). The following are common causes of concrete cracking: failure in proper control; carelessness made on to the points of stress concentration (e.g. around openings); excessive cement and water content; inadequate or no curing; temperature rise; and inadequate provisions in the design (e.g. related to thermal movements).

Figure 4: Craze type of cracks.

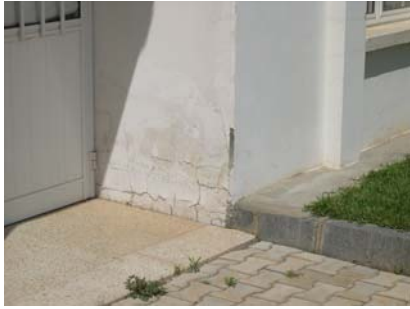
This originates mostly from the ground or other sources that draw the moisture up through the permeable masonry. Rising dampness is the other factor that creates several problems on housing surfaces. It is effective both on the exterior and interior finishes. It creates staining on the surfaces and

crumbling of the render (Figure 5). Due to rising damp, soluble salts are carried up to the surface layer where the damp evaporates (Figure 6).

Figure 5: Render damage due to rising damp.

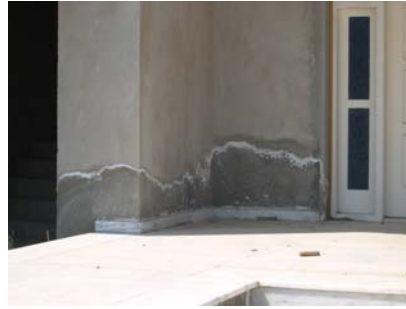
Figure 6: Efflorescence due to rising damp

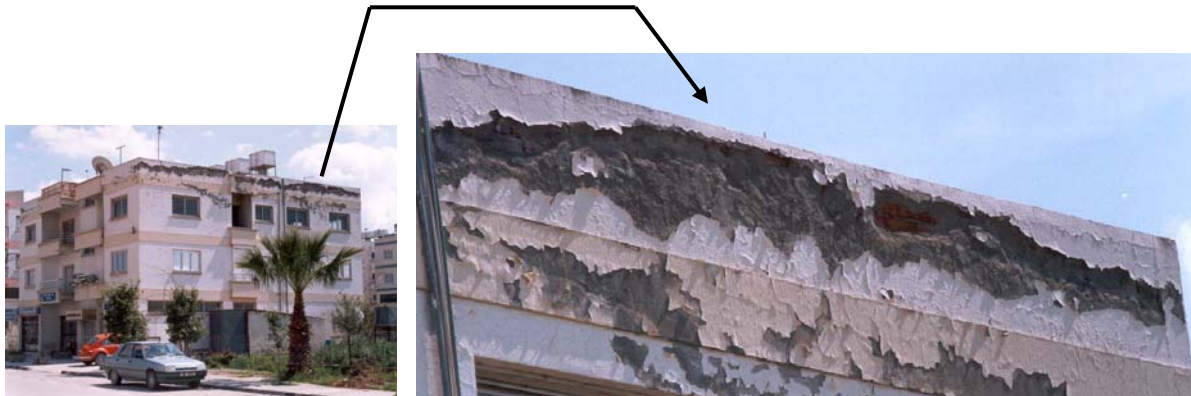
Penetrating dampness also creates very significant problems on concrete surfaces. Depending on the departures from the material specifications (e.g. inadequate cement, excessive water), the penetration of dampness and lack of periodic maintenance, result in deterioration of the concrete surfaces (Figure 7). If deficiency in the workmanship of the brick walls exists, the thickness of the render is increased to have better surfaces. This creates cracks and even sometimes detaches the render.

Figure 7: Deteriorations on the concrete surfaces.

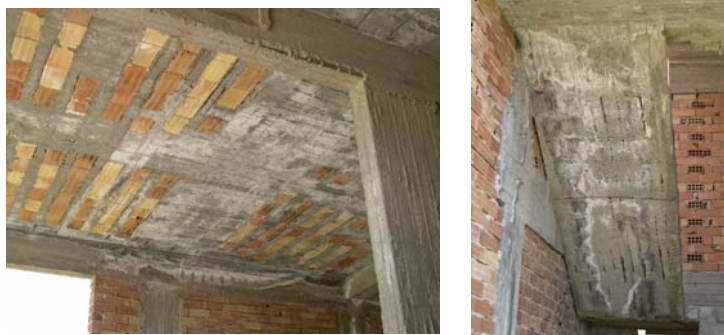
Figure 8: Efflorescence on the concrete surfaces.

This refers to the white calcium carbonate deposit on the concrete surfaces. During the drying process, permeable concrete continuously leaches the calcium hydroxide to the surface. Its reaction with the carbon dioxide in the air creates the calcium carbonate deposits on the surface [5] (Figure 8). Efflorescence can usually be removed by brushing or washing.

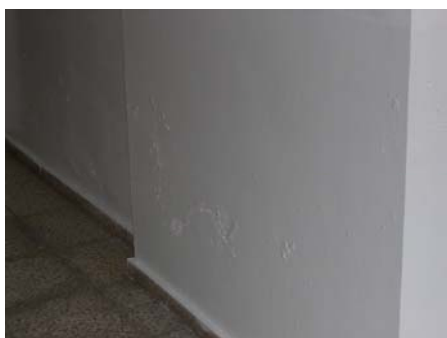
Defects on the paintwork mainly occurs because of the problematic painting surfaces, climatic conditions and painting methods. Periodic maintenance is important. The defects occurring on the paint gradually spread to the other layers of the surface. Therefore, if the problem is not solved at the start, a series of problems continue to happen in consequence causing the maintenance expenses to increase. The most commonly observed defects related to paintwork are: flaking, blistering of the paint, peeling, cracking, brush and other marks and mildew on the paint (Figure 9 & Figure 10). They are due to loss of adhesion between paint film and the surface, presence of moisture on the surface, presence of trapped air, differential movement, application of thick paint coat, un-dried undercoat, poor workmanship, and humidity and temperature that lead to fungal growth.

Figure 9: Blistering on a painted surface.

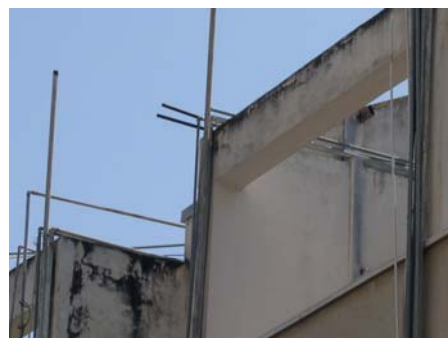
Figure 10: Fungal growth on a painted surface.
